Pre-application Proposal

Site Pictures of Building One

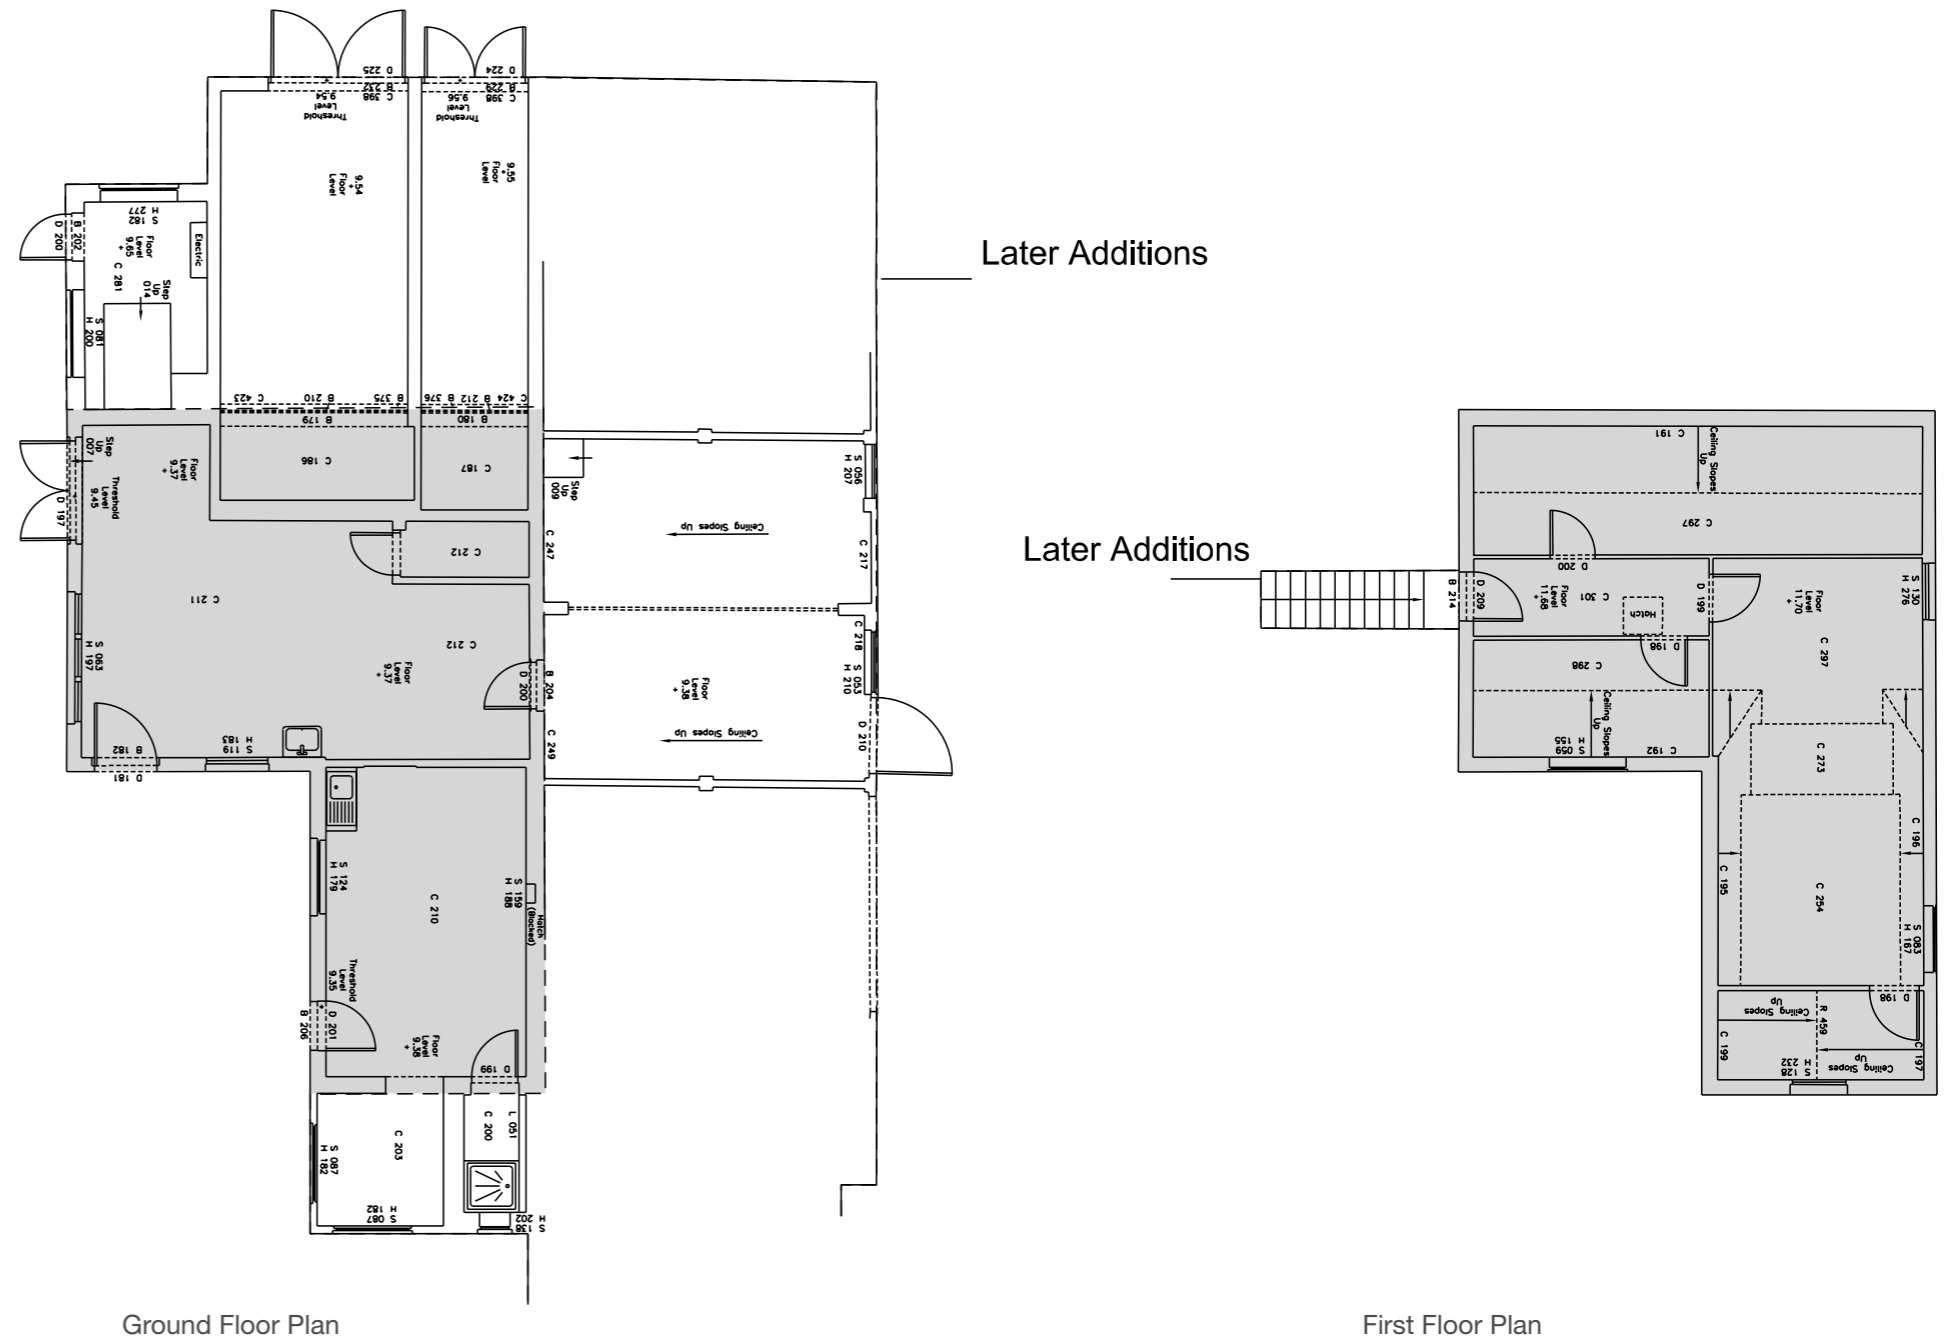
The original building footprint is shown toned in grey. At ground floor the original building is surrounded on 3 sides by extensions.

Openings have been cut into the ground floor walls to connect the extension to the existing building.

New walls have been constructed internally and existing staircase or features removed.

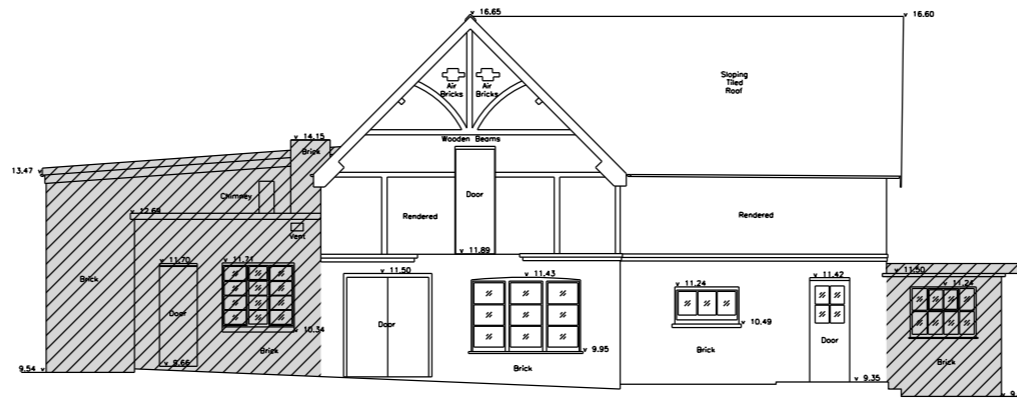
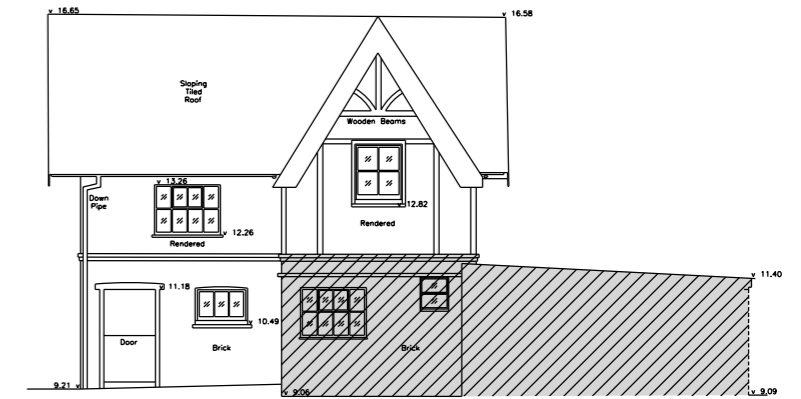
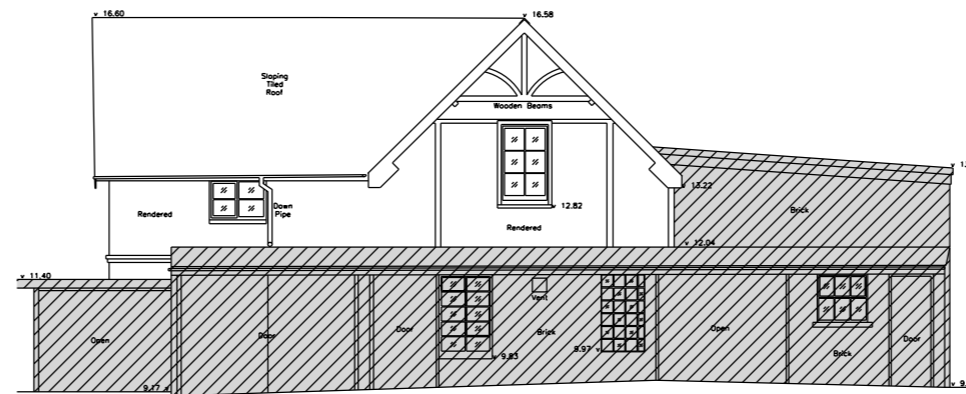
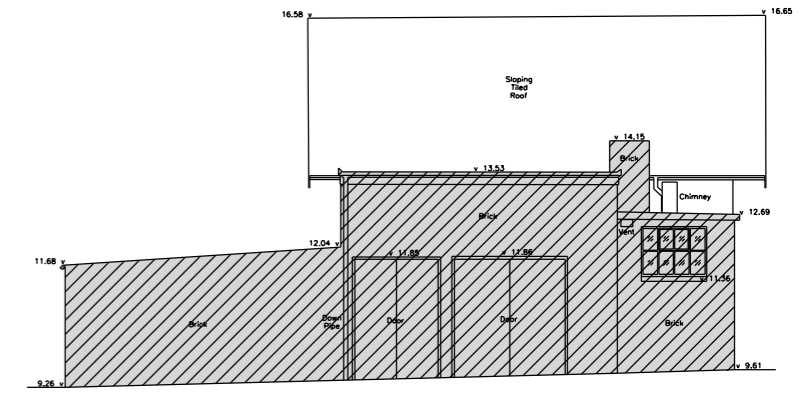
The hatched areas show later extensions – around 45% of the original elevations are obscured. RSK have surveyed the condition of the existing building which is summarised here:

'The original structure has obviously gone through various additions. However the main roof, with its timber framed walls with masonry infill on the first floor, has lost its structural integrity and it will not be cost effective to improve on the integrity.'

1. New roof required with new structural members to comply to the current codes of practices
2. First floor wall would require virtual rebuilding.
3. Ground floor walls require strengthening/rebuilding
4. Lintels require to be replaced
5. Ground floor slab required to be rebuilt
6. Ground floor to ceiling height not adequate if there is any alterations to the floor
7. First floor timbers need strengthening and tying into external walls.'

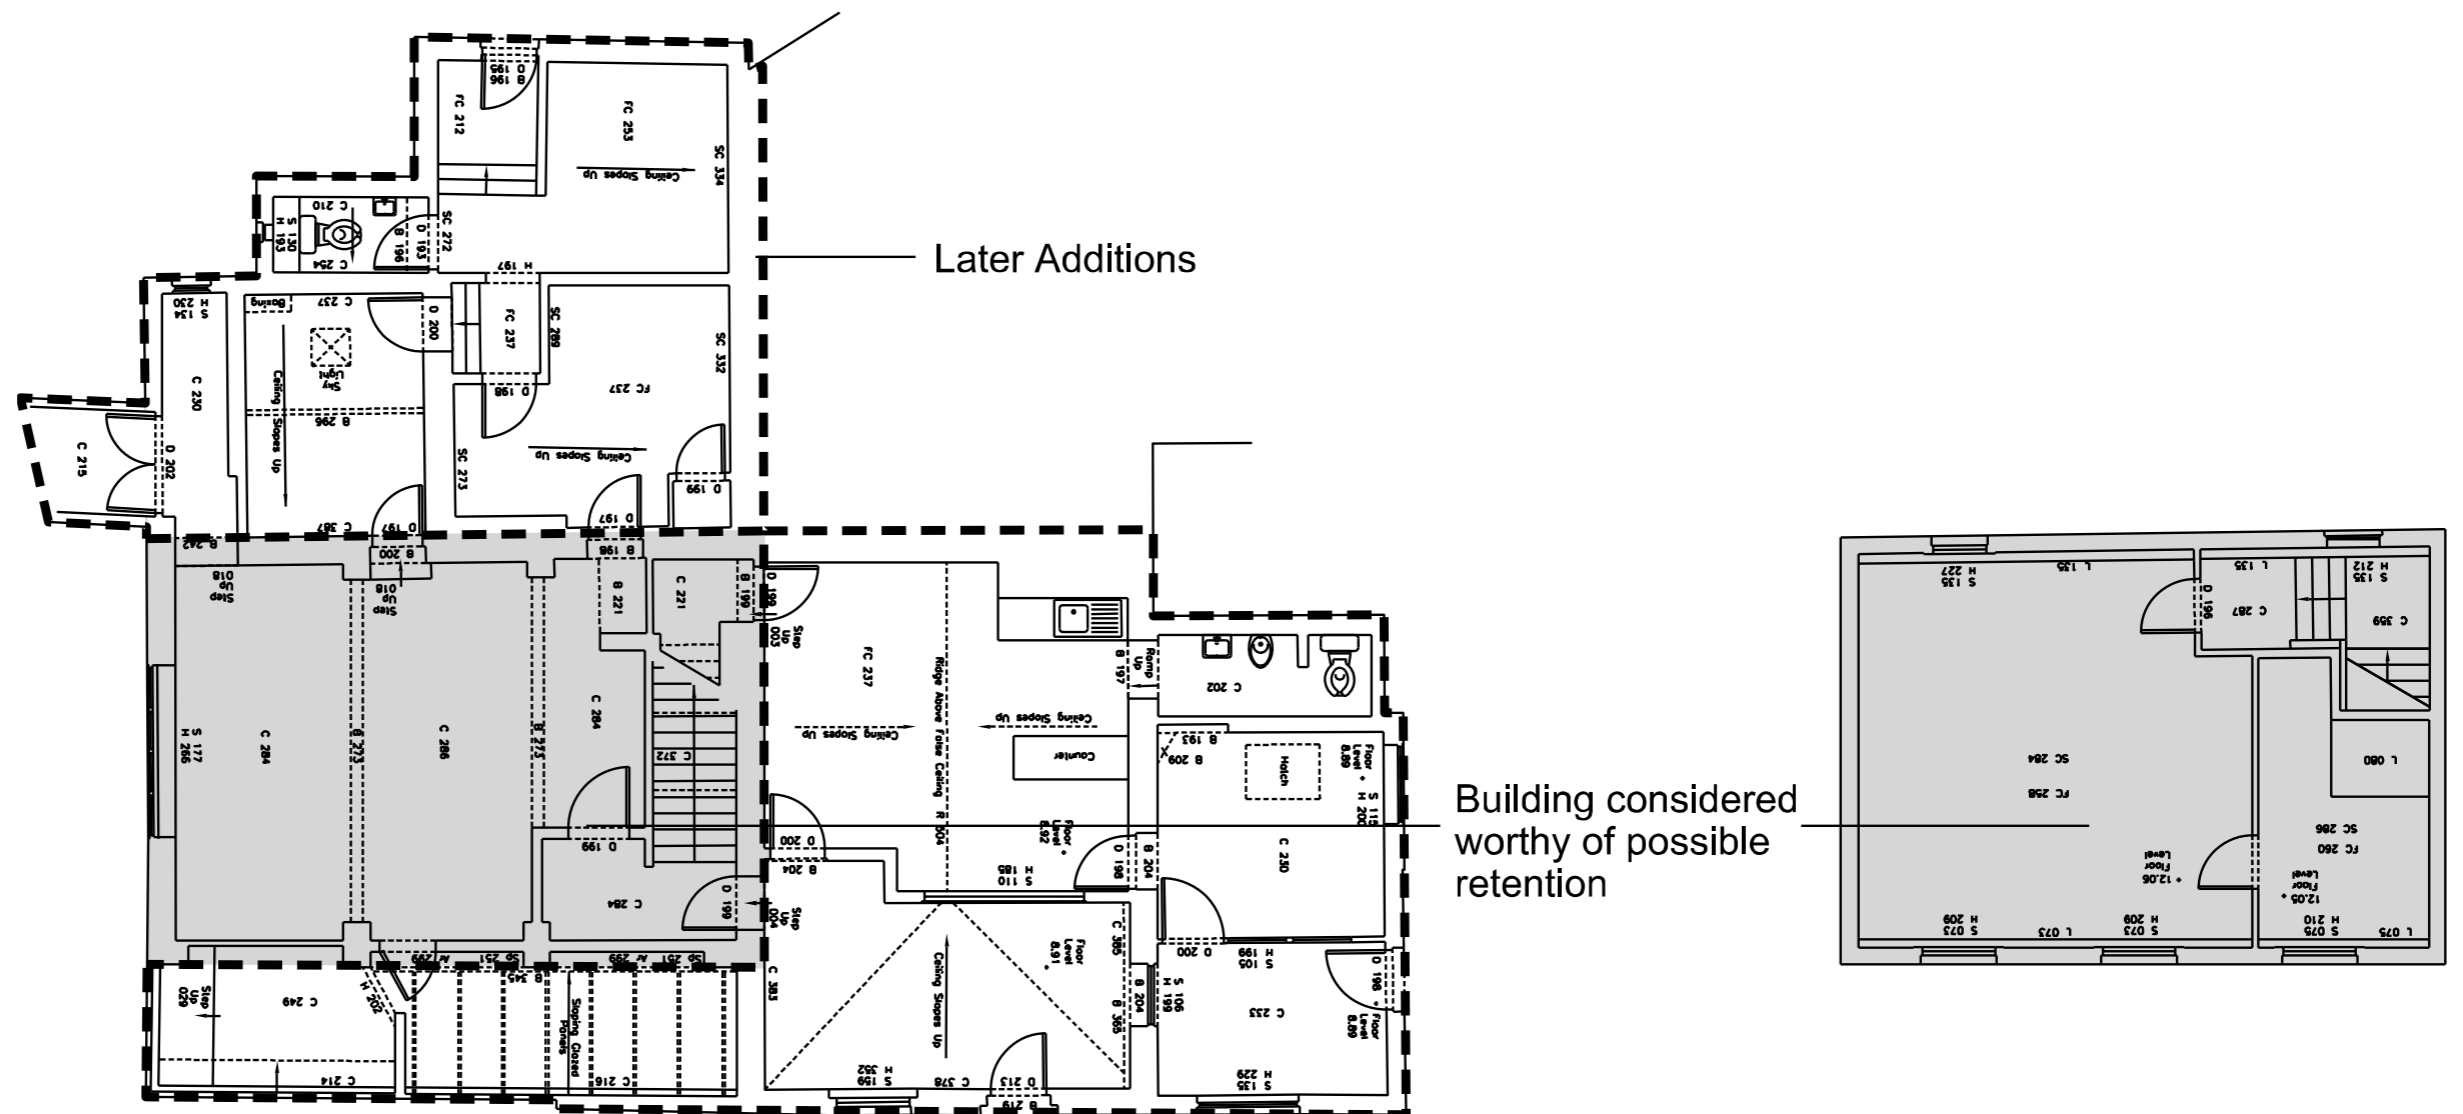
The identified building is shown greyed out on the plans below. The building is surrounded on 3 sides by later extensions. The original internal walls have been removed and new walls and concrete staircase inserted.

New openings have been formed at ground floor to connect the existing building to the surrounding extensions. At first floor all internal walls have been removed, new walls built and a concrete stair inserted.

The original brickwork on the external, now internal walls, have been rendered and painted.

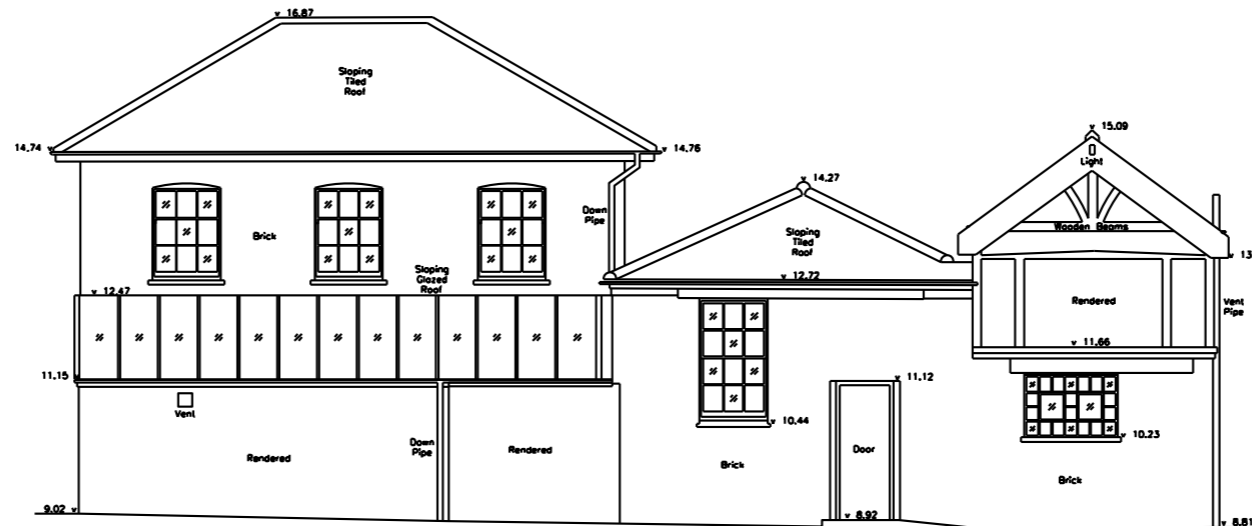
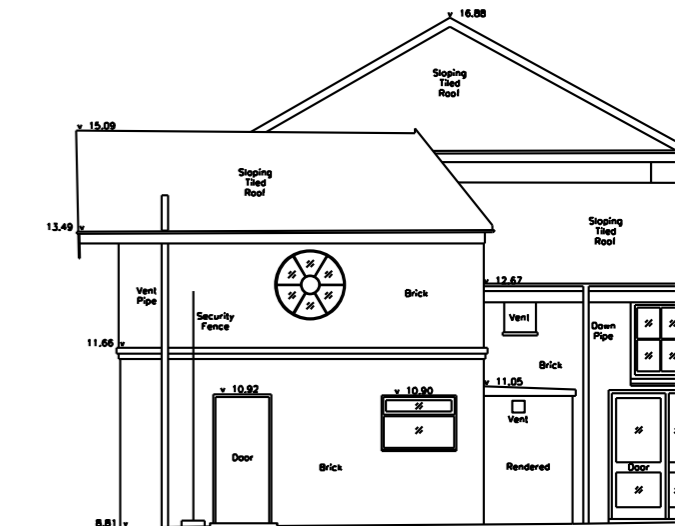
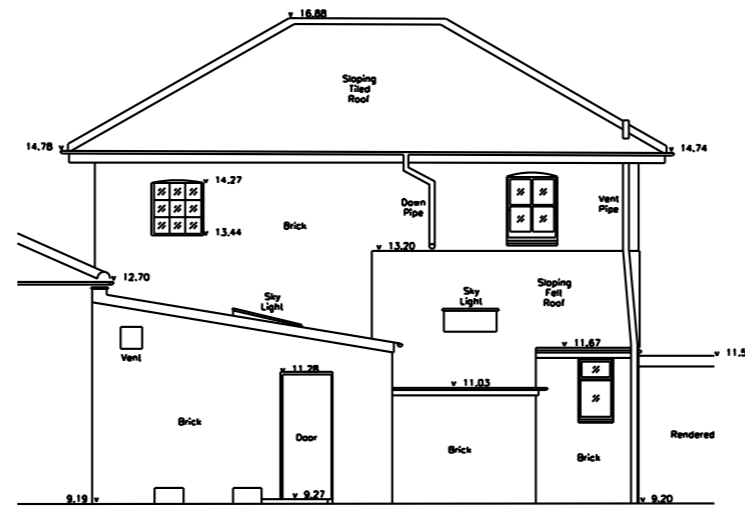
The main part of the structure ie the rectangular core has been altered heavily by the removal of internal walls and replacing with beams. Therefore on one side the structure is left with 2 piers with 3 arched features, currently possibly restrained by the internal stud walls in both directions. Therefore any attempt to remove any part of the structure including the internal walls would seriously impinge on the structural integrity.

As it stands, the high level arched window openings are already showing signs of distress in the way of cracks.

On the first floor level, cracks are evident above the windows. The window frames with their sash windows require replacement. The brickwork either side of these windows are already showing signs of distress and losing their structural integrity. The thickness of the upper floor walls reduces in thickness towards the top starting from approximately at the window cill level. Therefore it would be virtually impossible to justify the structural integrity of the wall using the current codes of practices especially if the roof hasn't been tied in horizontally at ceiling level. The wall will require strengthening by way of thickening the walls and/or adding wind posts.

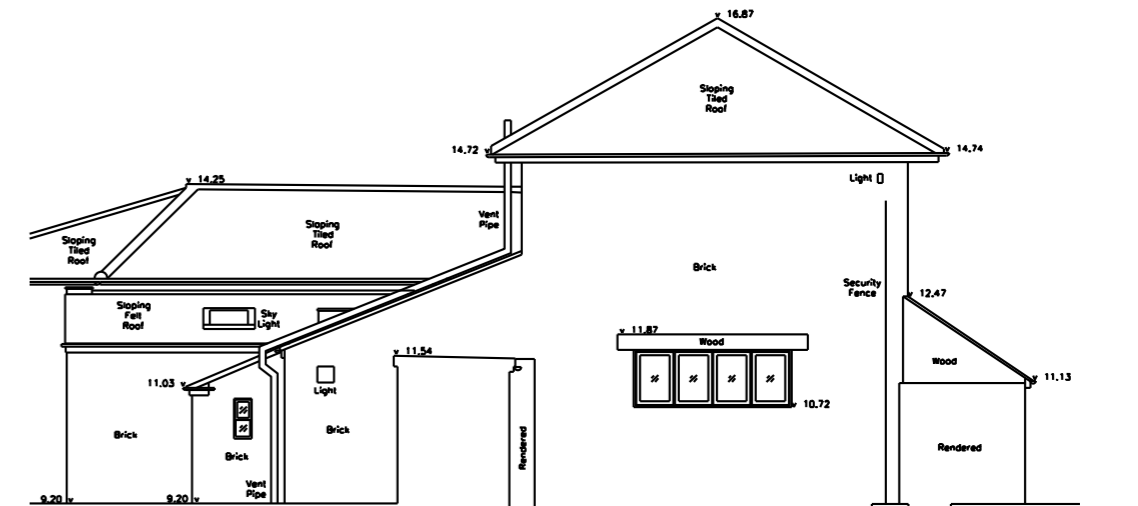
Elevation 4

As evident from elevation 4, the bearings on both ends of the lintel has been badly disturbed to the extent that it would require propping and rebuilding. The base of the brickwork would require attention to avoid any water ingress.

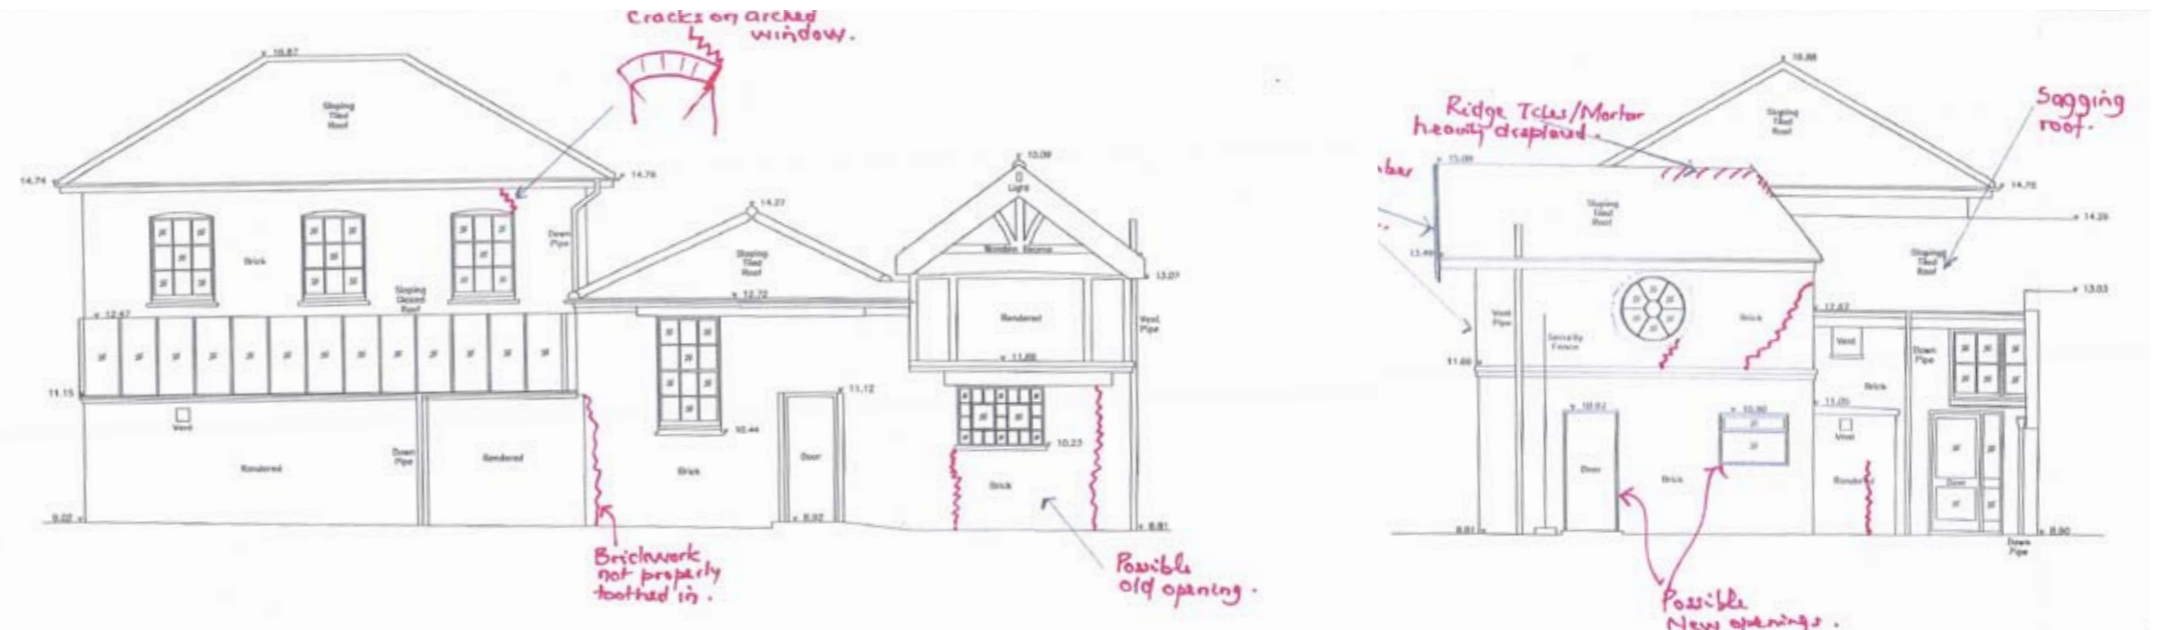
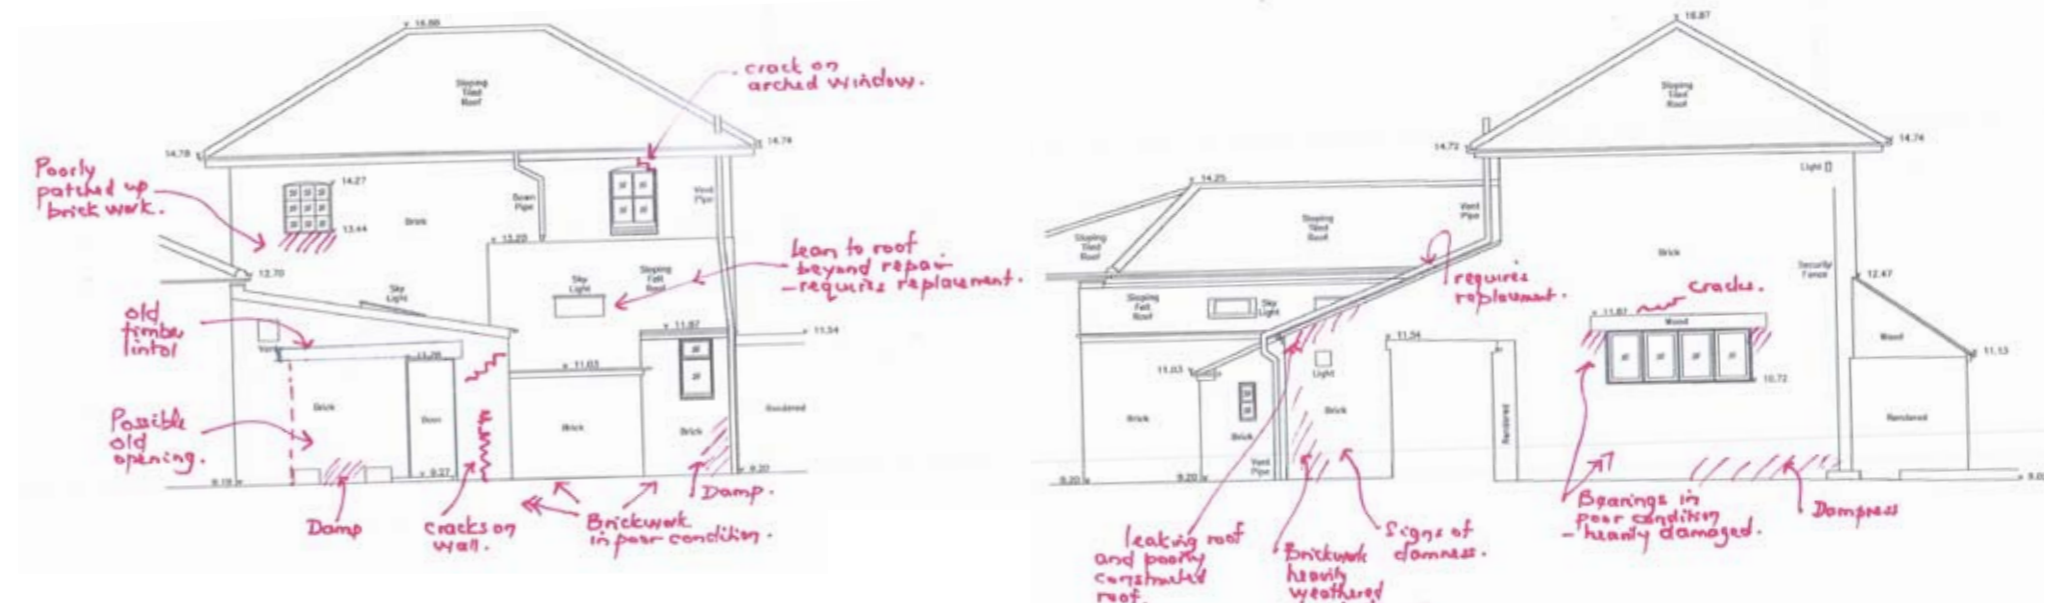
Rising damp seems to be common problem on all external and internal walls. Therefore all plastering need to be removed to the brick face and a chemical injection added to provide the damp proof course. To avoid any damp problems though the ground floor, some form of damp proof membrane need to be provided and lapped onto the new damp proof course on the walls.

The lean to roof at the back with its roof coverings/ roof lights is beyond repair and would need to be completely replaced with proper fascia /soffit boards and to comply with the current thermal requirements. The ring damp, the dampness due to leaky roof and the various structural alterations by way of bricking up the old openings have destroyed the structural integrity and the fabric of the external walls and it is my opinion that they will have to rebuilt if the existing outline of the building is to be kept.
