Our ref: 14120/DIC/JMC  
9<sup>th</sup> July 2012

12 / 2968 / FULL

REPORT ON  
STRUCTURAL APPRAISAL  
OF  
THE OLD SCHOOL  
PARK LANE  
RICHMOND  
TW9 2RA

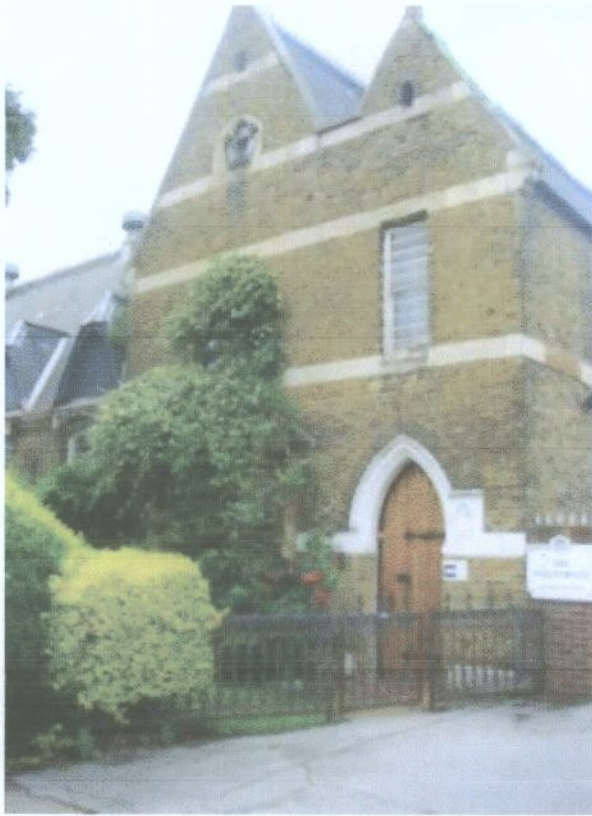
1

### **Front Elevation Headmaster's House (see photograph 1)**

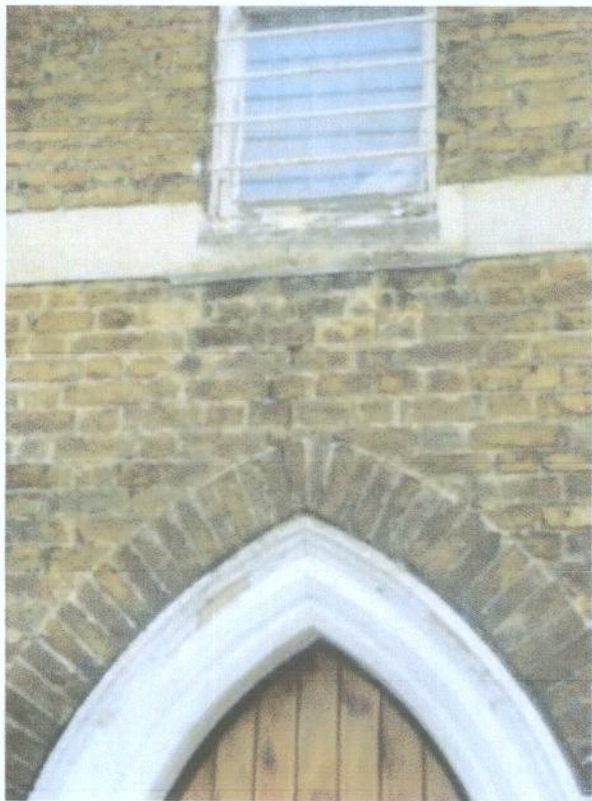
2. The crack continues through the stone windowsill as a 3.0mm wide vertical crack (see photographs 2 and 3).
3. The left-hand side of this windowsill has dropped approximately 10mm relative to the right-hand side.

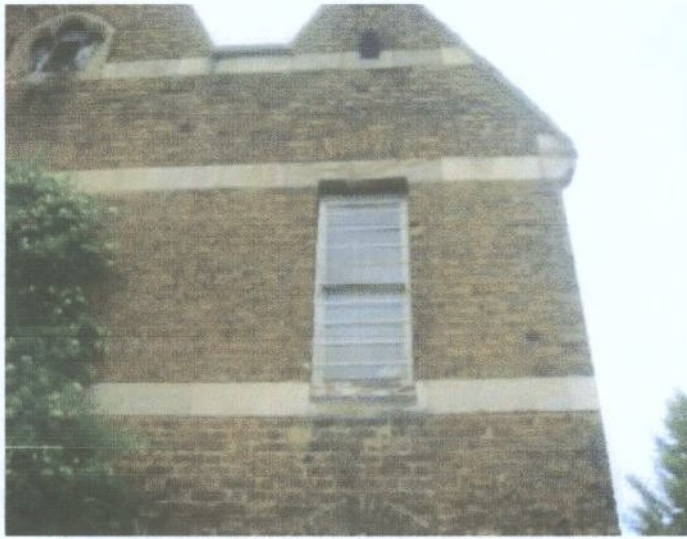
4. Over the top of this first floor window the stone lintel has cracked at the middle to left-hand side, this crack then extends across and up through the lintel (see photographs 4 and 5).

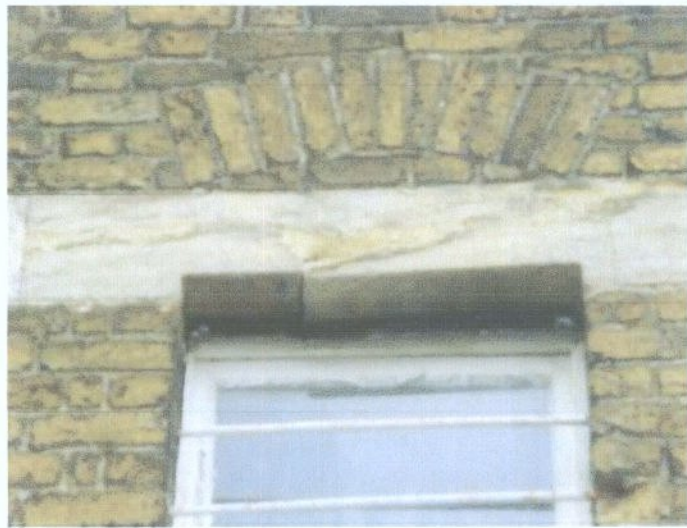
5. Just to the right-hand side of the window there is also a 1mm wide vertical crack through the stone lintel itself. Water has penetrated at both of these crack locations as can be seen on photographs 5 and 6 and the lintel will need to be replaced.

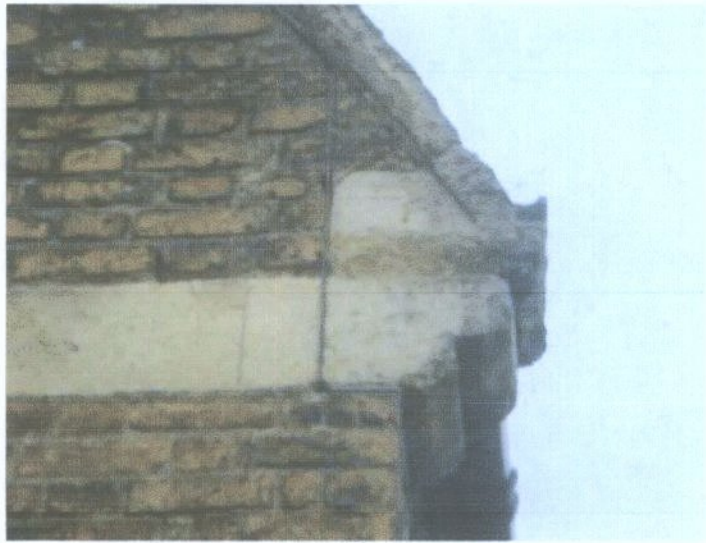
7

6. At the front right-hand corner of the building the stone corbelling has deteriorated quite significantly (see photograph 7).

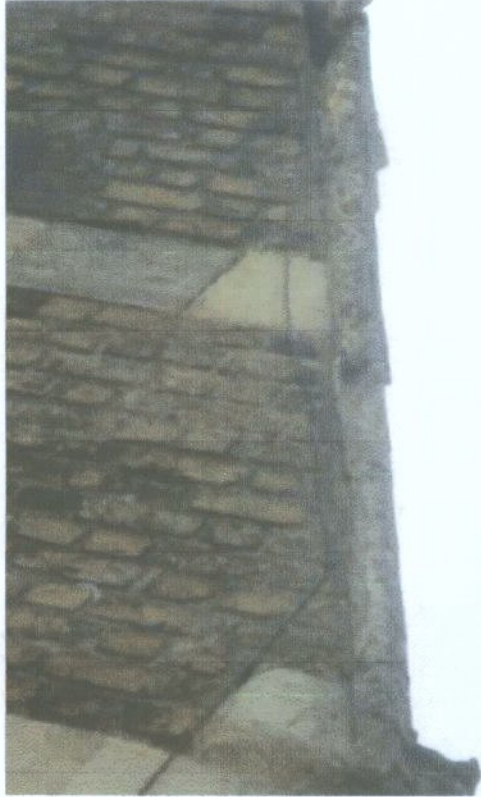
7. The coping stones both sides of the main roof are all damaged by frost action and the top coping stone has a 50mm wide gap on the underside (see photographs 8 and 9).

7. It is concluded that the stone coping stones on the Headmaster's office in particular but also elsewhere throughout the building have reached the end of their working life. These require complete replacement.

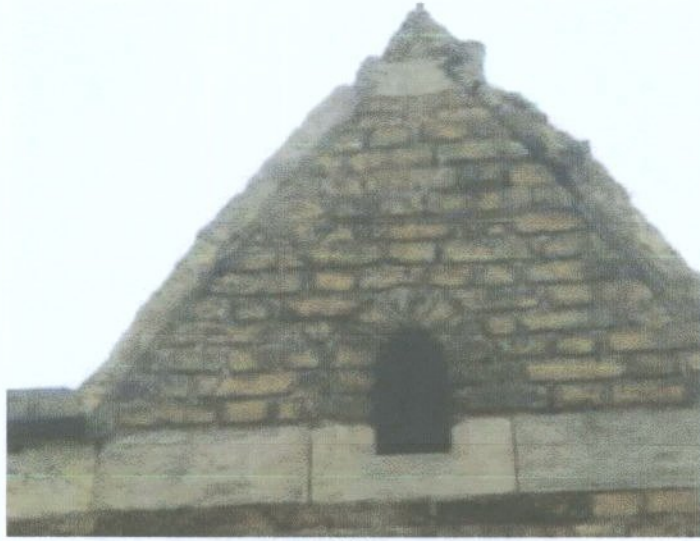
10

8. At the top of the gable the brickwork face on some of the bricks has been damaged by frost action (see photograph 10).
9. On the larger roof at the left-hand side of this section of the building there is similar damage to the coping stones to both the left-hand and right-hand roof slopes (see photograph 11). The mortar joints have also been washed out due to frost action below the coping stones.

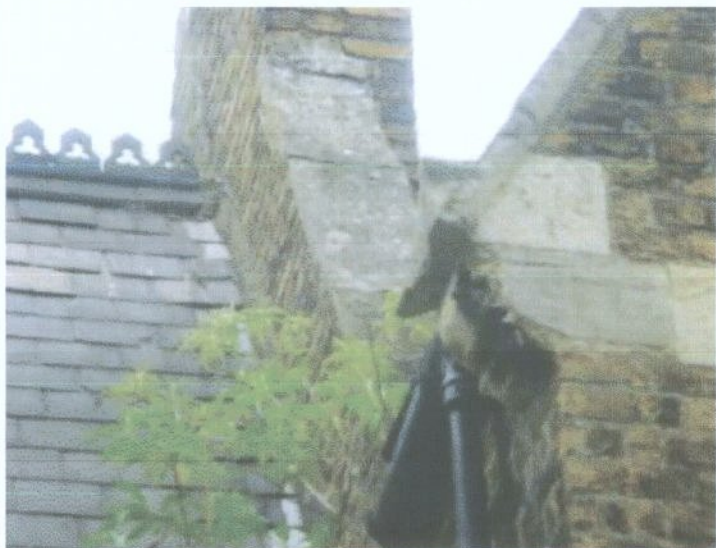
10. The stone corbelling at the front left-hand corner of this section of the building is also crumbling as can be seen on photograph 12.
11. The gable wall and chimney to the rear (as shown on photograph 12) has coping stones on the top and these are bowing quite significantly. The cause of this is not known but they will need to be replaced.

12. The mortar flashings at the junction of the roofs with the gable walls (see photograph 12 as an example) need to be replaced with lead flashings.
13. The stone corbelling or stone capping on the chimney is also deteriorating due to frost action (see photograph 13).

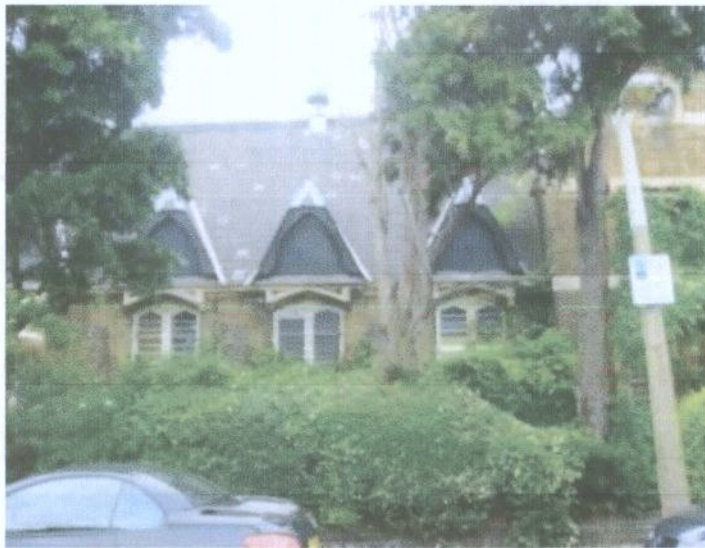
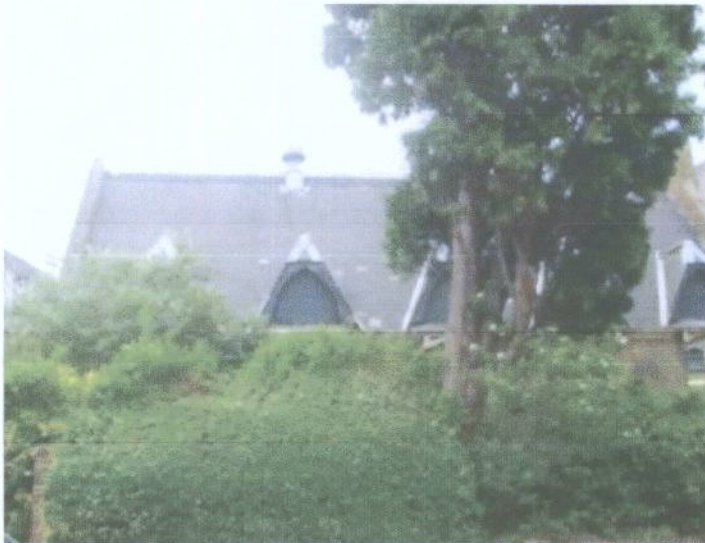
Front Elevation Main Building (see photographs 14 and 15)

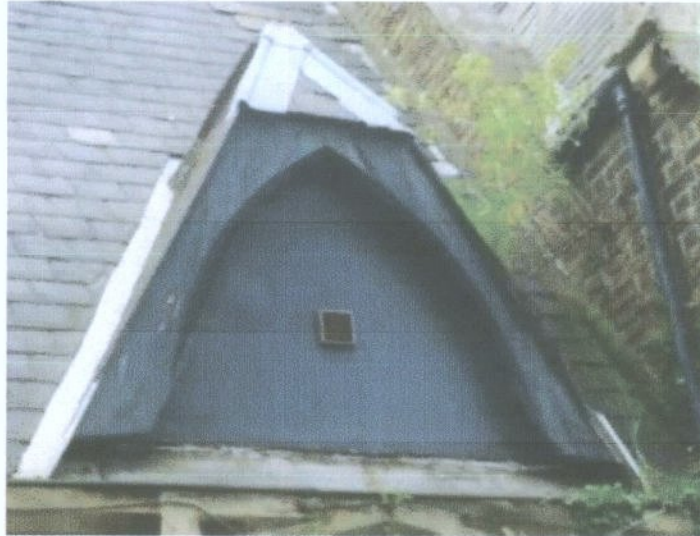
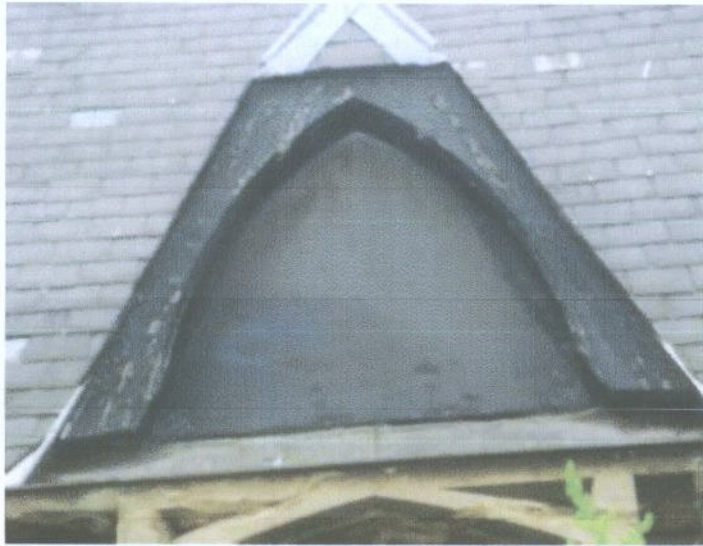
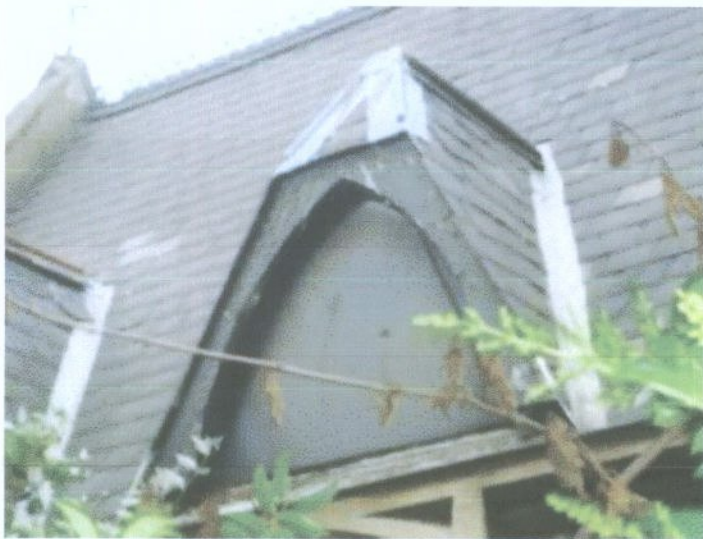
1. The timberwork around the dormer windows in the main roof is all deteriorating. See photographs 16, 17 and 18 as examples.
2. Over the right-hand ground floor window the stone arch is crumbling due to frost action and has been poorly repaired with mortar (see photograph 19).
