VALIDATION REPORT

AT
LATCHMERE HOUSE

FOR
BERKELEY HOMES WEST LONDON

Issue No	01
Project No.	LW00298 - 2016
Date of Issue:	4 th August 2016
Author:	Tom Kiddier
Checked by:	Charlie Jarvis

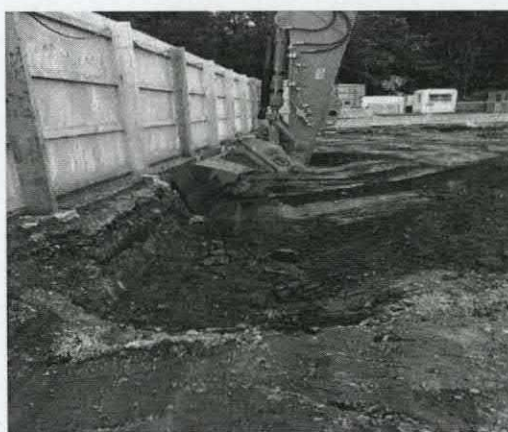
Excavation of Lead contaminated soils

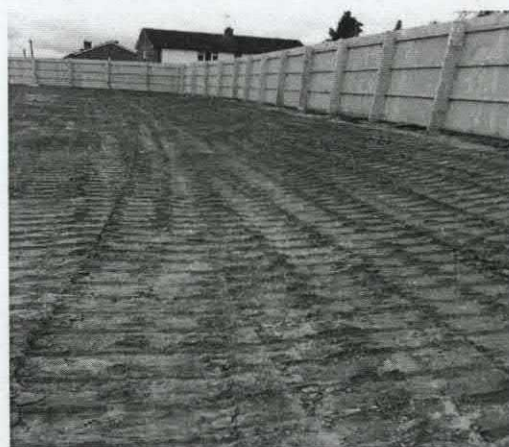
Natural ground after hotspot removal

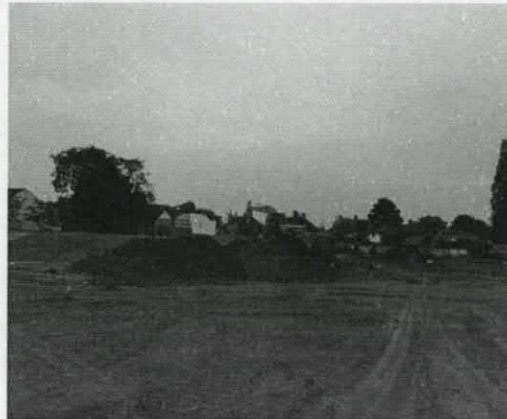
Contaminated stockpiles on bunded membrane

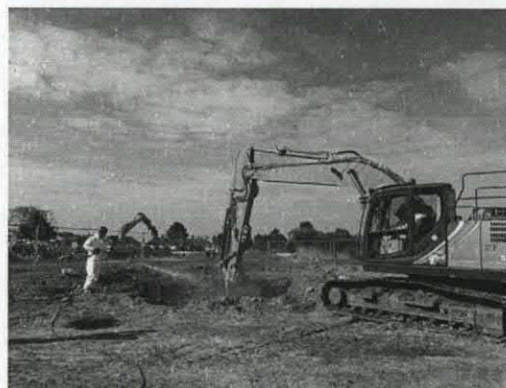
During the breakout, a brick tank was found, approximately 500mm below ground level (bgl), which contained slurry, construction rubble, and pieces of ACMs (see Appendix B). The area was segregated using Heras fencing, and appropriate signage was installed. A decontamination area was set up, and an asbestos skip was brought to site and installed in the asbestos works' area. The area was then hand-picked with ACMs, appropriately double bagged, and placed within the skip. The surrounding materials were then excavated down to natural ground, and stockpiled in a bunded area (SP5), covered with polythene, and tested (SP5).

Suppression of ACM's using wetting agent

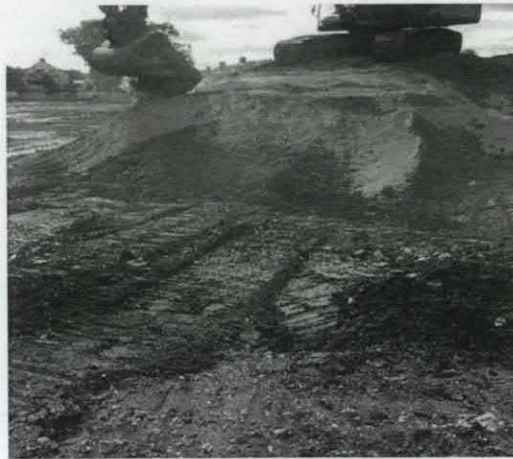
Stabilisation of stockpile 6

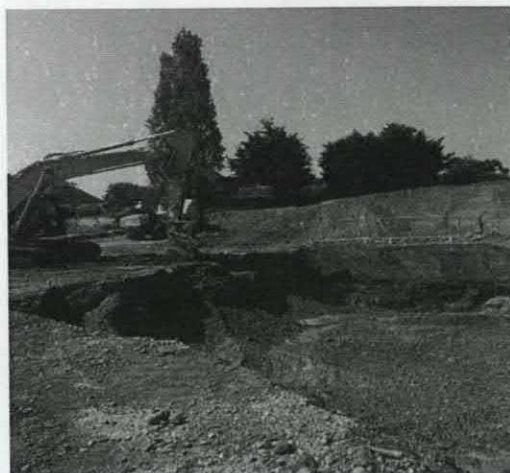
Excavation of road

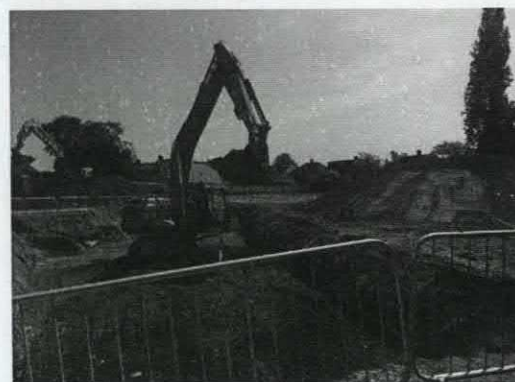
Placement of stabilised fill from SP2 and 3

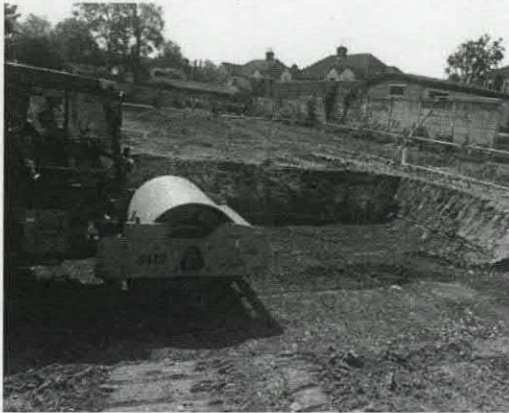
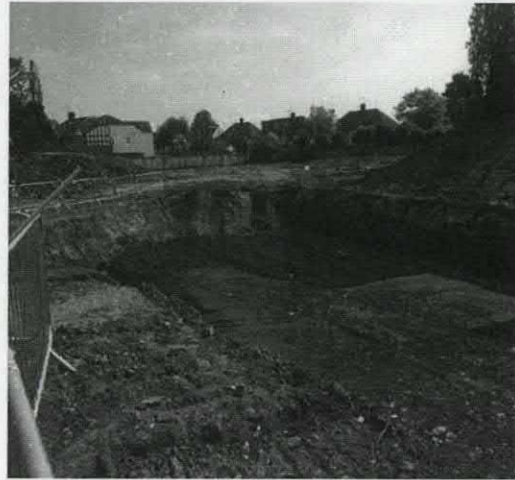
Compaction of stabilised material from stockpile 2 and 3

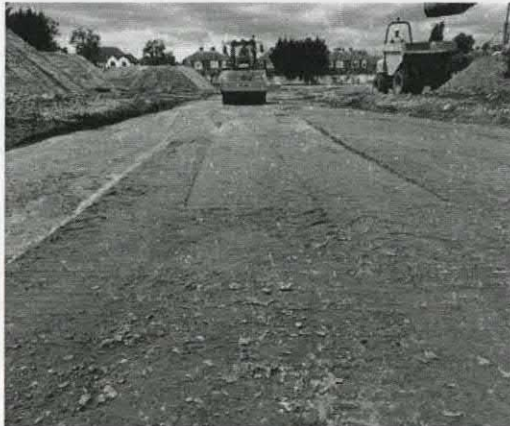
Compaction of natural stabilised clean cap

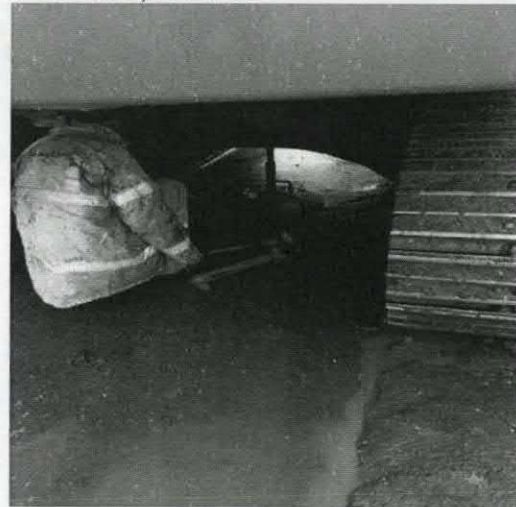
Geotechnical testing

Test Reference	Location	Average Settlement at 253kn/m ²	Estimated CBR%	Pass	Notes
PB-1	Around E5	1.17mm	69	Yes	None
PB-2	Around M10	1.85mm at 66kn/m ²	5.2	No	Area re-rolled and re-tested (PB-3)
PB-3	Around M10	1.38mm	64	Yes	Re-test passed

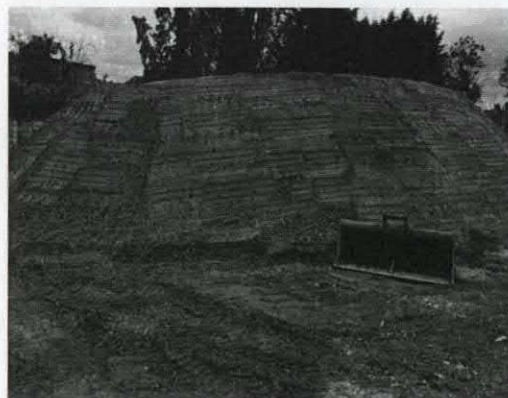
The only material left stockpiled on site is the natural ground which was excavated within the road area to allow the contaminated stockpiles to be backfilled.

Remaining natural ground stockpiled
