CLIENT
English Heritage

PROJECT
Marble Hill House

TITLE
Main House:
South Elevation; repairs

DRAWING N°
223

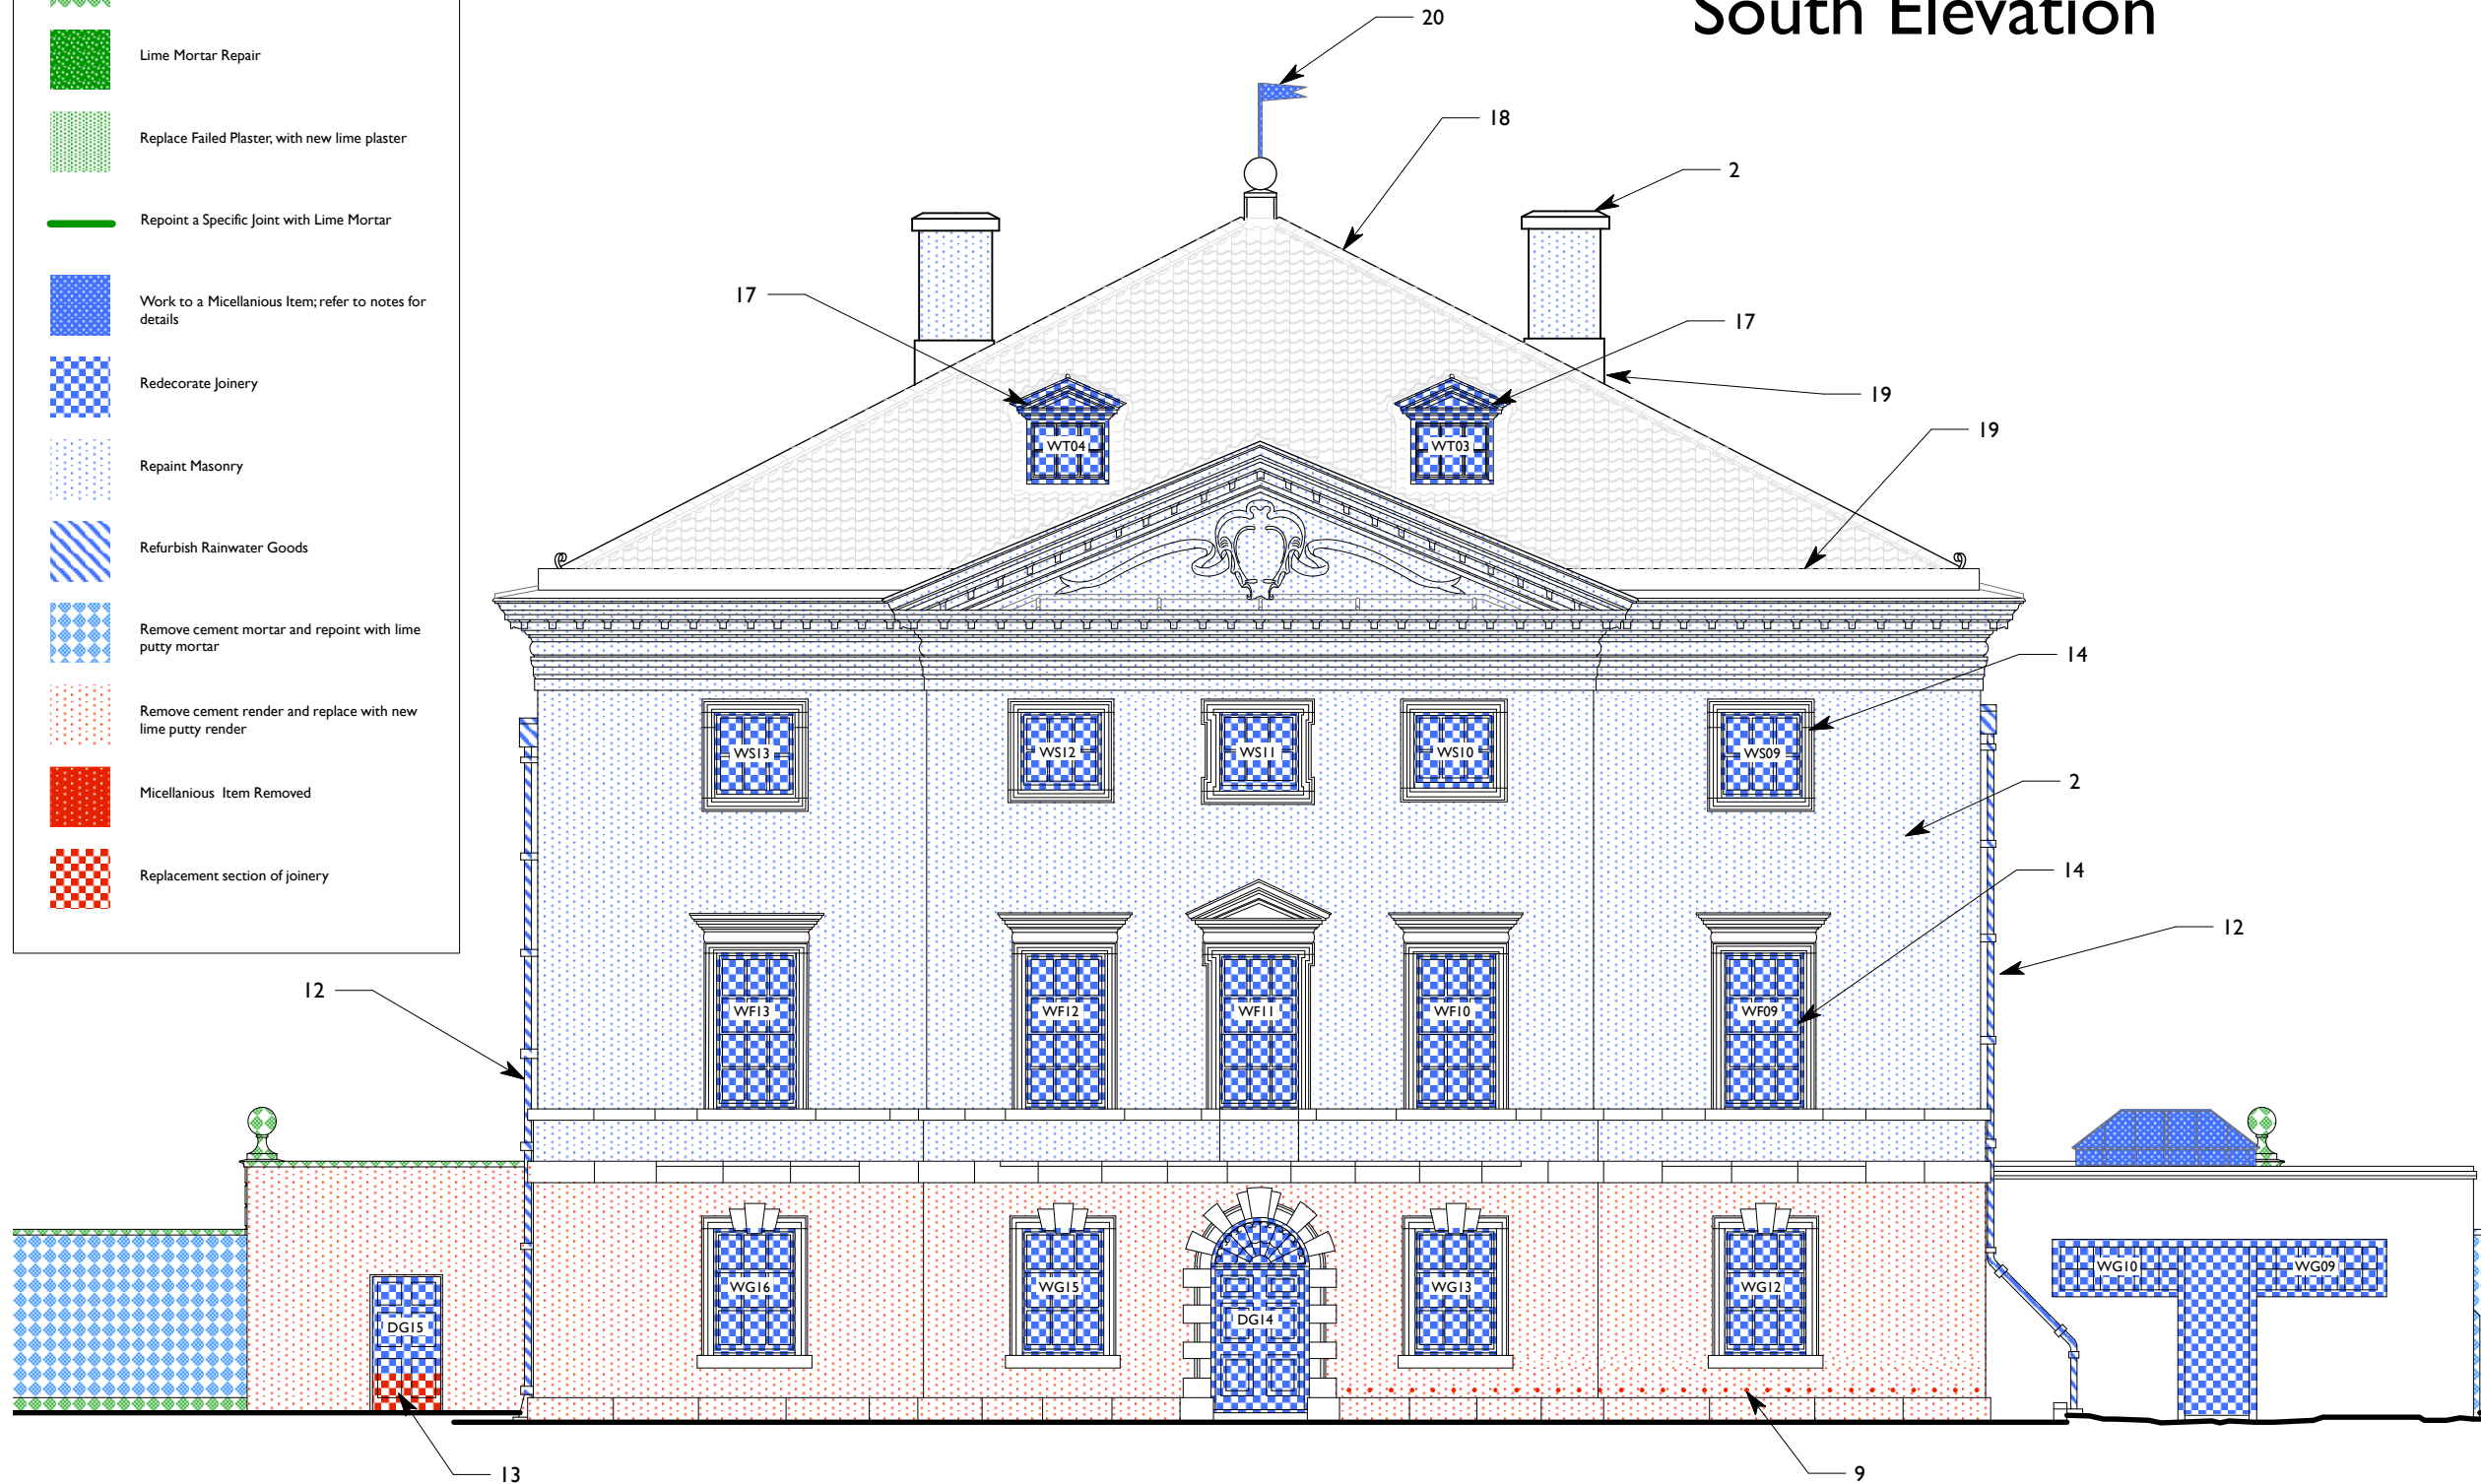
South Elevation

8. Repoint crack with lime mortar, refer to drawing for crack details.
9. Chemical DPC plugs; prepare to remove exceptionally hard cement filling to the chemical DPC holes.

13. Replace the lower portion of door; this will include the bottom rail and a lower 400 mm of the stiles.
14. To the windows in addition to redecoration, generally allow as follows. 1 no completely new sash window (assume 1 no. of the larger windows. Allow to replace 8 no sash bottom rails, 15 no timber sills and the lower 500 mm of 12 no pairs of front cover boards. Prepare, treat and repaint the steel lintel to WG19

16. Repairs to roof tiles; assumed that a total of 100 no tiles will need to be replaced with salvaged glazed pantiles.
17. Leadwork to roof; assume that localised patch repairs are required. assume that crack will need to be welded repaired in 30 no locations. Also assume that the flashing to 1 no chimney will need to be replaced with new Code 7 sandcast lead.

1. Repoint stone plinth course, note specific percentages on drawing
2. Existing cementitious render (assumed), remove existing 'alkyd resin' masonry paint, make good any cracks with lime putty mortar and repaint with new silicate paint (Kiem).

3. Architectural features formed in render (possibly cementitious), remove existing 'alkyd resin' masonry paint, make good any cracks with lime putty mortar and repaint with new silicate paint (Kiem).

4. Remove cementitious render as indicated, make good and repoint brickwork with lime putty mortar and replaster with a lime putty plaster. Once cured, paint with limewash (to be confirmed).

5. Flaunch top of plinth with lime mortar
6. Remove airbrick and make good using brick and lime mortar infill.
7. Remove plastic siphons and make good with lime mortar (17no to West Elevation, 21no to North Elevation).

10. Remove wall mounted plastic/metal boxes
11. Carryout lime mortar repair to corroded column capital; this will use ceramic armatures drilled into the existing substrate. Mortar selection will need to take place onsite to ensure that it is compatible.

12. Rainwater pipes; these are to be taken down and fully refurbished and reinstalled. They are to be put back in their original locations, they will be repainted with micaceous iron oxide undercoat and a Dulux Metalshield topcoat (colour to be determined, assume white as existing or lead grey), all joints are to be left uncaulked. The gully is to be replaced with a new accessible gully, the downpipes are to be fitted with a shoes.

15. Rooflight, this is rotten and non-historic, allow to replace with an aluminium rooflight Works to Dormer Windows; in addition to redecoration, assume the following: Allow to fully replace 1 no. casement with a new casement to match. Also allow to replace the bottom rail and the external architraves to the remaining 3 no. windows.

18. Regild weather vane
19. Rear of wing walls, these are pointed in a cement mortar, remove cement pointing and repoint wall with lime putty mortar.
- 20.
