CLIENT  
English Heritage

PROJECT  
Marble Hill House

TITLE  
Main House:  
North Elevation; repairs

DRAWING N°  
231

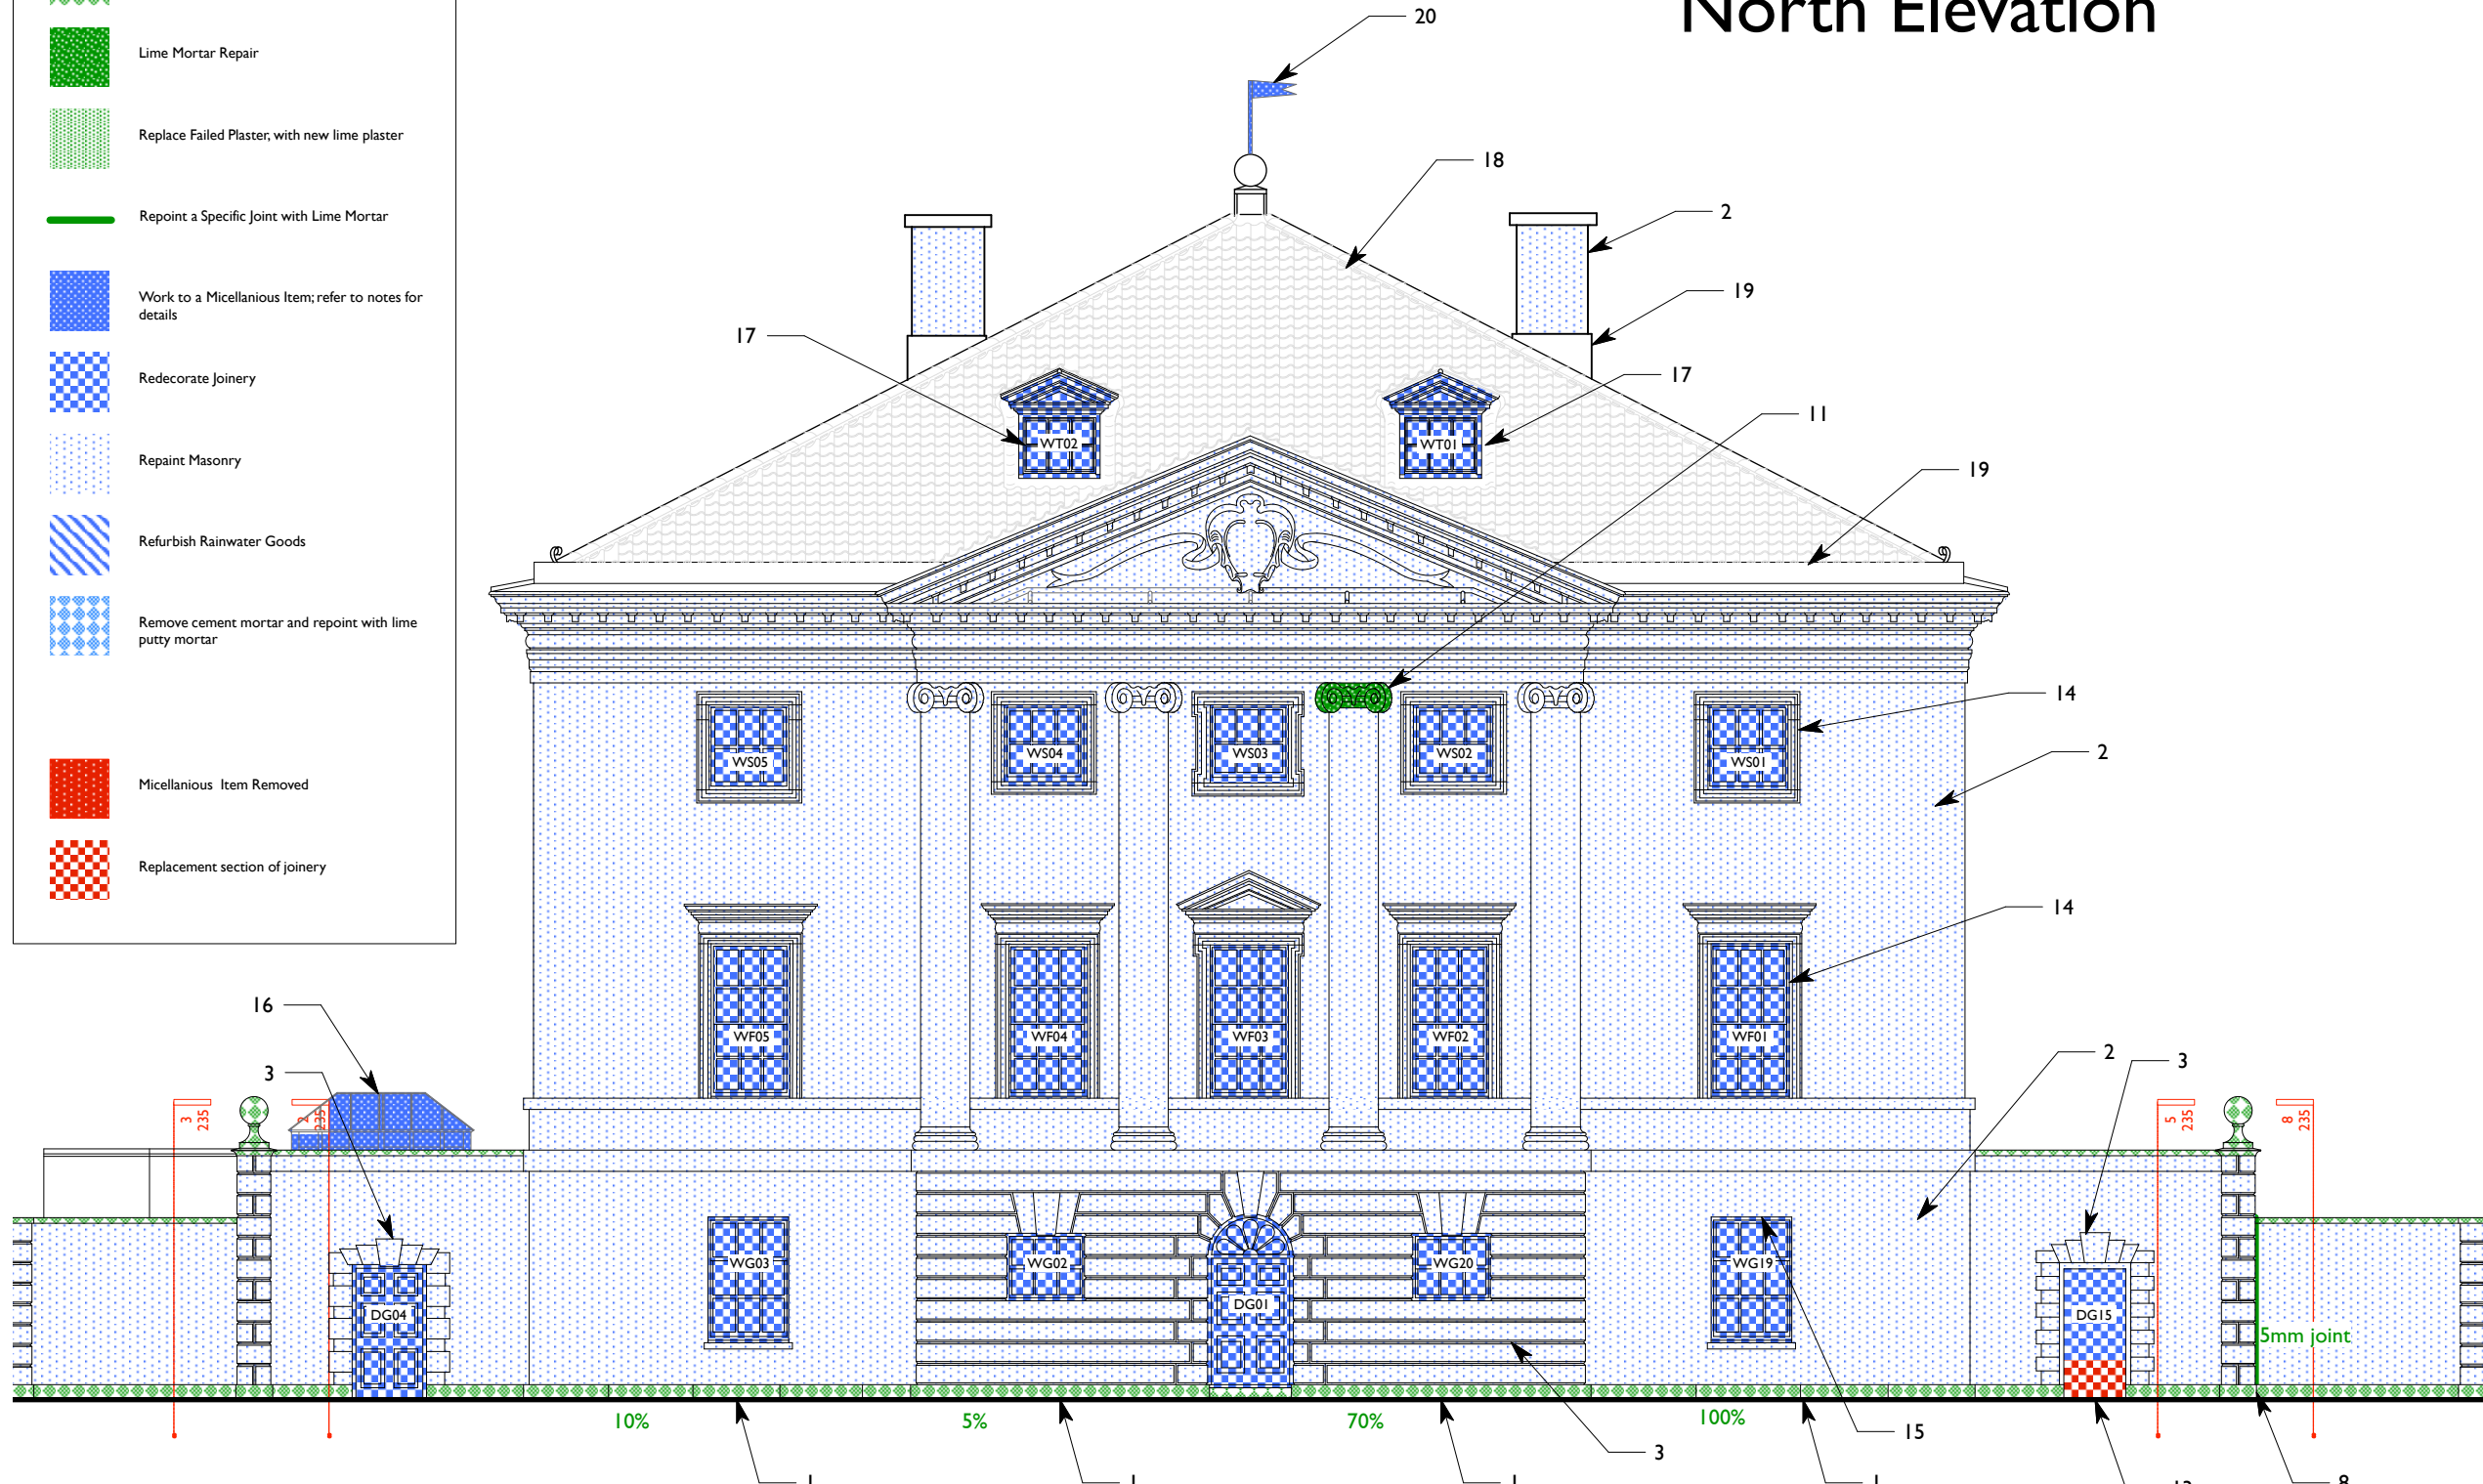
# North Elevation

1. Repoint stone plinth course, note specific percentages on drawing
2. Existing cementitious render (assumed), remove existing 'alkyd resin' masonry paint, make good any cracks with lime putty mortar and repaint with new silicate paint (Kiem).

3. Architectural features formed in render (possibly cementitious), remove existing 'alkyd resin' masonry paint, make good any cracks with lime putty mortar and repaint with new silicate paint (Kiem).

5. Flaunch top of plinth with lime mortar
6. Remove airbrick and make good using brick and lime mortar infill.
7. Remove plastic siphons and make good with lime mortar (17 no to West Elevation, 21 no to North Elevation).

8. Repoint crack with lime mortar, refer to drawing for crack details.
9. Chemical DPC plugs; prepare to remove exceptionally hard cement filling to the chemical DPC holes.

10. Remove wall mounted plastic/metal boxes
11. Carryout lime mortar repair to corroded column capital; this will use ceramic armatures drilled into the existing substrate. Mortar selection will need to take place onsite to ensure that it is compatible.

16. Repairs to roof tiles; assumed that a total of 100 no tiles will need to be replaced with salvaged glazed pantiles.
17. Leadwork to roof; assume that localised patch repairs are required. Assume that cracks will need to be weld repaired in 30 no locations. Also assume that the flashing to 1 no chimney will need to be replaced with new Code 7 sandcast lead.

12. Rainwater pipes; these are to be taken down and fully refurbished and reinstalled. They are to be put back in their original locations, they will be repainted with micaceous iron oxide undercoat and a Dulux Metalshield topcoat (colour to be determined, assume white as existing or lead grey), all joints are to be left uncaulked. The gully is to be replaced with a new accessible gully, the downpipes are to be fitted with a shoes.

13. Replace the lower portion of door; this will include the bottom rail and a lower 400 mm of the stile.
14. To the windows in addition to redecoration, generally allow as follows. 1 no completely new sash window (assume 1 no. of the larger windows. Allow to replace 8 no sash bottom rails, 15 no timber sills and the lower 500 mm of 12 no pairs of front cover boards. Prepare, treat and repaint the steel lintel to WG19

15. Rooflight, this is rotten and non-historic, allow to replace with an aluminium rooflight Works to Dormer Windows; in addition to redecoration, assume the following: Allow to fully replace 1 no. casement with a new casement to match. Also allow to replace the bottom rail and the external architraves to the remaining 3 no. windows.

18. Regid weather vane
19. Rear of wing walls, these are pointed in a cement mortar, remove cement pointing and repoint wall with lime putty mortar.
- 20.
