## 8.21 STABLE BLOCK & CAFE - BOUNDARY WALL REPORT & PHOTOS

**STRUCUTRAL REPORT  
BOUNDARY WALL TO REAR OF STABLES  
MARBLE HILL PARK  
TWICKENHAM  
LONDON**

**Date:** January 2017

**Ref:** JC/17549~Boundary Wall srep rev 1

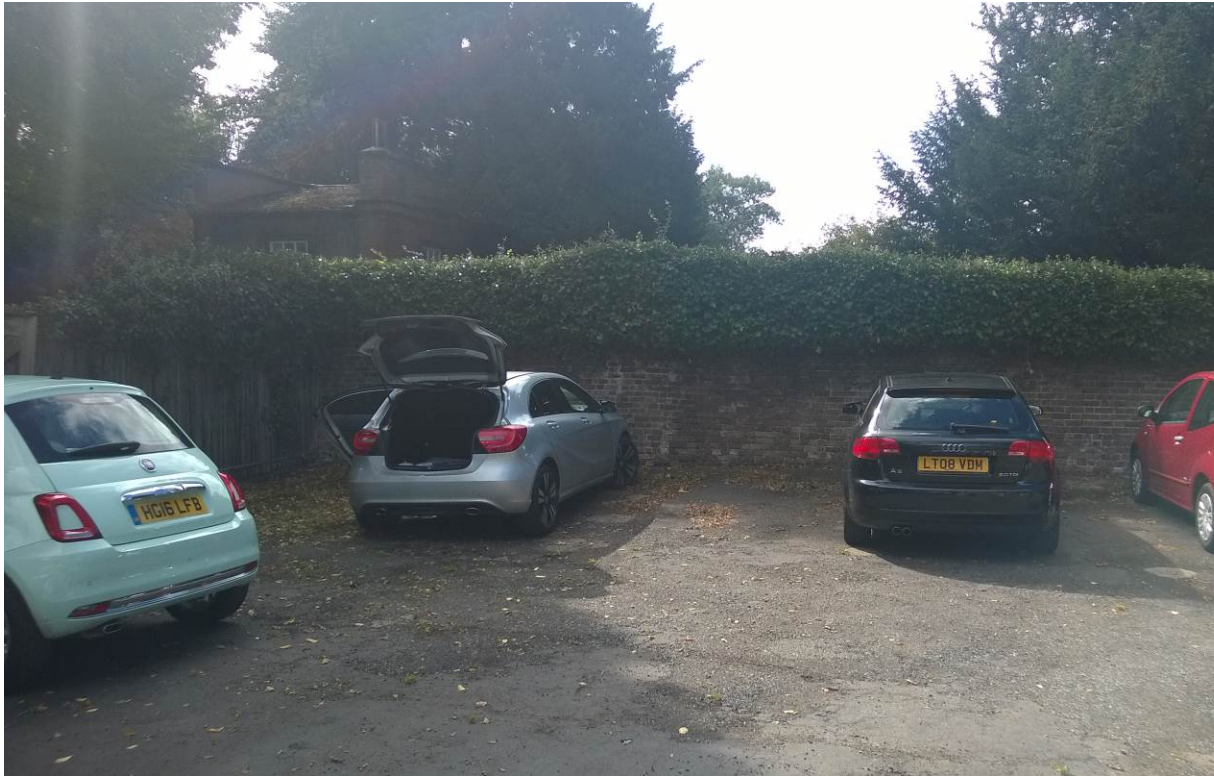
Photograph 1 – View of boundary wall.

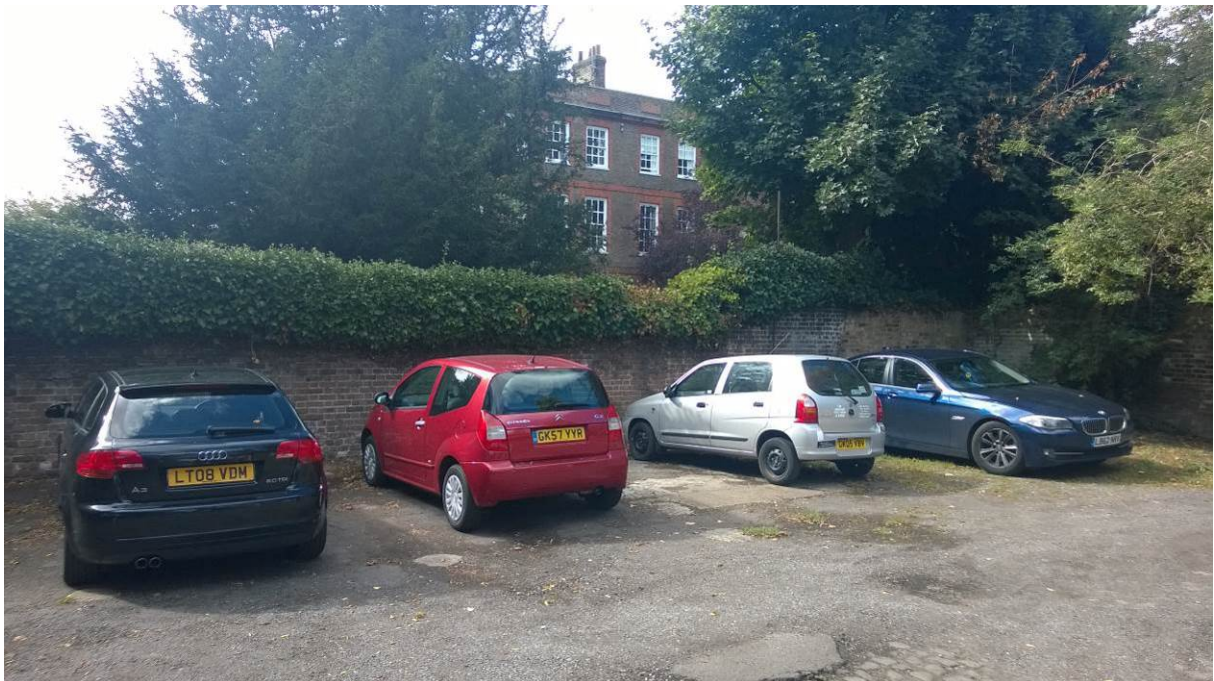
Photograph 2 – North end of boundary wall.

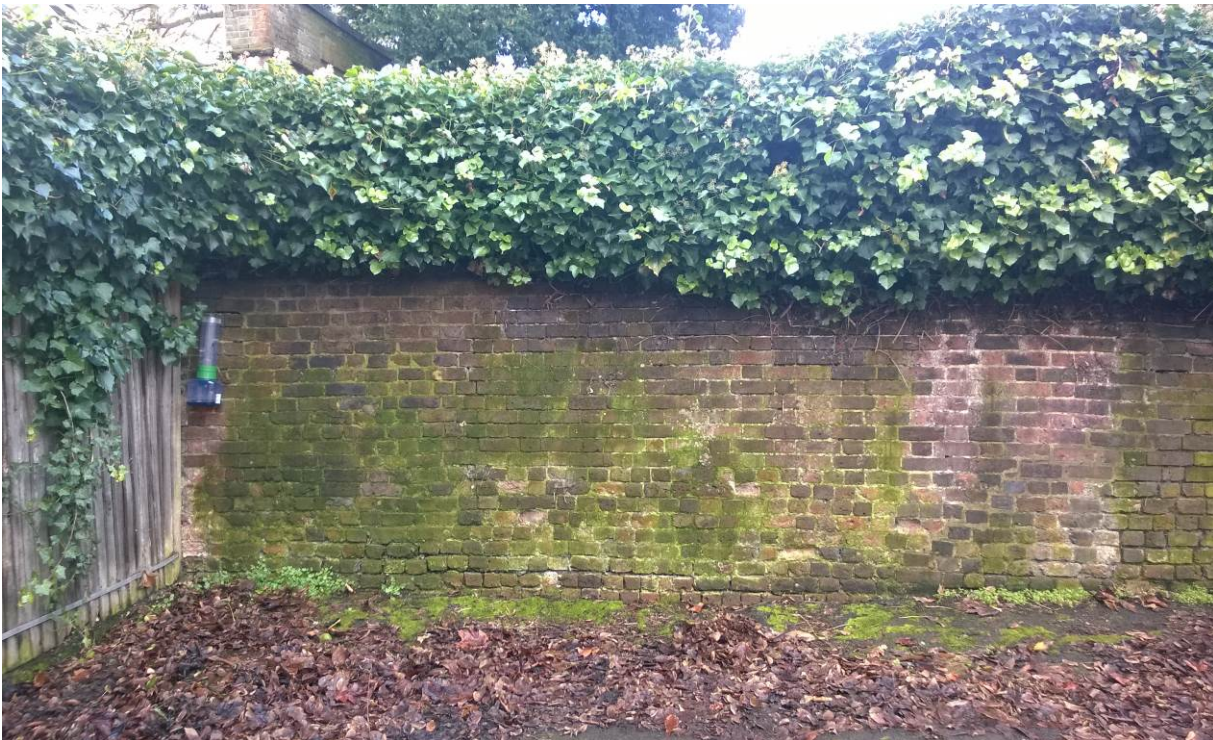
- 3.1 The first 5-6m of the wall is severely out of plumb, leaning approximately 140mm over a height of 1.74m towards the east. This out of plumbness affects the stability of the wall as it exceeds the "middle third rule" in which the centre of gravity of the wall should lie within the middle third of the wall which is 110mm in thickness. The out of plumbness reduces to 70mm towards the north end of the wall.

Photograph 4 – South end of wall, wall severely bowed in this area.

- 3.2 Only rebuilding can correct the lean in the wall. The length of rebuilding will be in the region of 5-7m as the new coursing has to be tied into the existing; alternatively a new pier could be added, this would be a natural point to adjust for the out of plumbness of the remaining length of wall. Rather than rebuilding, buttresses could be added to brace the wall but this would have a visual impact and also increase the footprint of the wall.

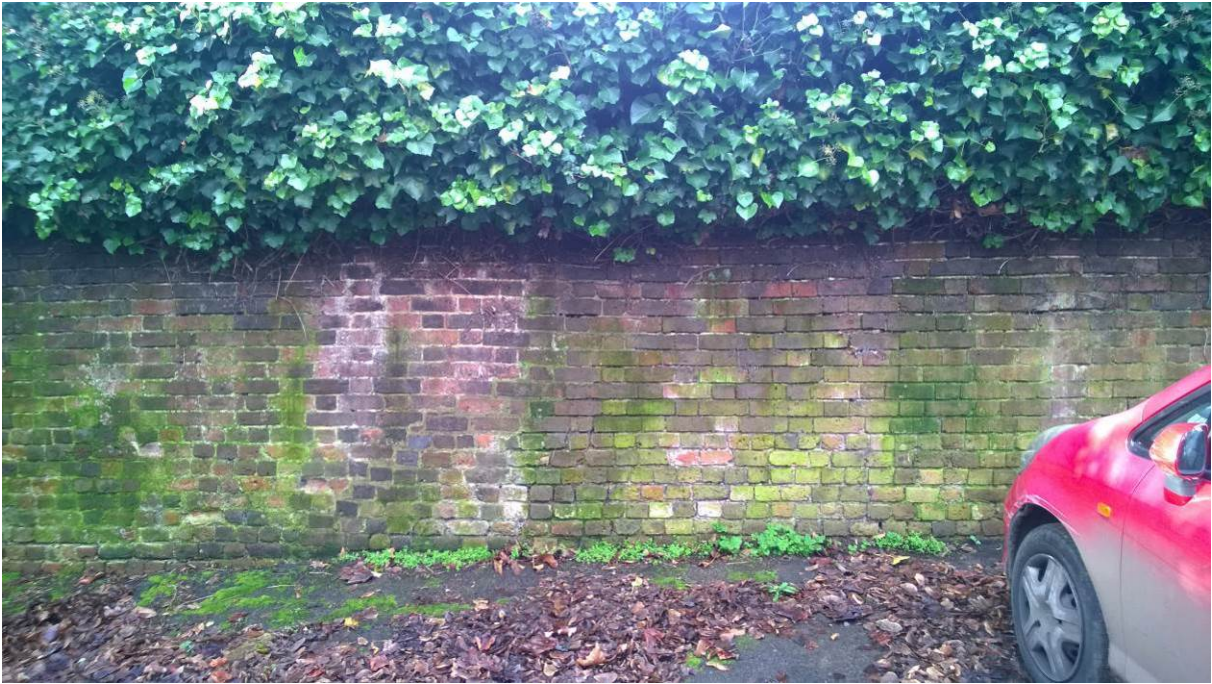
**Photograph 5 – Near south end, area of rebuilding to wall.**

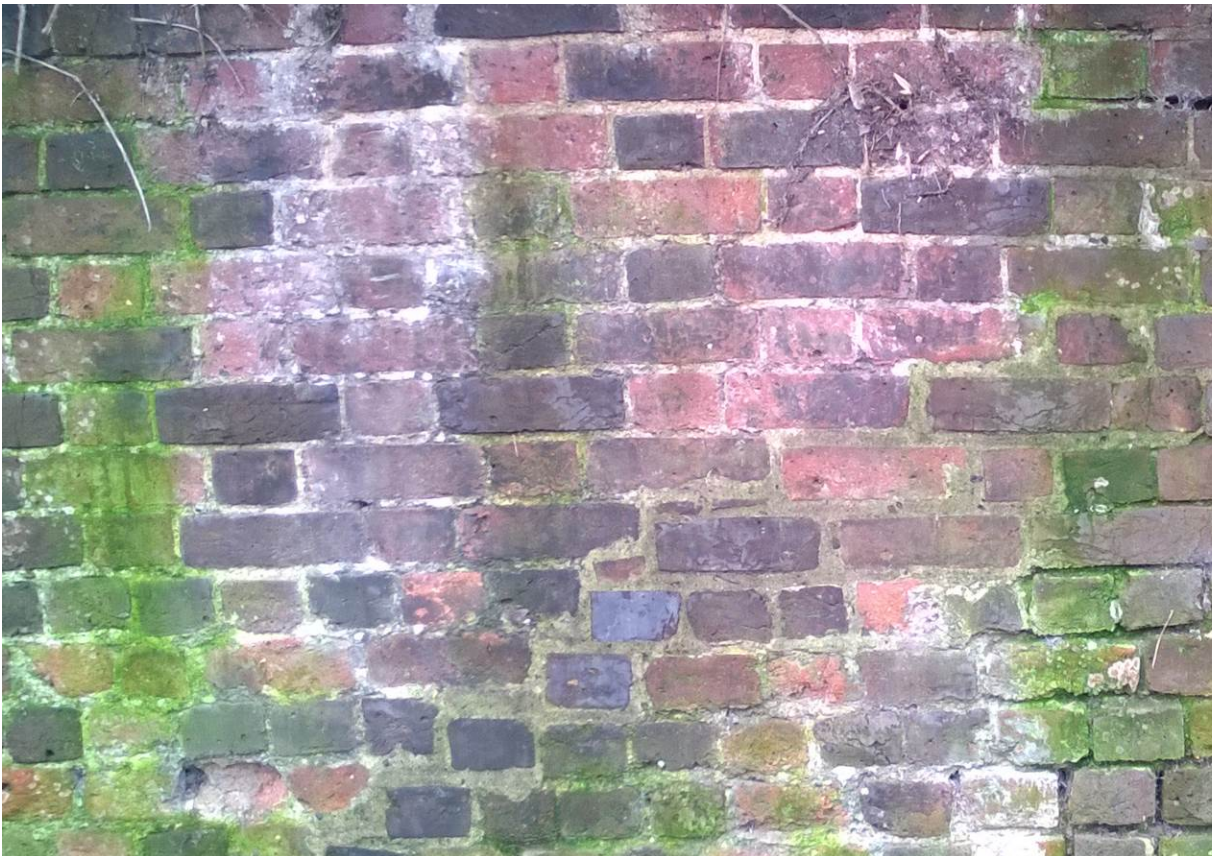
- 3.4 The mortar to the lower four courses of the wall is severely eroded. Deep repointing of this area is required for the full length of the wall.
- 3.5 Cementitious mortar has been used for repointing in particular to the top of the wall and the coping, but there are also patch repairs throughout the length of the wall. This mortar will trap moisture, causing erosion of the adjacent bricks, and also possibly movement in freeze thaw cycles. This should be removed and repointed with an appropriate lime based mortar.

**Photograph 6 – Cementitious mortar to rebuilt area of wall.**

- 3.6 All of the repairs should be carried out with an appropriate lime based mortar. Mortar testing is advised as this will inform the repairs and mortar selection.

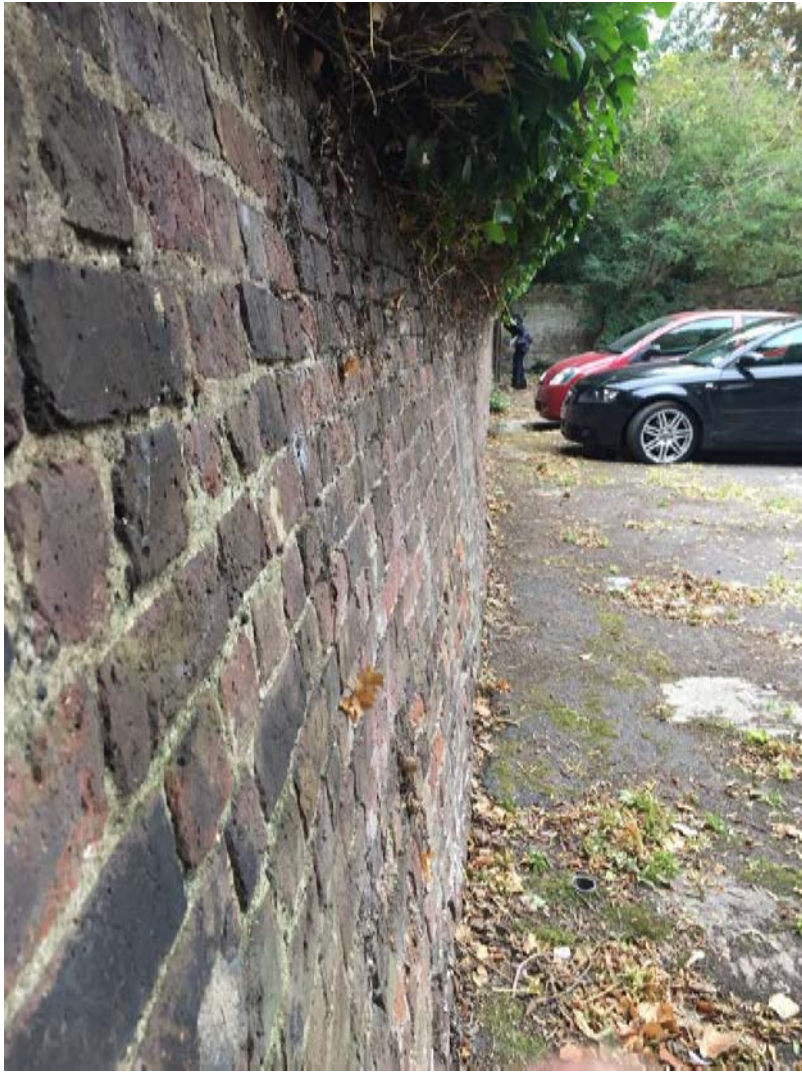
**Photograph 7 –The severe lean in wall as viewed from the south end of the wall.**

- 5.2 Recommended repairs to stabilise the main wall in the long term in the existing arrangement:
  - 5.2.1 Rebuilding of approximately 5-7m of the wall where the wall is severely bowed.

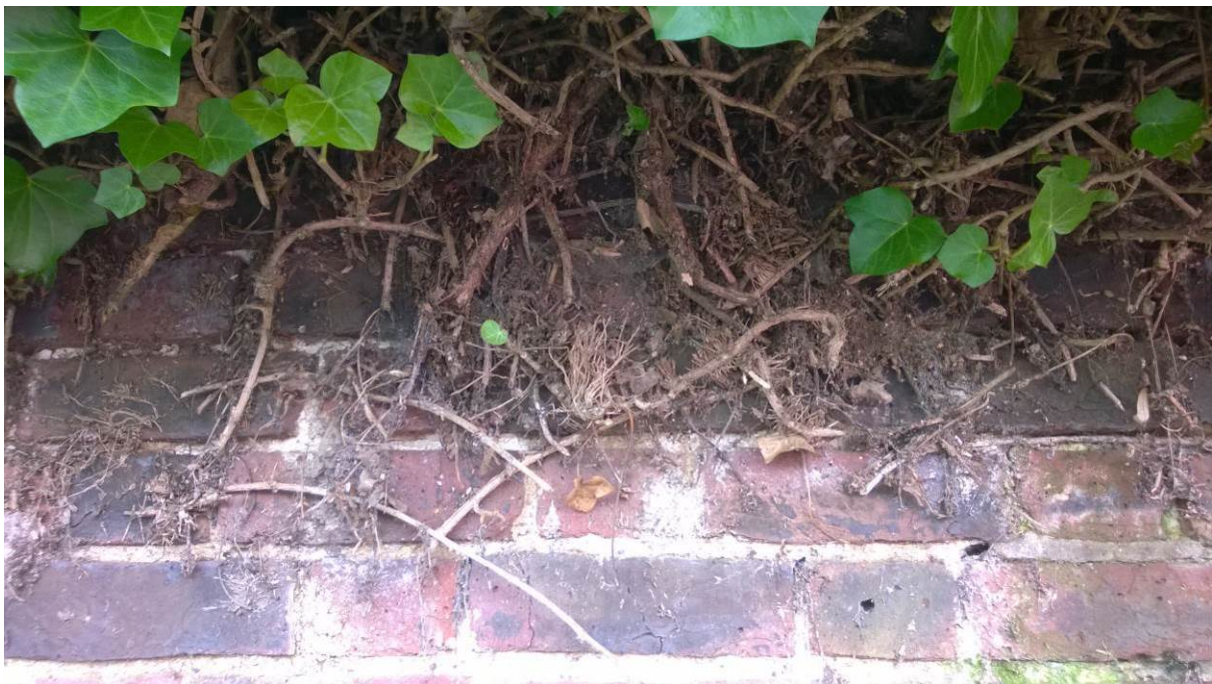
- 3.3 Roots from the established ivy bush have penetrated the upper 4 courses of masonry. The ivy should be removed, the upper four courses carefully dismantled to allow for removing the vegetation within the wall, and then these courses can be rebuilt. The extent of root penetration is not clear but it appears that the full length of the wall requires this treatment. This repair is required as the vegetation allows for water to penetrate the wall, which in turn erodes the masonry and further destabilises the wall.

**Photograph 8 Root penetration into masonry to top of wall.**

- 5.2.4 Removing cementitious repointing patch repairs. Assume an area equal to 5m<sup>2</sup>.
  - 5.2.5 Dismantling and rebidding of upper 4 courses of brick work including coping for full 27m length of wall.

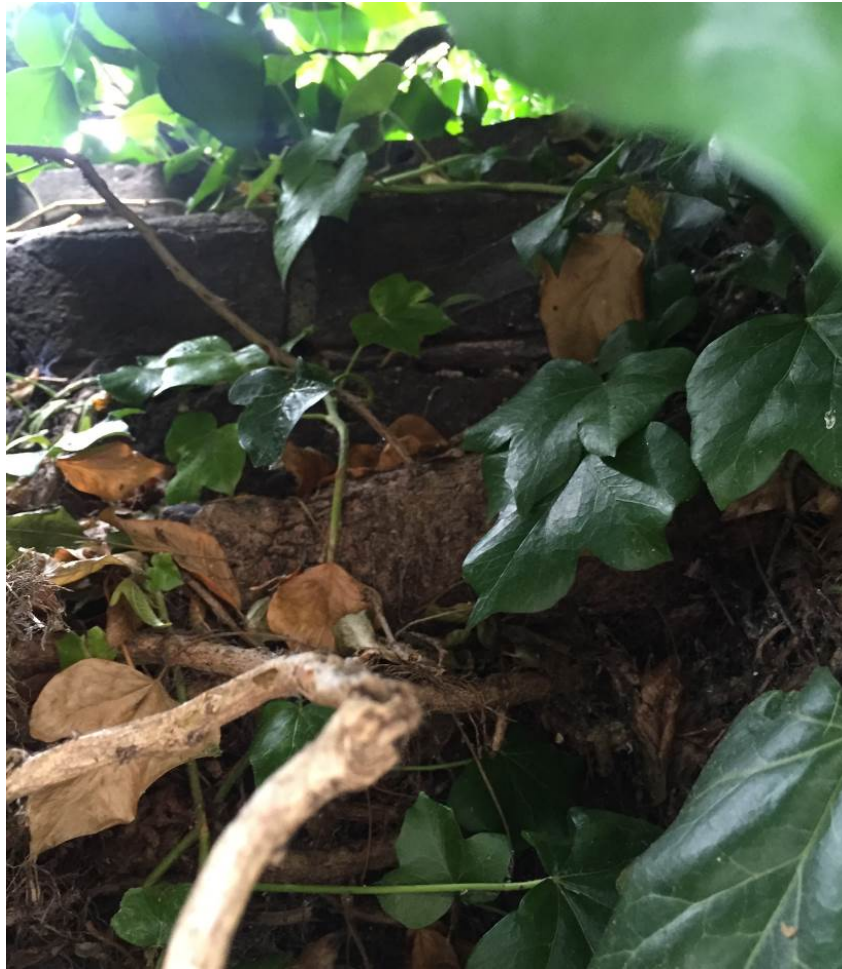
**Photograph 9 – Vegetation growth and cementitious mortar has destabilised the top of the wall.**

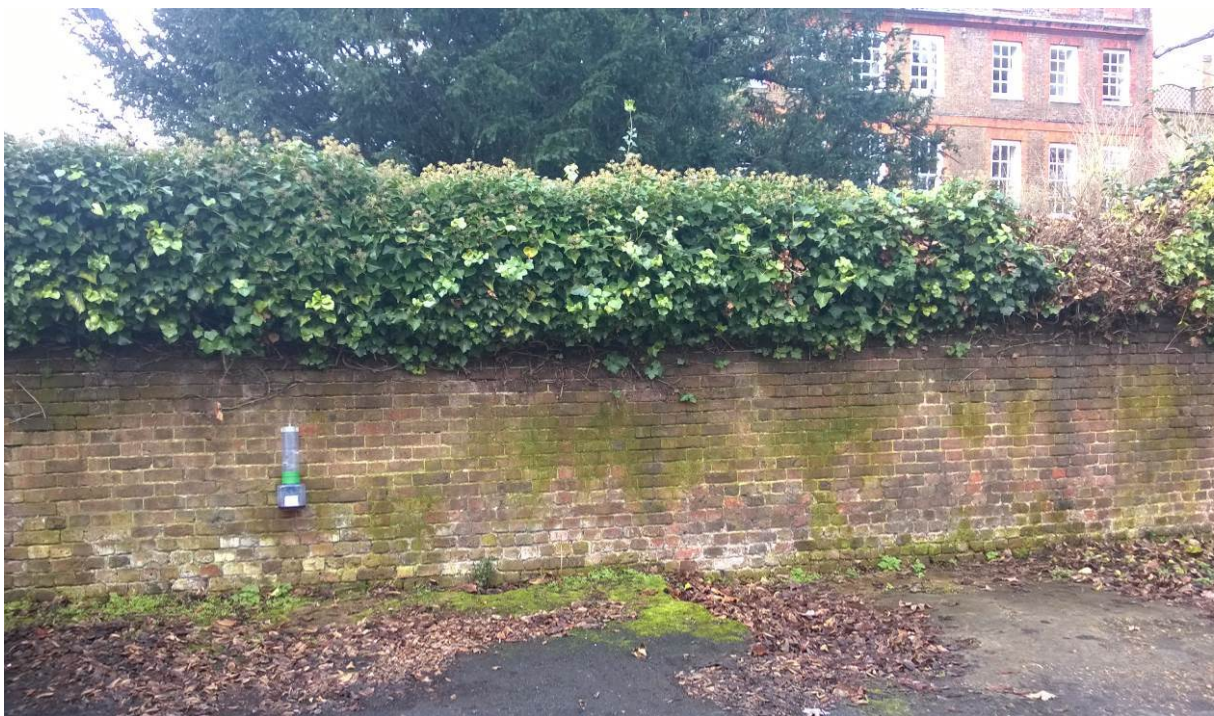
**Photograph 10 – Extensive ivy growth to top of wall.**

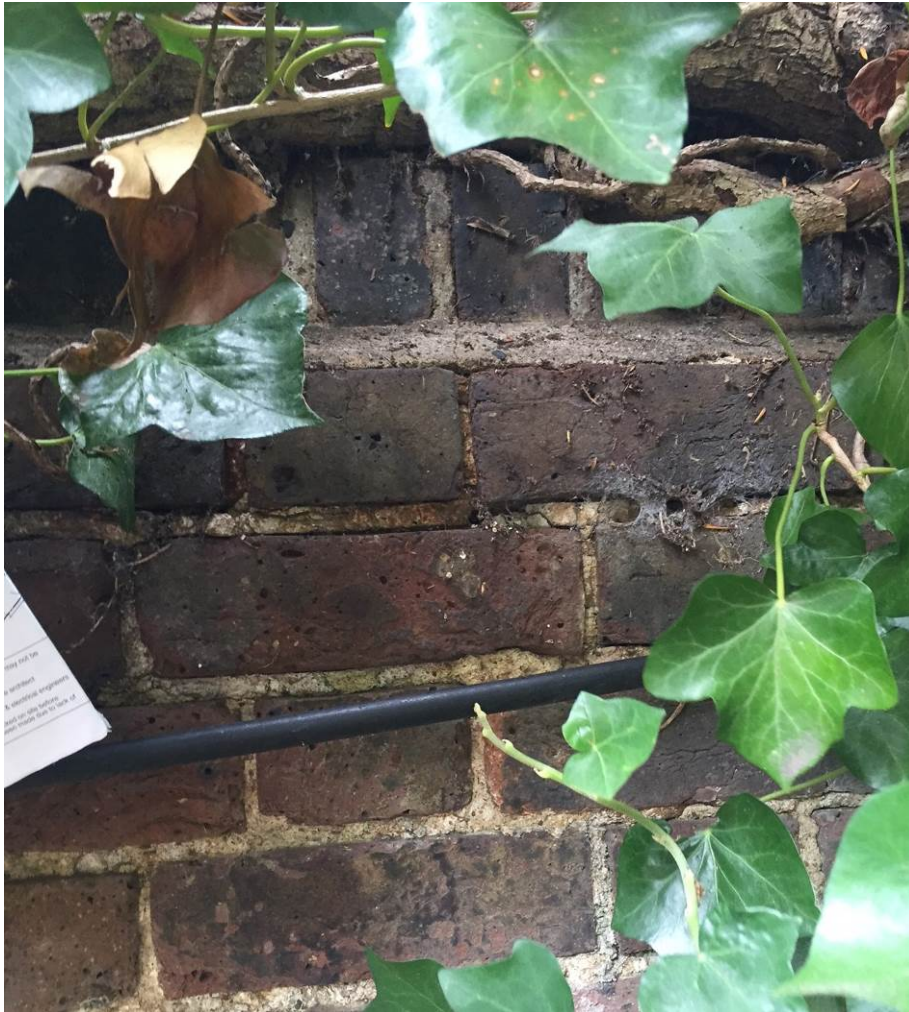
**Photograph 11 – Cementitious mortar pointing to top of the wall.**

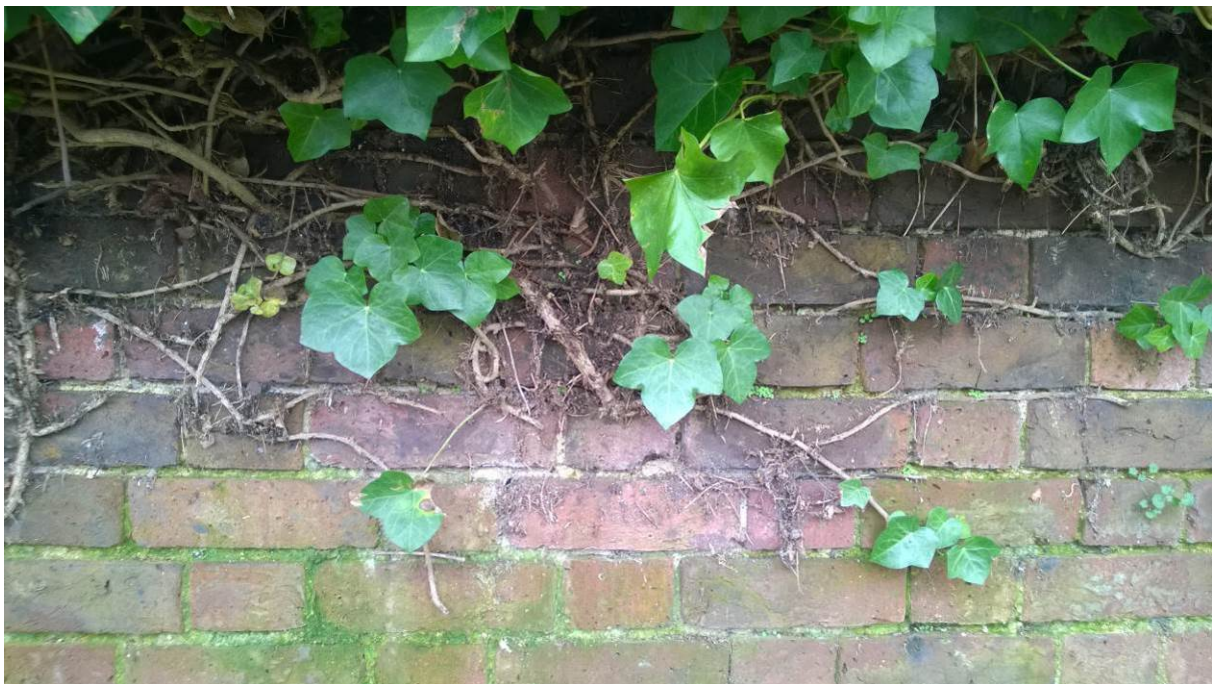
**Photograph 12 - Root penetration into masonry to top of wall.**

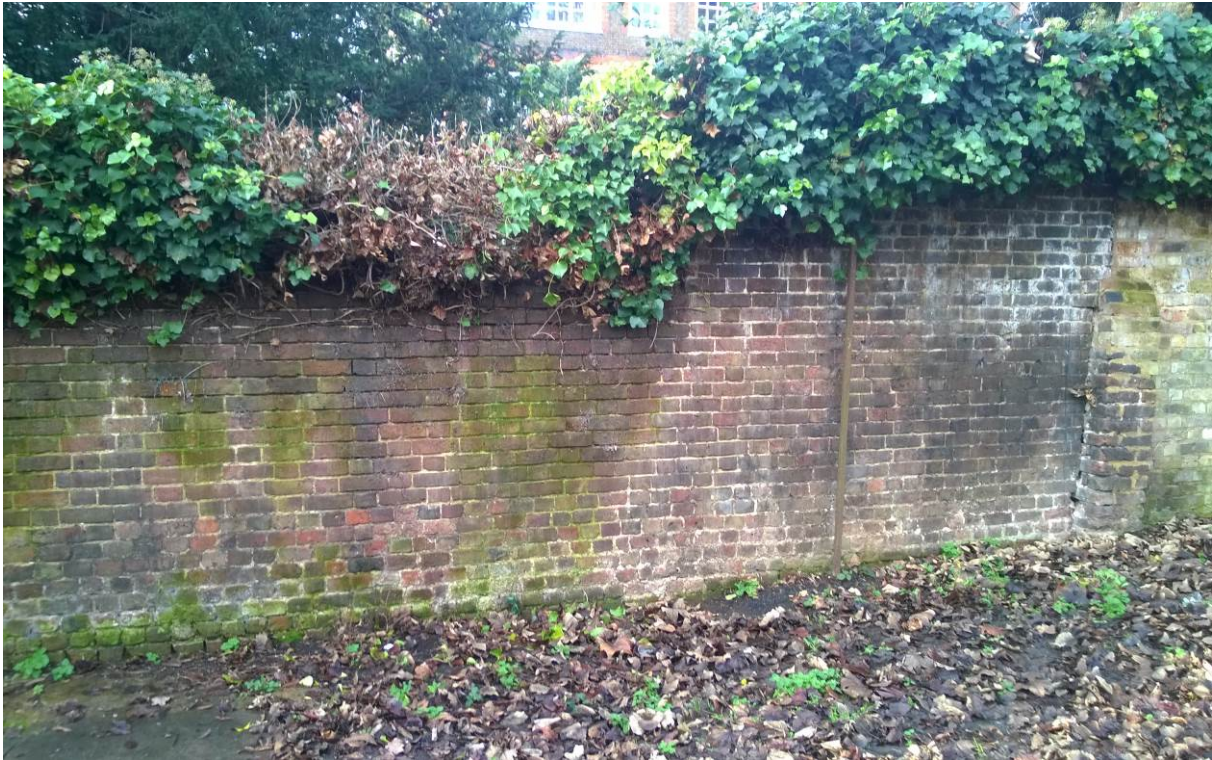
**Photograph 13 – North end of wall, change in wall height.**

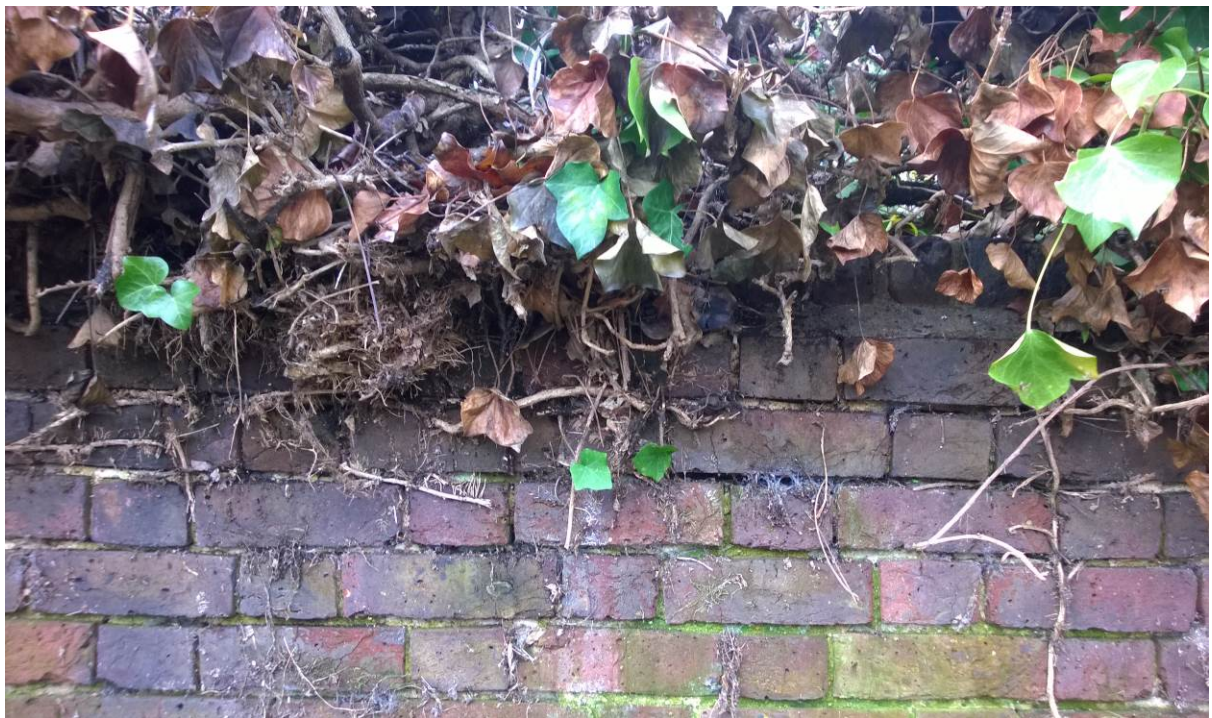
**Photograph 14 – Root penetration into masonry at north end of wall.**

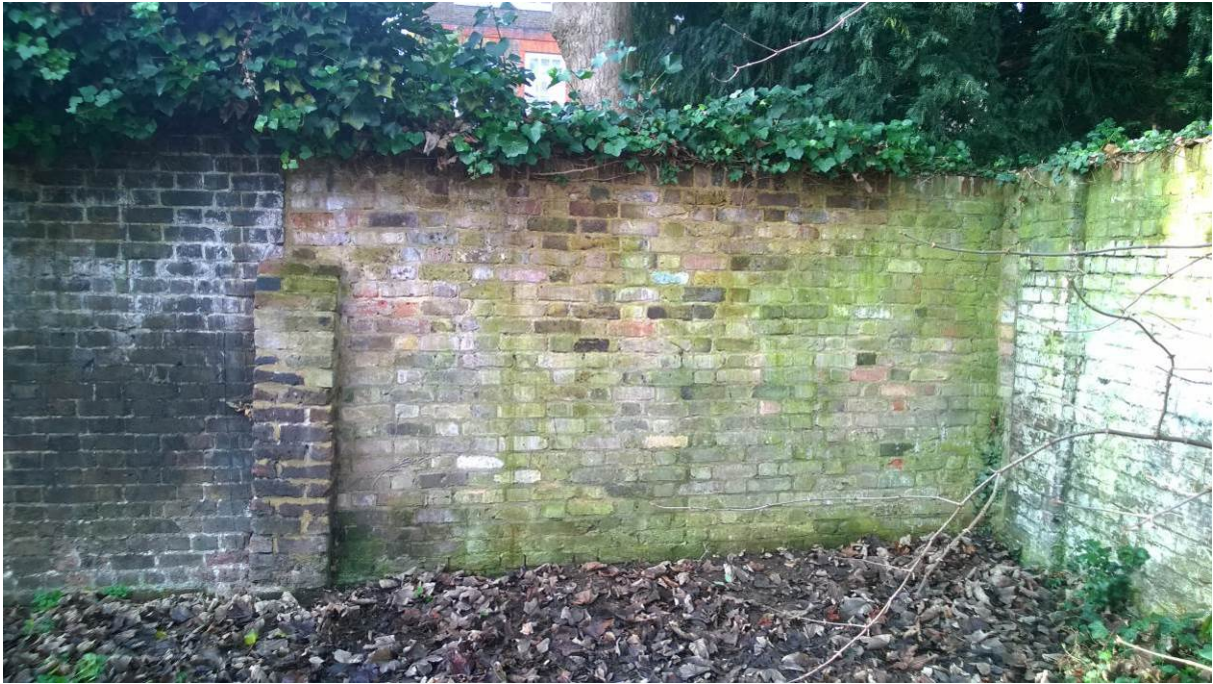
- 3.7 To the north end of the wall there are two large trees on the west side (within Southend House's grounds) growing in close proximity to the wall. As these trees cannot be removed, this area of the wall must be closely monitored. It is clear this portion of the wall has been rebuilt in the past and it is likely because of the proximity of the trees. The roots of the large trees could cause shrinkage of the soils, and even physical pressure against the footings from the growth of the roots. These changes could cause cracking and movement in the wall. It is likely in the long term some rebuilding will be required or deep underpinning.

**Photograph 15 – Junction of north end of wall and North cross wall, change in construction at pier- wall is likely rebuilt because of proximity of large trees to west elevation.**

- 5.2.6 Continue to monitor wall in close proximity to the large trees at North End. Long term remedial work to deepen footings may be required.
- 5.3 Recommendations for building on the existing wall:

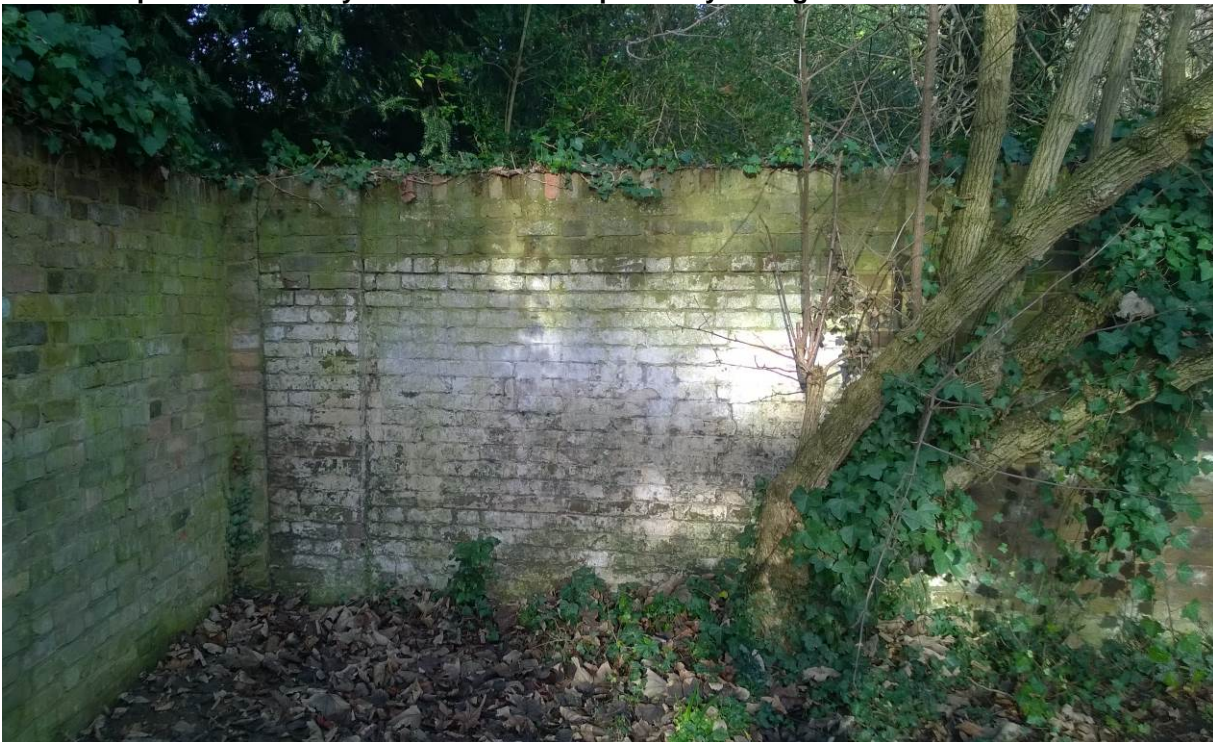
**Photograph 16 – North cross wall.**

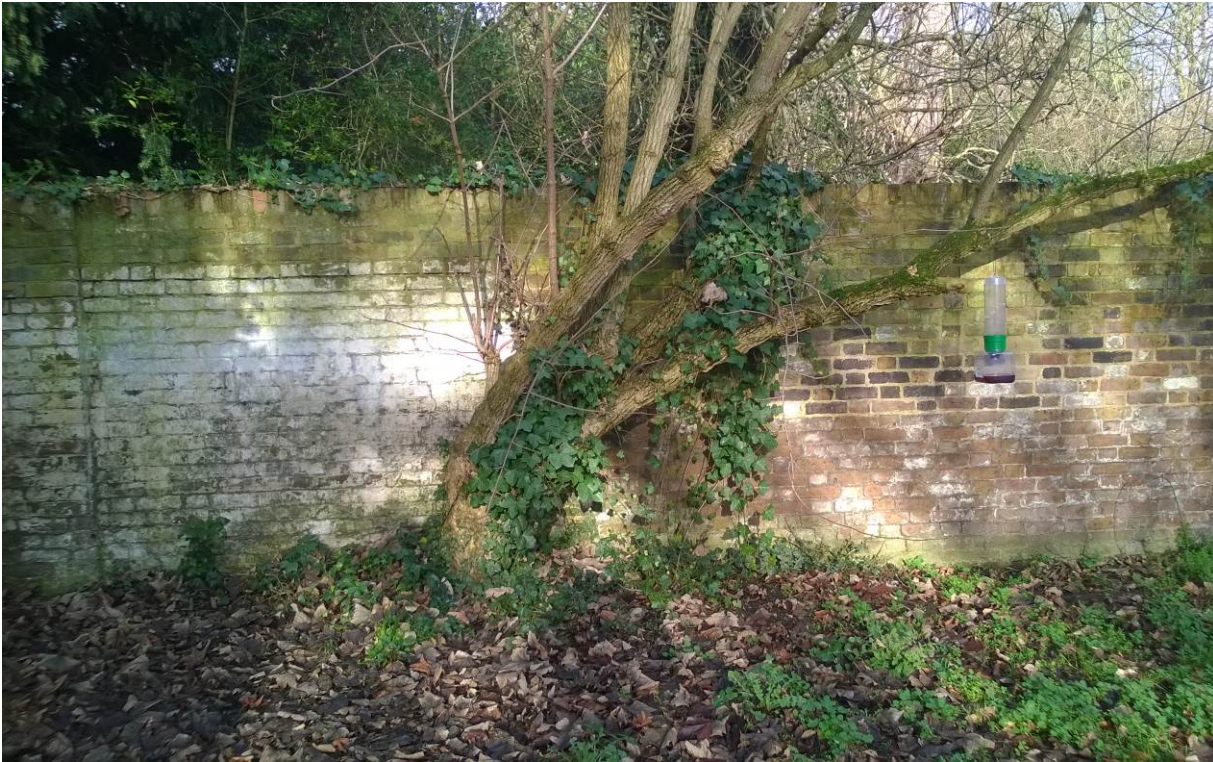
- 3.8 The north end cross wall has extensive ivy growth to the north elevation which carries over the top of the wall. The wall is likely to require some repointing below the vegetation, but we did not observe and root penetration into the masonry. There is also a medium sized elder tree growing from the base of the wall. As this tree matures the growth may become a problem for the adjacent masonry wall, this area of the wall should be monitored if the tree is retained.

Photograph 17 – Elder tree in close proximity to north cross wall.

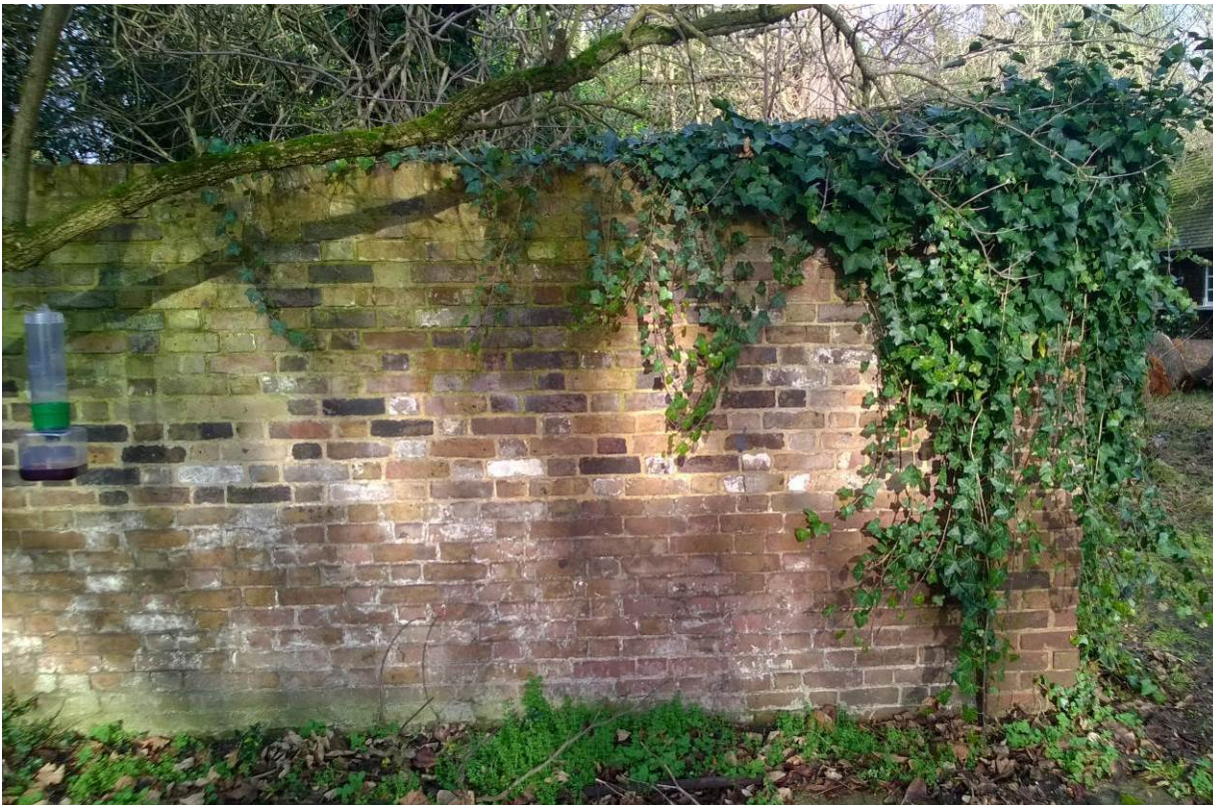
Photograph 18 – Ivy growth to north cross wall.

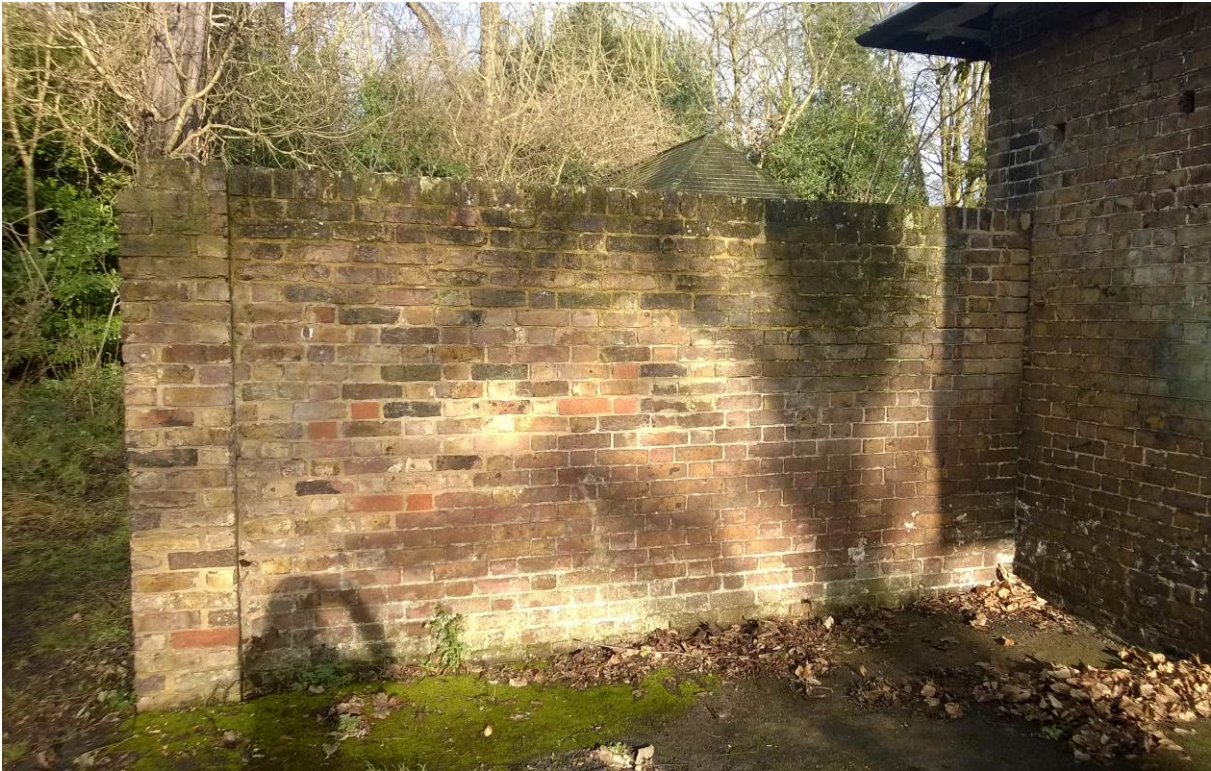
**Photograph 19 – Continuation of north wall and junction with stables building.**

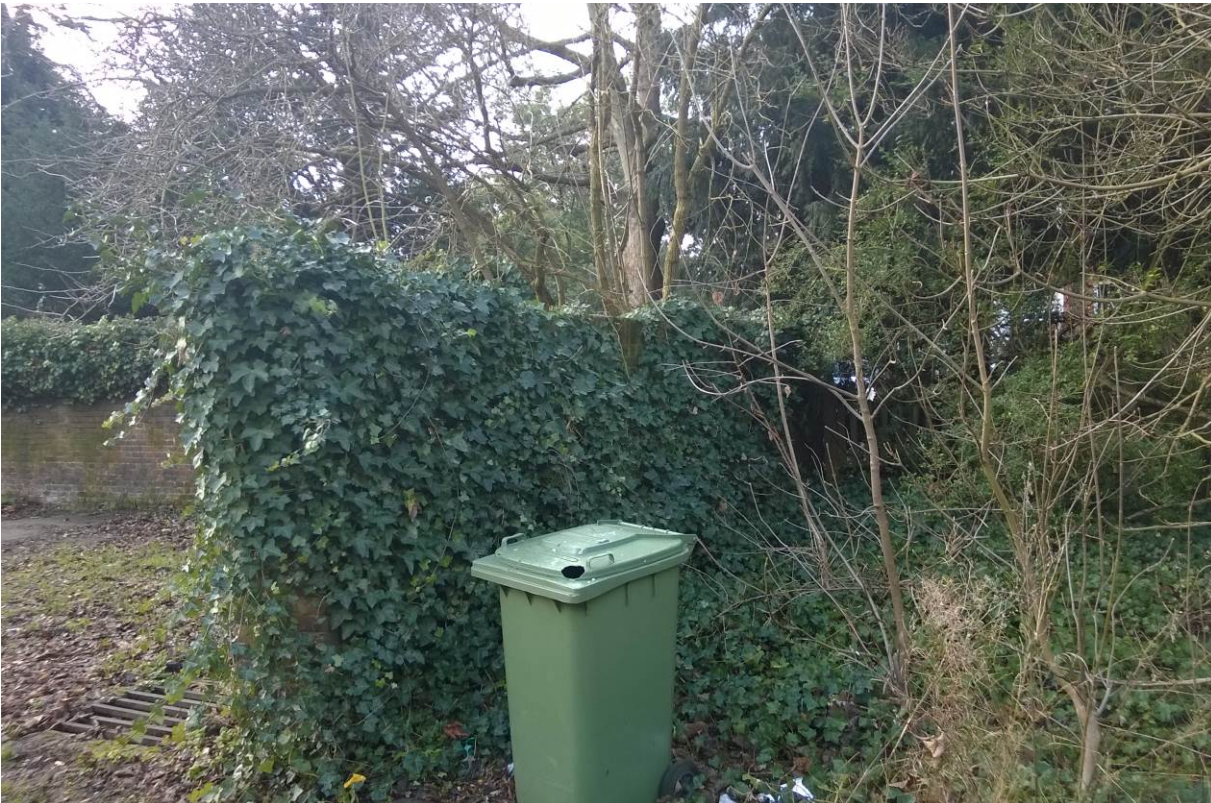
**Photograph 20 – Ivy growth to north elevation of north end cross wall.**

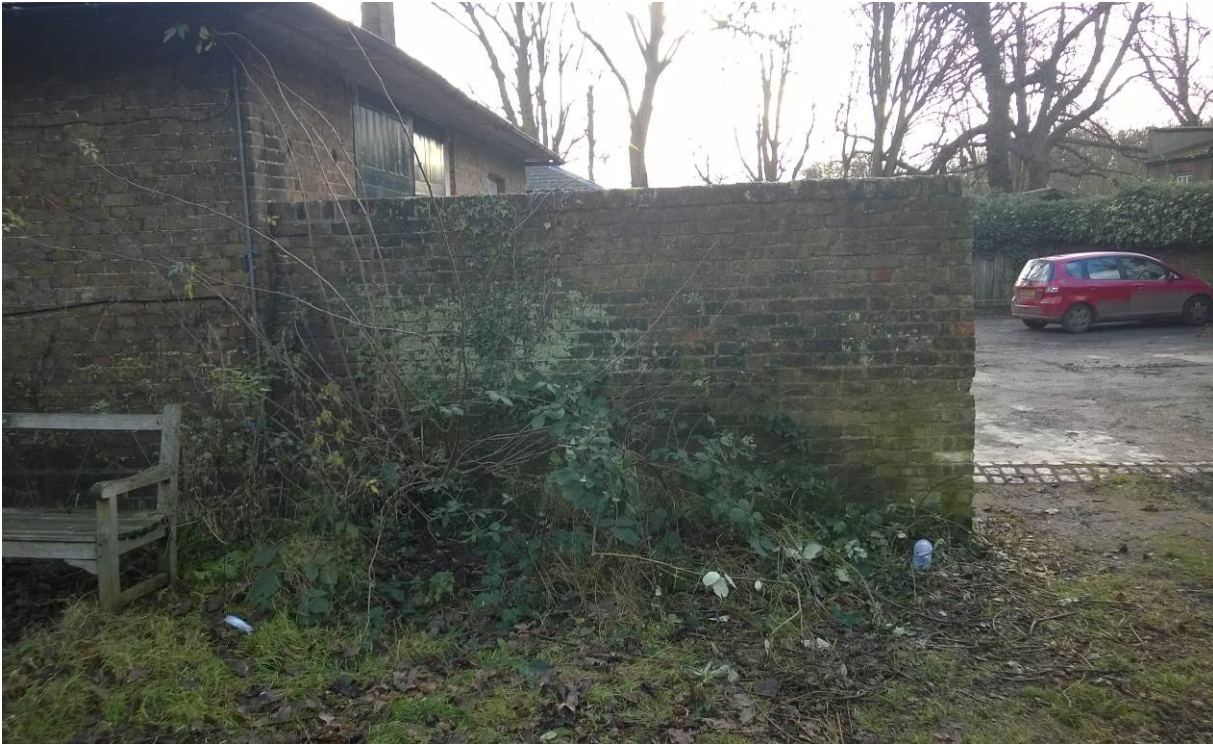
Photograph 21 – Vegetation growth in close proximity to North elevation of north end cross wall.

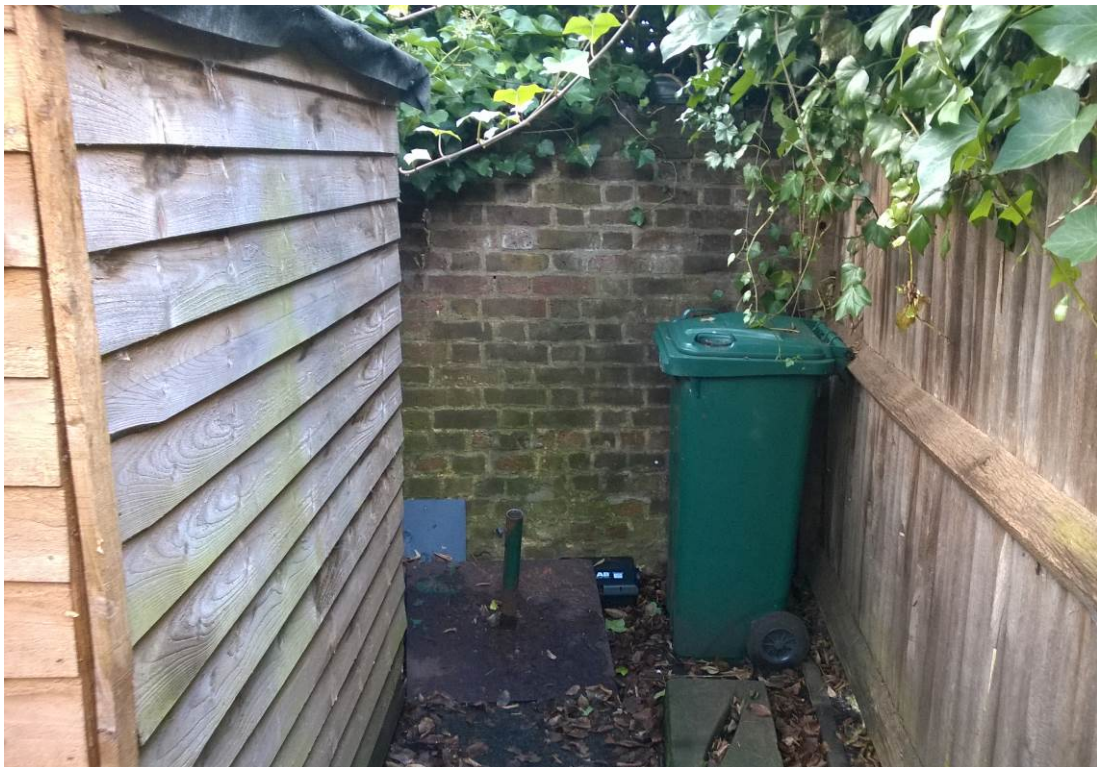
Photograph 22 – South end of main wall.

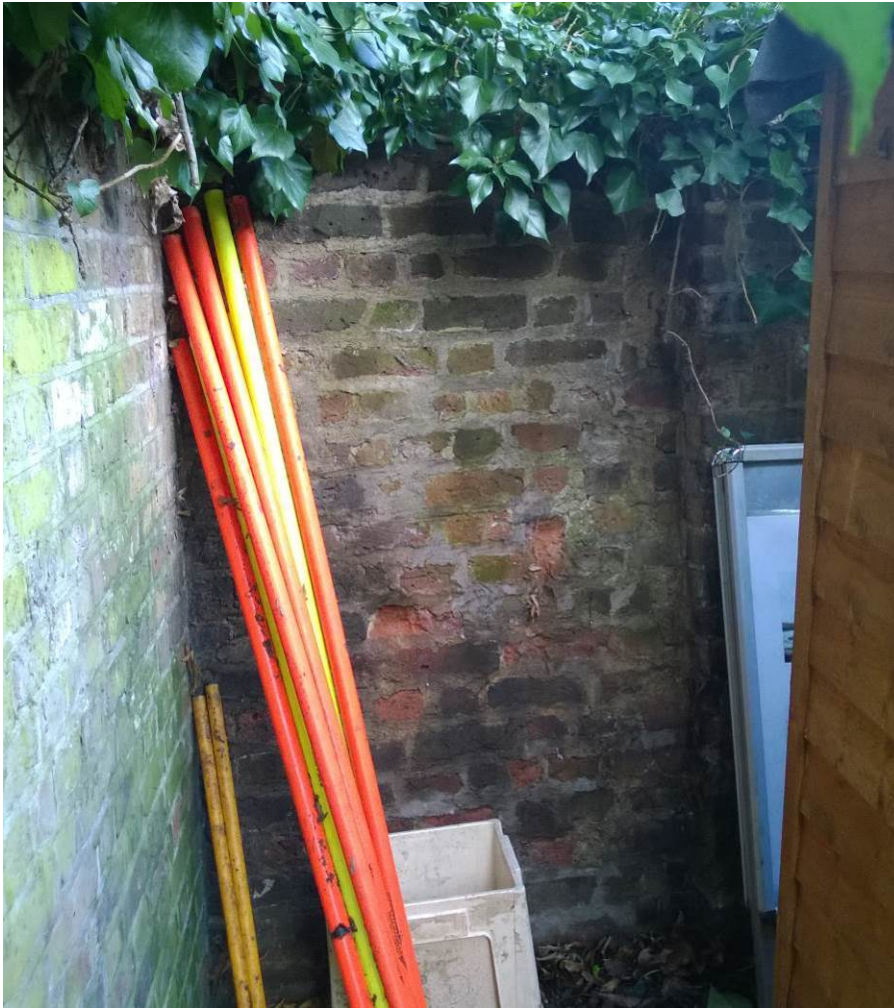
Photograph 23 – South end of main wall, minor erosion of bricks and extensive ivy growth.

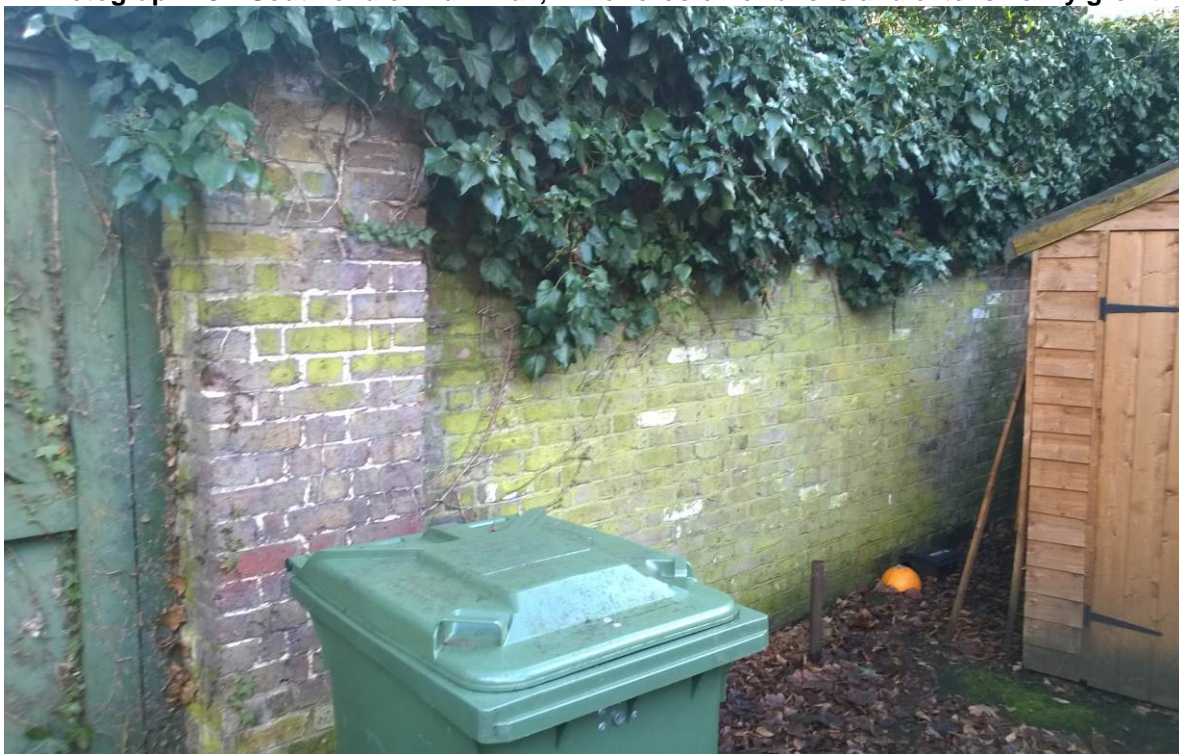
- 3.9 The condition of the south end cross wall appears fair but some repointing of the upper courses below the ivy is likely required.
- 3.10 Trial pits revealed the a stepped brick footing to a depth of approximately 750mm-850mm below ground level which is sufficient for a wall of this height.

Photograph 24 – South end cross wall, height of wall increases, extensive ivy growth to top of wall.

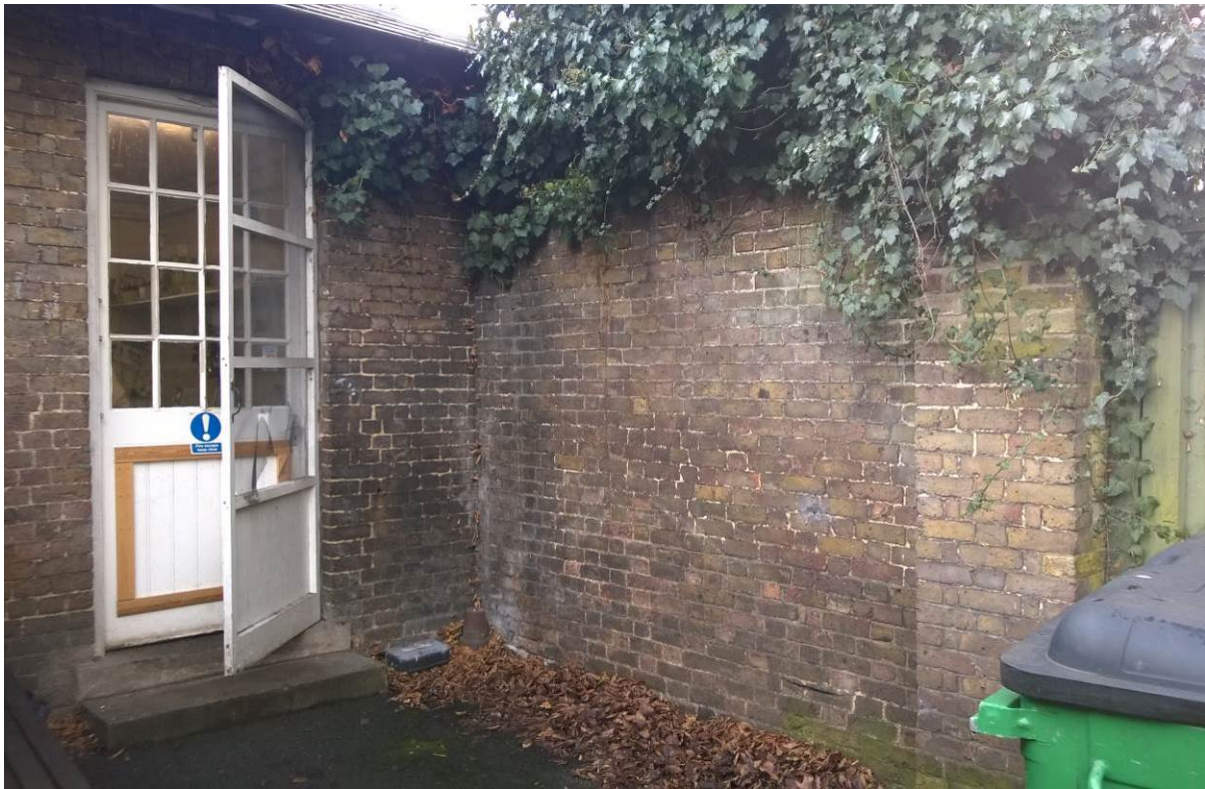
**Photograph 25 – South end cross wall at junction of stables building.**
