8.27 STABLE BLOCK & CAFE - STABLE WALL ARCHAEOLOGICAL INVESTIGATION

**STABLE YARD WALL
AT MARBLE HILL,
TWICKENHAM,
LONDON BOROUGH OF
RICHMOND-UPON-THAMES**

Archaeological Investigation

2016

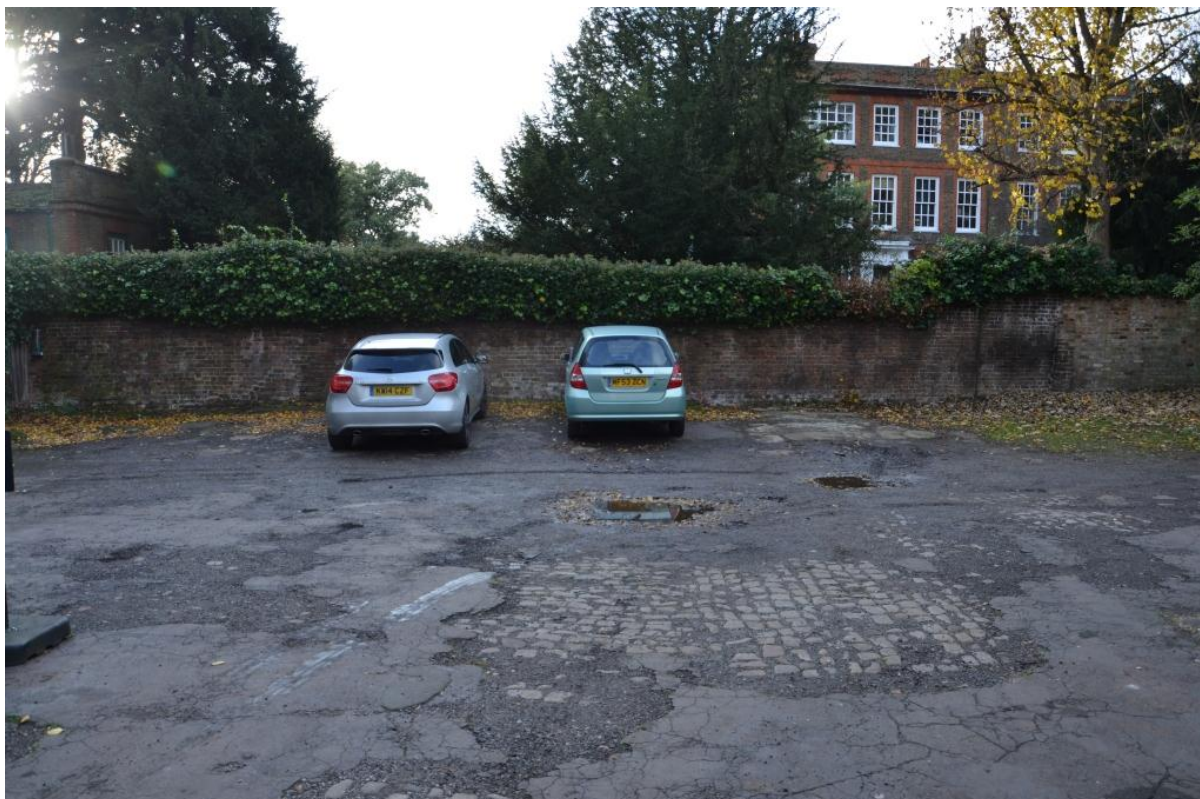
4.3 The rear, west long wall of the yard rises to approximately 1.8 metres in height, and extends to a length of 30 metres (Plate 2). It has a western lean along much of its length of some four degrees from perpendicular. The majority appears to be of one phase, though the northern three metres is of modern construction using recycled brick and cement pointing, and clearly closes a formerly open aperture to the garden of South End House beyond (Plate 6).

Plate 2 View of the long, western yard wall from the east.

enclosure and discrete screening of their activities from the park and house. The most significant fabric, in terms of degree of preservation comprises the short arm nearest on the south, extending from the building to the gate pier and this should be retained in order to preserve a sense of the original enclosure of the yard. The historic integrity of the yard could also be enhanced by the repair or rebuilding of the long west wall and the exposure of original cobbles.

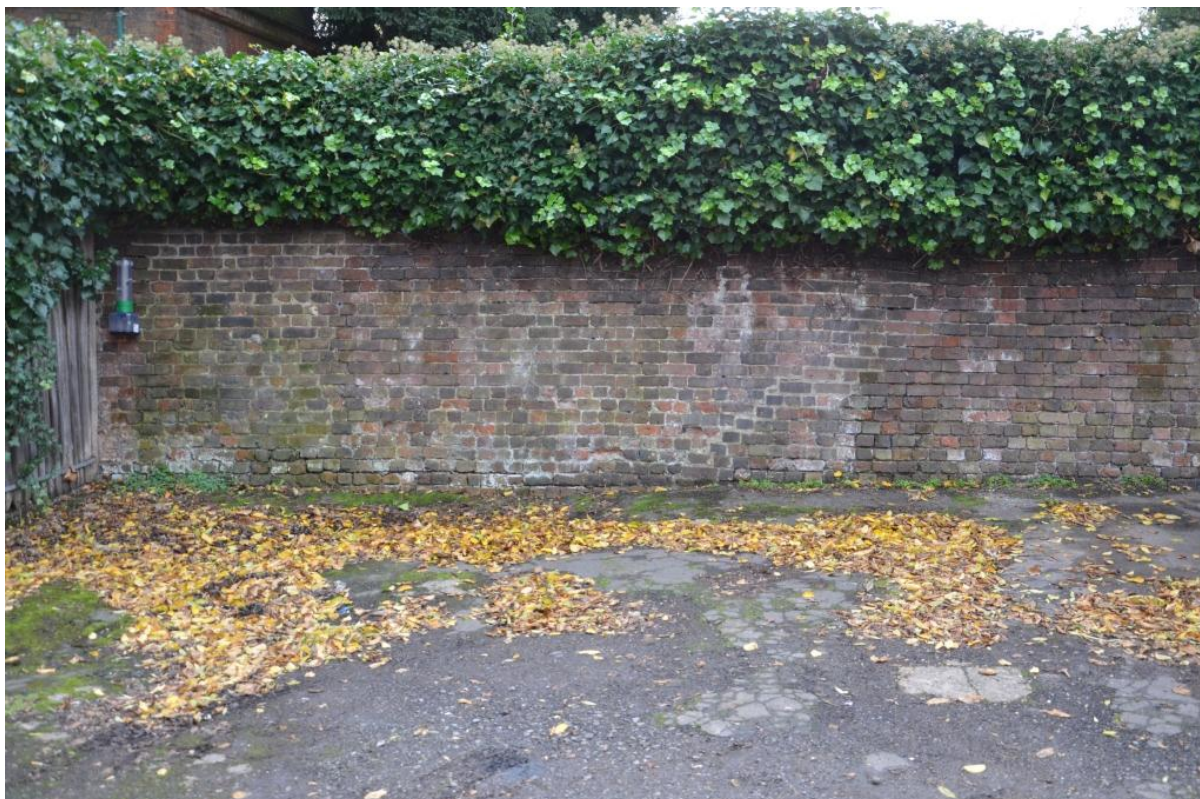
4.4 In terms of construction, the majority is built in Flemish bond, though the lowest nine courses (visible to its maximum extent where the ground falls at the southern end) are exclusively of header bond (Plate 3). This may reflect a more substantial foundation, which is flush with the wall on this side; the rear face was not examined. Most of the wall is now capped with a single course of headers in cement, now mostly obscured by dense ivy from the rear. In the northern section, however, approximately three metres of the wall rises a further ten courses to over two metres in height (Plate 4). There is no evidence for any coping stone or particular finish.

size, measuring $8\frac{3}{4}$ by $2\frac{1}{2}$ by 4 inches, laid with half-inch joints in a fairly pale lime mortar, now softened and decayed by weathering. One or two distinct repairs in modern cement appear to make good diagonal cracks associated with partial slumping.

Plate 3 Southern end of the long western yard wall showing repaired crack and slumping to the north. Viewed from the east

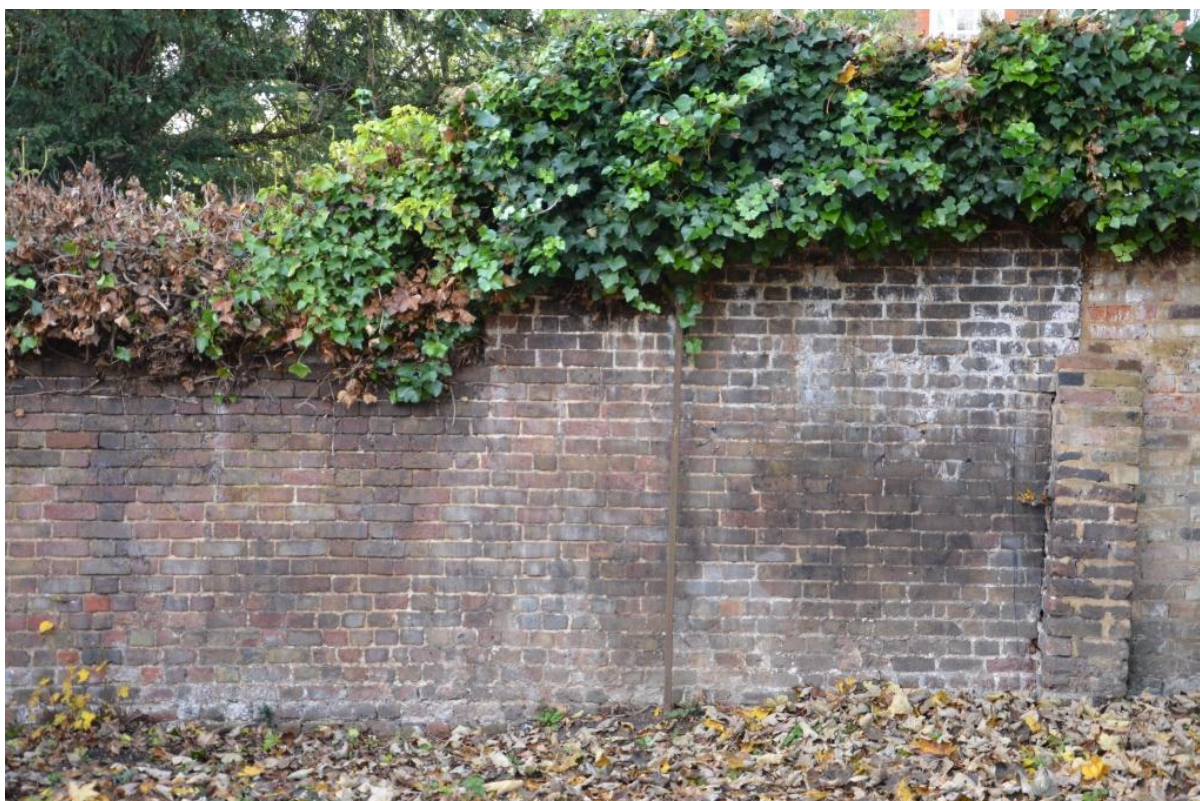
Plate 4 Northern end of the long western wall showing rise and buttress marking newer section to right.

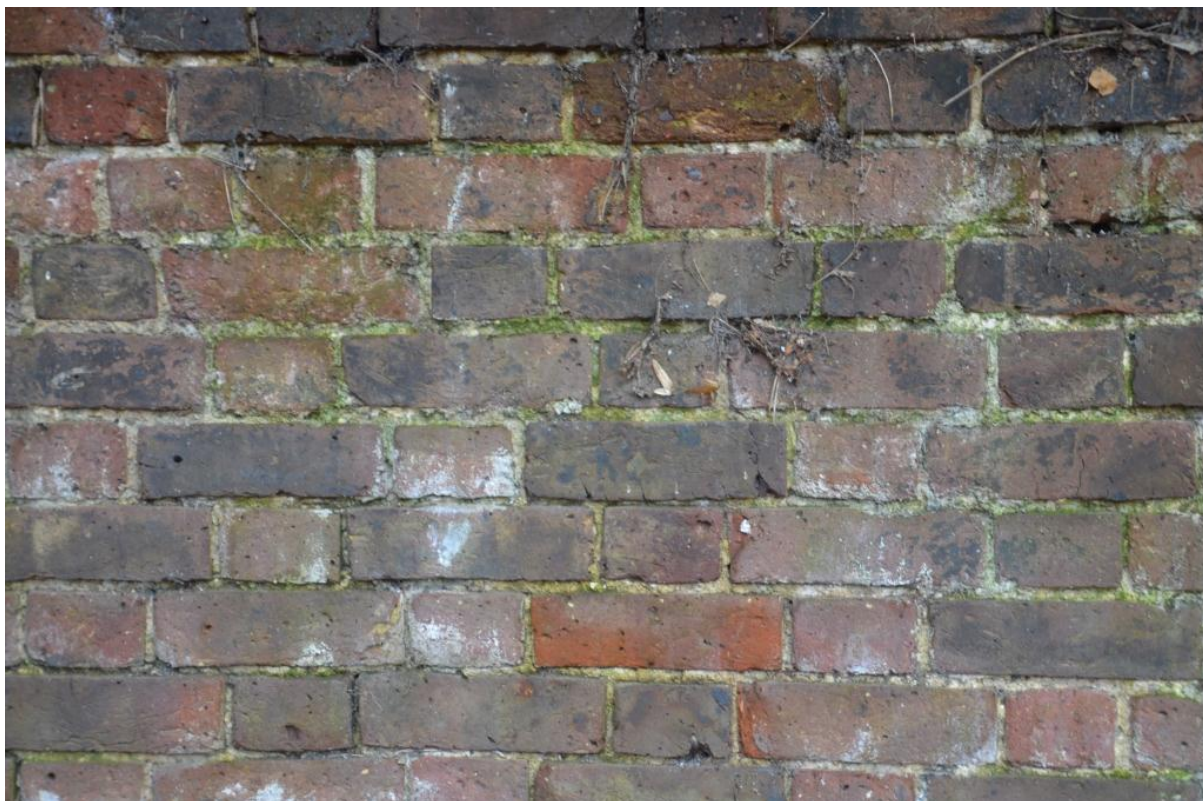
4.5 The brick is a variable purple stock with some inclining to an orange hue, but all fairly homogenous in texture with a few creases, but clearly stock-made (Plate 5). Some small inclusions of flint, ash and glass are present. The bricks are of regular

Plate 5 Brickwork detail

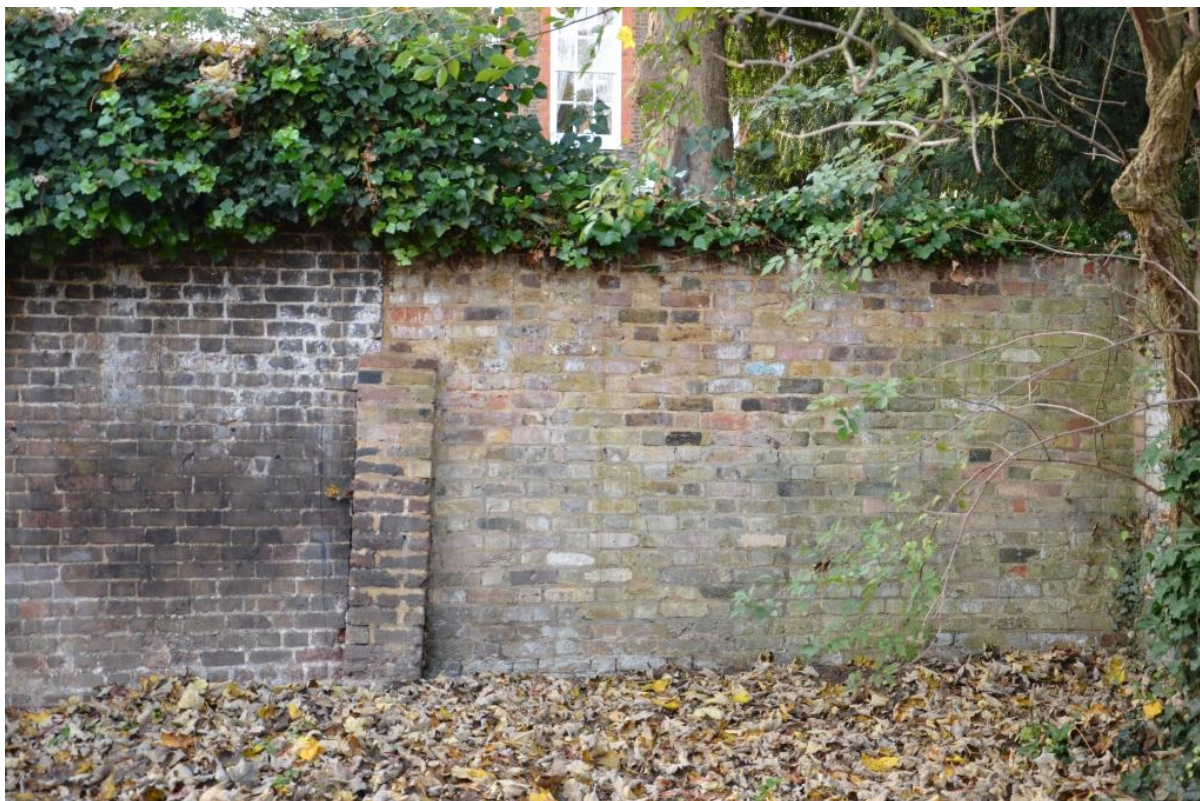
Plate 6 Northern end of the long western yard wall with later blocking. Viewed from the east.

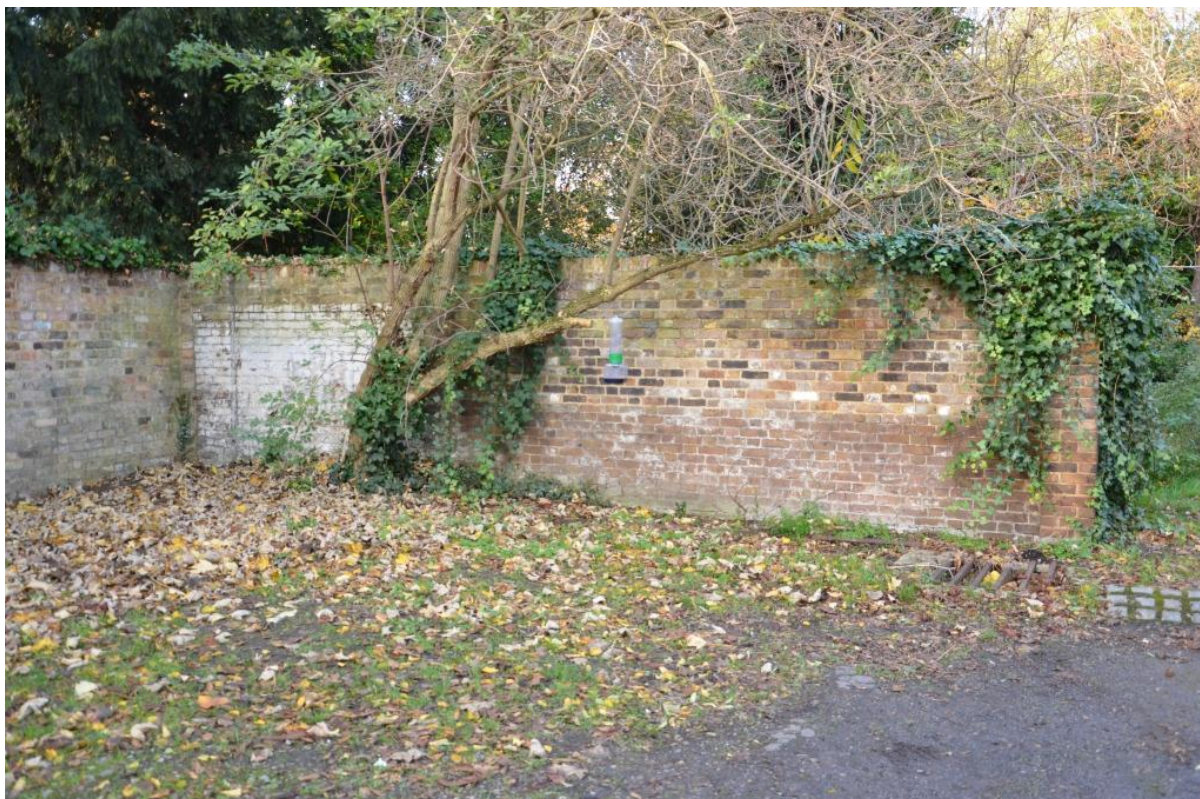
4.7 The northern arm of the wall abuts the stable with a straight joint and is battered to its exterior face at lower level. The western end is much rebuilt (Plate 7), but the lower bricks are consistent with the main building. The upper brickwork appears to have been reconstructed using a mixture of original fabric and recycled industrial stocks.

Plate 7 Northern return of the yard wall. View from the south-east.

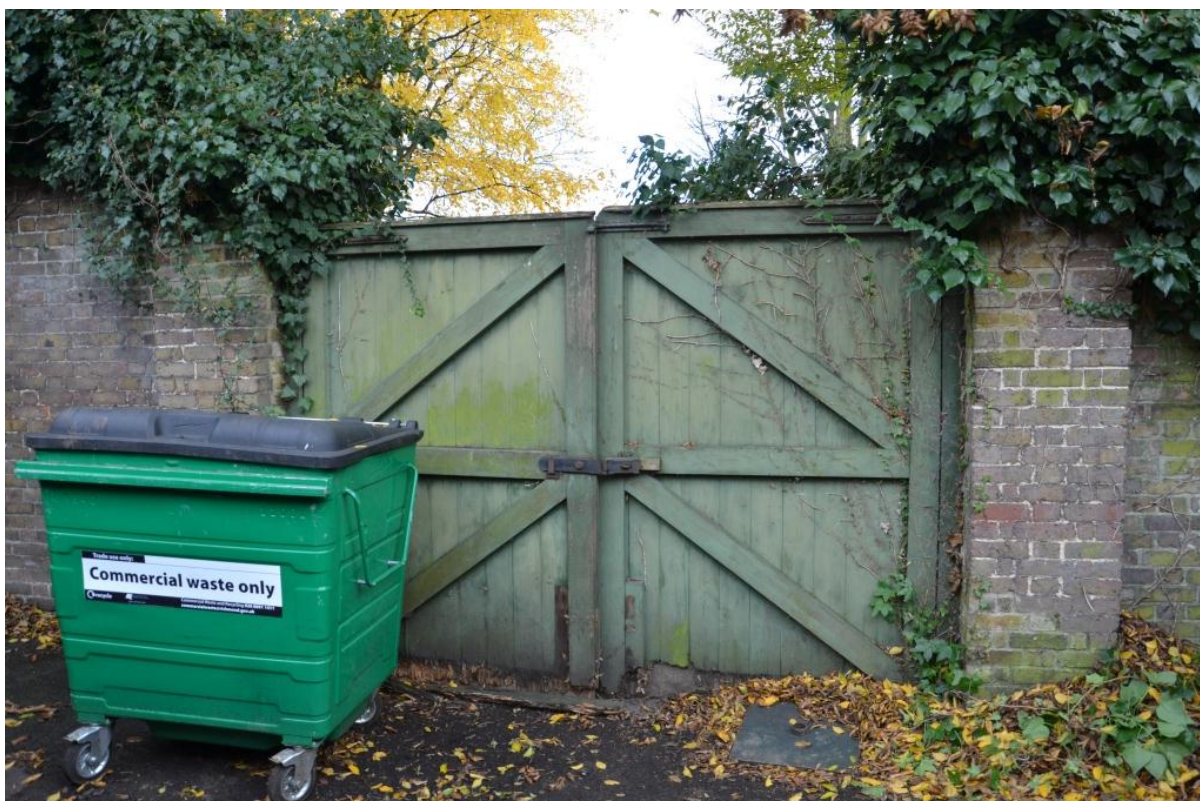
4.8 The southern return of the wall is now partly separated from the rest of the yard by a modern timber fence. It extends on either side of the gateway noted above (Plate 8). That to the east, abutting the stable with a straight joint is battered to its external face in the same manner as its northern counterpart, but preserves its original height and internal pointing, which has been protected from weathering and so remains in good condition (Plate 9). The western section has been much repointed in modern materials to its internal face, but rises to the original height seen at the northern end of the long wall. The external face of this section is mostly obscured by ivy.

Plate 8 Gate piers framed by the southern return of the yard wall; internal view from the north.

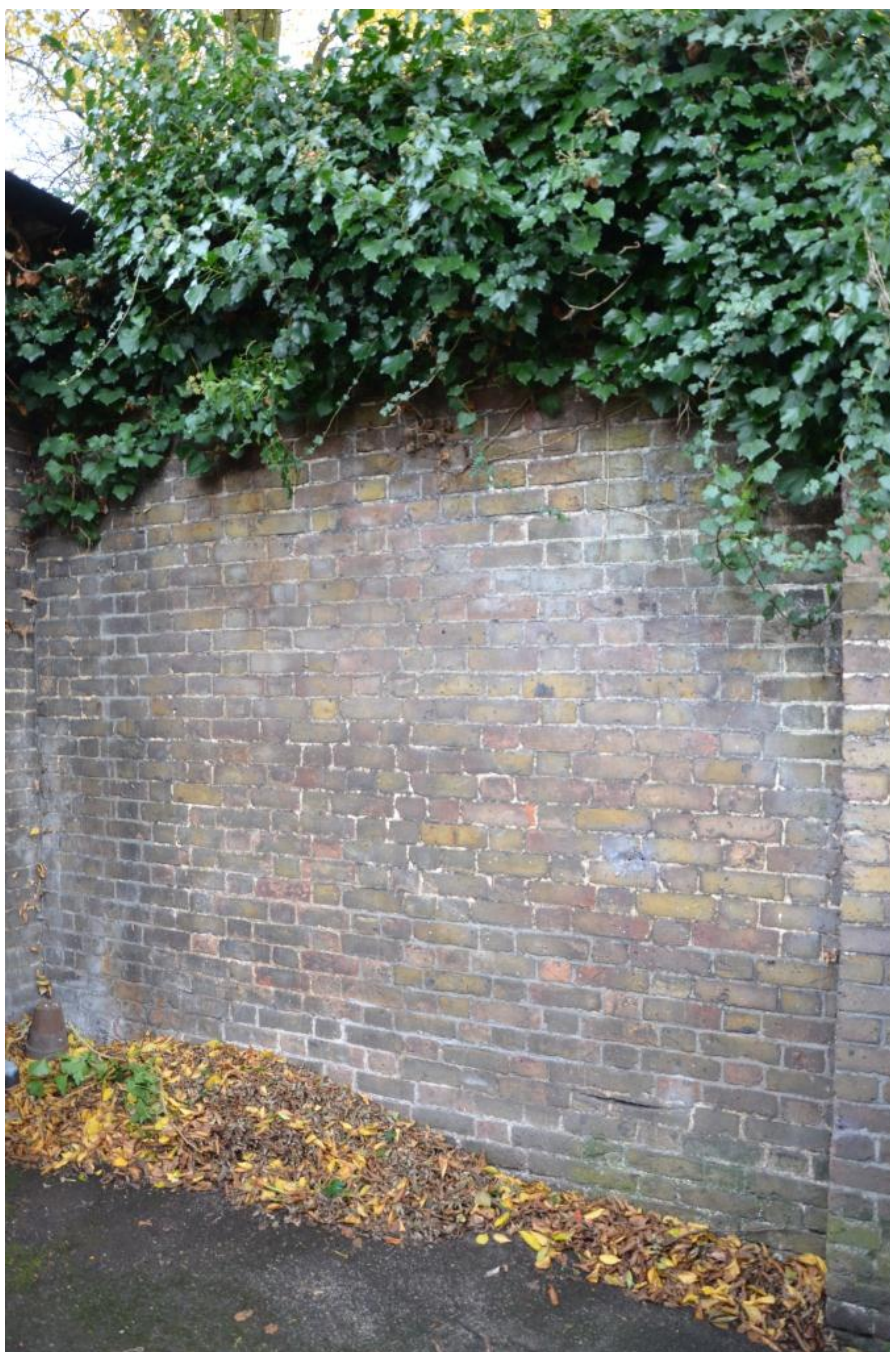
Plate 9 Southern wall, abutting the stable block.
View from the north-west.
