ASBESTOS MANAGEMENT PLAN

MARBLE HILL HOUSE TWICKENHAM

ISSUE DATE: OCTOBER 2015
REVISION: 04
ON BEHALF OF: ENGLISH HERITAGE
 ESTATES TEAM LONDON

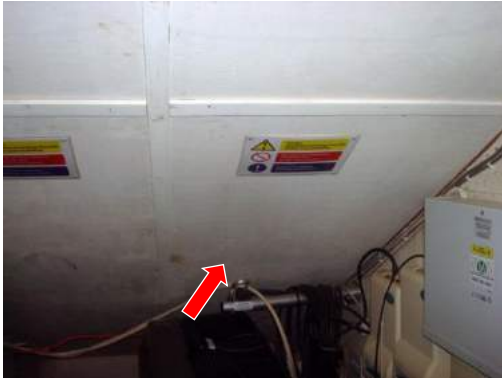
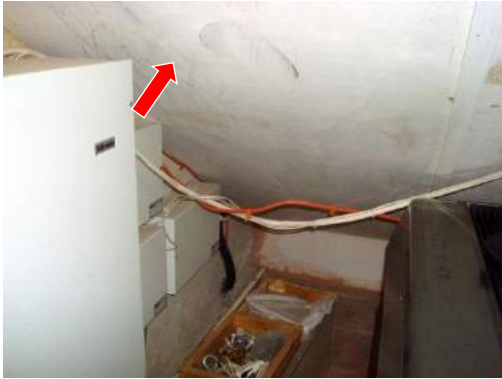
MATERIAL ASSESSMENT (MA)				
AMA Ref. AMP-MHH-02	FLOOR - SPACE	Main House Ground floor - Room 6 understairs cupboard	SAMPLE No. 93588/15	
DETAIL Insulation board to underside of stairs (behind timber over-cladding)		SAMPLE RESULT	Chrysotile	✓
			Amosite	✓
			Crocidolite	X
			NAD	X
ASSESSMENT		See floor plans for detailed location		
Product	2			
Damage	0			
Surface	0			
Type	2			
AMA SCORE	6

PART 2 - PRIORITY ASSESSMENT (PA)				
Variable	Score	Variable	Score	
Normal occupant activity	1	Human Exposure	1	
Likelihood of disturbance	1	Maintenance activity	1	
Priority Assessment (PA) Score	4	Total Risk Score (AMA + PA)	10	
Management Strategy	Inform, Manage, Restrict			
PART 3 - RE-INSPECTION NOTES				
Re-inspected October 2015, no apparent change in condition since last inspection, full mechanical protection in place, labelled				
Re-inspect by end of Q4 2016 or if maintenance/refurb access required in the meantime

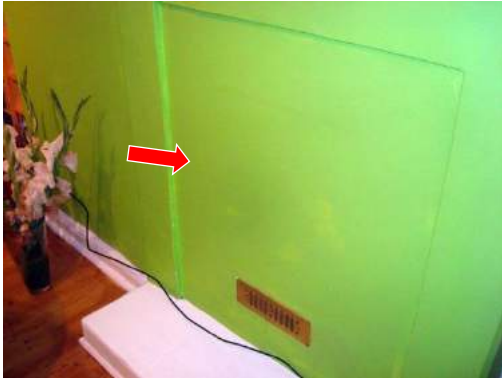
MATERIAL ASSESSMENT (MA)				
AMA Ref. AMP-MHH-12	FLOOR - SPACE Beaufort Lodge Living room	SAMPLE No. Not accessed		
DETAIL Presumed panel blocking off fireplace (behind non-asbestos facing panel)		SAMPLE RESULT	Chrysotile	N/A
			Amosite	N/A
			Crocidolite	N/A
			NAD	N/A
ASSESSMENT		See floor plans for detailed location		
Product				
Damage				
Surface				
Type				
AMA SCORE

PART 2 - PRIORITY ASSESSMENT (PA)				
Variable	Score	Variable	Score	
Normal occupant activity		Human Exposure		
Likelihood of disturbance		Maintenance activity		
Priority Assessment (PA) Score		Total Risk Score (AMA + PA)		
Management Strategy		Inform, Manage, Restrict		
PART 3 - RE-INSPECTION NOTES				
<p>Re-inspected October 2015, visible panel is non-asbestos but no access has been gained beyond this panel. On the basis of findings elsewhere it is currently presumed that there may be an asbestos panel behind the over-boarding.</p> <p>Re-inspect prior to refurb or if maintenance access required in the meantime</p>

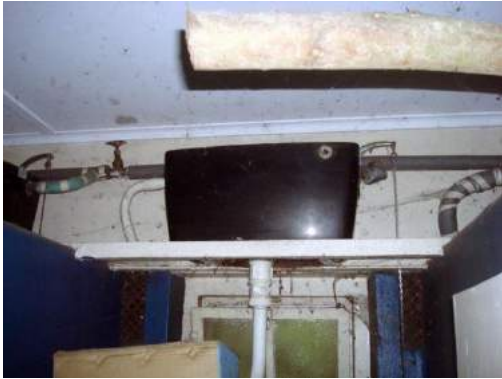
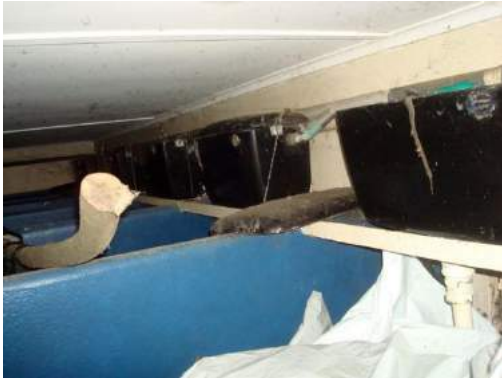
MATERIAL ASSESSMENT (MA)				
AMA Ref. AMP-MHH-13	FLOOR - SPACE Disused WCs in grounds	SAMPLE No. XA94327/22		
DETAIL WC cisterns in cubicles		SAMPLE RESULT	Chrysotile	X
			Amosite	✓
			Crocidolite	X
			NAD	X
ASSESSMENT		See floor plans for detailed location		
Product	1			
Damage	0			
Surface	0			
Type	2			
AMA SCORE	3

PART 2 - PRIORITY ASSESSMENT (PA)				
Variable	Score	Variable	Score	
Normal occupant activity	0	Human Exposure	1	
Likelihood of disturbance	1	Maintenance activity	0	
Priority Assessment (PA) Score	2	Total Risk Score (AMA + PA)	5	
Management Strategy	Inform, Manage, Restrict			
PART 3 - RE-INSPECTION NOTES				
<p>Re-inspected October 2015, no change in condition since last inspection, WCs are not used except for some storage so no on-going maintenance requirement</p> <p>Re-inspect prior to refurbishment or if maintenance access required in the meantime</p>

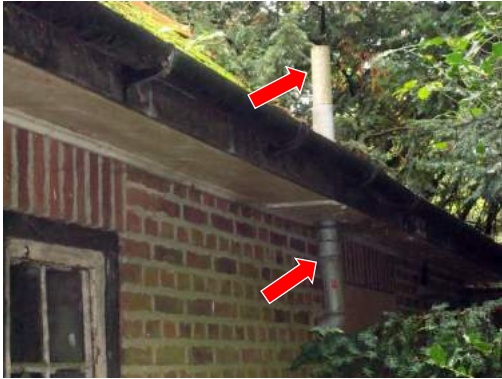
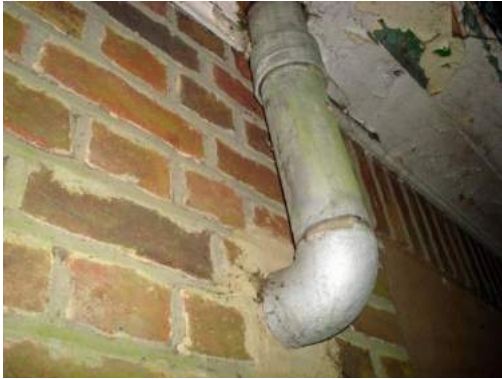
MATERIAL ASSESSMENT (MA)			
AMA Ref. AMP-MHH-14	FLOOR - SPACE Disused WCs in grounds	SAMPLE No. Visual ID	
DETAIL Redundant incinerator flue on outside wall		SAMPLE RESULT (Presumed)	Chrysotile ✓
			Amosite X
			Crocidolite ✓
			NAD X
ASSESSMENT		See floor plans for detailed location	
Product	1		
Damage	1		
Surface	1		
Type	3		
AMA SCORE	6

PART 2 - PRIORITY ASSESSMENT (PA)			
Variable	Score	Variable	Score
Normal occupant activity	0	Human Exposure	0
Likelihood of disturbance	1	Maintenance activity	0
Priority Assessment (PA) Score	1	Total Risk Score (AMA + PA)	7
Management Strategy	Inform, Manage, Restrict		
PART 3 - RE-INSPECTION NOTES			
Re-inspected October 2015, no change in condition since last inspection			
Re-inspect by end of Q4 2016 or if maintenance/refurb access required in the meantime

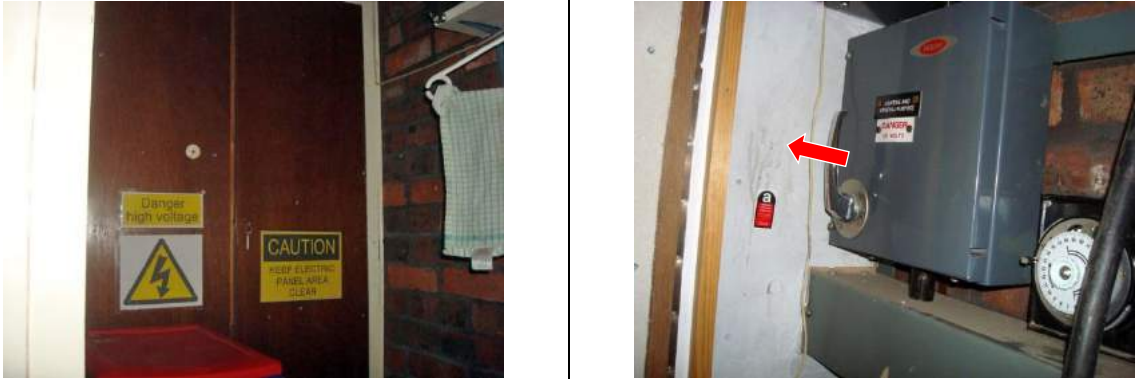
MATERIAL ASSESSMENT (MA)				
AMA Ref. AMP-MHH-16	FLOOR - SPACE One O'clock Club Kitchen	SAMPLE No. XA94330/25		
DETAIL Store/electrics cupboard - Panel lining left-hand side of cupboard		SAMPLE RESULT	Chrysotile	X
			Amosite	✓
			Crocidolite	X
			NAD	X
ASSESSMENT		See floor plans for detailed location		
Product	2			
Damage	1			
Surface	1			
Type	2			
AMA SCORE	6

PART 2 - PRIORITY ASSESSMENT (PA)				
Variable	Score	Variable	Score	
Normal occupant activity	1	Human Exposure	1	
Likelihood of disturbance	2	Maintenance activity	1	
Priority Assessment (PA) Score	5	Total Risk Score (AMA + PA)	11	
Management Strategy	Inform, Manage, Restrict			
PART 3 - RE-INSPECTION NOTES				
<p>Re-inspected October 2015, panel is painted and labelled, no change in condition since last inspection. (Door lining panels are non-asbestos material.)</p> <p>Re-inspect by end of Q4 2016 or if maintenance/refurb access required in the meantime</p>

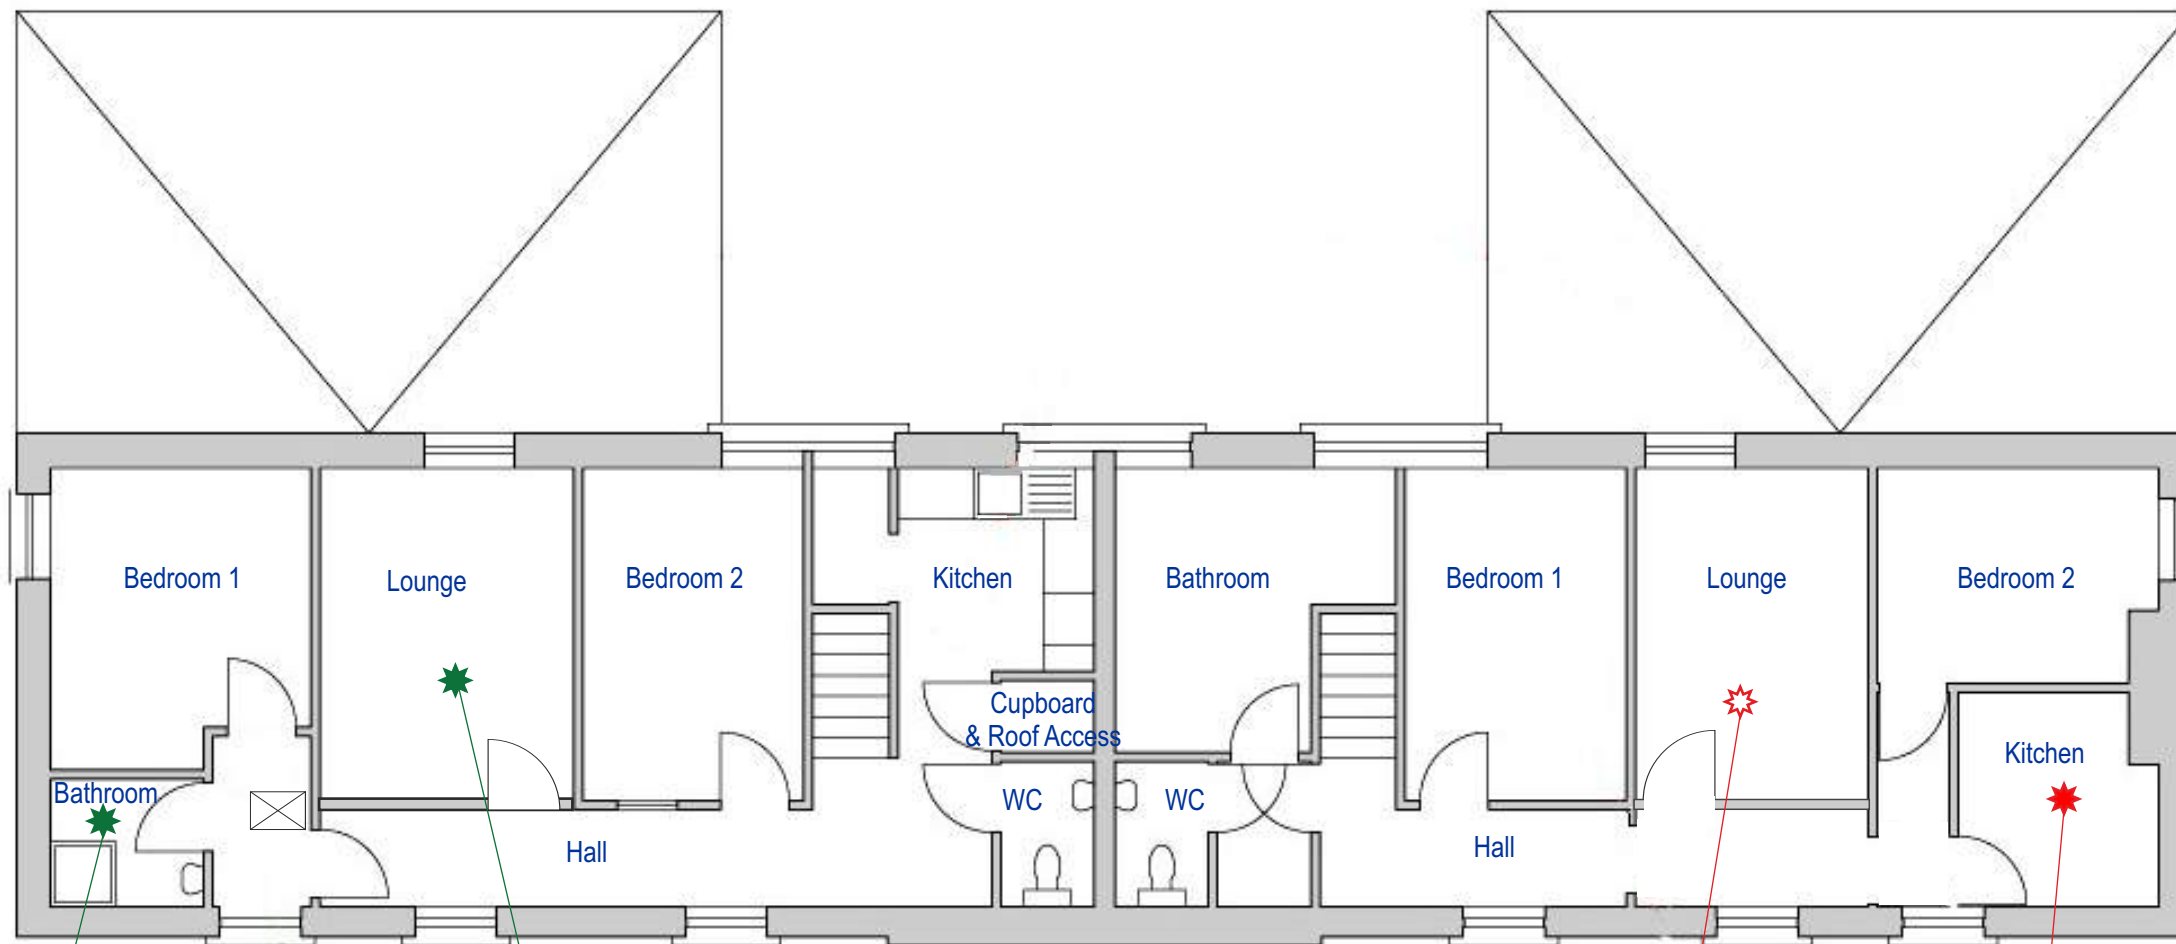
DRG No.
AMP-MHH-1015-CH1

ASBESTOS STRING ON
INSULATION IN ROOF VOID
REMOVED (2004)

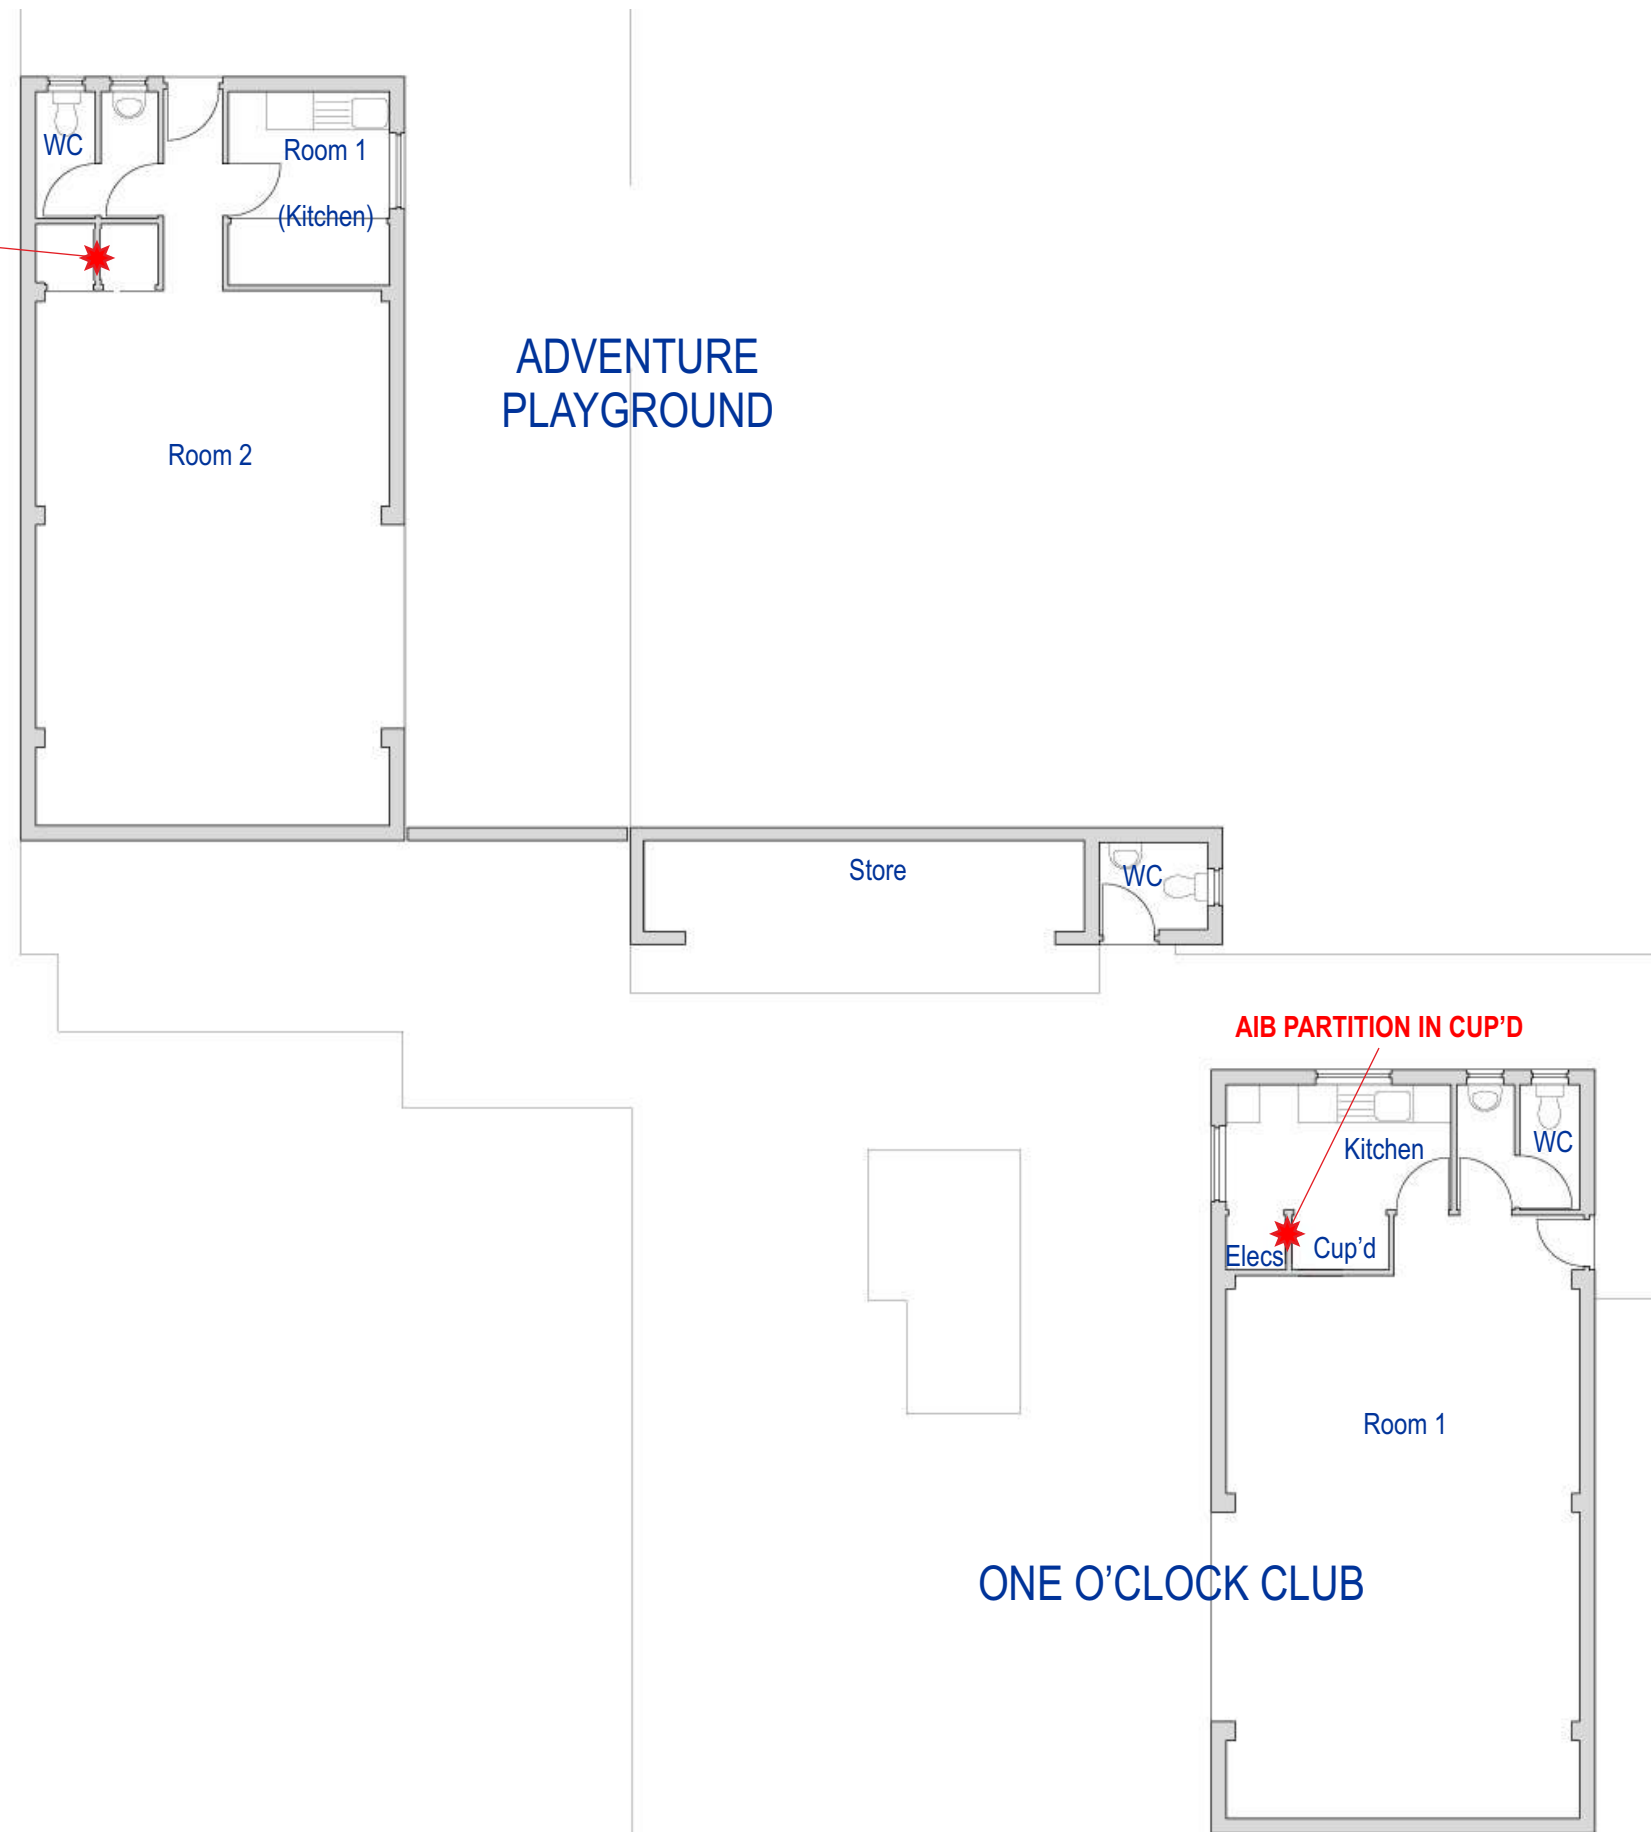
AIB PARTITION IN CUP'D

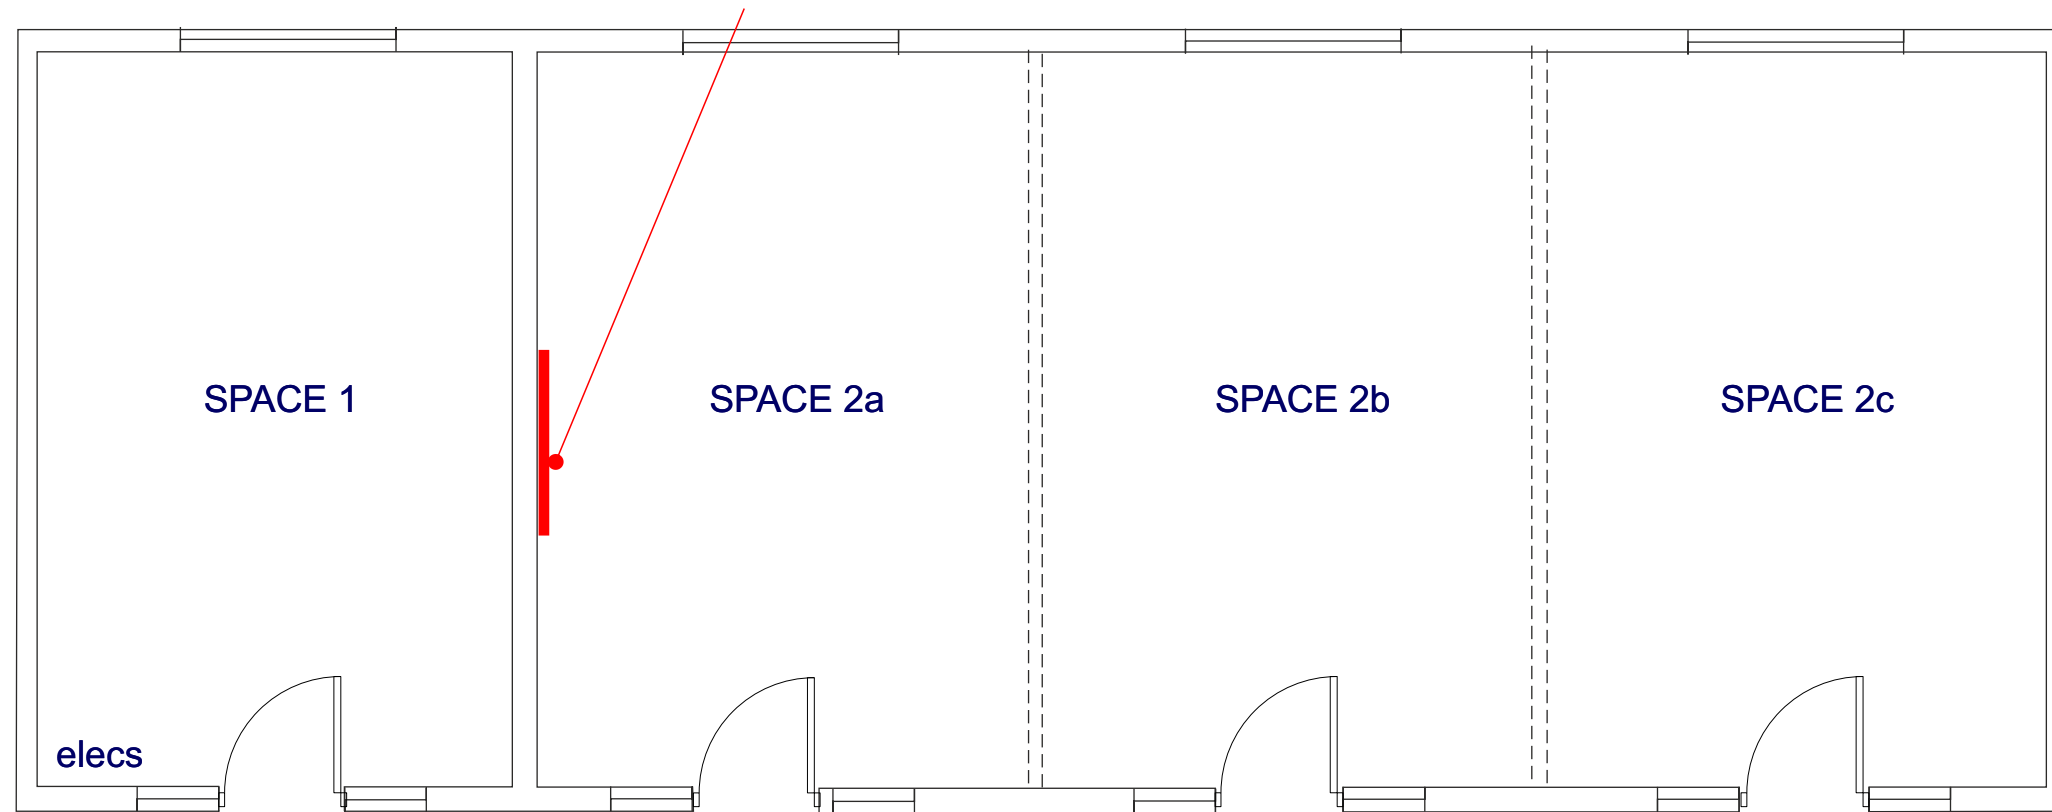
AC BOARD ON WALL
BEHIND HEATER

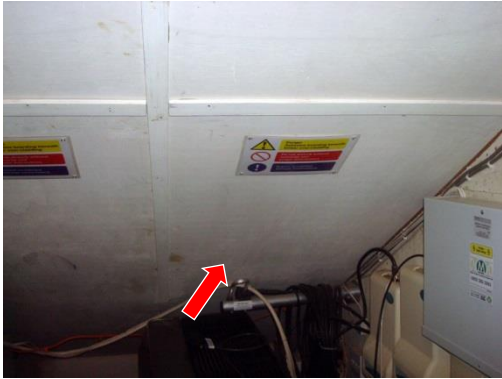
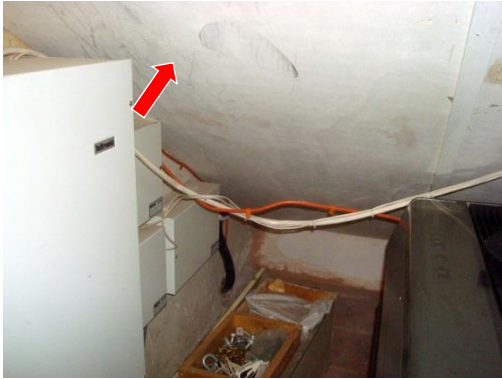
MATERIAL ASSESSMENT (MA)				
AMA Ref. AMP-MHH-02	FLOOR - SPACE	Main House Ground floor - Room 6 understairs cupboard	SAMPLE No. 93588/15	
DETAIL Insulation board to underside of stairs (behind timber over-cladding)		SAMPLE RESULT	Chrysotile	✓
			Amosite	✓
			Crocidolite	X
			NAD	X
ASSESSMENT		See floor plans for detailed location		
Product	2			
Damage	0			
Surface	0			
Type	2			
AMA SCORE	6

PART 2 - PRIORITY ASSESSMENT (PA)				
Variable	Score	Variable	Score	
Normal occupant activity	1	Human Exposure	1	
Likelihood of disturbance	1	Maintenance activity	1	
Priority Assessment (PA) Score	4	Total Risk Score (AMA + PA)	10	
Management Strategy	Inform, Manage, Restrict			
PART 3 - RE-INSPECTION NOTES				
Re-inspected October 2015, no apparent change in condition since last inspection, full mechanical protection in place, labelled				
Re-inspect by end of Q4 2016 or if maintenance/refurb access required in the meantime
