8.33 MARBLE HILL HOUSE - COMPARTMENTATION REPORT

Marble Hill House

Report on compartmentation

Subject: Marble Hill House

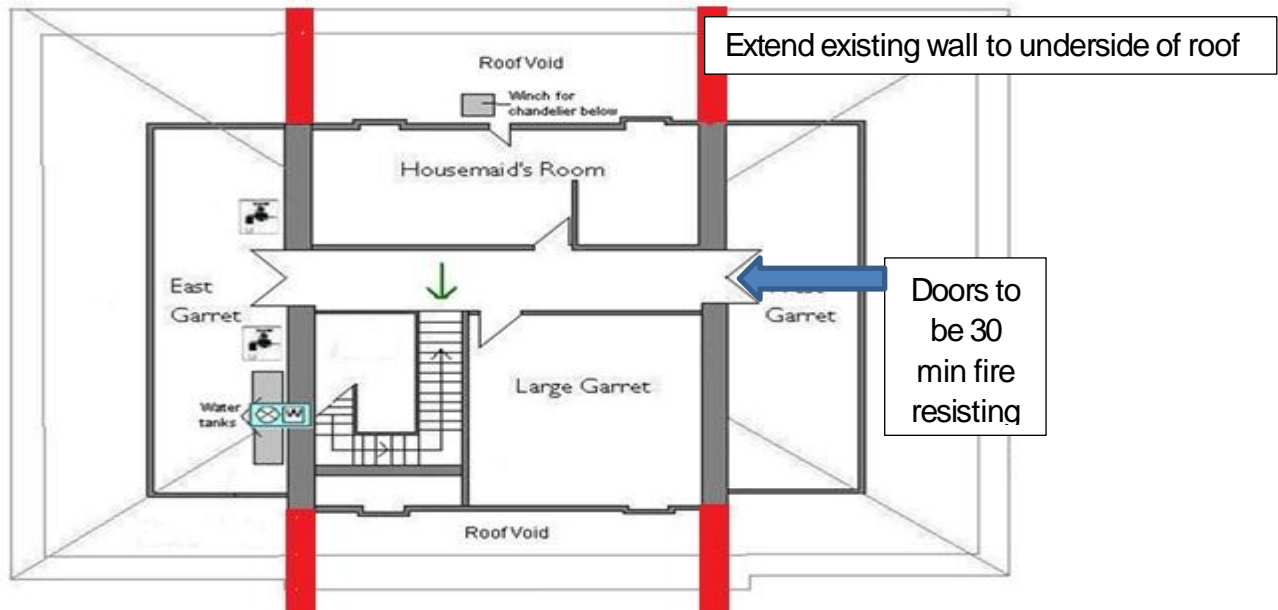
Extending the compartment line to the existing walls to the East and West Garret will afford some level of protection and reduce the compartment sizes on the third floor level considerably. As the roof felt and tiles sit directly onto roof battens and rafters, it will be necessary to ensure that fire spread cannot compromise the adjacent compartment in the event of fire. Fire resistance must be provided either side of the fire wall to ensure that fire spread does not occur. Door leading to the East and West Garret should be 30 min fire resisting.

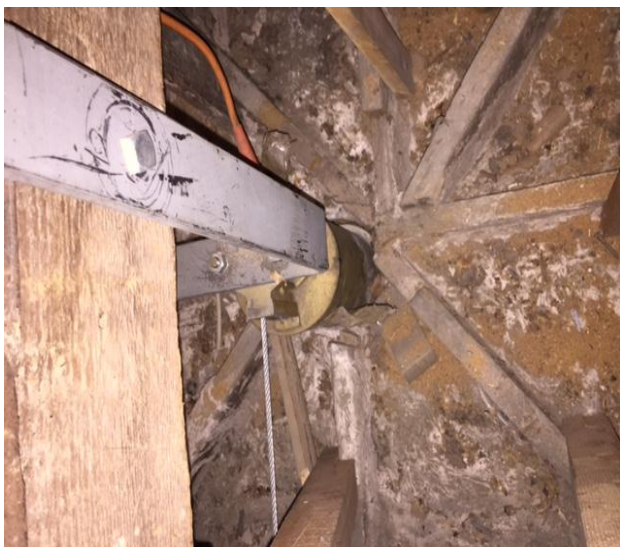
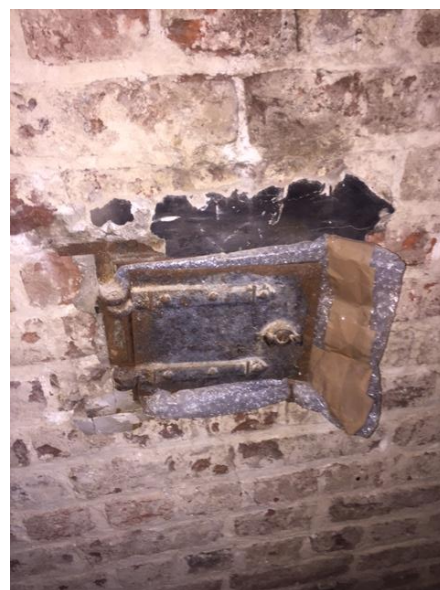
A common void is present under the middle section of the floor beneath the Garret floor; it appears to be large enough that fire detection would be required for this area under the British Standard for fire alarms. Access for maintenance purposes would be problematic and difficult to maintain. It is recommended that an engineered approach could be taken to consider a form of suppression system as a compensatory feature for the lack of compartmentation with the additional positives of giving the premises greater resilience in the event of fire (property protection). It was also noted that there were penetrations to the ceiling where the chandelier passes through it. A register plate in the large Garret Room should be investigated to ensure that fire has not the ability to pass through any void or duct that may be hidden behind this plate.

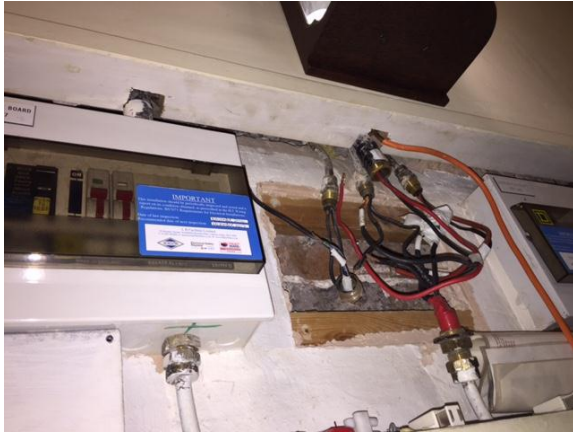
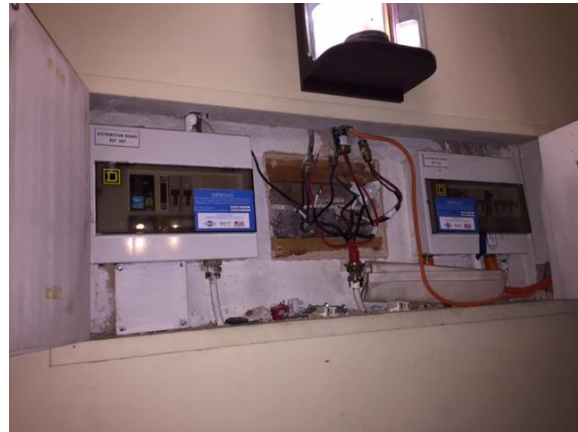
The electrical riser, passing vertically through the stone staircase from ground floor to roof Garret level is an area where fire could spread. Wiring should be checked for compliance and any void or duct should be fire stopped as required to prevent fire spread.

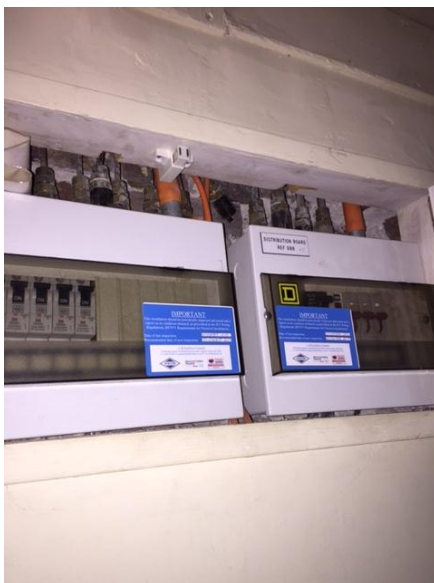
Ground floor electrical cupboard appears to have little appropriate fire stopping, it could not be ascertained if compartments have been penetrated and fire stopped. It is understood that major works to the electrics are to be included in the project, a check to confirm fire stopping should be undertaken.

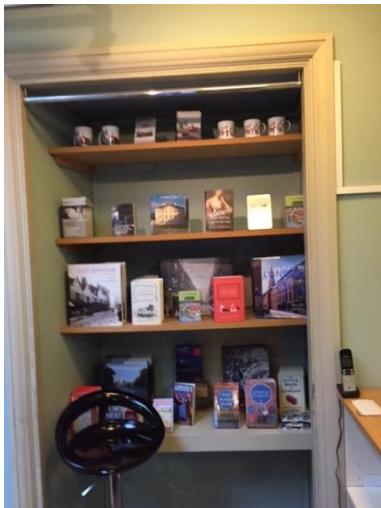
The shop book shelf rear wall is not fire resisting and should be upgraded to give 1 hour protection due to the incorporation of the lift platform being introduced. The fire strategy should be revisited to ensure that means of escape for disabled visitors are compliant with the Fire Safety Order.

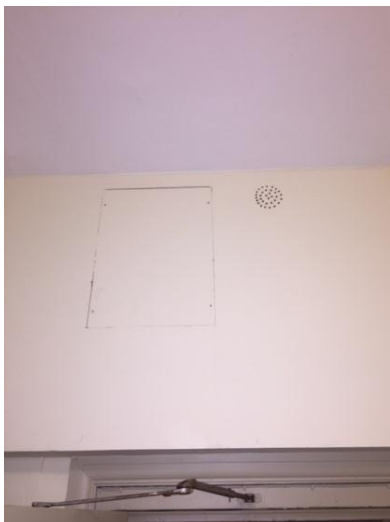
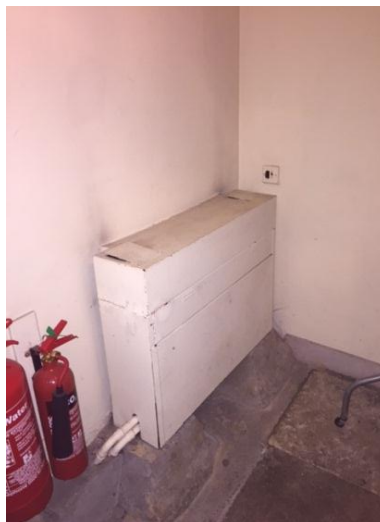
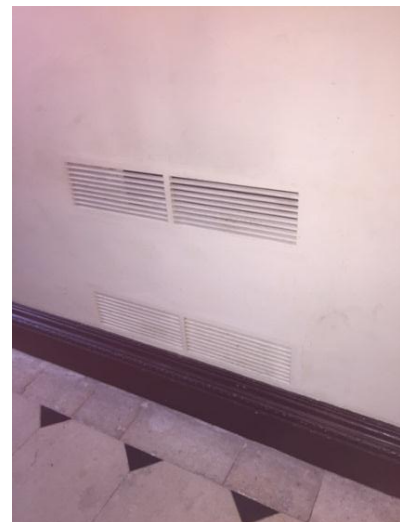
The stone staircase becomes a critical area for means of escape purposes from the upper floors of Marble Hill House. There are breaches to the compartmentation at ground floor level, mainly due to the heating system passing through the wall. This heating unit should be relocated to the hall or alternatively the grill in the hall should be fitted with an intumescent grill to prevent fire spread. The heating unit is located within a critical stair, if it is to be retained it should be encased within a fire resisting cupboard.

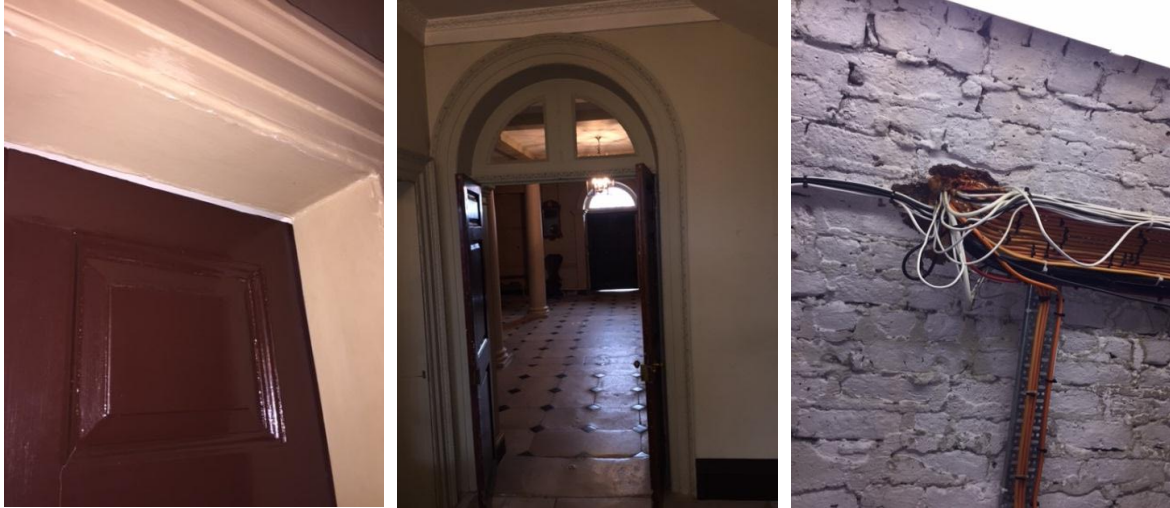
Other areas noted that the fire risk assessment should review were, door leading to under stairs requiring maintenance to gaps around door. Glazing and upgrade to door leading from entrance hall to main hall with gaps likewise to door to breakfast parlour. The basement has numerous breaches to walls ceilings caused by penetrations by contractors to fit services and electrics.
