8.39 MARBLE HILL HOUSE - DAMP LEVEL INVESTIGATION

An investigation of dampness levels at

Marble Hill House, Twickenham

Survey: 05.12.12
Report: 30.01.13

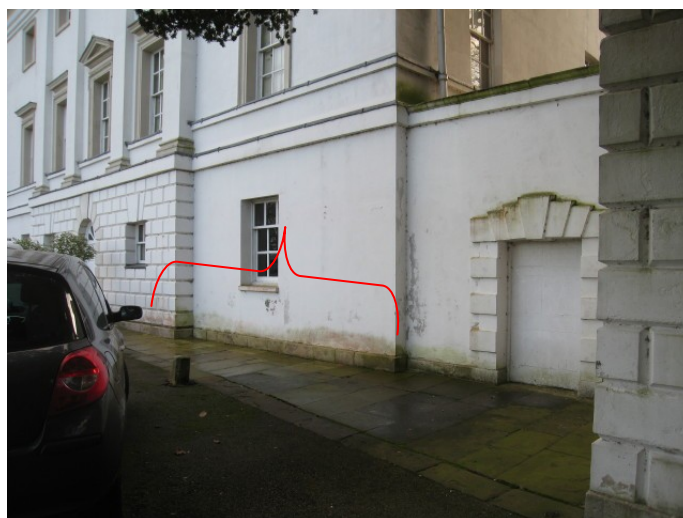
N elevation of Paper Room showing incorrect surface falls around the NW corner. Water is able to percolate between the pavoirs – presumably migrating to the wall base.

Wall siphons (of some kind) have been installed to the extent of the red bracket.

The plinth is composed of stone units.
The facade finished in stucco.

A small amount of groundwork to the N elevation should bring long term benefits, where the pavoirs shown in photo 1 could be relayed (and well grouted) to fall away from the building. However water collection/discharge could be a problem due to the existing falls. The only possibility would seem to be the installation of a soakaway in the front lawn.

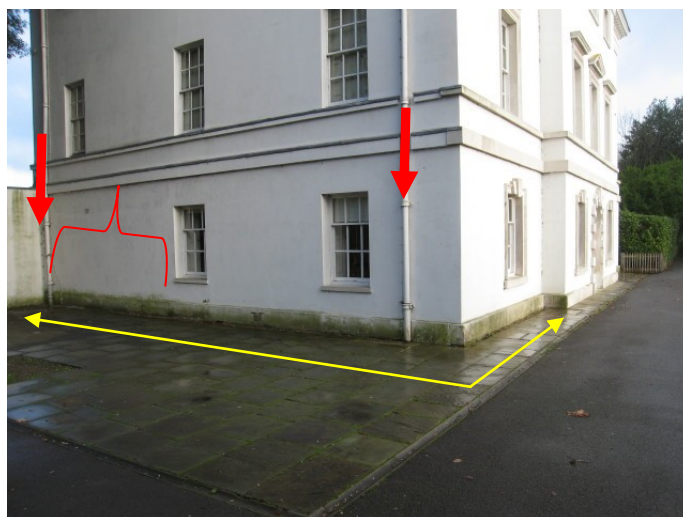
2

Wall siphons continue along W elevation to extent of bracket. Gulleys and possibly downpipes were blocked. (Drain runs recently inspected and found to be clear).

External pavoirs do not seem to have sufficient falls away from building perimeter.

Small trench installed at wall perimeter (yellow arrow) – filled with pea gravel – which was very wet.

Plinth along W elevation has been covered (in render?).

The stone filled trench along the W and S elevations could be replaced with an open channel which discharges into the downpipe gullies. The ends of the downpipes should be changed to spouts which discharge into the same grated gulleys as opposed to travelling sub surface where they become blocked out of view. This should decrease the water loading on the W wall.

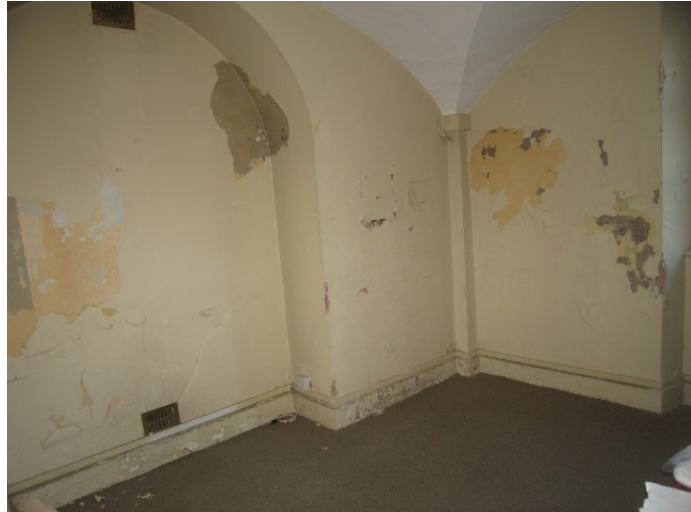
3

The N and W internal walls have been rendered with hard (almost certainly cementitious) render – much of which has blown (for one or a combination of reasons which will only become obvious after the damaged render is removed). In places salts are efflorescing through the surface.

The floor has been covered with a resin based substance – almost certainly as a damp proofing measure.

See masonry analysis.

Internally all loose plaster should be removed from the N and W walls. This will have to be carried out with care (to preclude the damage which often results when chiselling well bonded cementitious material off soft brickwork). Ordinarily the recommendation would be to line the wall in moisture resistant plasterboard and simply allow the wall to be damp. This might have been rejected in the past due to the difficult curves and contours in the W wall and it will probably now be necessary to board straight over the alcove. Any well bonded cementitious render can just remain on the wall. The wall lining will have to be well designed around the N window and ideally the cavity should be air tight.

However the overall design of the wall lining and cavity can only be finalised when the loose render has been removed and the extent of the wall siphons and condition of the masonry have been confirmed. It would be advisable to block the siphon cavities completely.

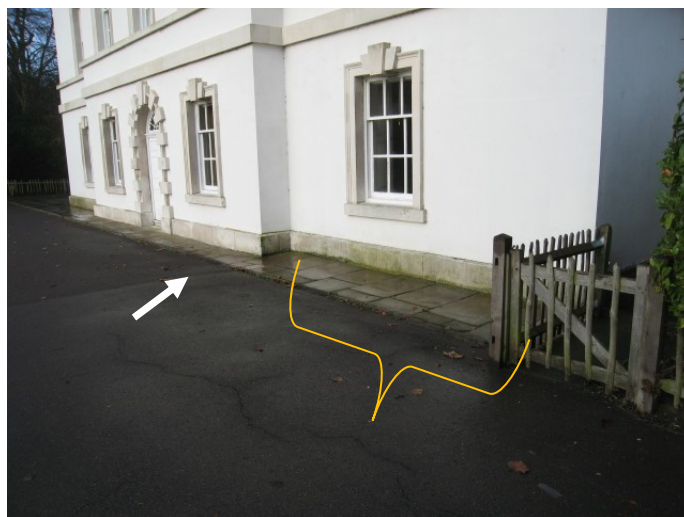
4

Problems with collection and discharge of surface water – similar to that shown in photo 1.

Water has been percolating into the cellar (extent shown by bracket), causing plaster loss from the S wall

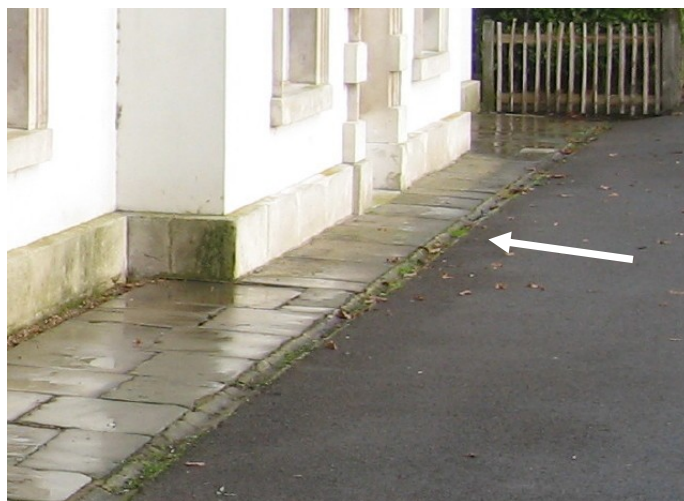
The open channel – into which the tarmac and pavoids shed water – has open joints and falls to the point arrowed - where leaves have been collected then deposited where the water has disappeared. below ground

The open channel arrowed in photo 5 could be repaired to collect and discharge surface water more effectively. While the overall problems with surface water collection and defective falls are similar to those experienced on the W and N walls, repair of the open channel arrowed in photo 5 should produce particularly good results along this elevation in the long term.

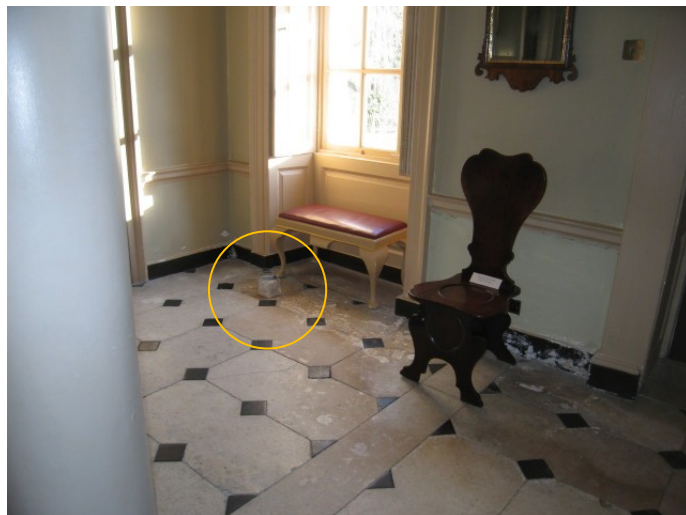
6

Deterioration of the stone floor tiles in the SE corner of the Hall has recently accelerated (photo 6).

The upper 1 – 4mm of the floor tiles (probably limestone) has delaminated locally, leaving spots of lighter coloured substrate.

The floor surface is darkening – possibly due to excess moisture, with small areas of the floor surface disassociating from the floor tiles. It is understood this process has accelerated recently.

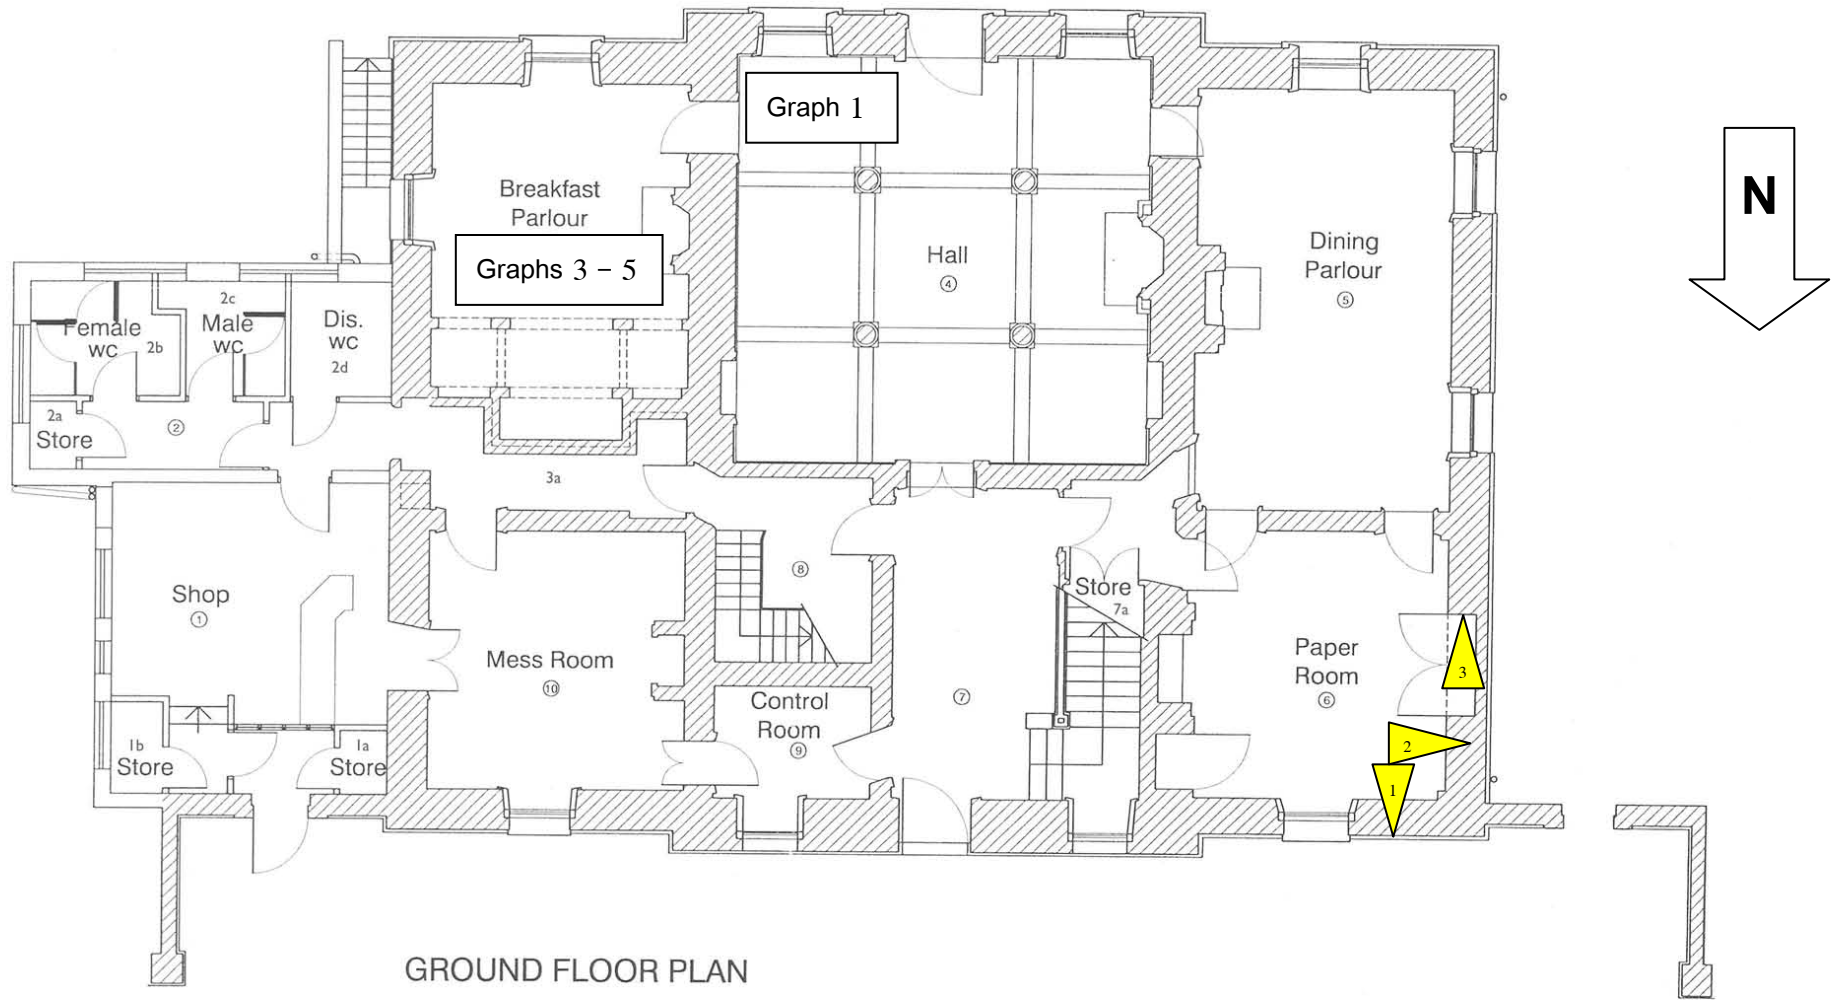
Graph 1 – Hall

The data from graph 1 shows the environment at the floor surface to be approaching 90%RH indicating there is excess moisture at the floor surface. The environment of the Hall generally has a much more variable RH. Looking at 01/01/2012 for example, in a 24 hour period the RH ranges from over 70% (equating with an air moisture loading of $9\text{g H}_2\text{O/M}^3$) down to under 55% ($7\text{g H}_2\text{O/M}^3$). This variation occurs at a relatively stable 15°C temperature showing that moisture is probably being extracted from the environment – but being reintroduced - 24 hours later. The reason for this is unclear.

Graph 1 confirms there is excess moisture at the floor surface which is likely to have emanated from the external defective surface drainage - *if the pre existing moisture in the room is regularly removed by the air conditioning system*. Graphs 2 – 5 seem to show that water is also drawn from the defective external perimeter surfaces into the (elevated and constant air temperatures of the) cellar. Graphs 3 – 5 indicate the temperature of the Breakfast Parlour is probably affected more by the cellar below - as its temperature is closer to that of the cellar rather than the Hall. Graph 5 should be treated with a degree of caution due to breaks in the data and high readings recorded in June 2012.
