**ROOM BY ROOM SCHEDULE OF INTERNAL WORKS
MARBLE HILL HOUSE
REPAIRS AND ALTERATIONS**

16_132 – R9-A

March 2017

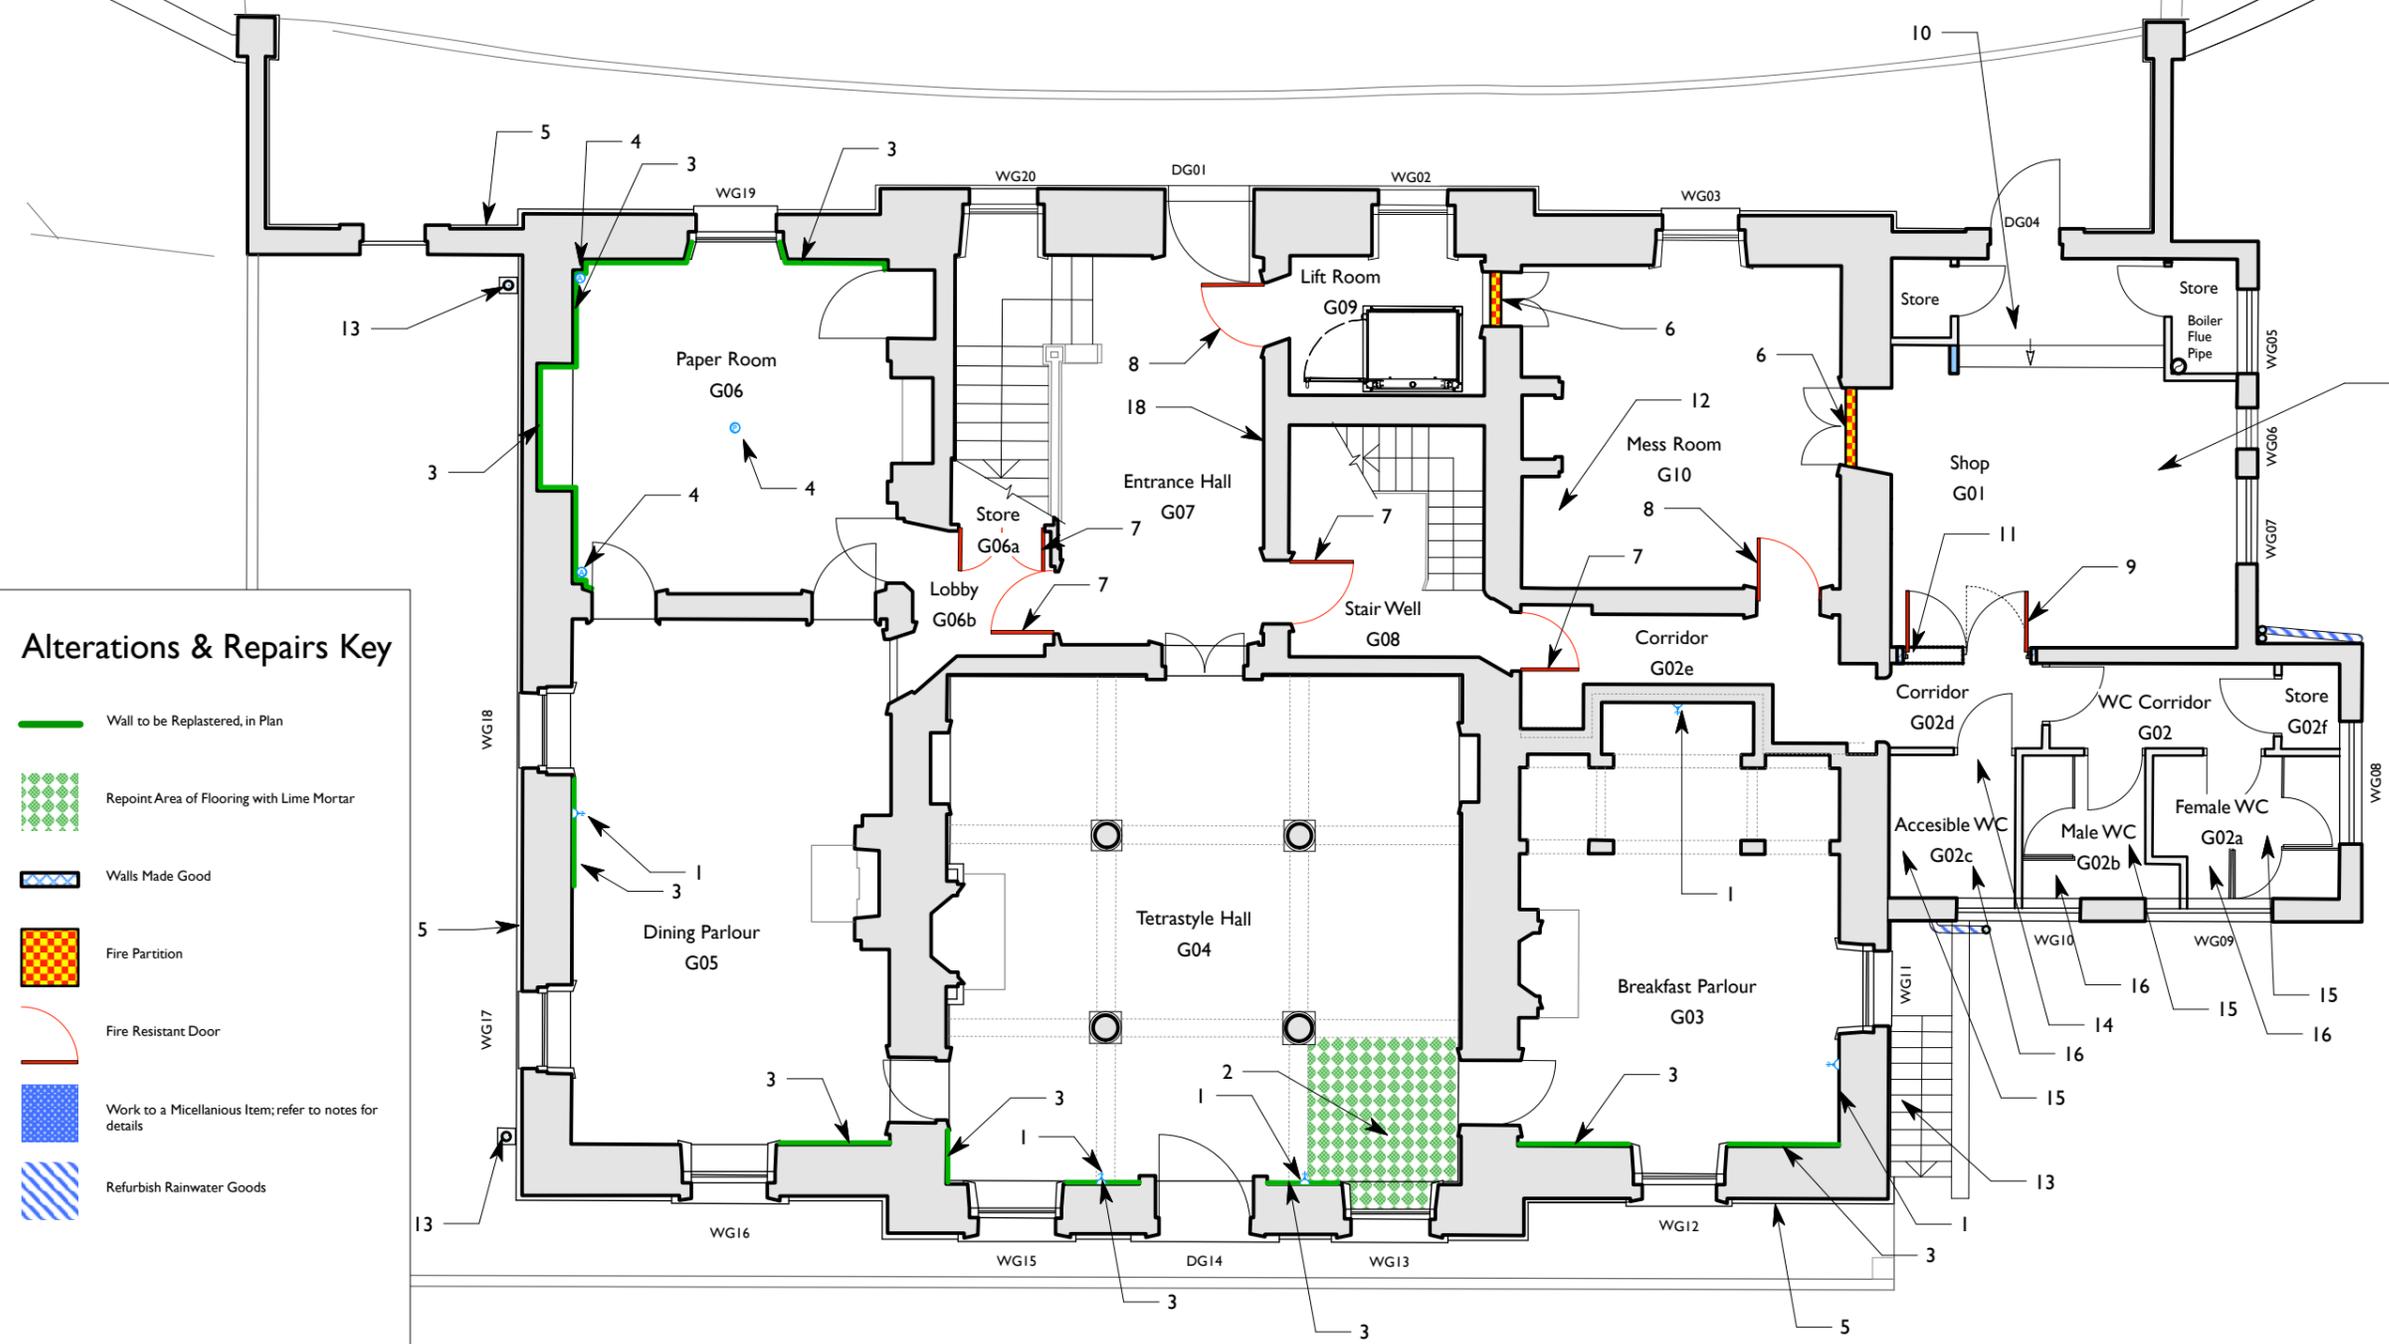
DRAWING N°
210 - B

1. New/replacement electrical socket. This is to be fitted with a plastic backbox, where this is replacing a failed route, the original wiring is to be removed and a new 20 mm PVC conduit installed in the chase. The conduit is to be mortared in place with new lime putty mortar.

2. Damp affected paving slabs; carefully rake out all mortar joints and repoint with lime putty mortar.
3. Failed wall cementitious/gypsum plaster to be removed, the masonry is to be pointed with lime putty mortar and then plastered with a lime putty three coat plaster. Within the Dining Parlour, the Hall & the Breakfast Parlour the plaster affected by damp is only a Dado Level.

6. New fire partition; refer to detail drawing
7. Existing asbestos clad fire resistant door, this is to have its asbestos removed and new fire resistant material added.

10. Existing screen removed and the existing steps modified.
11. Existing doorway widened and made good or existing opening retained as existing. THIS ITEM MAY BE OMITTED, THE DOORWAY IS PERHAPS HISTORIC.

12. Room G10 (Mess Room); this is to be fitted with all the security and electrical controls
13. Rainwater pipes; these are to be taken down and fully refurbished and reinstalled. They are to be put back in their original locations, they will be repainted with micaceous iron oxide undercoat and a Dulux Metalshield topcoat (colour to be determined, assume white as existing or lead grey), all joints are to be left uncaulked. The gully is to be replaced with a new accessible gully, the downpipes are to be fitted with a shoes.

14. WC door fitted with a closer
15. WC space fitted with a baby changing unit.
16. WC walls and floors to be painted with a conventional paint system and have tiles cleaned and regrouted where grout has failed.

17. Works to entrance and interpretation room, refer to the interpretation report.
18. Intumescent grill to replace the existing metal grill. New grill to be as sensitive as possible.

Replace approximately 1 m² of modern plaster at very low level with lime putty plaster; as indicated upon drawing 210.

Replace approximately 3 m² of modern gypsum/cement plaster at low level with lime putty plaster; as indicated upon drawing 210.

Replace approximately 2 m² of modern gypsum/cement plaster at low level with lime putty plaster; as indicated upon drawing 210.

Replace approximately 10 m² of modern gypsum/cement plaster with lime putty plaster; as indicated upon drawing 210.

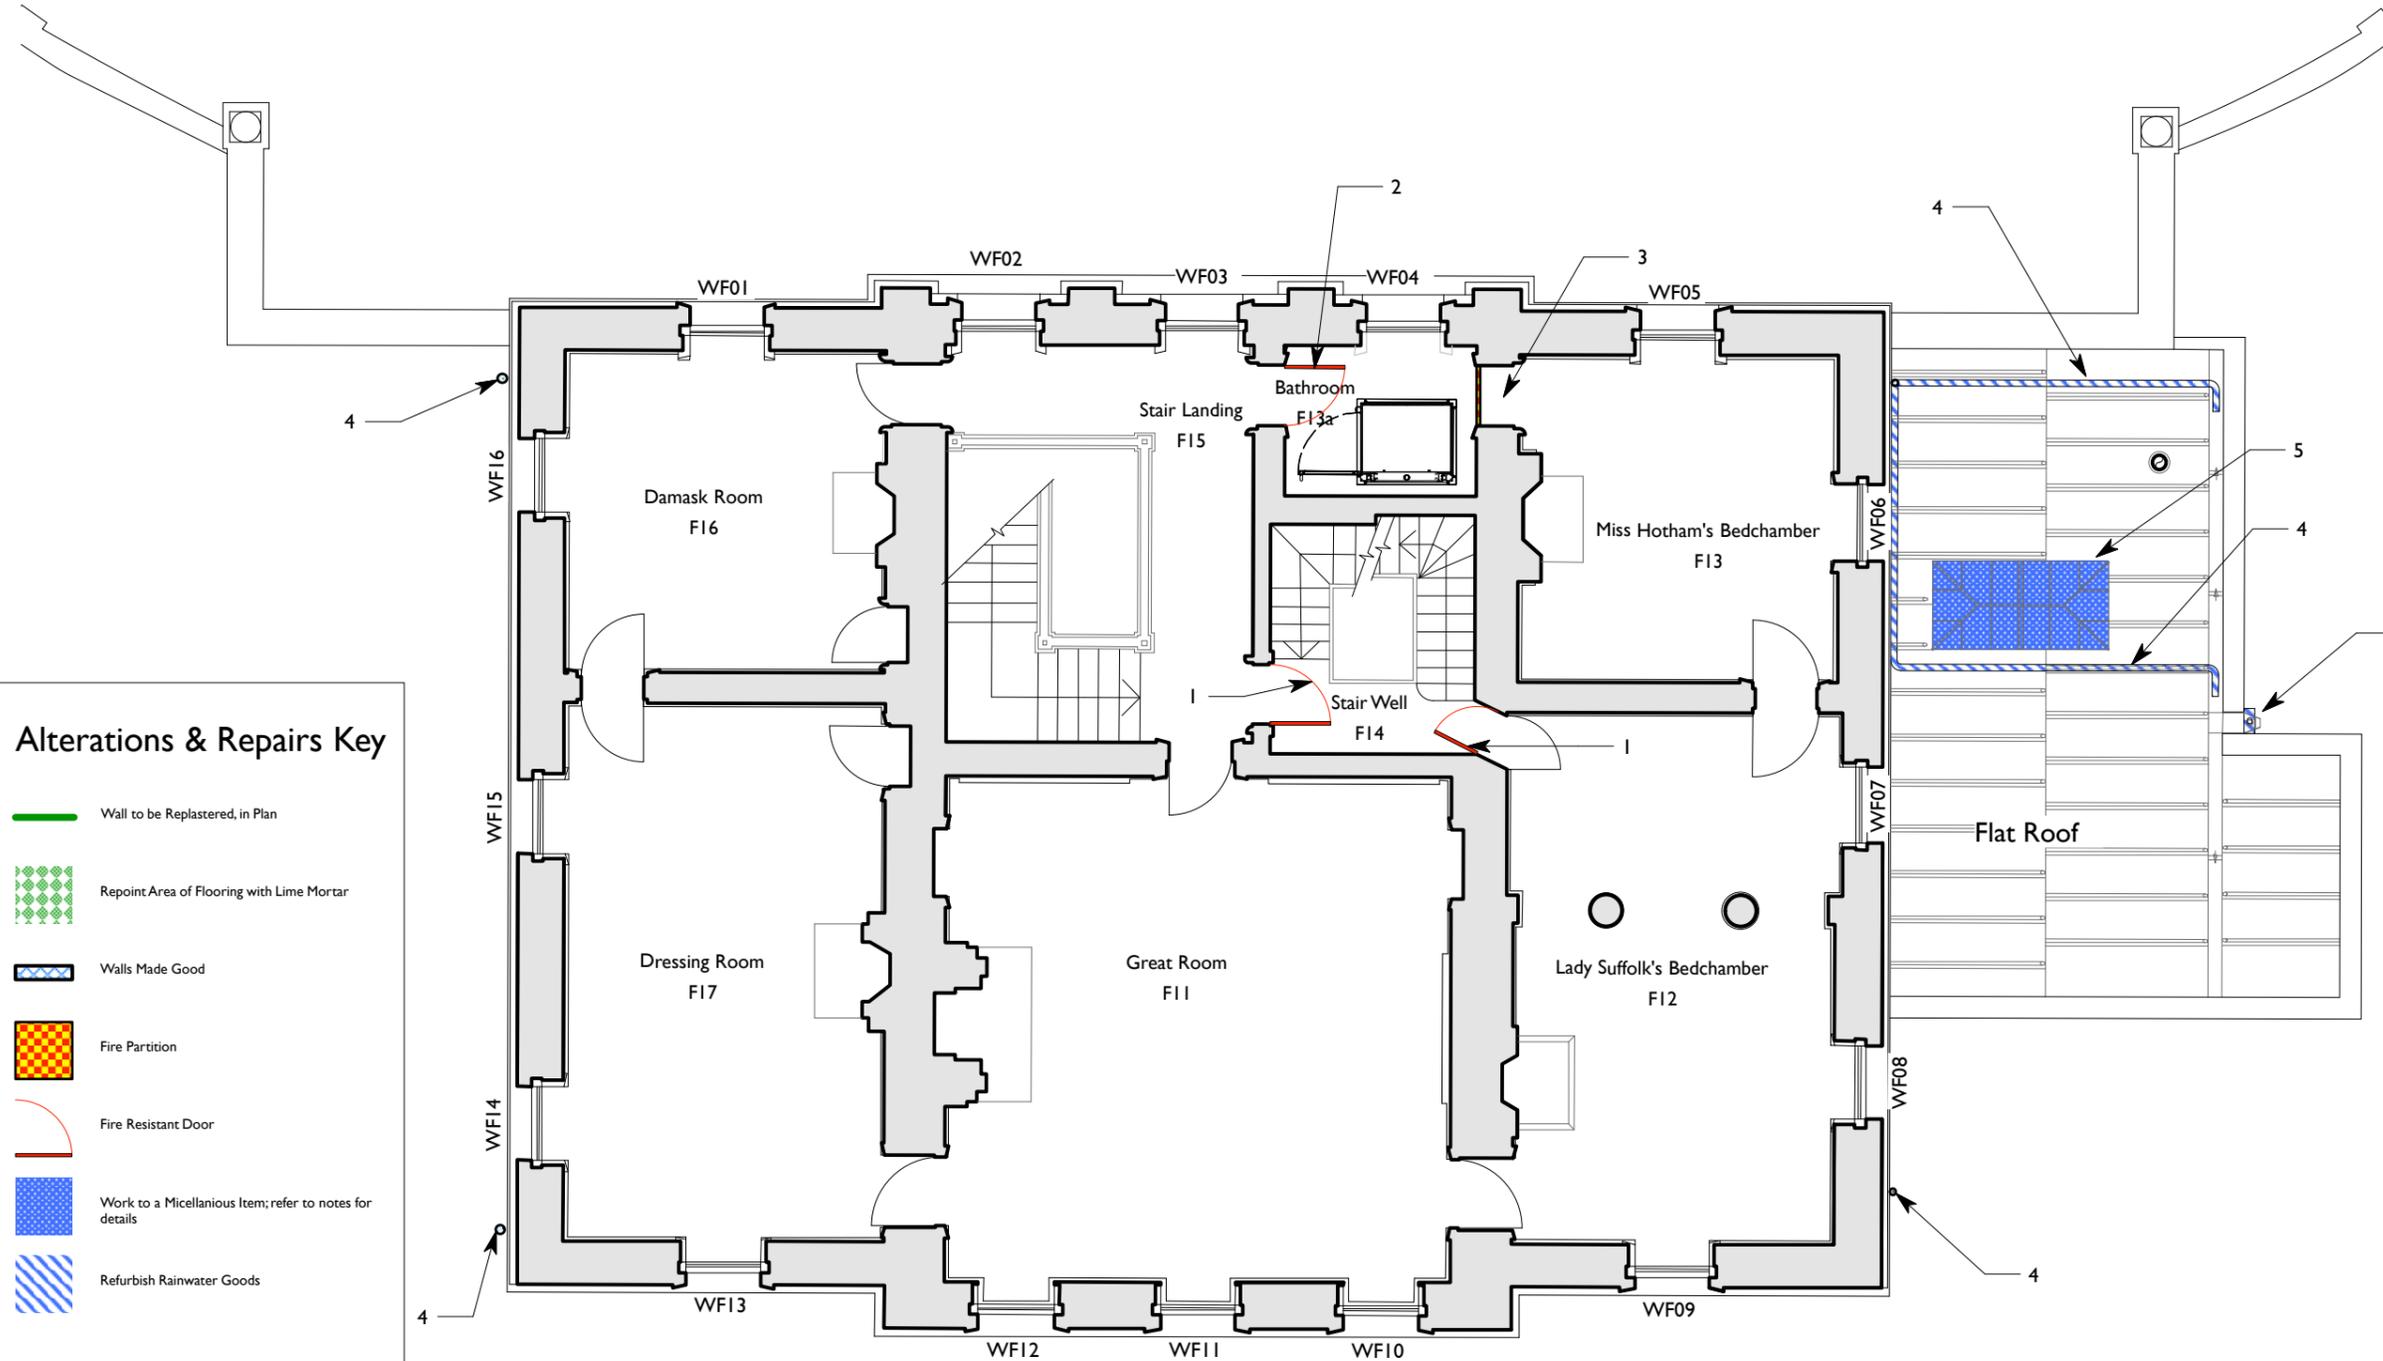
DRAWING N°
211

- Existing asbestos clad fire resistant door; this is to have its asbestos removed and new fire resistant material added.
- Existing door rehung to open outwards and its fire resisting features enhanced; refer to drawing.
- New fire partition; refer to detail sketch.
- Rainwater pipes; these are to be taken down and fully refurbished and reinstalled. They are to be put back in their original locations, they will be repainted with micaceous iron oxide undercoat and a Dulux Metalshield topcoat (colour to be determined, assume white as existing or lead grey), all joints are to be left uncaulked. The gully is to be replaced with a new accessible gully, the downpipes are to be fitted with a shoes.
- Rooflight, this is rotten and non-historic, allow to replace with an aluminium rooflight.
