C. Appendix 12.3: Condition Survey of the River Wall

Condition Survey of the Thames River Wall

Stag Brewery

14 December 2016

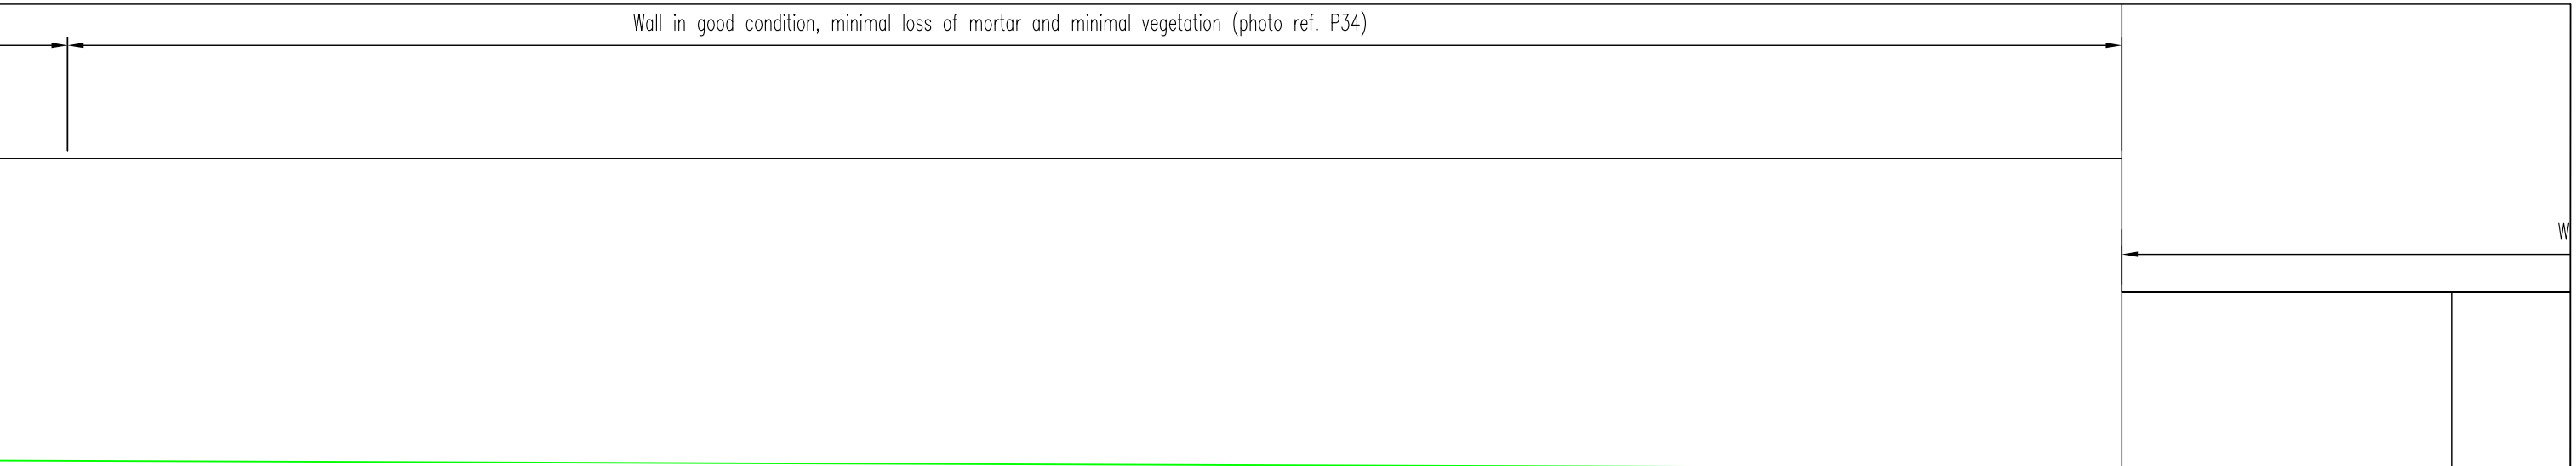
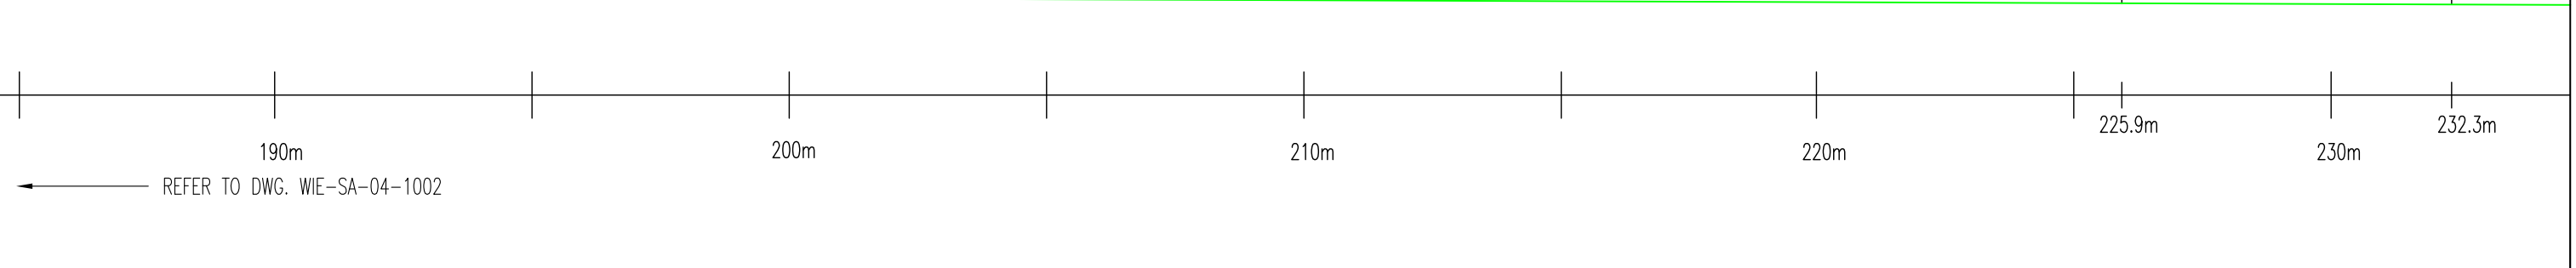
STAG BREWERY BUDWEISER SIGN

Wall in good condition, minimal loss of mortar and minimal vegetation (photo ref. P35)

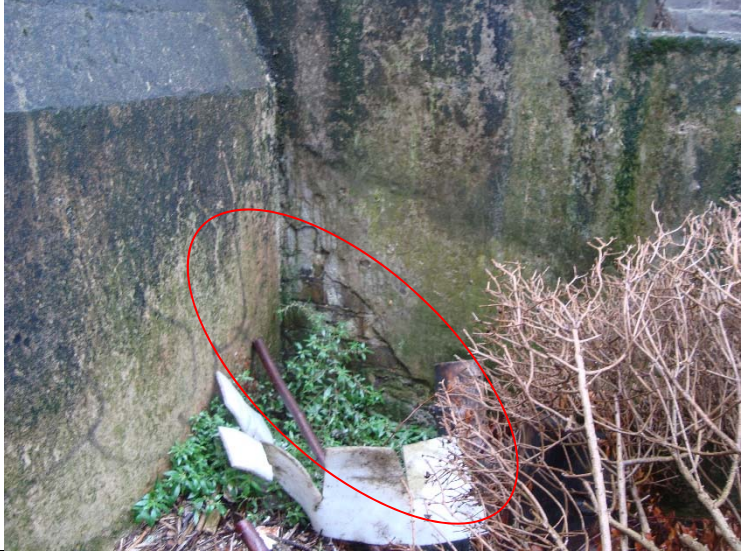
Approx. Chainage	Defects	Photo ID
0m	Render spalled off bricks at the base of the stairs.	P01
0m	Crack propagating upwards from the top of the stairs.	P03
0m – 4m	Loss of mortar on the face of the brick wall above the stairs.	P02
5m	Crack propagating upwards from the corner of a bricked up window.	P04
8m	Crack in the brick wall, extending upwards from the top of the RC wall (to the right of a bricked up window).	P05
10m	Crack propagating down from a change in height at the top of the wall.	P06
16m	The foundation of the reinforced concrete retaining wall's south-eastern corner is exposed.	P07
39m – 46m	Loss of mortar along the bottom face of the wall.	P08
45m	Crack from the top of a bricked up window to the top of the wall.	P09
49m	Cracks running diagonally in the wall.	P10 & P11
52m	Loss of mortar on the face of the bricked up window.	P12
53m	Cracks running vertically in corners of the wall.	P14 & P15

Name	Photograph
<p>P01</p> <p>Render spalled off bricks at the base of the stairs</p>

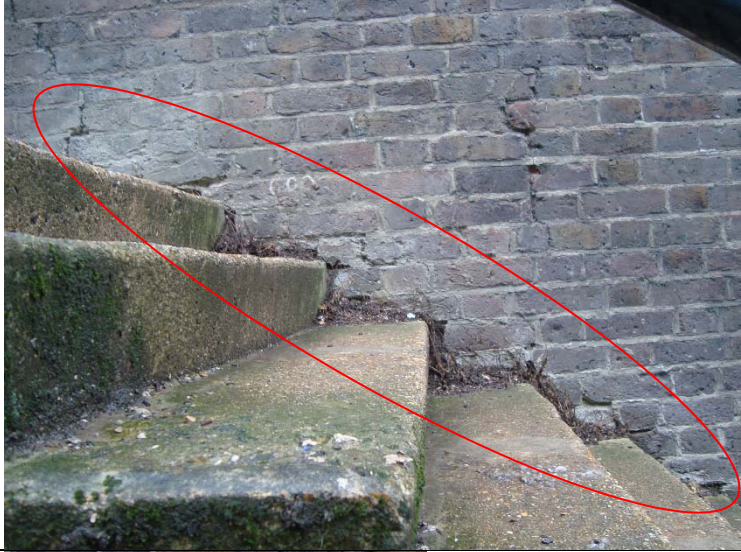
<p>P02</p> <p>Loss of mortar on the face of the brick wall above the stairs</p>

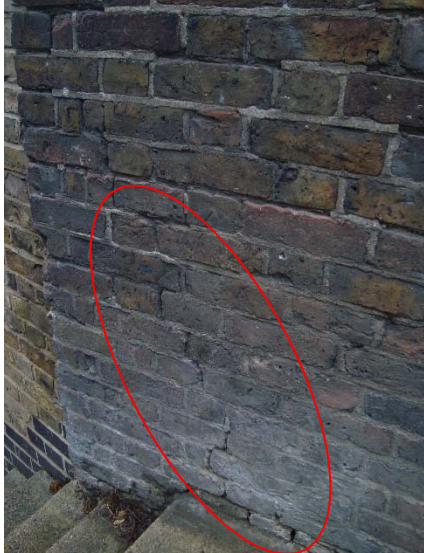
<p>P03</p> <p>Crack propagating upwards from the top of the stairs</p>

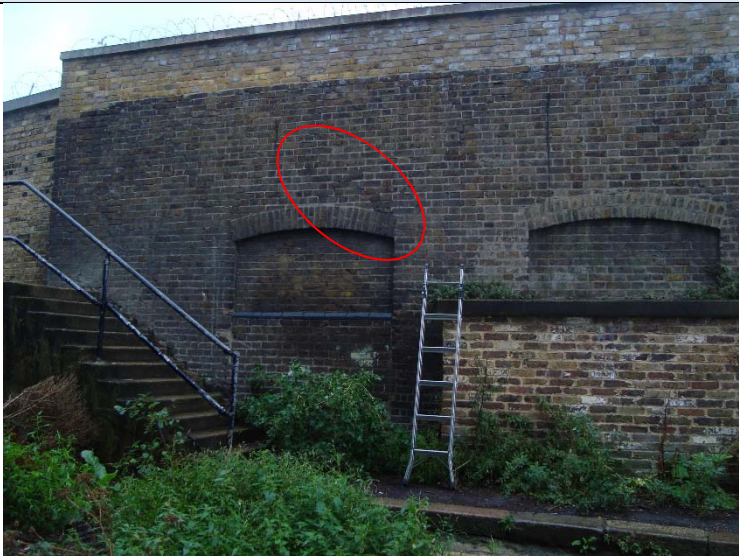
Name	Photograph
<p>P04</p> <p>Crack propagating upwards from corner of a bricked up window</p>

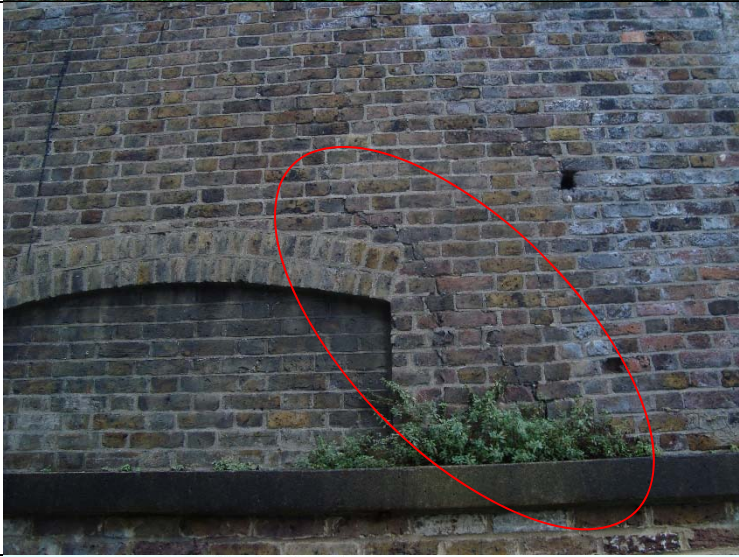
<p>P05</p> <p>Crack in the brick wall extending upwards from the top of the RC wall (to the right of a bricked up window)</p>

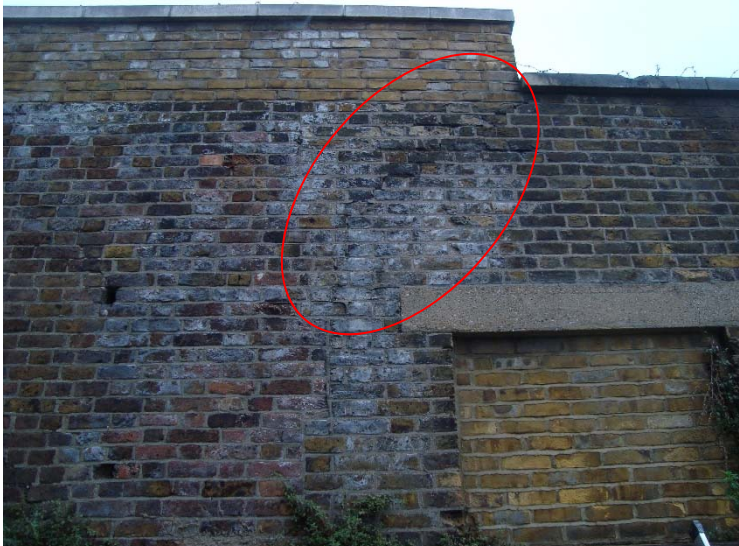
<p>P06</p> <p>Crack propagating down from a change in wall height, at the top of the wall</p>

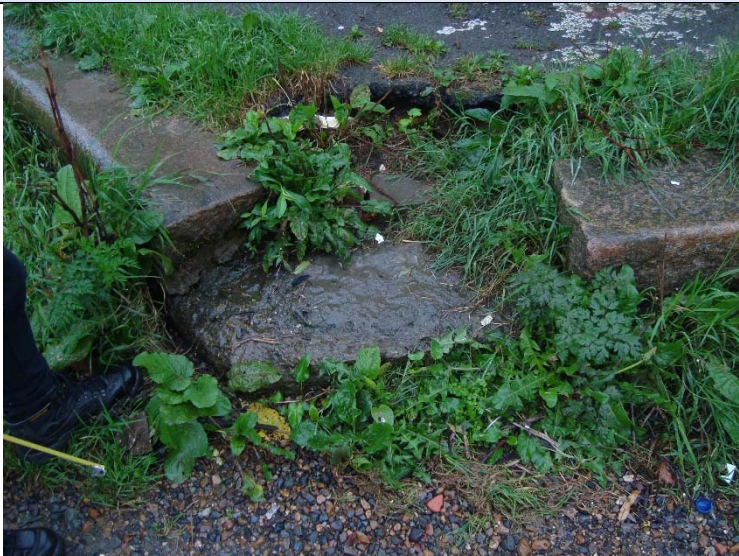
Name	Photograph
<p>P07</p> <p>Corner of concrete foundation exposed</p>

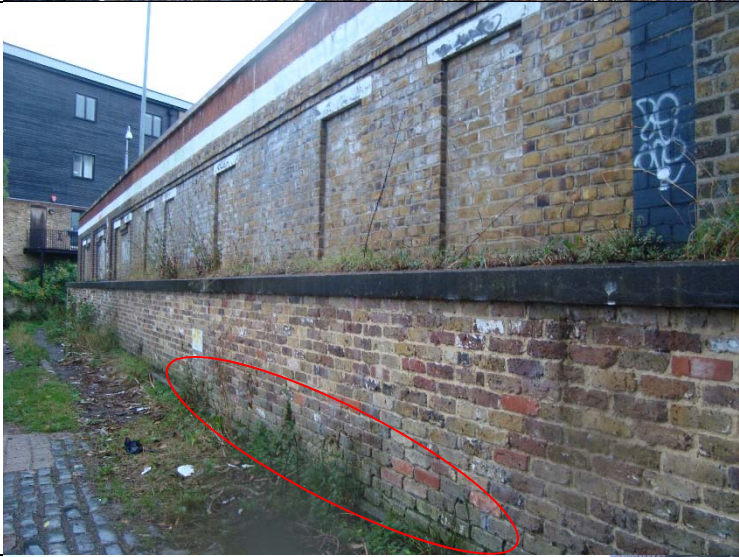
<p>P08</p> <p>Loss of mortar along bottom face of wall</p>

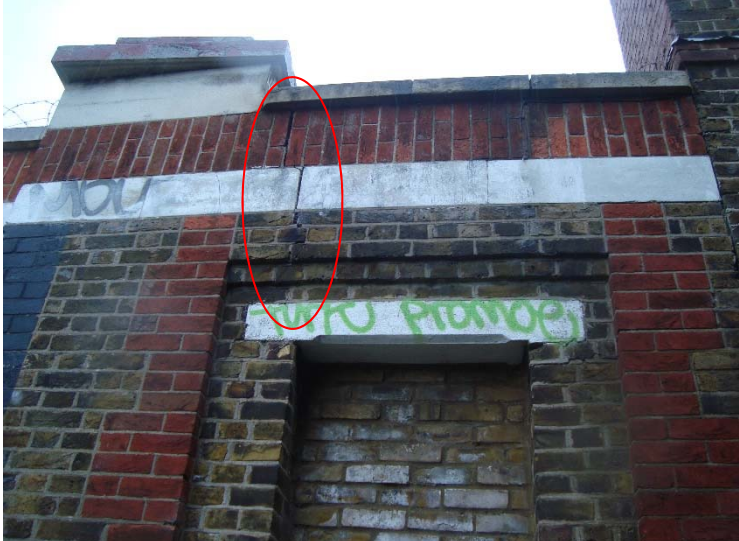
<p>P09</p> <p>Crack from the top of a bricked up window to the top of the wall</p>

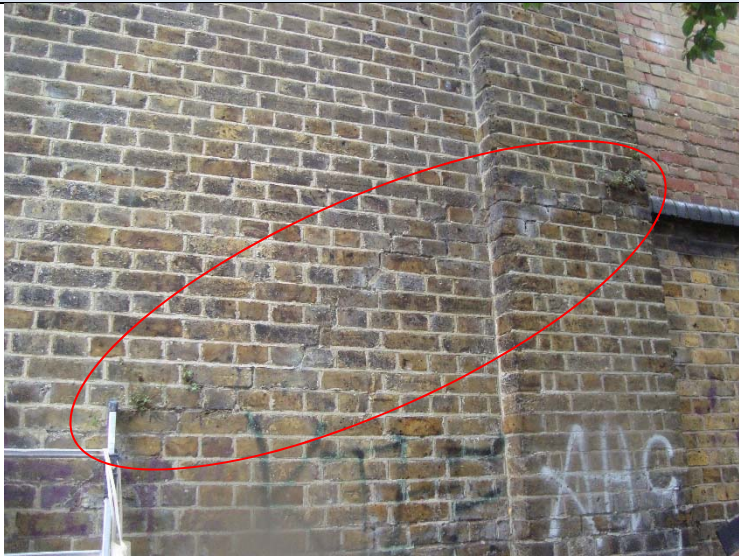
Name	Photograph
P10 Crack running diagonally

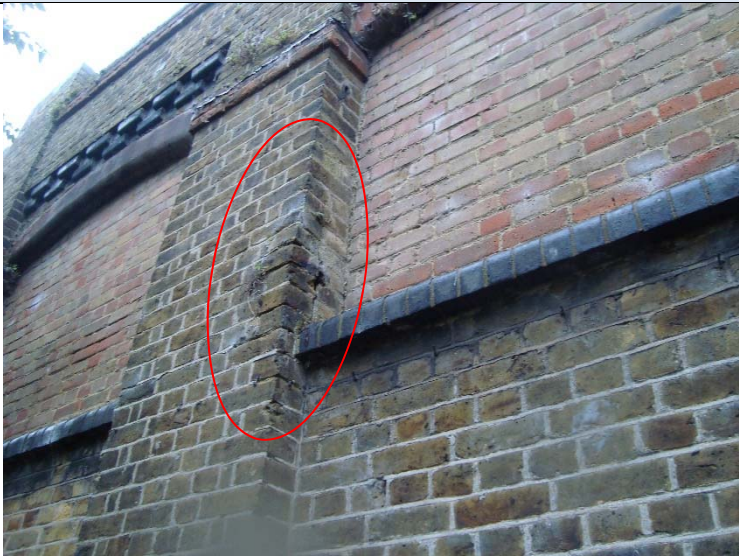
53m	Bricks spalling due to a rusting metal pipe in the wall.	P13
60m – 77m	Loss of render (330mm high) along the bottom face of the wall.	P19
61m	Render on a previously blocked up vent shaft is cracked/missing and the vent is now open.	P17
62m	Loss of mortar on face of brick wall.	P18
112m – 125m	Cracks from the top of wall. Vegetation on top of the wall appears to be pushing the concrete capping out.	P21 – P24
129m	Bricks spalled off or missing from the top of the wall.	P25
130m	Crack propagating upwards from the top of a bricked up window.	P26
130m – 161m	Minor spalling on the edges of bricked up windows and doors.	P27
142m	Missing/damaged bricks resulting in a hole through the wall.	P28
145m	Loss of mortar on the face of the brick wall near the top of the wall.	P29
163m	A large crack (approx. 20mm) that runs the height of the wall.	P30 – P32

Name	Photograph
P13 Bricks spalling due to rusting metal pipe

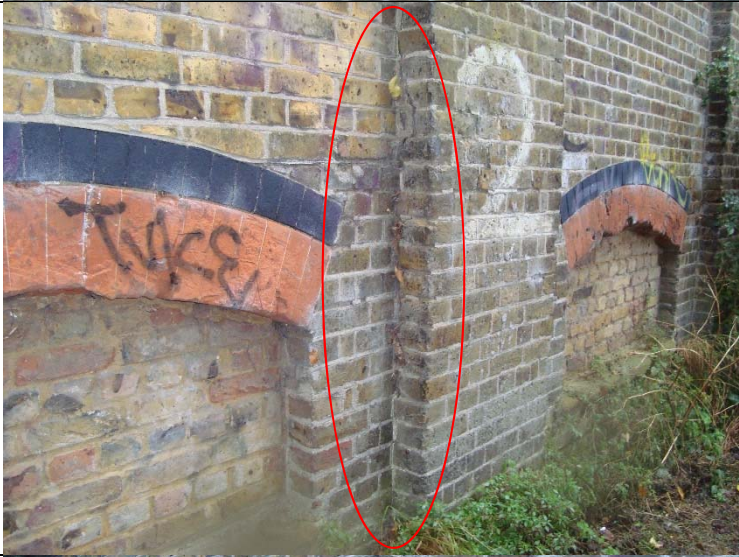
P14 Crack

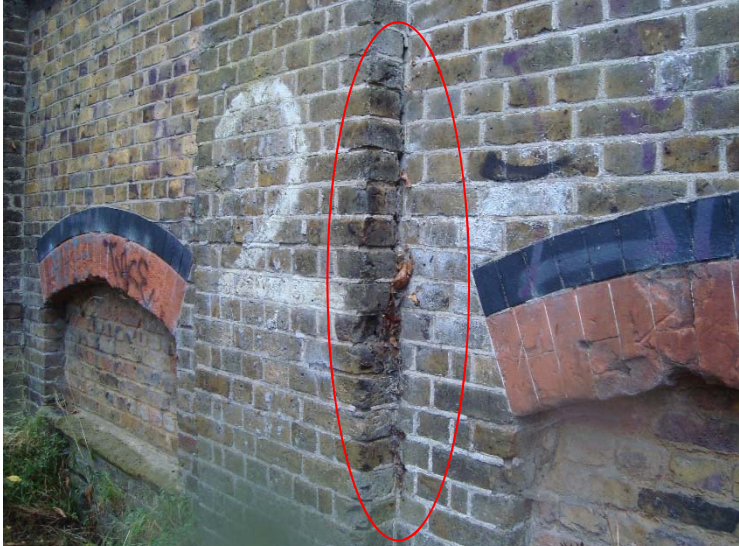
P15 Crack

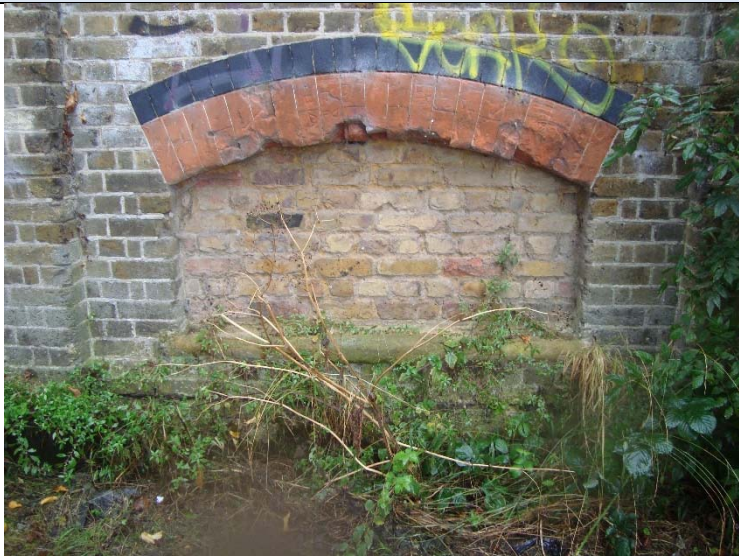
Name	Photograph
<p>P16</p> <p>Brick window edges major spalling</p>

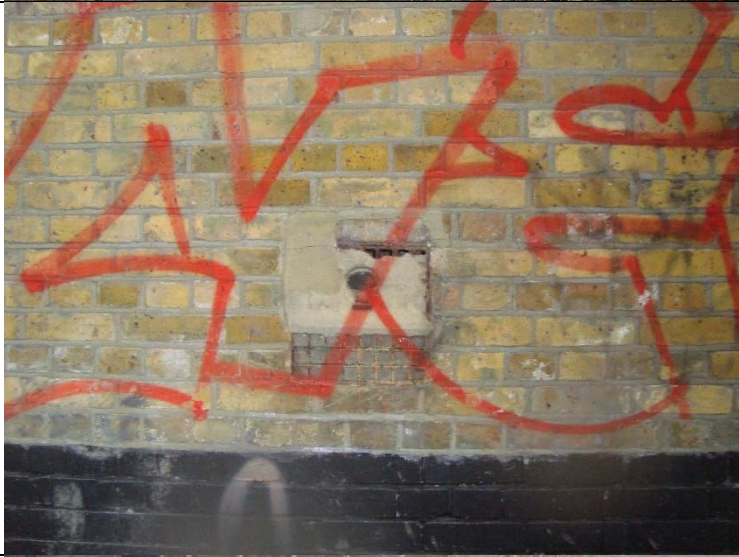
<p>P17</p> <p>Render on the existing blocked up vent is cracked and missing</p>

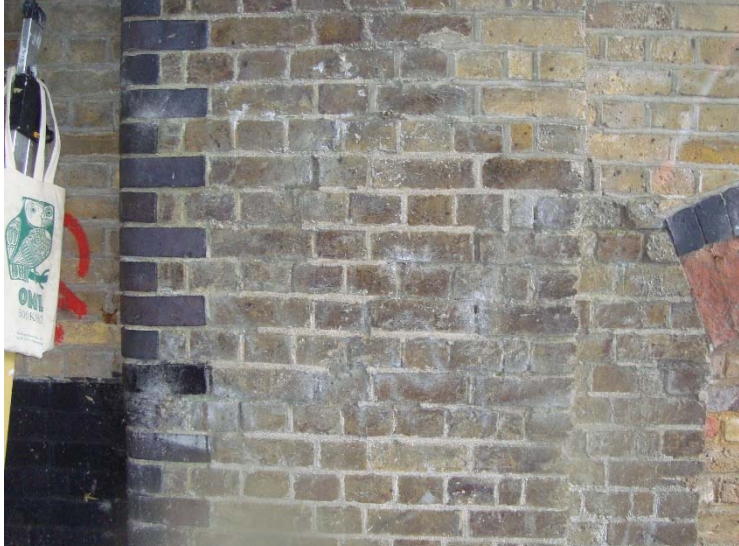
<p>P18</p> <p>Loss of mortar on face of brick wall</p>

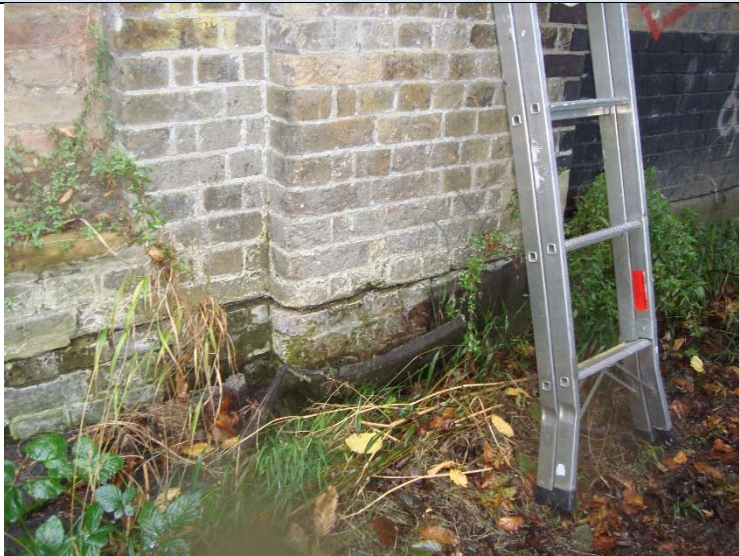
Name	Photograph
<p>P19</p> <p>Loss of render (330mm high) along bottom face of wall</p>

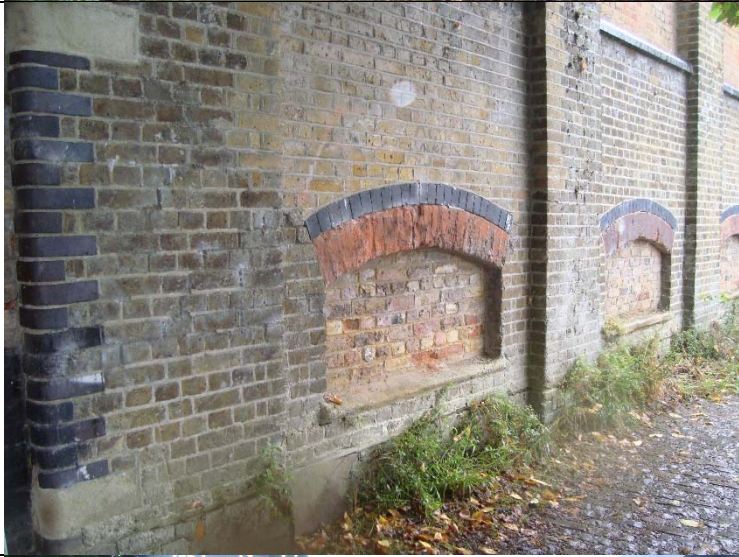
<p>P20</p> <p>Bricked window edges minor spalling</p>

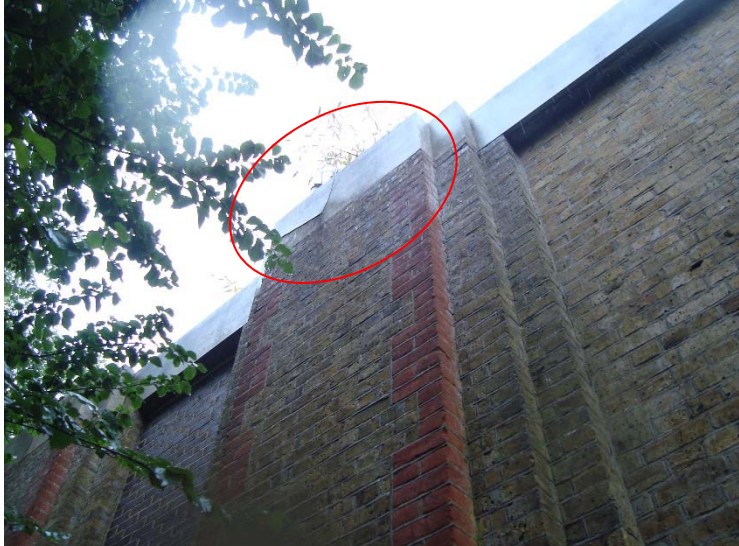
<p>P21</p> <p>Crack from the top of wall</p>

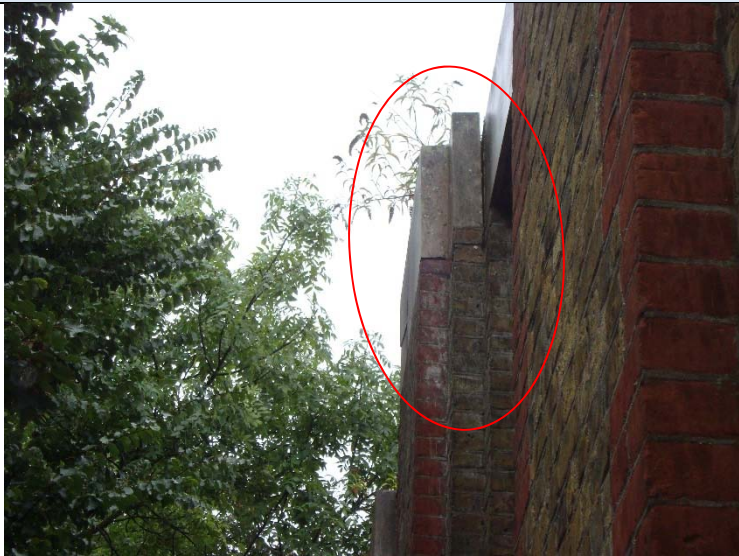
Name	Photograph
<p>P22</p> <p>Crack from the top of wall</p>

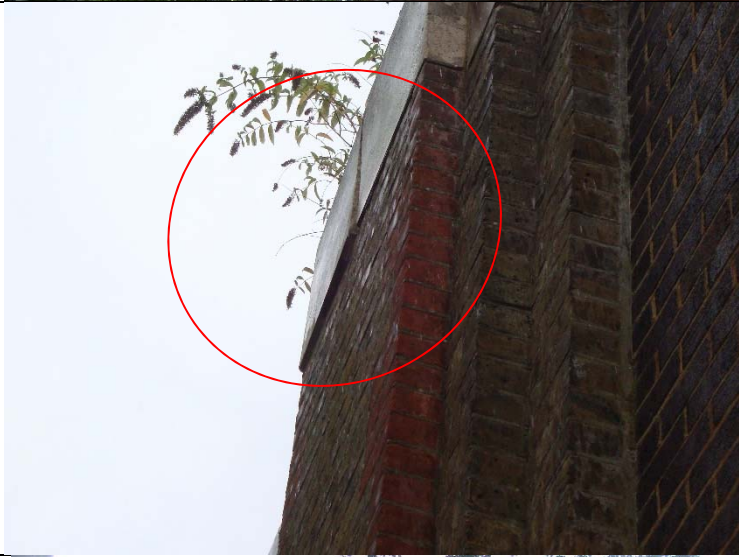
<p>P23</p> <p>Crack from the top of wall</p>

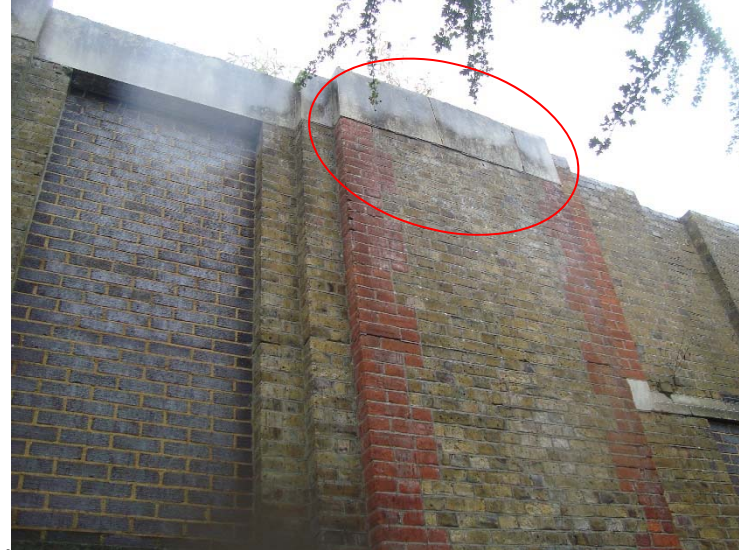
<p>P24</p> <p>Crack from the top of wall</p>

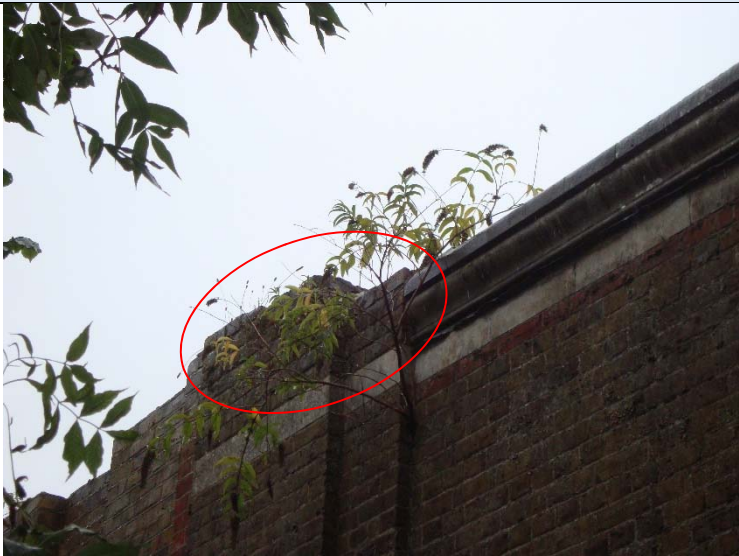
Name	Photograph
<p>P25</p> <p>Bricks missing from top of wall</p>

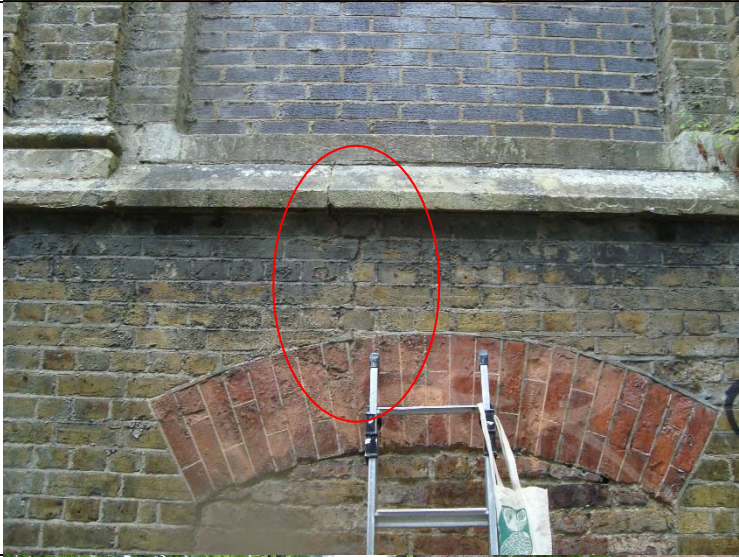
<p>P26</p> <p>Crack propagating upwards from the top of a bricked up window</p>

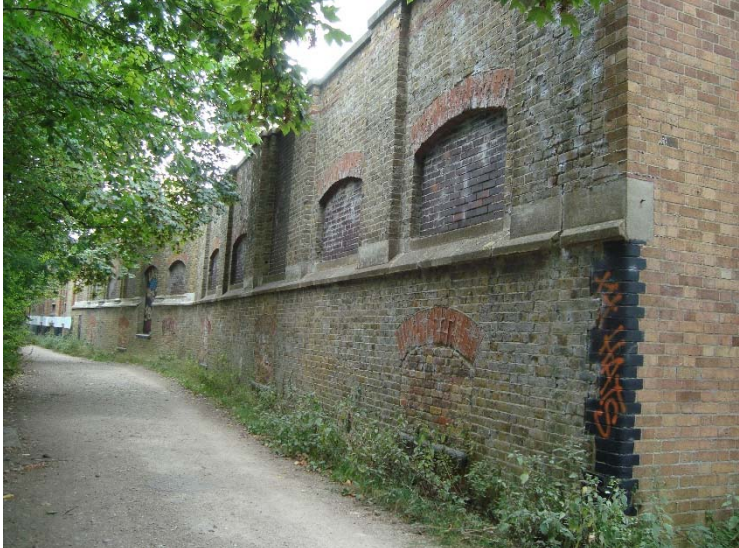
<p>P27</p> <p>Bricked window edges minor spalling</p>

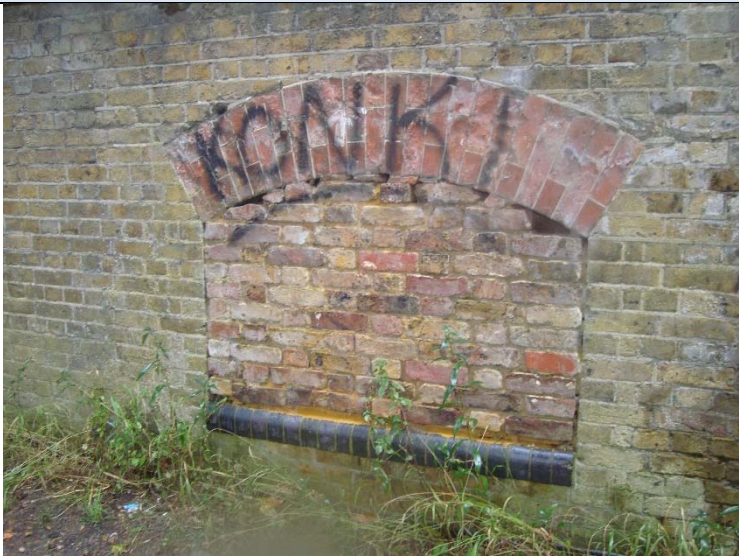
Name	Photograph
<p>P28</p> <p>Missing bricks, hole through wall, daylight visible</p>

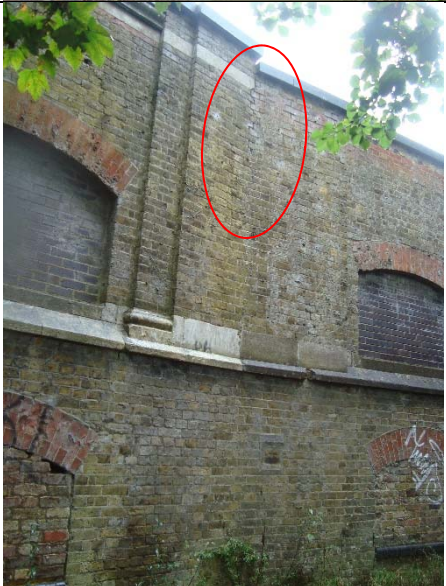
<p>P29</p> <p>Loss of mortar on face of brick wall</p>

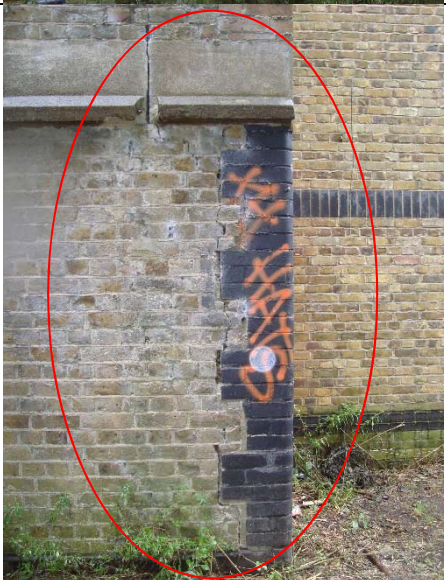
<p>P30</p> <p>Crack along length of wall, largest gap 20mm</p>

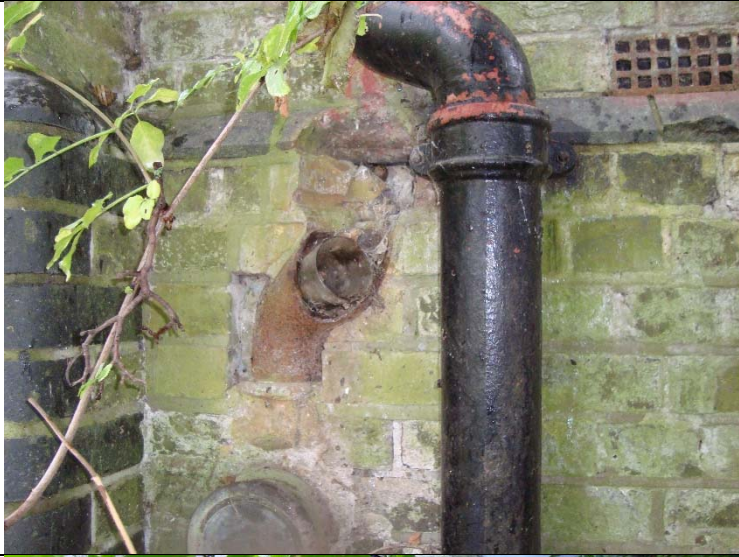
Approx. Chainage	Defects	Photo ID
271m	Bricks chipped out around old pipes embedded in the wall.	P37
271m	Mortar loss below metal pipe in brick wall.	P38
287m	Loss of mortar on the face of the brick wall.	P39
288m	Mortar loss below metal pipe in brick wall.	P40
300m	Loss of render along bottom face of wall. Render cracked and broken off.	P41
301m – 318m	Loss of mortar along the bottom face of the western wall.	P43 & P44
303m	The top of the wall to the west of the building is cracked.	P42
314m	Mortar loss and spalling bricks near the top of the western wall.	P45

Name	Photograph
<p>P37</p> <p>Bricks chipped out around old pipes embedded in the wall</p>

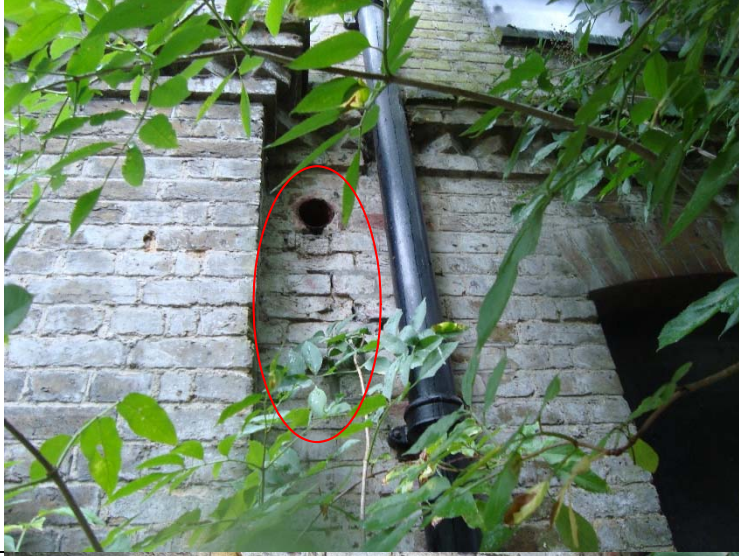
<p>P38</p> <p>Mortar loss below metal pipe in brick wall</p>

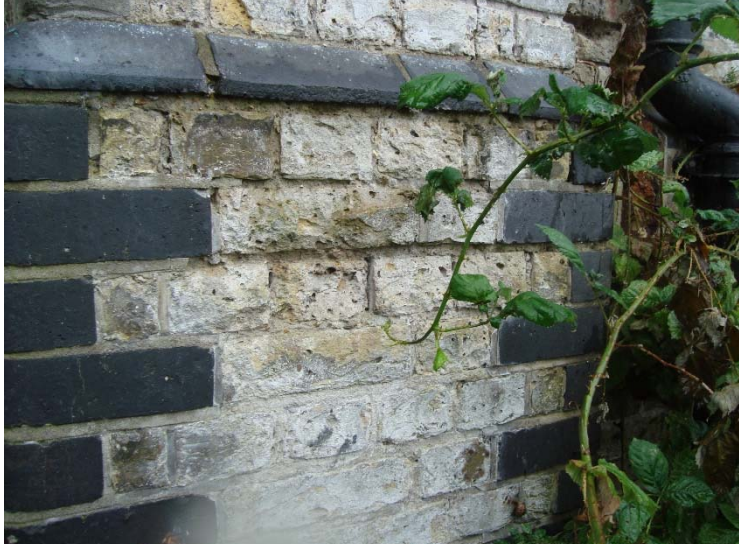
<p>P39</p> <p>Loss of mortar on face of brick wall</p>
