APPENDIX 12.3 CONDITION SURVEY OF THE RIVER WALL

Condition Survey of the Thames River Wall

Stag Brewery

14 December 2016

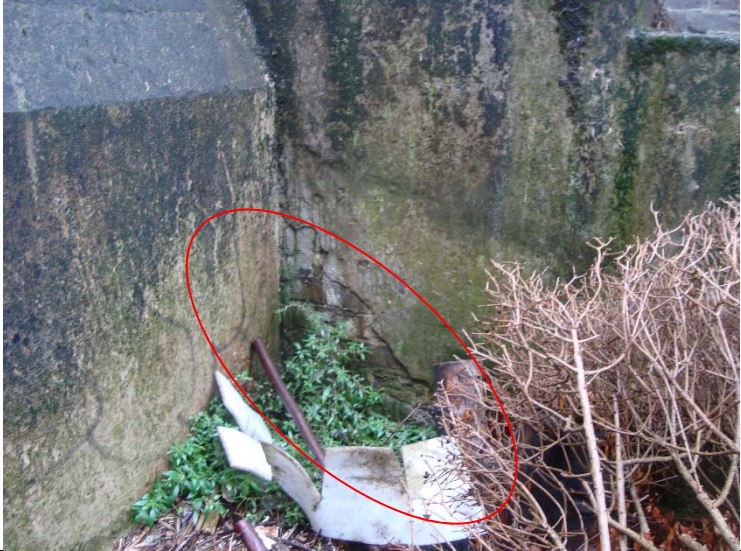
Approx. Chainage	Defects	Photo ID
0m	Render spalled off bricks at the base of the stairs.	P01
0m	Crack propagating upwards from the top of the stairs.	P03
0m – 4m	Loss of mortar on the face of the brick wall above the stairs.	P02
5m	Crack propagating upwards from the corner of a bricked up window.	P04
8m	Crack in the brick wall, extending upwards from the top of the RC wall (to the right of a bricked up window).	P05
10m	Crack propagating down from a change in height at the top of the wall.	P06
16m	The foundation of the reinforced concrete retaining wall's south-eastern corner is exposed.	P07
39m – 46m	Loss of mortar along the bottom face of the wall.	P08
45m	Crack from the top of a bricked up window to the top of the wall.	P09
49m	Cracks running diagonally in the wall.	P10 & P11
52m	Loss of mortar on the face of the bricked up window.	P12
53m	Cracks running vertically in corners of the wall.	P14 & P15

Name	Photograph
<p>P01</p> <p>Render spalled off bricks at the base of the stairs</p>

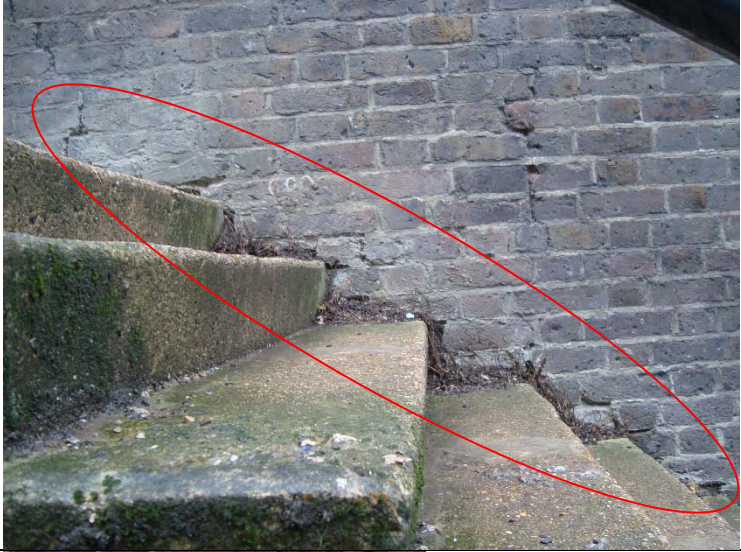
<p>P02</p> <p>Loss of mortar on the face of the brick wall above the stairs</p>

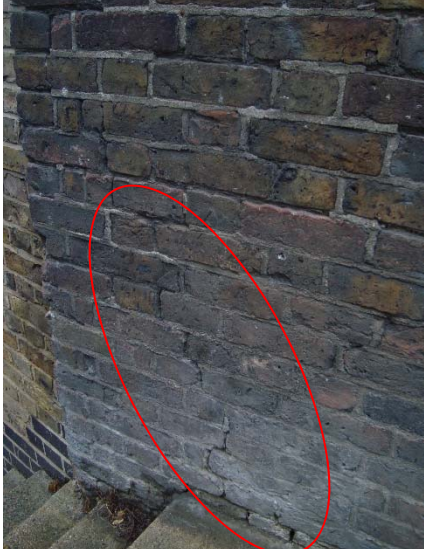
<p>P03</p> <p>Crack propagating upwards from the top of the stairs</p>

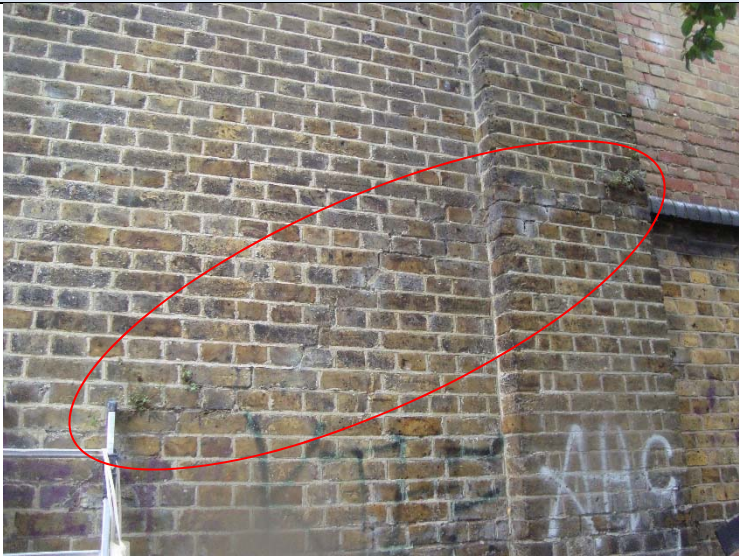
Name	Photograph
P10 Crack running diagonally

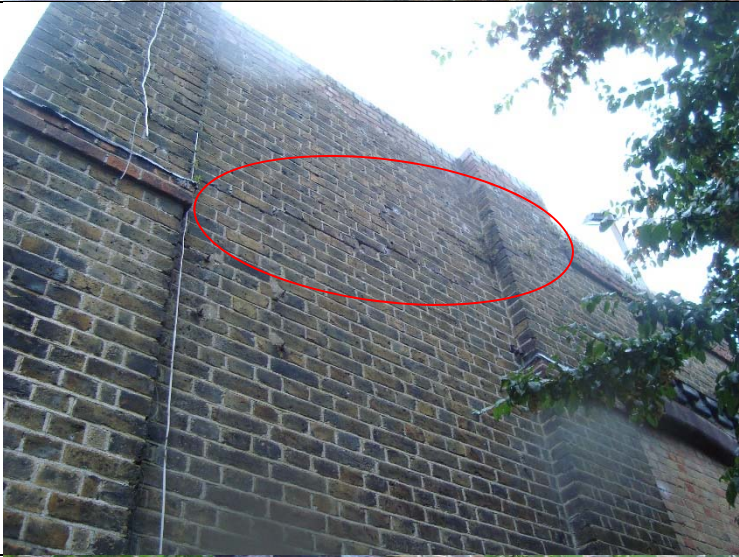
A photograph of a brick wall corner. A diagonal crack runs from the bottom left towards the top right, passing through the mortar joints. The crack is circled in red. There is some graffiti on the wall.
P11 Crack running diagonally

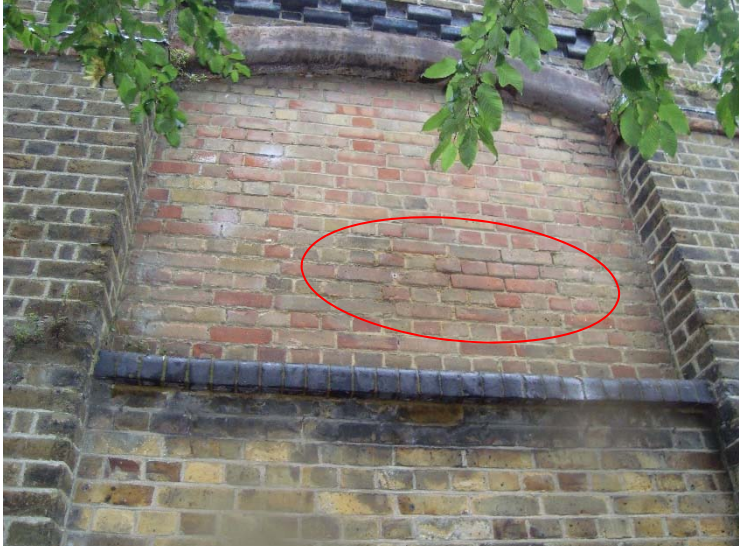
A photograph of a brick wall corner, viewed from a lower angle. A diagonal crack runs from the bottom left towards the top right, passing through the mortar joints. The crack is circled in red.
P12 Loss of mortar on brick face

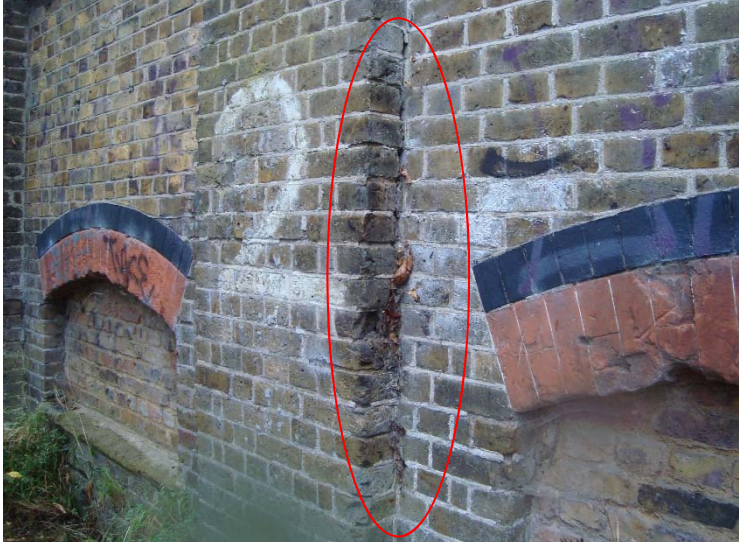
<p>P14</p> <p>Crack</p>

<p>P15</p> <p>Crack</p>

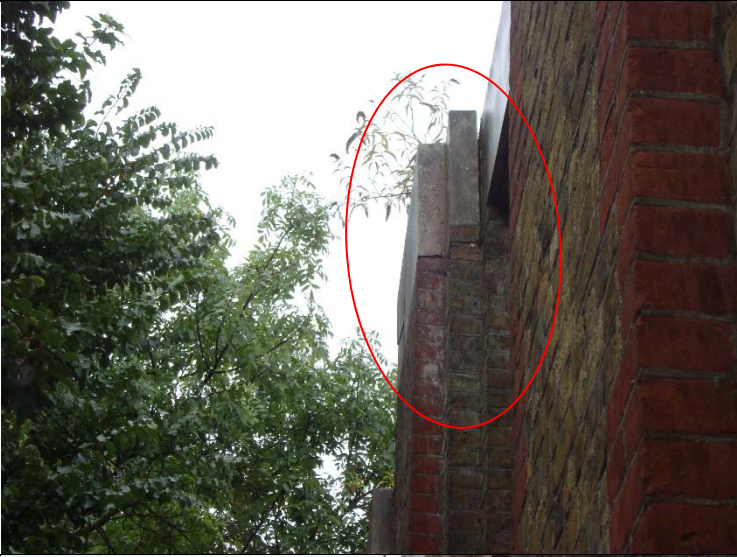
Name	Photograph
P22 Crack from the top of wall

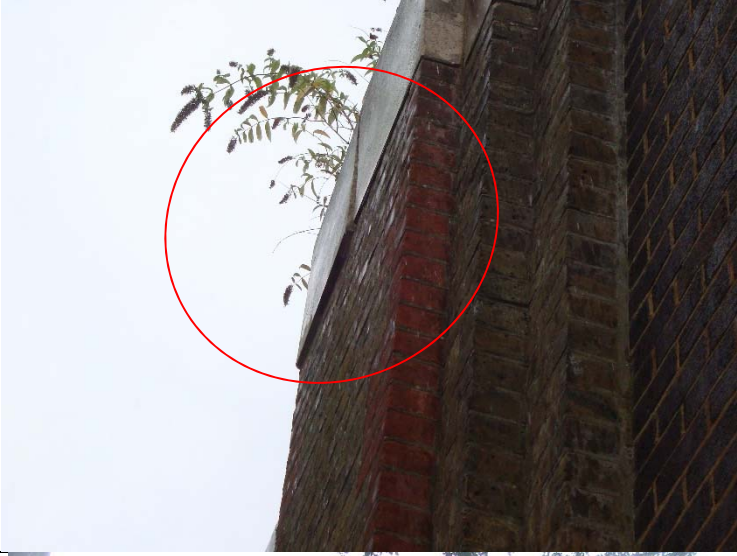
P23 Crack from the top of wall

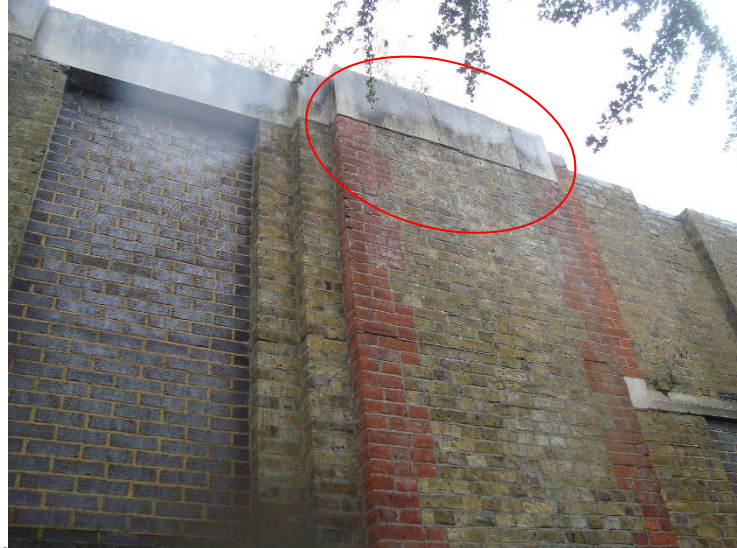
P24 Crack from the top of wall

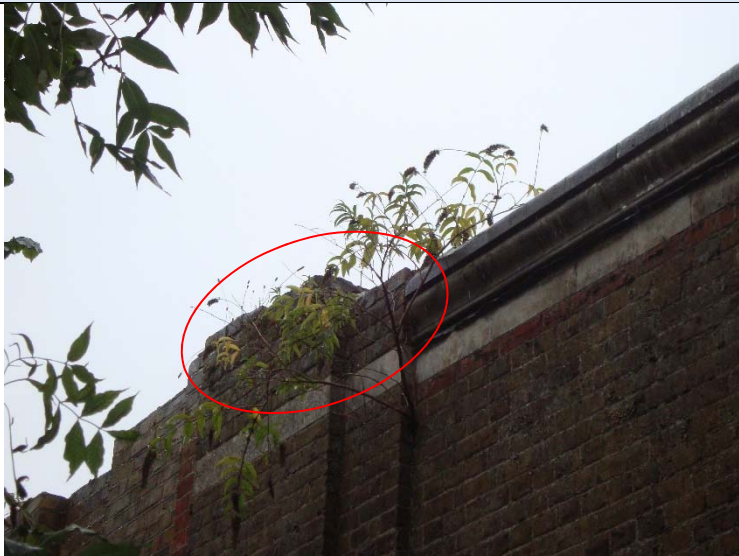
Name	Photograph
<p>P25</p> <p>Bricks missing from top of wall</p>

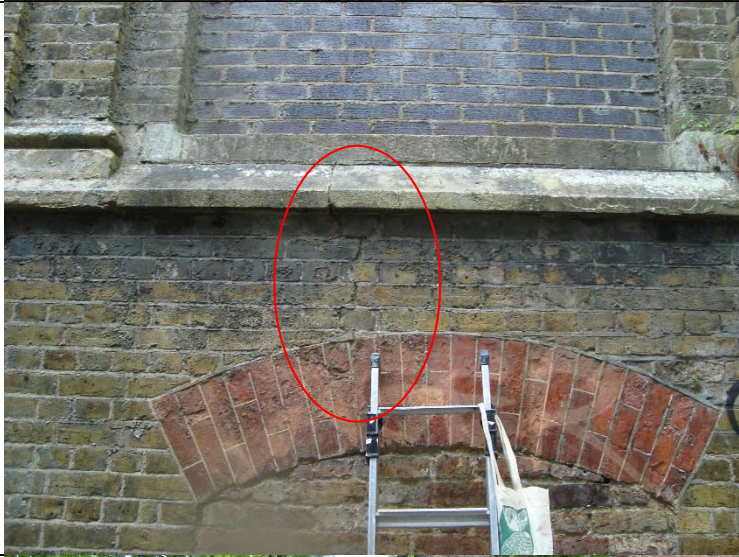
<p>P26</p> <p>Crack propagating upwards from the top of a bricked up window</p>

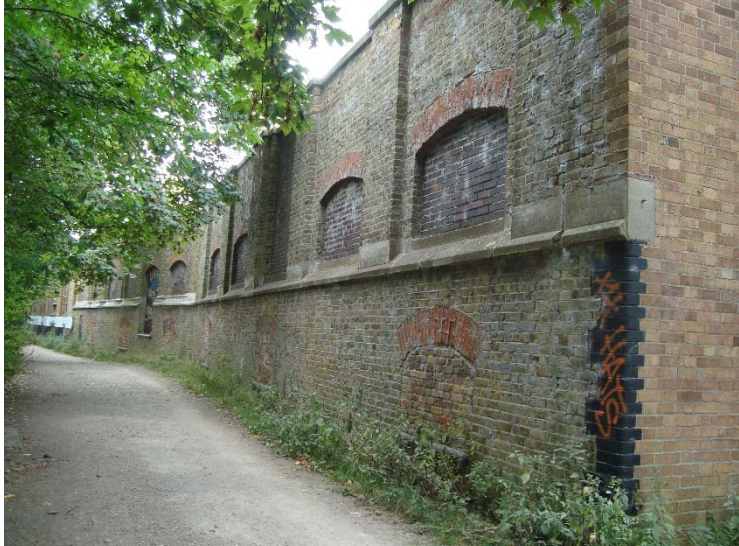
<p>P27</p> <p>Bricked window edges minor spalling</p>

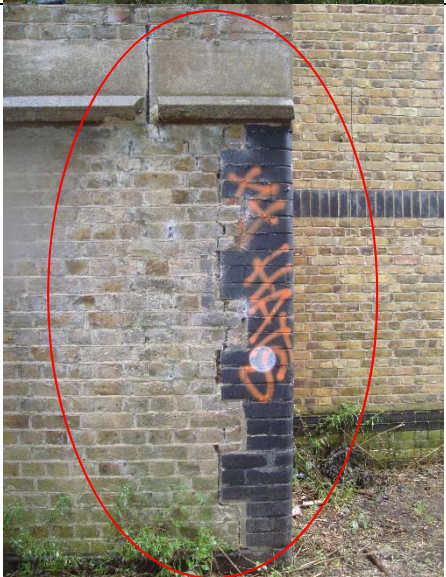
53m	Bricks spalling due to a rusting metal pipe in the wall.	P13
60m – 77m	Loss of render (330mm high) along the bottom face of the wall.	P19
61m	Render on a previously blocked up vent shaft is cracked/missing and the vent is now open.	P17
62m	Loss of mortar on face of brick wall.	P18
112m – 125m	Cracks from the top of wall. Vegetation on top of the wall appears to be pushing the concrete capping out.	P21 – P24
129m	Bricks spalled off or missing from the top of the wall.	P25
130m	Crack propagating upwards from the top of a bricked up window.	P26
130m – 161m	Minor spalling on the edges of bricked up windows and doors.	P27
142m	Missing/damaged bricks resulting in a hole through the wall.	P28
145m	Loss of mortar on the face of the brick wall near the top of the wall.	P29
163m	A large crack (approx. 20mm) that runs the height of the wall.	P30 – P32

<p>P30</p> <p>Crack along length of wall, largest gap 20mm</p>

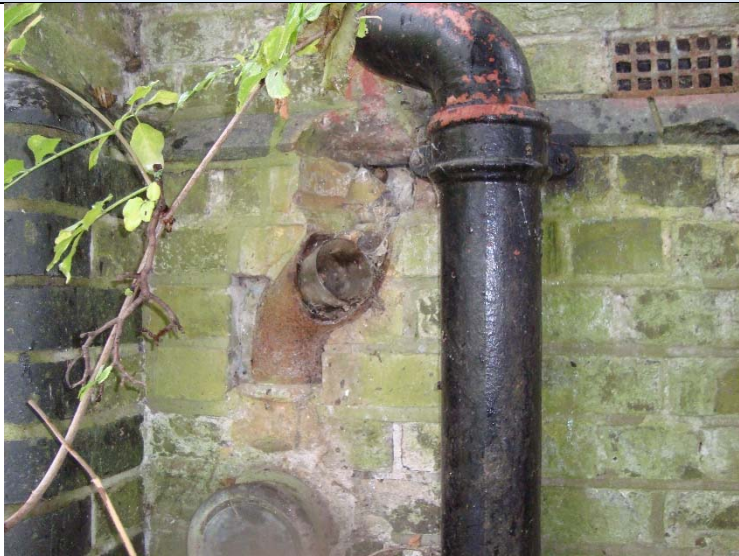
Approx. Chainage	Defects	Photo ID
271m	Bricks chipped out around old pipes embedded in the wall.	P37
271m	Mortar loss below metal pipe in brick wall.	P38
287m	Loss of mortar on the face of the brick wall.	P39
288m	Mortar loss below metal pipe in brick wall.	P40
300m	Loss of render along bottom face of wall. Render cracked and broken off.	P41
301m – 318m	Loss of mortar along the bottom face of the western wall.	P43 & P44
303m	The top of the wall to the west of the building is cracked.	P42
314m	Mortar loss and spalling bricks near the top of the western wall.	P45

Name	Photograph
<p>P37</p> <p>Bricks chipped out around old pipes embedded in the wall</p>

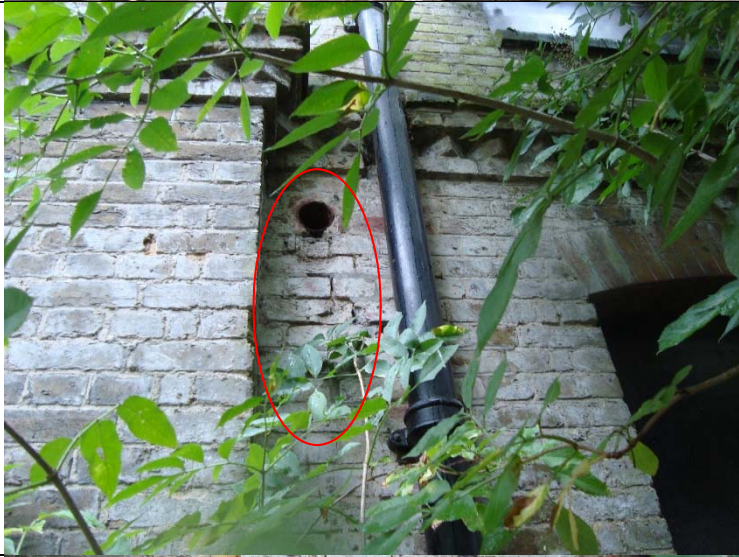
<p>P38</p> <p>Mortar loss below metal pipe in brick wall</p>

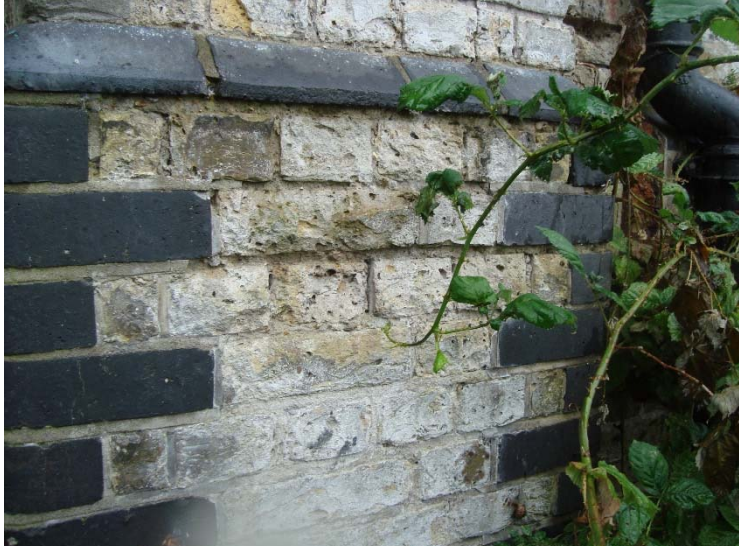
<p>P39</p> <p>Loss of mortar on face of brick wall</p>

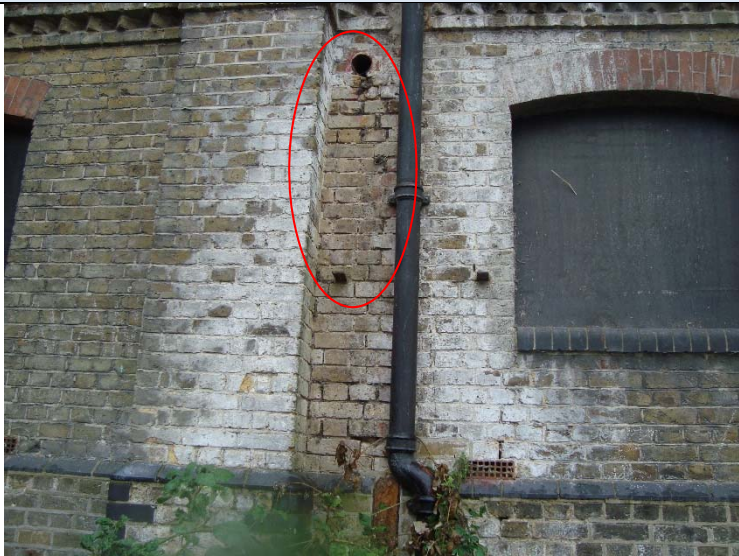
Name	Photograph
<p>P40</p> <p>Mortar loss below metal pipe in brick wall</p>

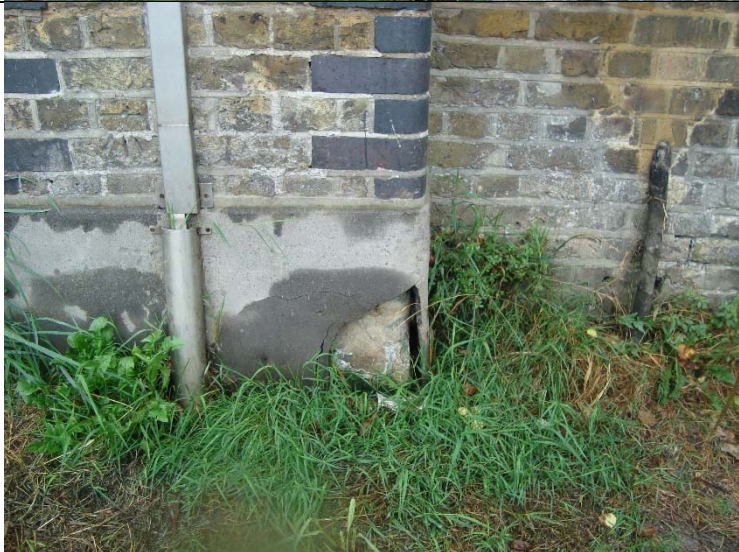
<p>P41</p> <p>Loss of render along bottom face of wall</p>

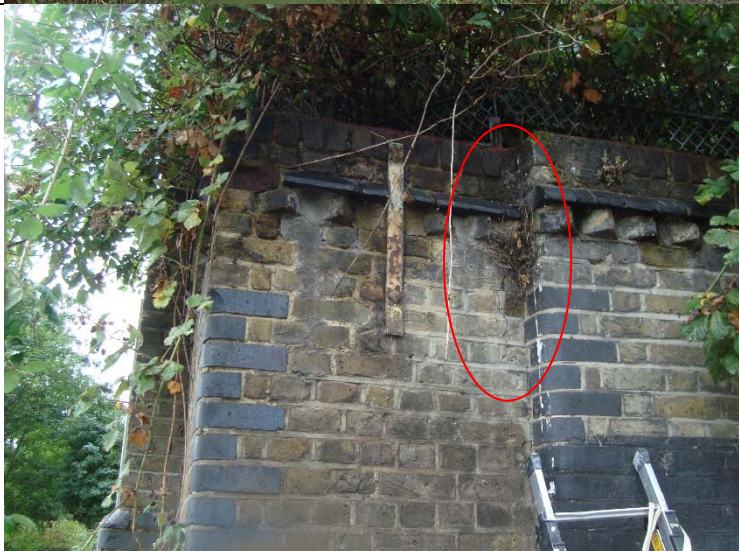
<p>P42</p> <p>Crack at the top of the wall</p>
