Marble Hill House

Report on compartmentation

BUILDING SERVICES AND EMERGENCY PLANNING TEAM MEMO

Subject: Marble Hill House

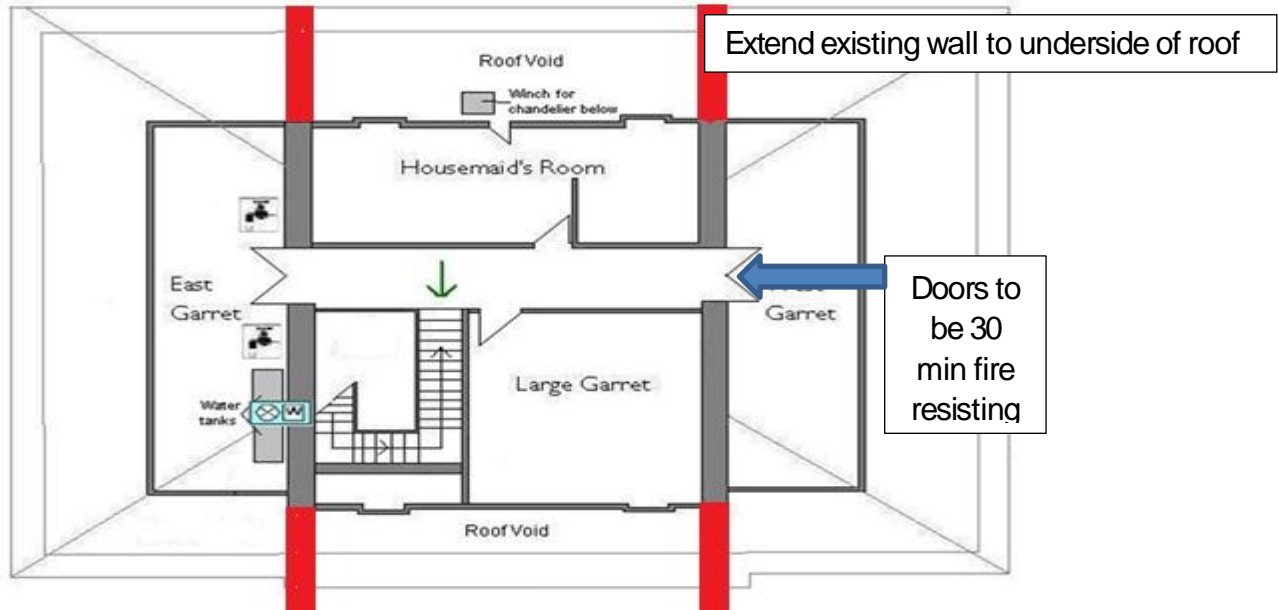
Extending the compartment line to the existing walls to the East and West Garret will afford some level of protection and reduce the compartment sizes on the third floor level considerably. As the roof felt and tiles sit directly onto roof battens and rafters, it will be necessary to ensure that fire spread cannot compromise the adjacent compartment in the event of fire. Fire resistance must be provided either side of the fire wall to ensure that fire spread does not occur. Door leading to the East and West Garret should be 30 min fire resisting.

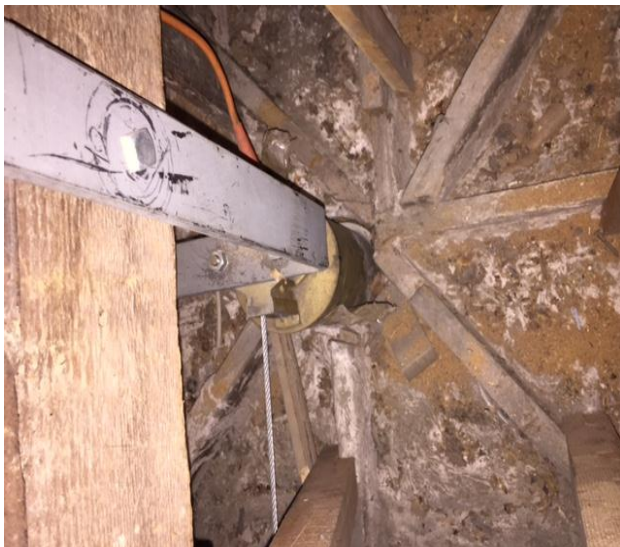
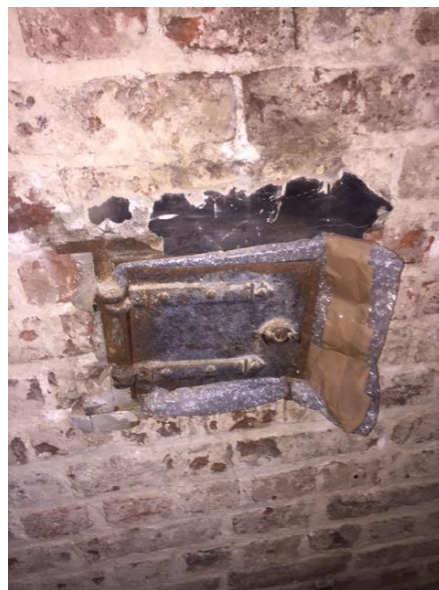
A common void is present under the middle section of the floor beneath the Garret floor; it appears to be large enough that fire detection would be required for this area under the British Standard for fire alarms. Access for maintenance purposes would be problematic and difficult to maintain. It is recommended that an engineered approach could be taken to consider a form of suppression system as a compensatory feature for the lack of compartmentation with the additional positives of giving the premises greater resilience in the event of fire (property protection). It was also noted that there were penetrations to the ceiling where the chandelier passes through it. A register plate in the large Garret Room should be investigated to ensure that fire has not the ability to pass through any void or duct that may be hidden behind this plate.

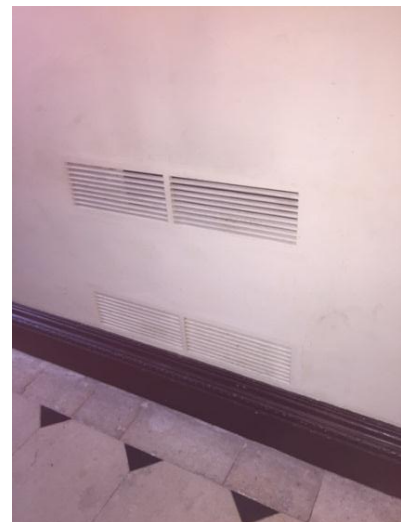
The stone staircase becomes a critical area for means of escape purposes from the upper floors of Marble Hill House. There are breaches to the compartmentation at ground floor level, mainly due to the heating system passing through the wall. This heating unit should be relocated to the hall or alternatively the grill in the hall should be fitted with an intumescent grill to prevent fire spread. The heating unit is located within a critical stair, if it is to be retained it should be encased within a fire resisting cupboard.
