An investigation of dampness levels at
Marble Hill House, Twickenham

1 INTRODUCTION

Following instructions from Robert Illingworth of English Heritage, I visited the above building on Wednesday 5th December 2012 to investigate 2 areas of the ground floor – namely damage to the wall coverings in the Paper Room and damage to the floor in the Hall (see ground floor plan, page 10).

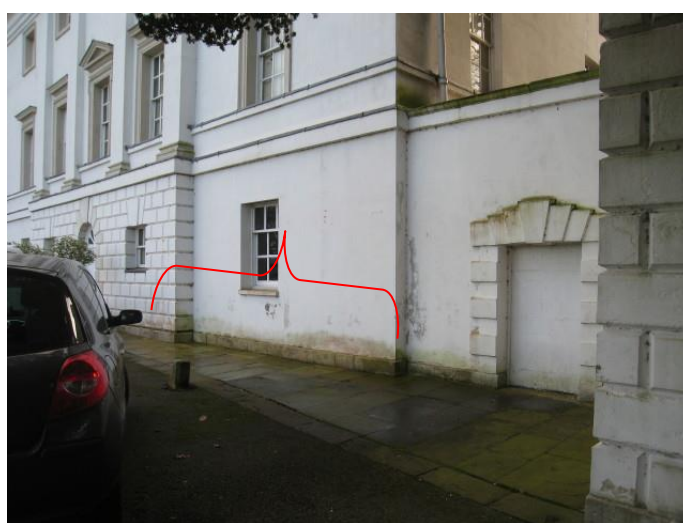
N elevation of Paper Room showing incorrect surface falls around the NW corner. Water is able to percolate between the paviours – presumably migrating to the wall base.

Wall siphons (of some kind) have been installed to the extent of the red bracket.

The plinth is composed of stone units. The facade finished in stucco.

A small amount of groundwork to the N elevation should bring long term benefits, where the pavements shown in photo 1 could be relayed (and well grouted) to fall away from the building. However water collection/discharge could be a problem due to the existing falls. The only possibility would seem to be the installation of a soakaway in the front lawn.

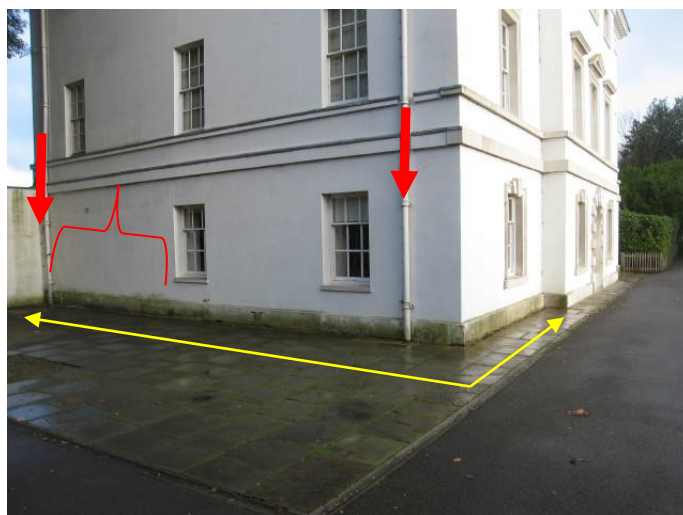
2

Wall siphons continue along W elevation to extent of bracket. Gulleys and possibly downpipes were blocked. (Drain runs recently inspected and found to be clear).

External paviours do not seem to have sufficient falls away from building perimeter.

Small trench installed at wall perimeter (yellow arrow) – filled with pea gravel – which was very wet.

Plinth along W elevation has been covered (in render?).

The W wall shows a (very) wet band at 750 – 1000mm above floor level. This would seem to be a result of the wall construction – where the masonry below about 500mm (see photo 2) is an enlarged (stone) plinth – with that above probably being soft brick encased in hard render. The plinth along the W elevation has been covered in a render. It is probable that wind driven rain is running down the wall to the step created by the plinth – then capillarizing into and behind the base of the external render. The covering of the plinth might also be allowing water to track up between the covering and the plinth itself from the wet trench.

The stone filled trench along the W and S elevations could be replaced with an open channel which discharges into the downpipe gullies. The ends of the downpipes should be changed to spouts which discharge into the same grated gulleys as opposed to travelling sub surface where they become blocked out of view. This should decrease the water loading on the W wall.

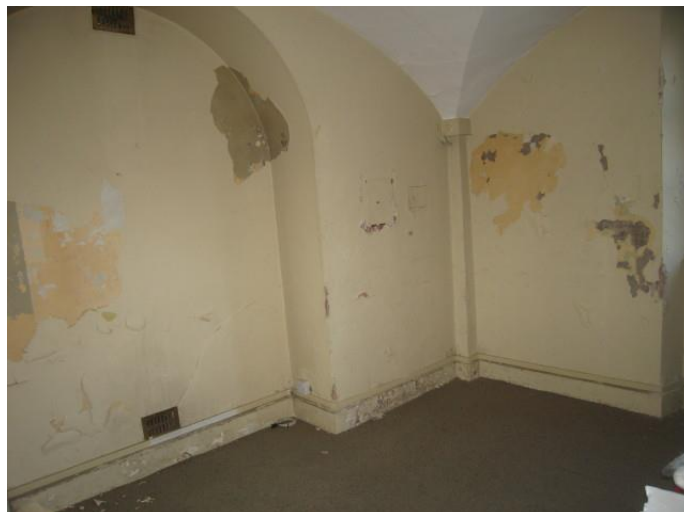
3

The N and W internal walls have been rendered with hard (almost certainly cementitious) render – much of which has blown (for one or a combination of reasons which will only become obvious after the damaged render is removed). In places salts are efflorescing through the surface.

The floor has been covered with a resin based substance – almost certainly as a damp proofing measure.

See masonry analysis.

Internally all loose plaster should be removed from the N and W walls. This will have to be carried out with care (to preclude the damage which often results when chiselling well bonded cementitious material off soft brickwork). Ordinarily the recommendation would be to line the wall in moisture resistant plasterboard and simply allow the wall to be damp. This might have been rejected in the past due to the difficult curves and contours in the W wall and it will probably now be necessary to board straight over the alcove. Any well bonded cementitious render can just remain on the wall. The wall lining will have to be well designed around the N window and ideally the cavity should be air tight.

However the overall design of the wall lining and cavity can only be finalised when the loose render has been removed and the extent of the wall siphons and condition of the masonry have been confirmed. It would be advisable to block the siphon cavities completely.

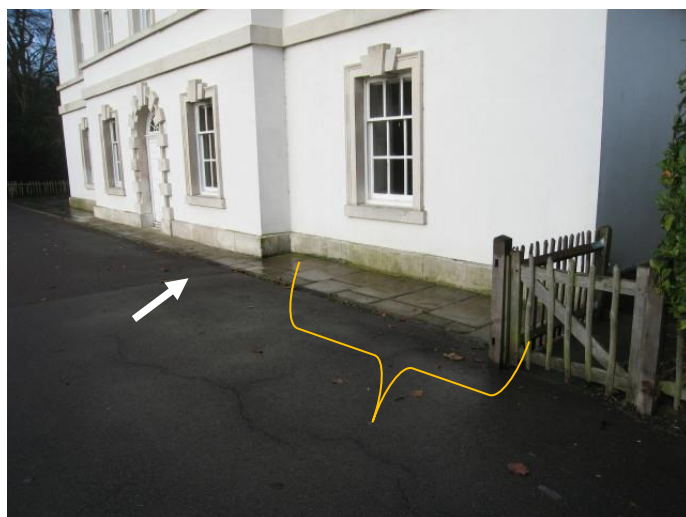
4

Problems with collection and discharge of surface water – similar to that shown in photo 1.

Water has been percolating into the cellar (extent shown by bracket), causing plaster loss from the S wall

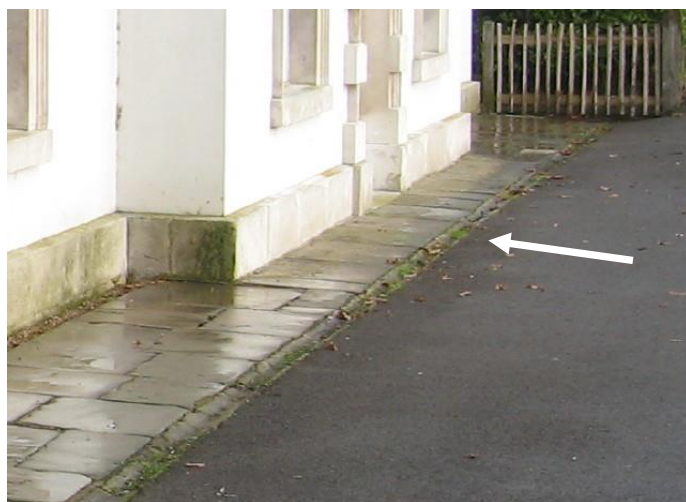
The open channel – into which the tarmac and pavements shed water – has open joints and falls to the point arrowed - where leaves have been collected then deposited where the water has disappeared. below ground

The open channel arrowed in photo 5 could be repaired to collect and discharge surface water more effectively. While the overall problems with surface water collection and defective falls are similar to those experienced on the W and N walls, repair of the open channel arrowed in photo 5 should produce particularly good results along this elevation in the long term.

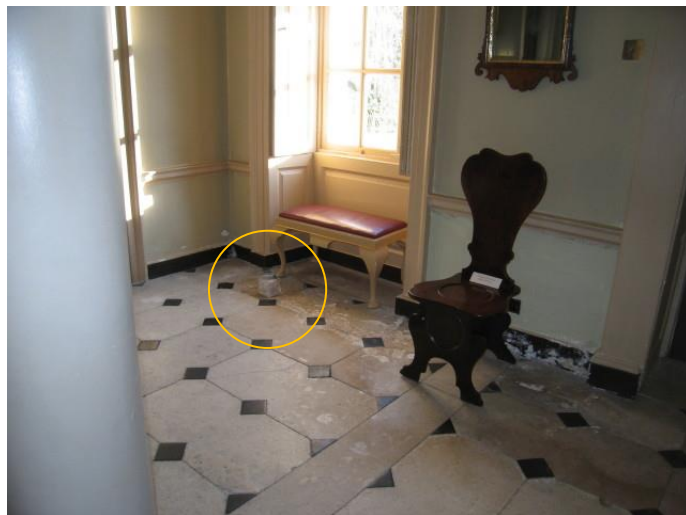
6

Deterioration of the stone floor tiles in the SE corner of the Hall has recently accelerated (photo 6).

The upper 1 – 4mm of the floor tiles (probably limestone) has delaminated locally, leaving spots of lighter coloured substrate.

The floor surface is darkening – possibly due to excess moisture, with small areas of the floor surface disassociating from the floor tiles. It is understood this process has accelerated recently.

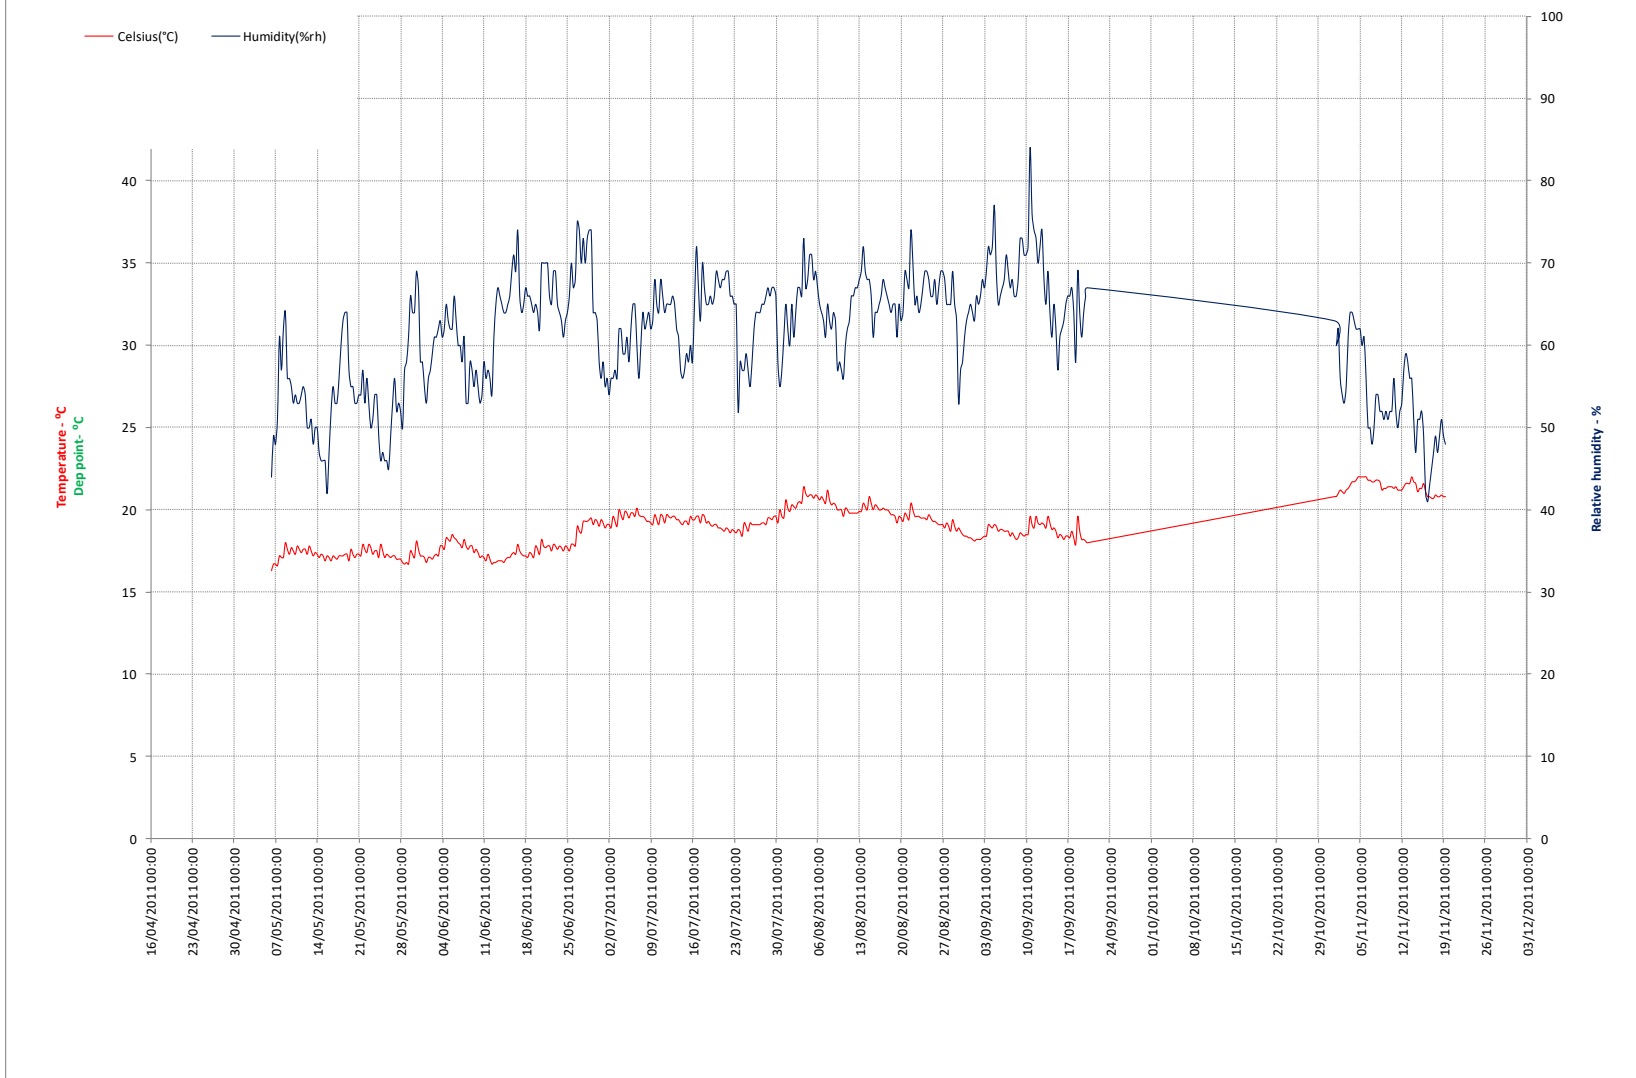
Graph 3 – Breakfast Parlour

The environment of the Breakfast Parlour is as variable as that of the Hall. Graph 4 shows the data from June only. Although the sun is at its highest, this data set should represent that period when the S facade is affected most by solar gain.

BREAKFAST PARLOUR = 06.05.11 - 19.11.11

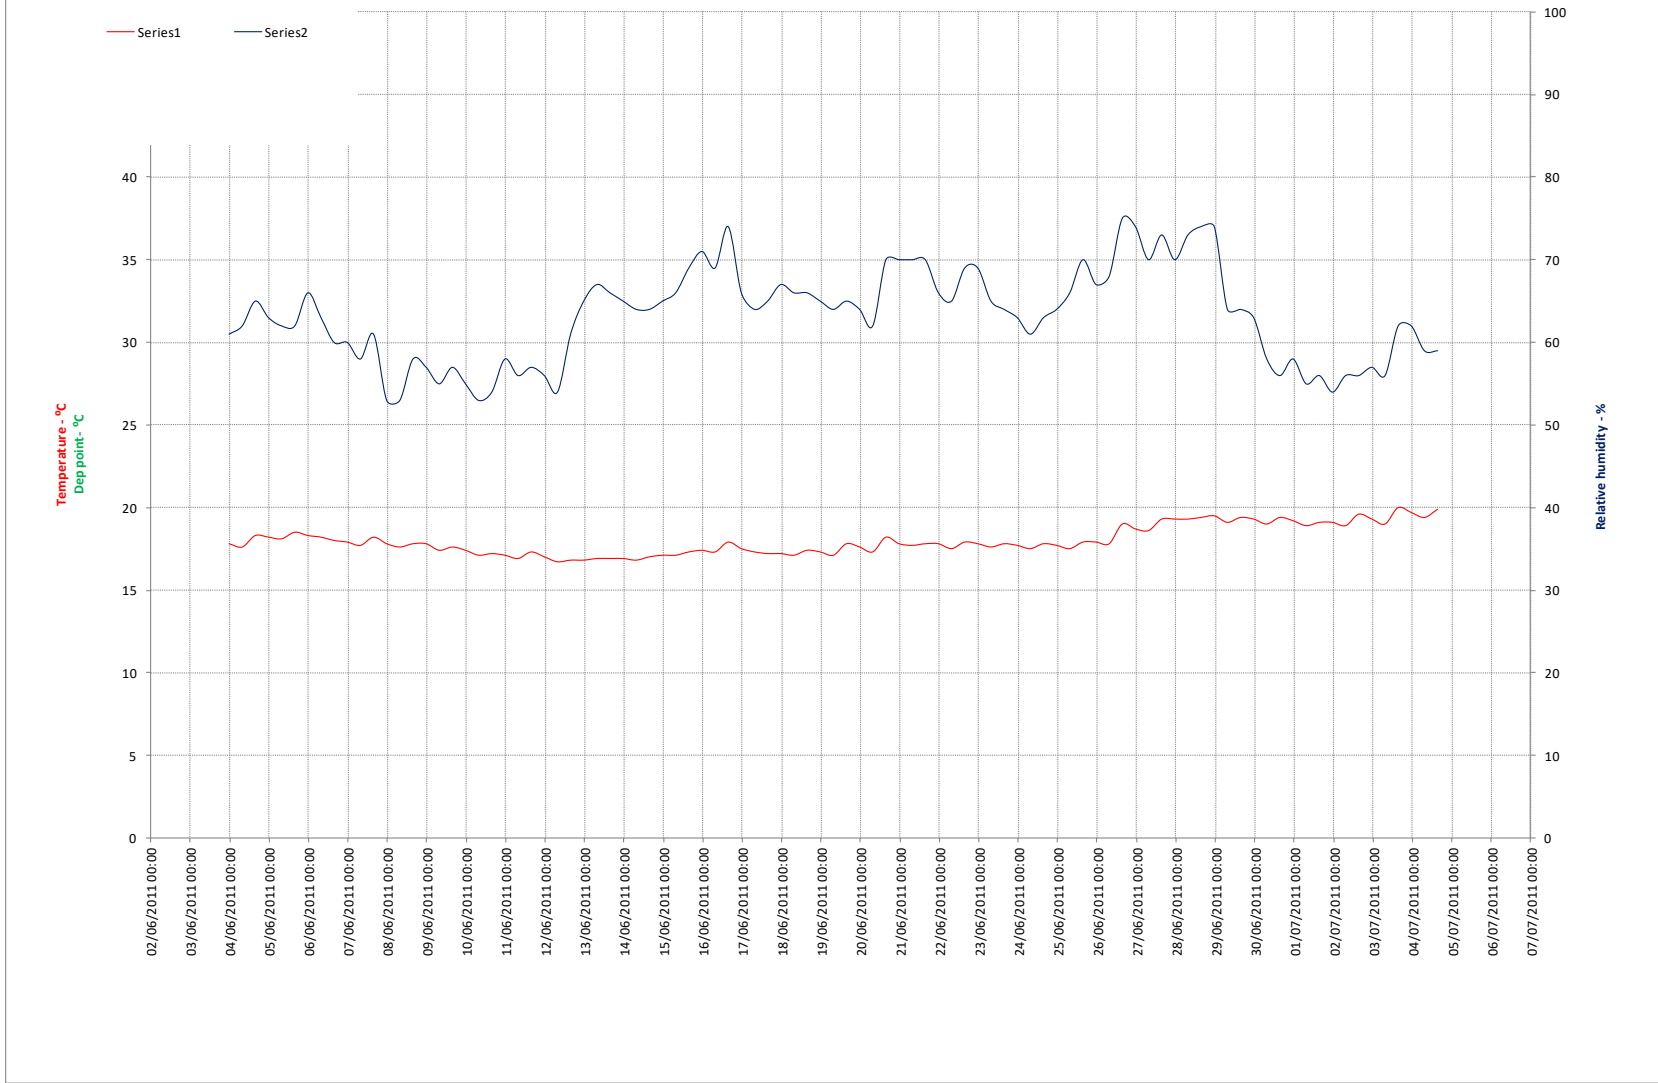
Graph4 – Breakfast Parlour (Close up of June)

It can be seen that although the temperature is maintained between 17 - 20°C, the RH ranges from 52% - 75%. Again this is likely to be the result of air conditioning, with moisture emanating from the cellar below.

BREAKFAST PARLOUR = 04.06.11 - 05.07.11

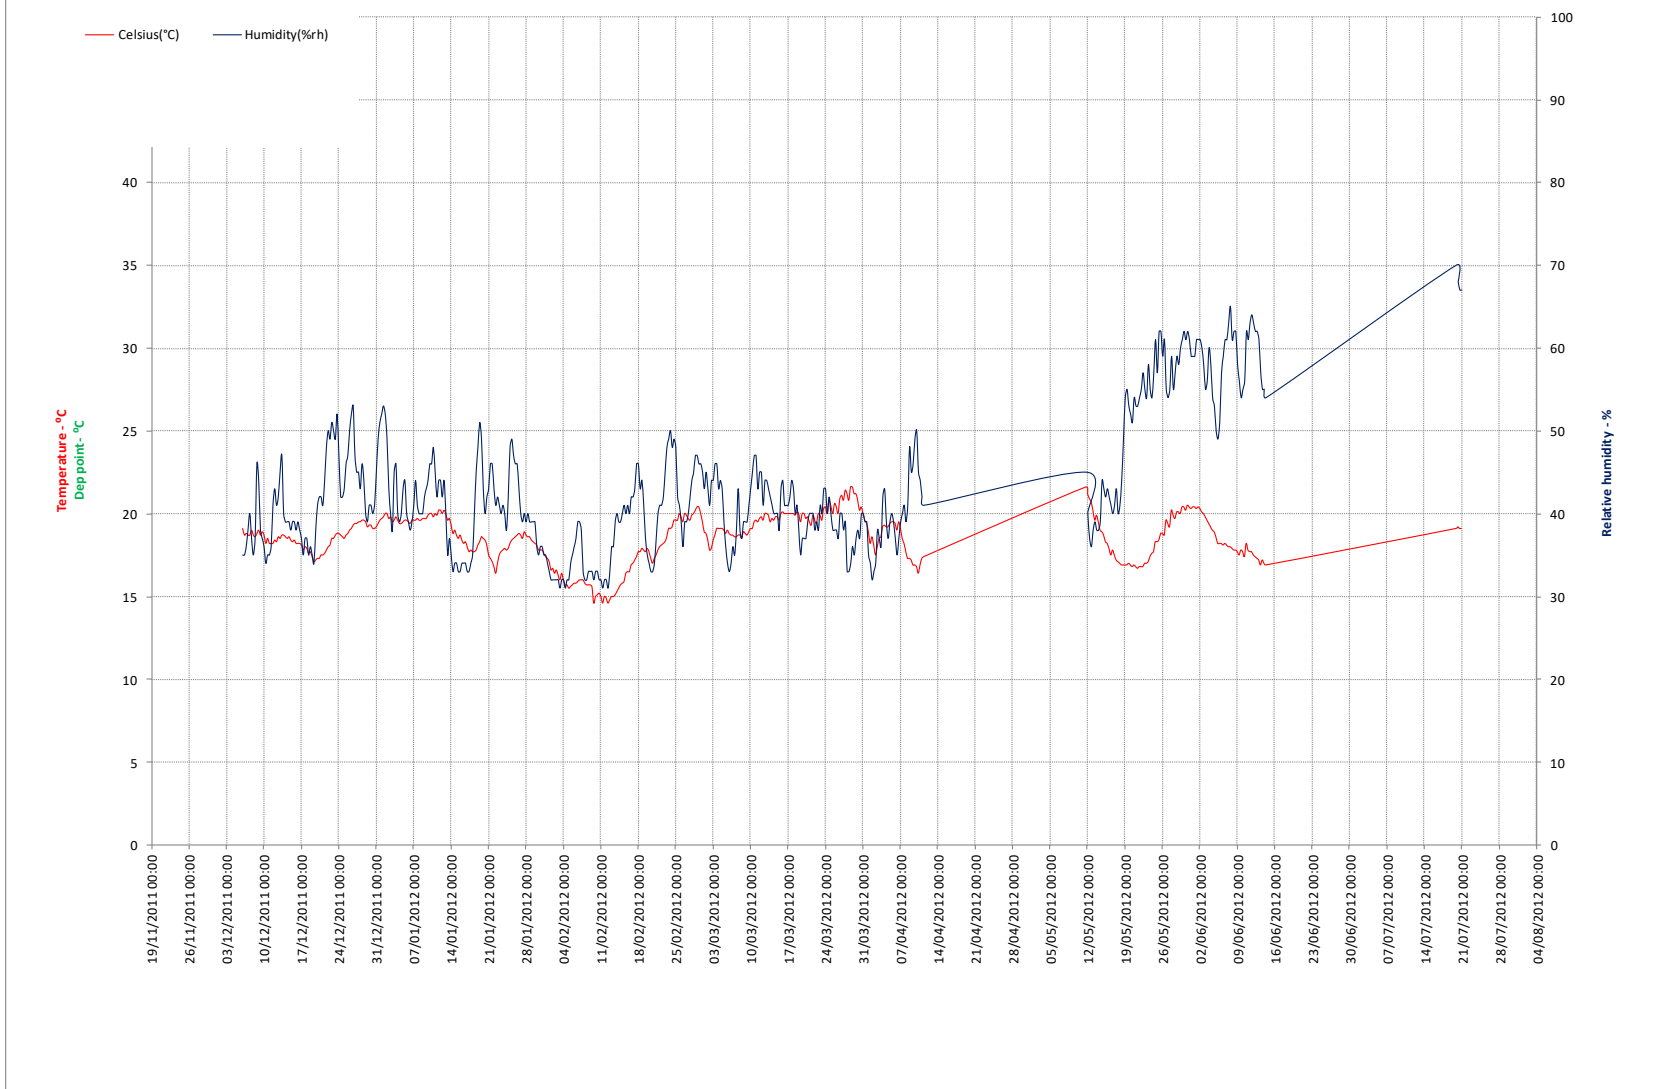
Graph 5 – Breakfast Parlour 2012

BREAKFAST PARLOUR = 06.12.11 - 31.07.12

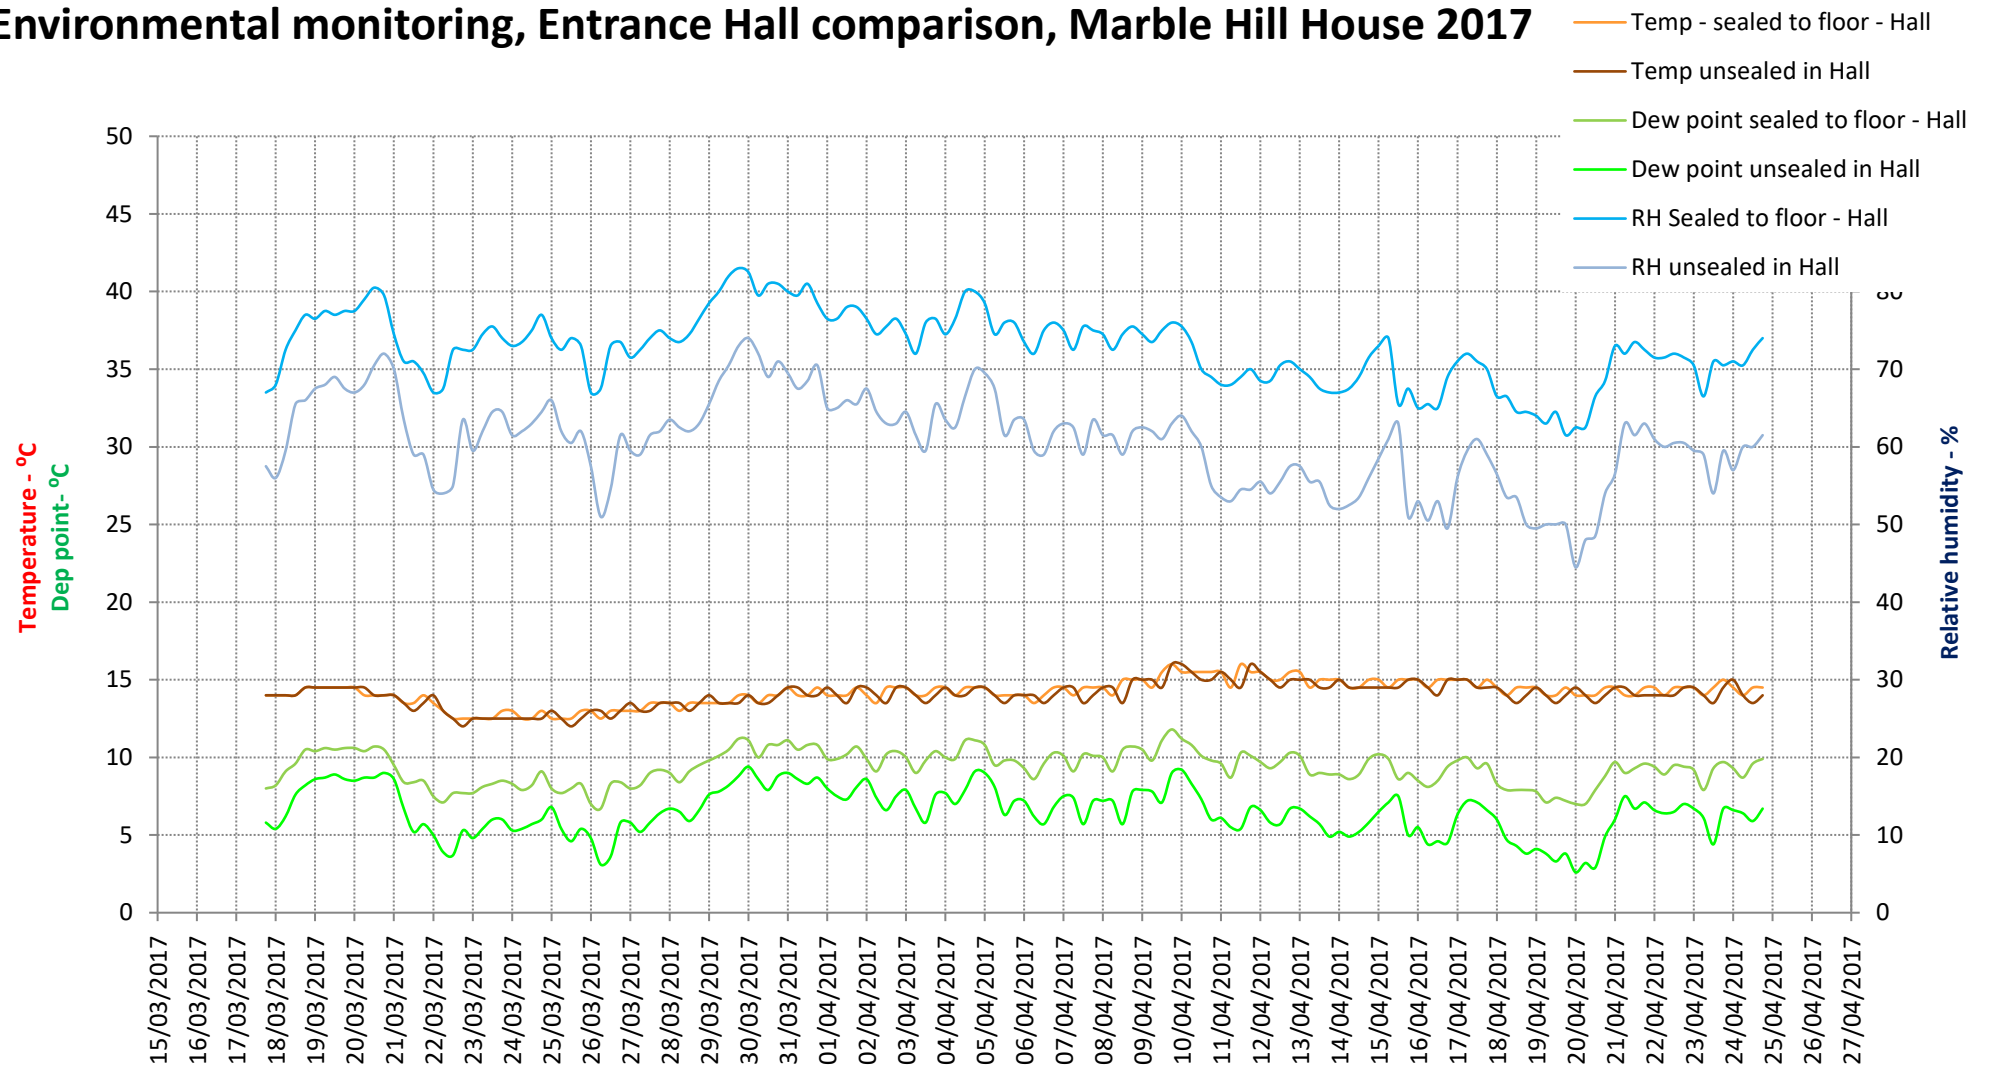
Environmental monitoring, Entrance Hall comparison, Marble Hill House 2017

The comparison of data acquired from loggers sealed and unsealed adjacent to the Hall floor was similar to that recorded in 2013 – (see page 11), with the exception that the data of the sealed logger in 2013 showed high and stable RH against the floor surface, whereas this data set shows the RH (and dew point) curve profiles replicating each other – albeit the RH of the sealed logger being approximately 10% higher than the unsealed logger. The reason for this is unclear – possibly indicating a less effective seal this time around. With regard to overall variability, the fluctuations and graph profiles bear some resemblance to those recorded in the Paper Room, indicating the main driver of RH fluctuation in this case is also the external environment.
