CLIENT
English Heritage

PROJECT
Marble Hill House

TITLE
Main House:
Roof Plan; Proposed Repairs

DRAWING N°
214 B

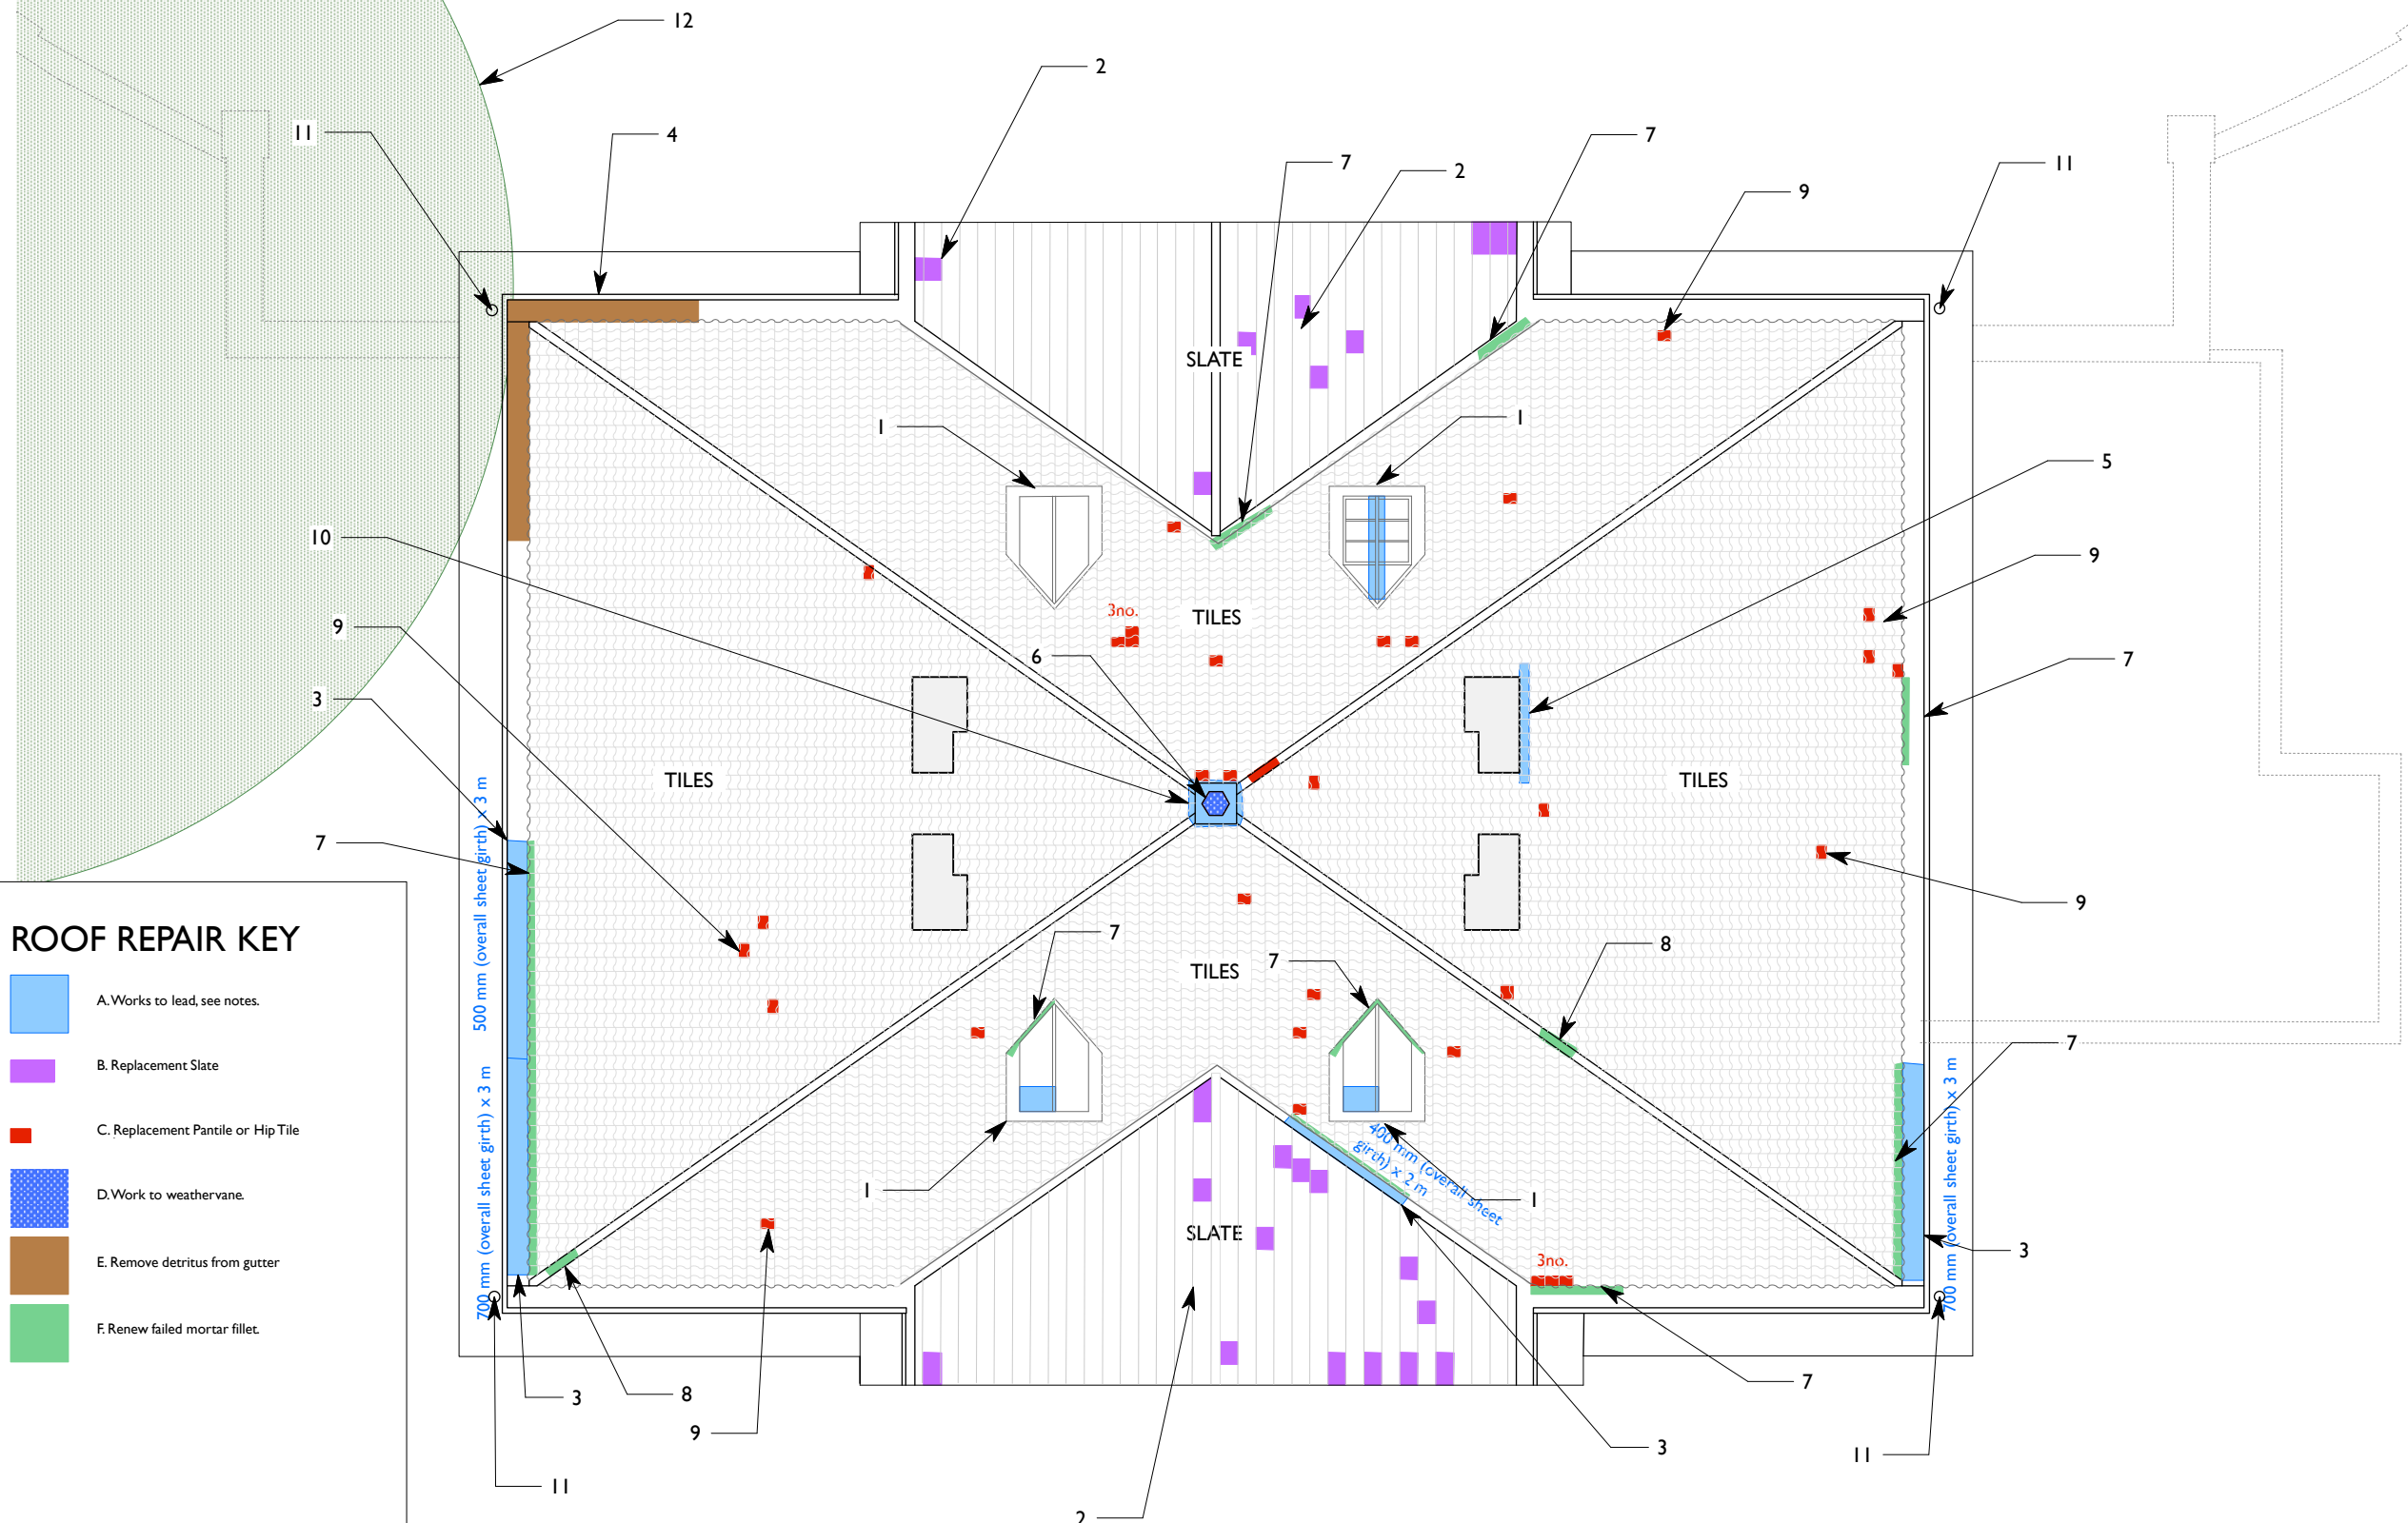
Roof Plan

- For repairs to the dormer windows; refer to drawing 316.
- Replace missing, slipped, broken or 'tingled' (repaired) slates with new slates to match existing. Approximate location of slates indicated. In addition to those show, replace an additional 25no in various locations. At the verges all half slates are to be replaced with one & one-half slates. Refer to Hatch B.
- Replace lead gutter sheet with new Code 8 sandcast lead sheet. Indicative size of sheets noted on this drawing. If gutter boarding is decayed, this is to be replaced with new boarding. Refer to Hatch A.
- Clear organic detritus from gutter, outlet and roof eaves to allow Architect to inspect leadwork and detailing; if leadwork is in poor condition, refer to note 3.

- Replace lead flashing.
- Regild weather vane.
- Remove failed cement mortar fillet and replace with a new lime putty mortar fillet. Refer to Hatch F.
- Rebed glazed hip tile in new lime mortar. Refer to Hatch C.

- Replace or reposition slipped, delaminated, broken or slipped black glazed pantiles with new black glazed tiles to match existing. Note that these tiles will require specialist manufacture. Locations of tiles are indicated, where more than one is subject, the number are noted. Refer to Hatch C.
- Leadwork to base of weathervane has a vulnerable repair allow to investigate leadwork. Repair/replace lead as per Architect's direction upon closer investigation.
- At outlets, allow to remove all pigeon guards that are retaining detritus and to remove mesh netting. A provisional sum will be allowed for to carryout any alterations to the outlet detail.
- Cut back tree branches by 5 m to the tree to the North-West of building, to reduce future organic detritus buildup.
