CLIENT  
English Heritage

PROJECT  
Marble Hill House

TITLE  
Main House:  
North Elevation; repairs

DRAWING N°  
221 B

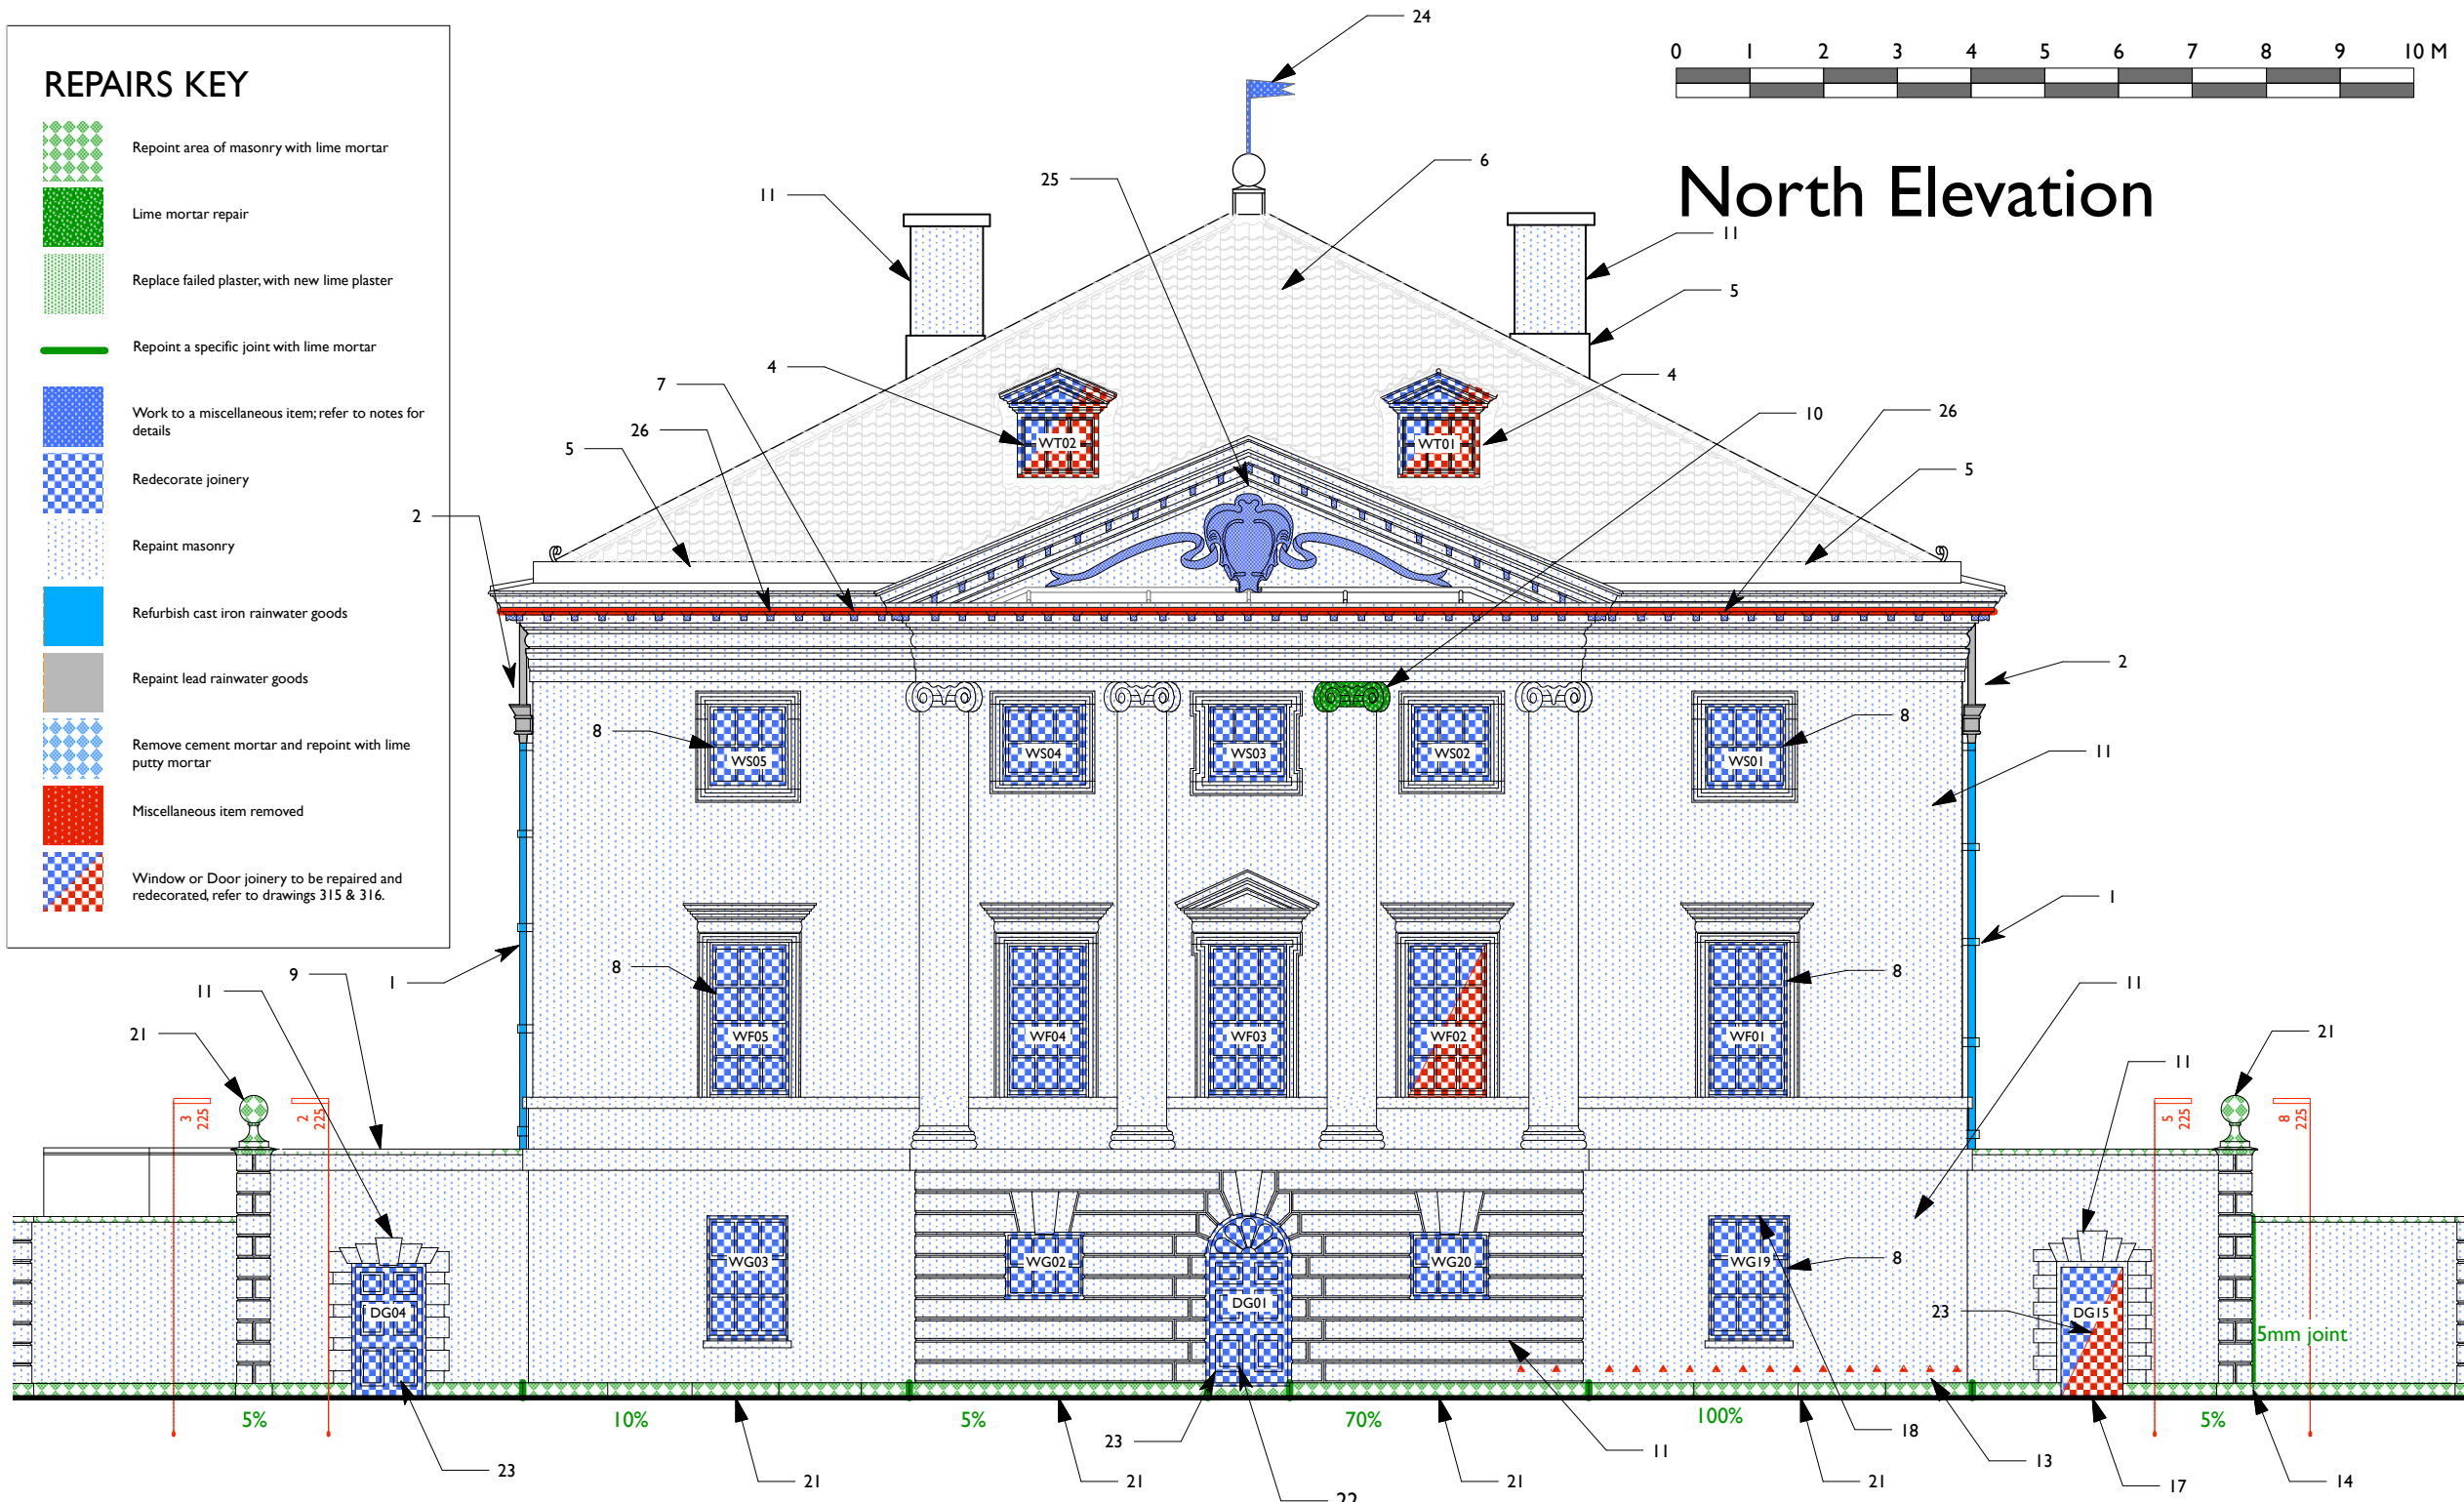
# North Elevation

5. Leadwork to roof; refer to drawing 214.
6. Repairs to roof; refer to drawing 214.
7. The cement plaster to the Soffit is loose in places and some has failed. Test the soundness of all of the soffit; where hollow allow to remove loose cement and re-render. Assume 5 metre square of soffit render to be replaced

9. Remove the decayed modern timber rooflight; including the internal modern wire glass glazing; and replace with a new low profile rooflight; such as 'The Conservation Plateau Rooflight' from 'The

13. Remove plastic ventilation siphons and make good with lime mortar (17 no to West Elevation, 21 no to North Elevation).
  14. Repoint open crack between the western wing wall and nib wall with lime mortar, refer to drawing for crack details

1. All existing cast iron rainwater pipes & fully refurbished, redecorated refinished and reinstalled. They are to be installed in their original locations; the downpipes are to be adapted and be fitted with shoes. The gulleys are to be replaced with new earthenware accessible gulleys fitted with cast iron covers. Paint colour to match existing; British Standard BS 4800 '00 E 55 White'.

2. Refurbish, repair and refinish the Lead rainwater pipes & hoppers.
4. Fully repaint the 4no. dormer windows; note that substantial joinery repairs are required to them. For details of joinery repairs refer to drawing 316. All windows are to have their glazing putty renewed with new linseed putty

8. Fully repaint all windows as indicated by hatch. All windows are to have their glazing putty renewed with new linseed putty. For details of joinery repairs to specific windows refer to drawing 315.

- Rooflight Company'; this will not be visible above the parapet level. Internally the plaster is to be made good and the existing 'soffit architrave' reused to form the opening. Size of rooflight is approximately 1250 x 2500 mm

10. Carry out mortar repair to column capital; assume that the entire capital will need replacement in situ. It is assumed that this repair will be executing in 'Roman Cement' (Vicat Prompt) using ceramic armatures and stainless steel pins drilled into the existing substrate for support. Precise mortar selection will take place in co-ordination with the English Heritage Curator and Craftmen.

11. Existing cementitious render including Architectural features, remove paint where it has failed to allow the existing 'alkyd resin' masonry paint to be overpainted with new masonry paint. Prepare surface by rubbing back loose paint, filling any cracks with natural hydraulic lime mortar. Paint colour to match existing; British Standard BS 4800 '00 E 55 White'.

17. Replace the lower portion of door; this will include the bottom rail and the lower 400 mm of the stiles.
18. Prepare, treat and repaint the steel lintel to WG19.
21. Repoint masonry plinth course and other Architectural features with lime putty mortar. Note percentages where provided.
22. Fix shut and seal the existing letter box to Door DG01.
23. Fully repaint all doors as indicated by hatch.
24. Regild weather vane; refer to drawing 214.
25. To the fibreglass 'Pediment Eschutcheon'; remove the rusted chicken wire, replacing this with new stainless steel pigeon netting. Check the fixings into the wall; allow for these to be inspected by the Structural Engineer. Clean fibreglass and repaint.
26. To the fibreglass 'Dentils'; individually check the security of each Dentil and report findings to the Architect; allow to refix 20no. Clean down fibreglass and repaint.
