Marble Hill House

Main House:
East Elevation; repairs

16\_132 222 B

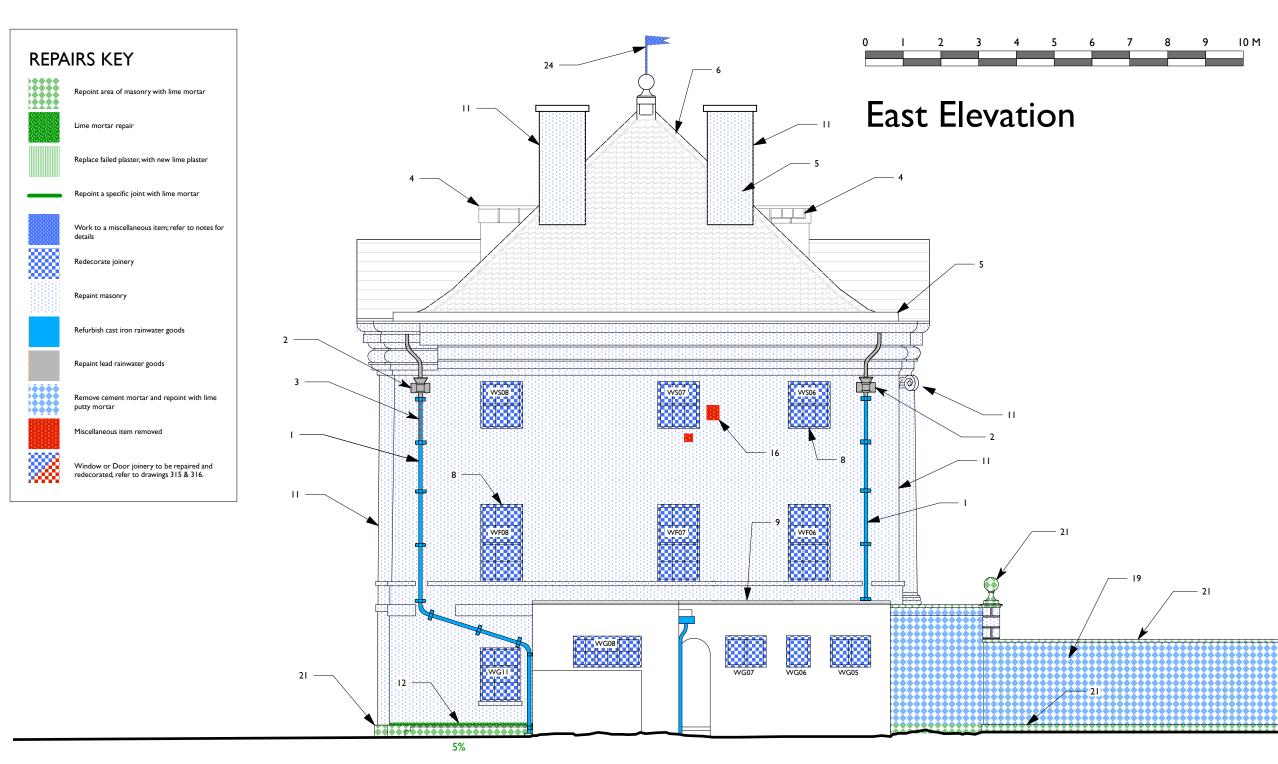
- I. All existing cast iron rainwater pipes & fully refurbished, redecorated refinshed and reinstalled. They are to be reinstalled in their original locations; the downpipes are to be adapted and be fitted with shoes. The gulleys are to be replaced with new earthenware accessible gulleys fitted with cast iron covers. Paint colour to match existing; British Standard BS 4800 '00 E 55 White'.

- 2. Refurbish, repair and refinish the Lead rainwater pipes & hoppers.
- 3. As a part of the wider repair works identified in note 1, take down indicated rainwater pipe and weld repair cracked iron ears.

- Fully repaint the 4no. dormer windows; note that substantial joinery repairs are required to them.
   For details of joinery repairs refer to drawing 316.All windows are to have their glazing putty renewed with new linseed putty

- Leadwork to roof; refer to drawing 214.
- 6. Repairs to roof; refer to drawing 214.
- The cement plaster to the Soffit is loose in places and some has failed. Test the soundness of all of the soffit; where hollow allow to remove loose cement and rerender. Assume 5 metre square of soffit render to be replaced

- 8. Fully repaint all windows as indicated by hatch. All windows are to have their glazing putty renewed with new linseed putty. For details of joinery repairs to specific windows refer to drawing

- Remove the decayed modern timber rooflight; including the internal modern wire glass glazing; and replace with a new low profile rooflight; such as 'The Conservation Plateau Rooflight' from 'The

Roofight Company'; this will not be visible above the parapet level. Internally the plaster is to be made good and the existing 'soffit architrave' reused to form the opening. Size of rooflight is approximately  $1250 \times 2500$  mm

- 11. Existing cementitious render including Architectural features, remove paint where it has failed to allow the existing 'alkyd resin' masonry paint to be overpainted with new masonry paint. Prepare surface by rubbing back loose paint, filling any cracks with natural hydraulic lime mortar. Paint colour to match existing; British Standard BS 4800 '00 E 55 White'.
- 12. Haunch top of plinth to the East Elevation with lime mortar.

- 16. Remove wall mounted plastic/metal boxes and make good with lime putty render.
- 19. Rear of wing walls, these are pointed in a cement mortar, where cement is failed or loose remove cement pointing and repoint wall with lime putty mortar.
- 21. Repoint masonry plinth course and other Architectural features with lime putty mortar. Note percentages where provided.
- 24. Regild weather vane; refer to drawing 214.
- 26. To the fibreglass 'Dentils', individually check the security of each Dentil and report findings to the Architect; allow to refix 20no. Clean down fibreglass and repaint.
