CLIENT
English Heritage

Marble Hill House

Main House: West Elevation; repairs

| SCALE | 1:100 @ A3 | DATE | DRAWIN | December 2016 | HS | DRAWING N° | DRAWING N° | 16 | 132 | 224 | B

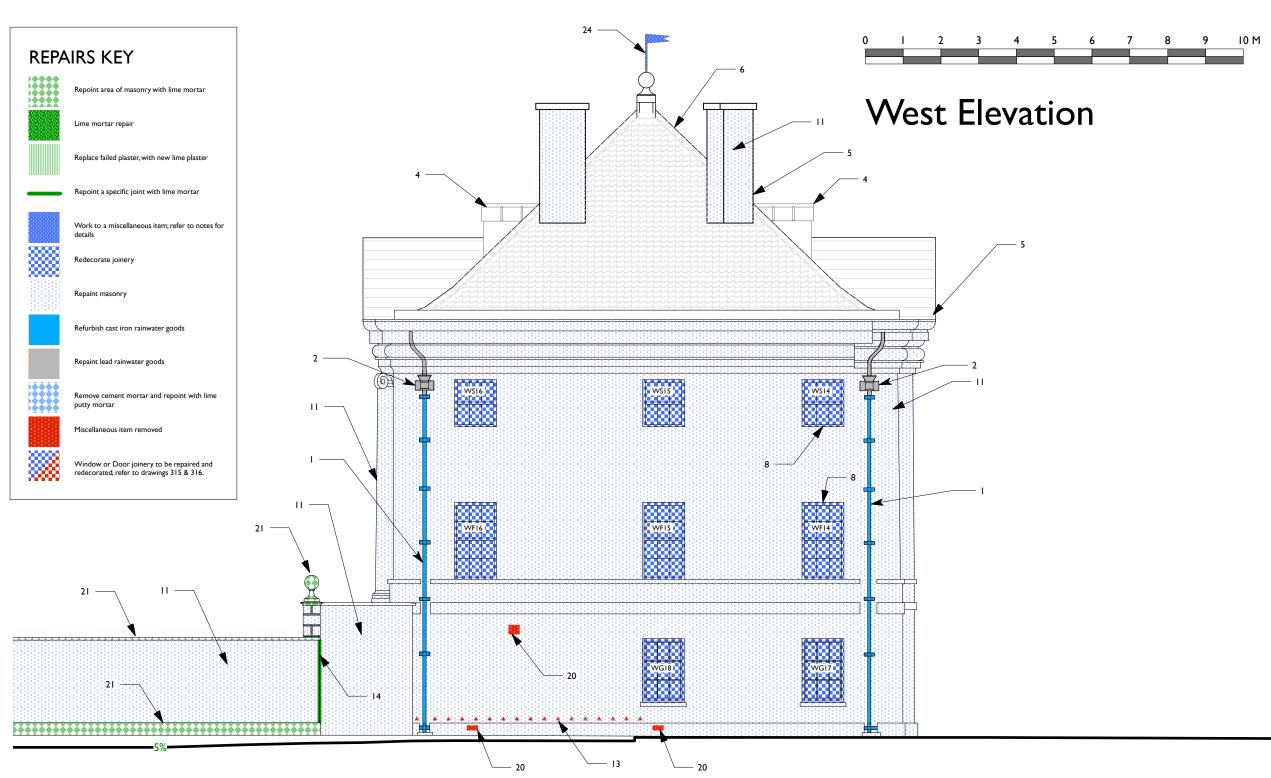
- I. All existing cast iron rainwater pipes & fully refurbished, redecorated refinshed and reinstalled. They are to be reinstalled in their original locations; the downpipes are to be adapted and be fitted with shoes. The gulleys are to be replaced with new earthenware accessible gulleys fitted with cast iron covers. Paint colour to match existing; British Standard BS 4800 '00 E 55 White'.

- 2. Refurbish, repair and refinish the Lead rainwater pipes & hoppers.
- 3. As a part of the wider repair works identified in note I, take down indicated rainwater pipe and weld repair cracked iron ears.

- 4. Fully repaint the 4no. dormer windows; note that substantial joinery repairs are required to them. For details of joinery repairs refer to drawing 316.All windows are to have their glazing putty renewed with new linseed putty

- Leadwork to roof; refer to drawing 214.
- 6. Repairs to roof; refer to drawing 214.
- The cement plaster to the Soffit is loose in places and some has failed. Test the soundness of all of
 the soffit; where hollow allow to remove loose cement and rerender. Assume 5 metre square of
 soffit render to be replaced

- Fully repaint all windows as indicated by hatch. All windows are to have their glazing putty renewed with new linseed putty. For details of joinery repairs to specific windows refer to drawing 315.

- 11. Existing cementitious render including Architectural features, remove paint where it has failed to allow the existing 'alkyd resin' masonry paint to be overpainted with new masonry paint. Prepare surface by rubbing back loose paint, filling any cracks with natural hydraulic lime mortar. Paint colour to match existing; British Standard BS 4800 '00 E 55 White'.

- Remove plastic ventilation siphons and make good with lime mortar (17 no to West Elevation, 21 no to North Elevation).
- 14. Repoint open crack between the western wing wall and nib wall with lime mortar, refer to drawing for crack details

- 20. Remove airbrick to western elevation and make good using brick and lime mortar infill.
- Repoint masonry plinth course and other Architectural features with lime putty mortar. Note percentages where provided.

- 24. Regild weather vane; refer to drawing 214.
- 26. To the fibreglass 'Dentils'; individually check the security of each Dentil and report findings to the Architect; allow to refix 20no. Clean down fibreglass and repaint.
