Marble Hill House

Main House: Elevation of Wing Walls; repairs

16 132

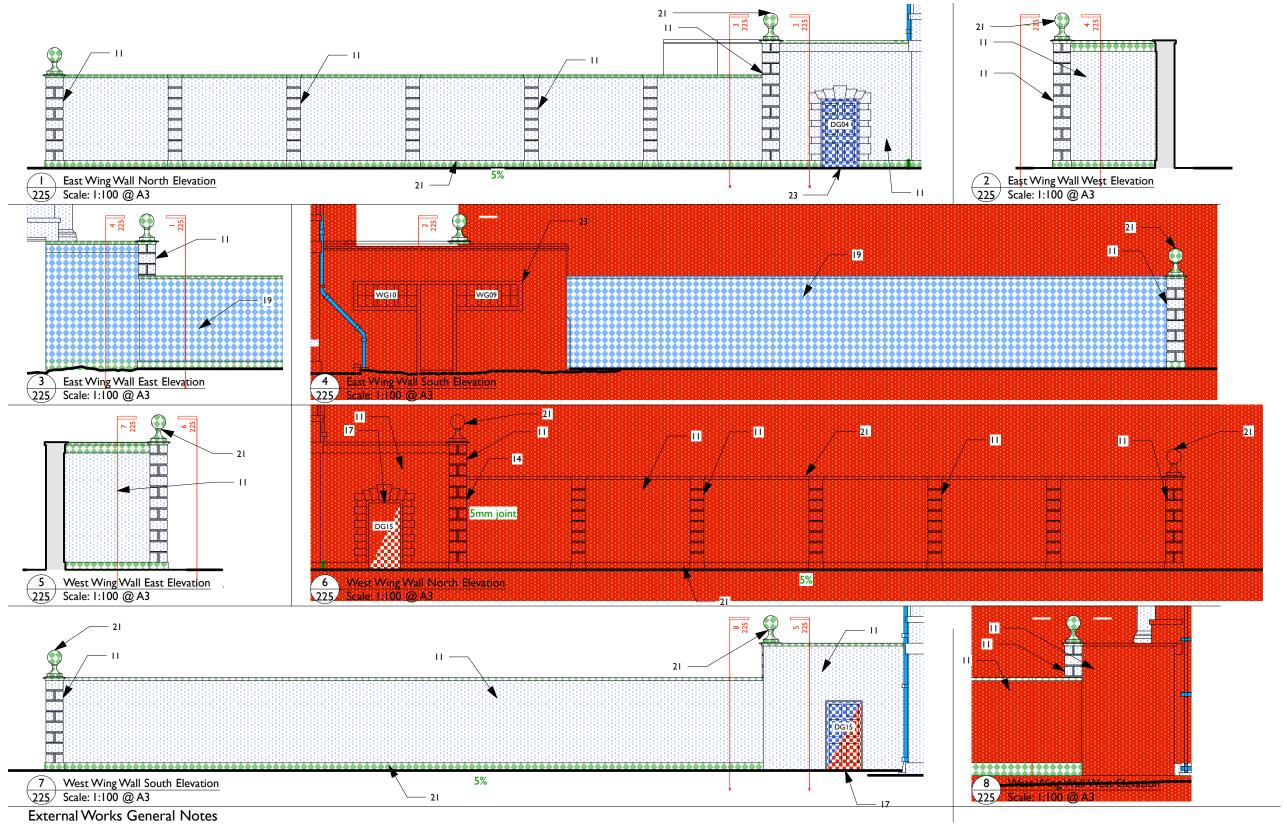
11. Existing cementitious render including Architectural features, remove paint where it has failed to

14. Repoint open crack between the western wing wall and nib wall with lime mortar refer to

drawing for crack details

17. Replace the lower portion of door; this will include the bottom rail and the lower 400 mm of the

allow the existing 'alkyd resin' masonry paint to be overpainted with new masonry paint. Prepare surface by rubbing back loose paint, filling any cracks with natural hydraulic lime mortar. Paint colour to match existing; British Standard BS 4800 '00 E 55 White'.

- 19. Rear of wing walls, these are pointed in a cement mortar, where cement is failed or loose remove cement pointing and repoint wall with lime putty mortar.
- 21. Repoint masonry plinth course and other Architectural features with lime putty mortar. Note percentages where provided.
- 23. Fully repaint all doors as indicated by hatch.
