Client:
St Mary's College
Project:
Walpole House & The Chapel in the Woods
Waldegrave Road, Strawberry Hill, Twickenham TW1 4SX

Drawing Title:
Chapel in the Woods
Front or West Elevation
As existing
showing ferrous cramp mapping and defects.

Drawing No: **086/ 59**

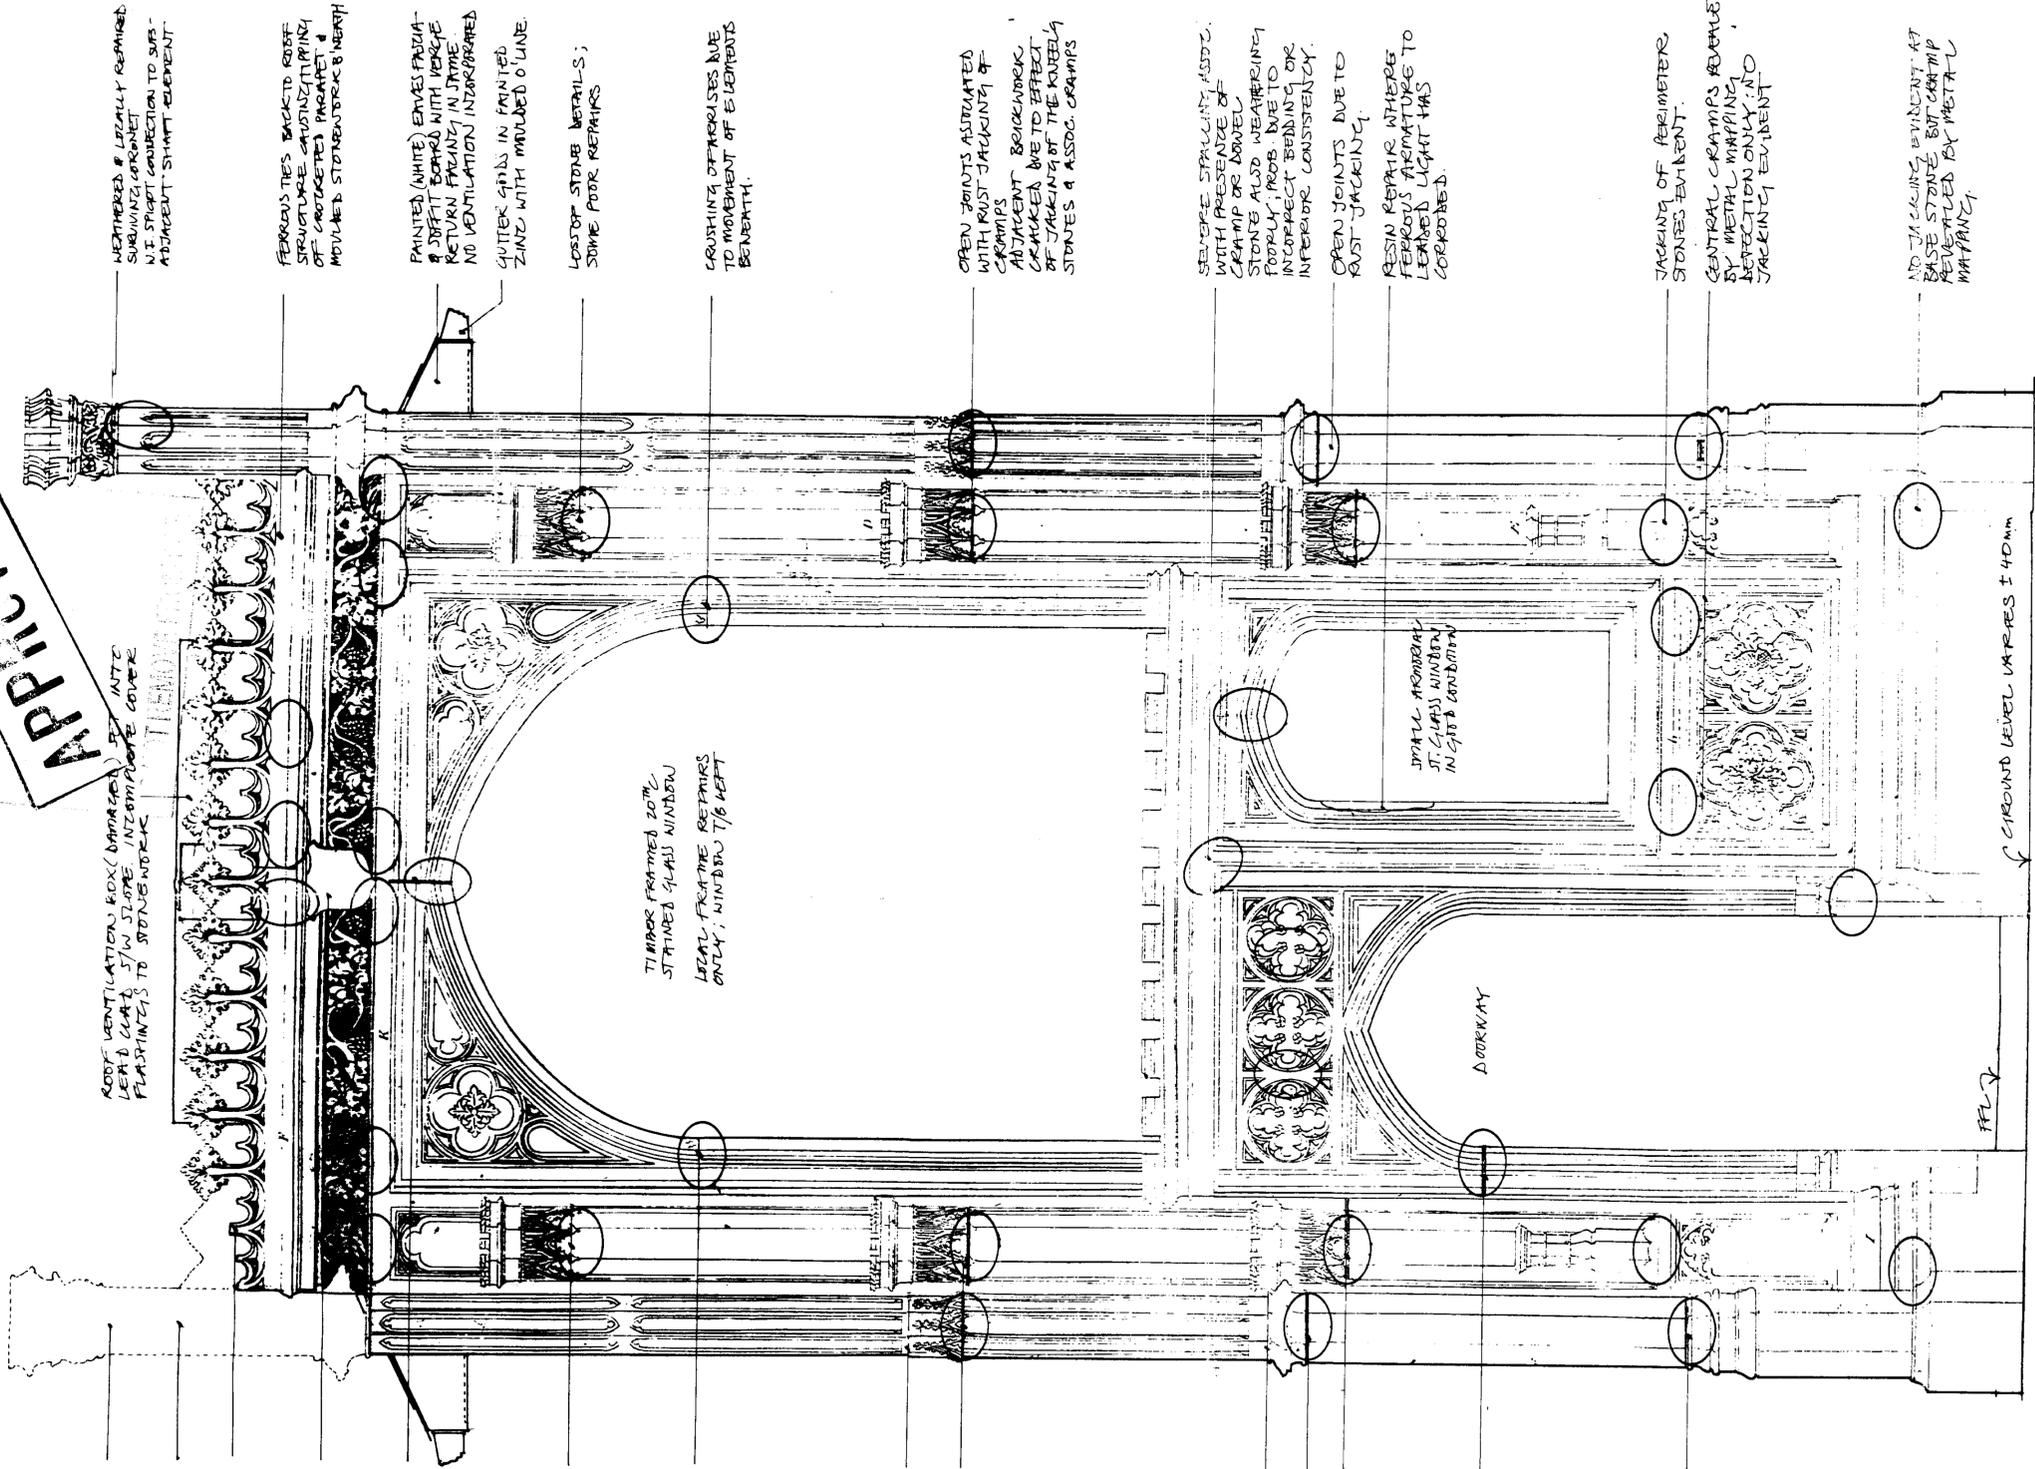
MISSING CORONET; PRESUMED LOST AFTER DAMAGE FROM ADJACENT WENTREE.
MISSING SHIRT ELEMENT, RECOVERED FROM STAFFE REEF IN IN MAINTENANCE STORE.
MISSING CROCINET FEATURES, PRESUMED ACUTELY WEATHERED AND POSSIBLY DAMAGED BY ADJACENT TREE.
HERALDIC ELEMENT WITH PEELING BLACK PAINT

APEX OF ARCH OPENED UP ASSOCIATED WITH OXIDISATION OF CRAMP IN JOINT + SPREAD

CREATED UP JOINT WITH SEVERELY WEATHERED CRAMP MISSING CARVED FEATURES

JOINT CRUSHING DUE TO JACKING FROM BELOW ARCHES DAMAGED

TOP OF "KNEELING STONE" INTO 18K WTR BEHIND

ACUTE OXIDISATION JACKING EVIDENT LOSS OF CARVED FEATURES ALSO JACKING OF BK WTR BEHIND ASSOCIATED WITH FERROUS TIES EXISTING

ACUTE OXIDISATION JACKING; RUSTING CRAMP VISIBLE IN JOINTS

ACUTE JACKING ASSOCIATED WITH JOOR SHOT CRAMP OXIDISATION

JOINTS EXHIBITING RUST JACKING

ROOF VENTILATION BOX (DAMAGED) SET INTO LEAD & GUTS WITH STONE INFILTRATION COVER FLASHINGS TO STONEWORK

CIRCUIT LEVEL VARIES ± 40mm

WEATHERED & LOCALLY REMOVED SURVIVING CORONET N.E. SHIRT CONNECTION TO SUR-ADJACENT SHIRT ELEMENT

FERROUS TIES BACK TO ROOF STRUCTURE ANCHORING TO CONCRETE PARAPET & MODULOR STONEWORK BEHIND

PAINTED (WHITE) EAVES FLASHING & JOINT BOARD WITH VERTICAL RETURN FLASHING IN FRAME. NO VENTILATION INTEGRATED

CUTTER GRIDS IN PAINTED ZINC WITH MODULOR O LINE. LOSS OF STONE DETAILS; SOME POOR REPAIRS

CRUSHING OF PARAPETS DUE TO MOVEMENT OF ELEMENTS BENEATH

OPEN JOINTS ASSOCIATED WITH RUST JACKING OF CRAMP AT JOINTS BEHIND. CRACKS ARE TO EFFECT OF JACKING OF THE KNEELING STONES & ASSOC. CRAMP

SEVERE SPALLING ASSOC. WITH PRESENCE OF CRAMP OR MODULOR STONE ALSO WEATHERING FOOTING; PROB. DUE TO IMPROPER BONDING OR INTERIOR CONSISTENCY. OPEN JOINTS DUE TO RUST JACKING

RESIN REPAIR ATHERE FERROUS ATHERATURE TO LEARNED LIGHT HAS CORRODED

JACKING OF PERIMETERS STONES EVIDENT

CENTRAL CRAMP REVEALED BY METAL MAPPING. DETECTION ONLY. NO JACKING EVIDENT

NO JACKING EVIDENT AT BASE STONE BUT CRAMP REVEALED BY METAL MAPPING
