tree:fabrik/ar/tf913/01

14th July 2017

LATCHMERE HOUSE, RICHMOND SYCAMORE – T65

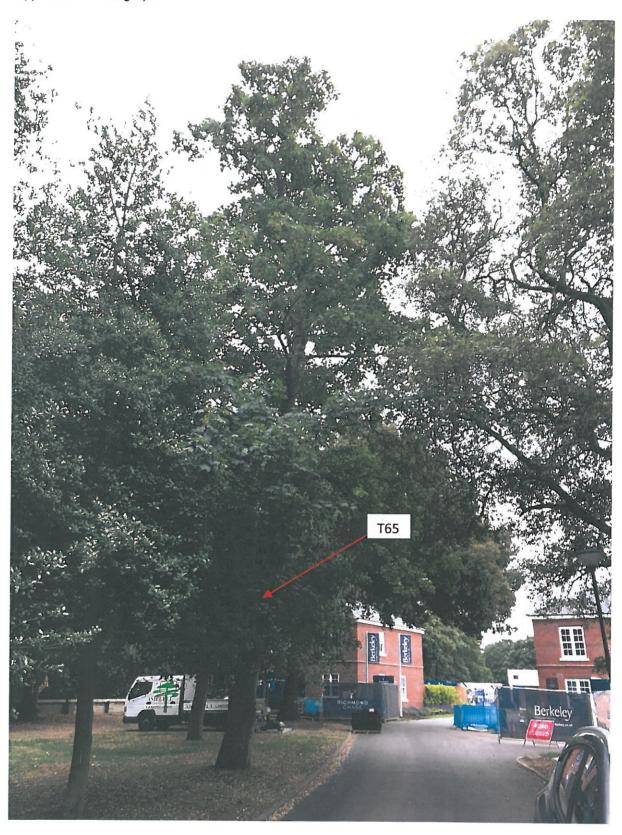
Sycamore T65

The mature tree, approximately 17m in height, is located to the north of Latchmere Close and set approximately 1.5m from the kerbline. The tree is formed of a single trunk supporting a full crown of 8m radius.

Outwardly, the tree appears to be of fair health with minor upper crown die-back and occasional squirrel damage on lateral branches. However, on detailed inspection fungi is noted at the base of the tree between the buttress roots at the south east and northeast cardinal points. The fungi is identified as perfect stage **Kretzschmaria deusta**.

commencement of highway works and increased target risk, I recommend that the tree be felled to

ground level and the stump ground out at the earliest opportunity and within three months of this

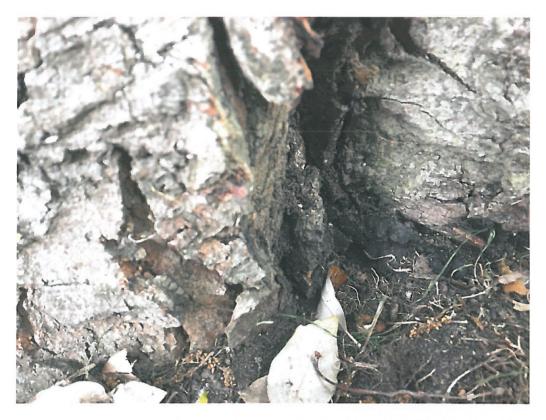
This fungi causes decay that compromises the structural integrity of the wood leading to brittle fracture. The importance of this fungi is that the tree displays no other indications prior to fracture.

Sycamore T65 Detailed view of fungi Kretzschmaria deusta (southeast of trunk)

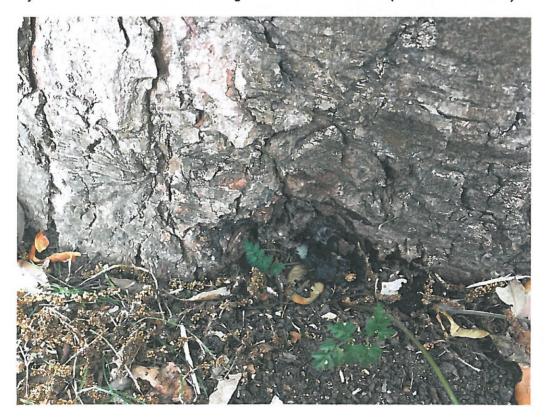
Sycamore T65 Detailed view of fungi Kretzschmaria deusta (northeast of trunk)
