tree:fabrik/ar/tf913/03

7th December 2017

**LATCHMERE HOUSE, RICHMOND**  
**False Acacia (G122)**

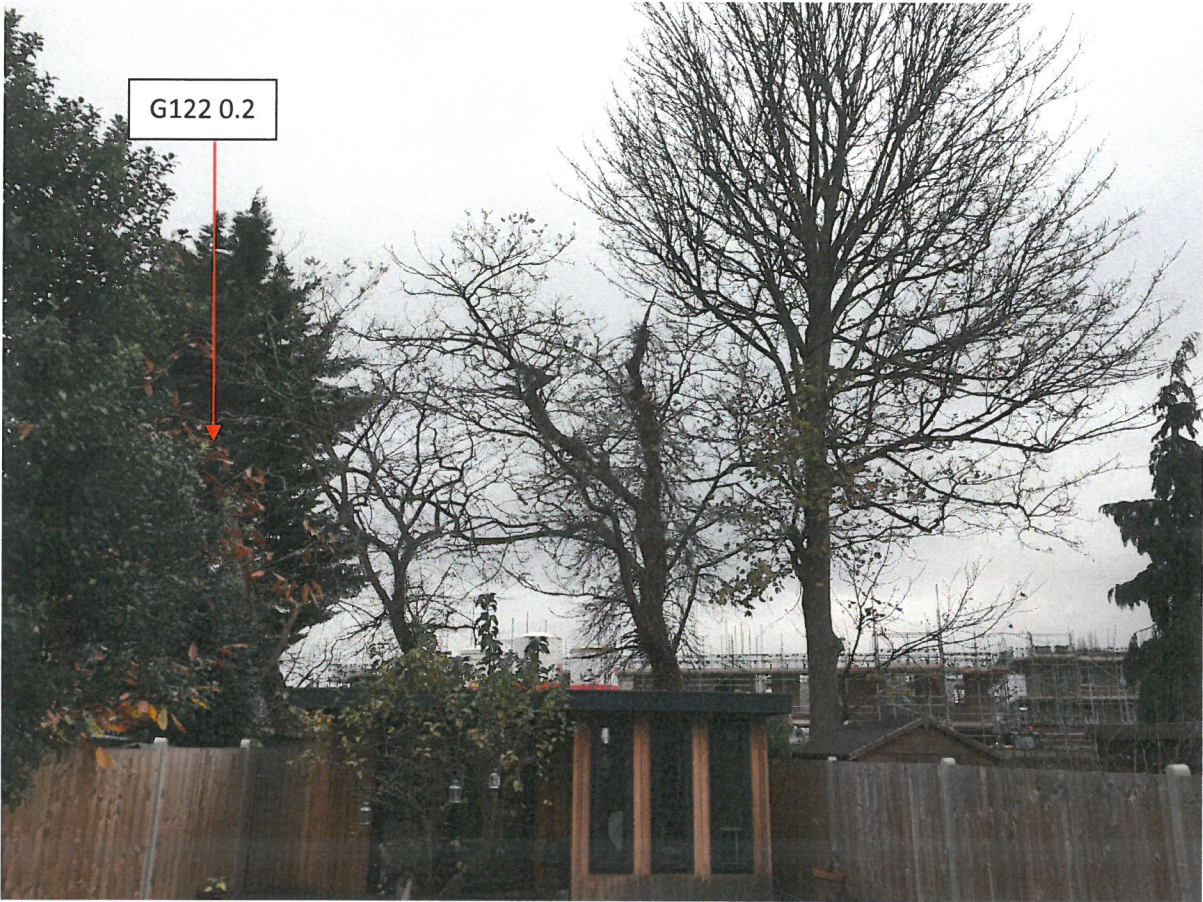
Photo 1 View of False Acacia from No.1 Garth Close

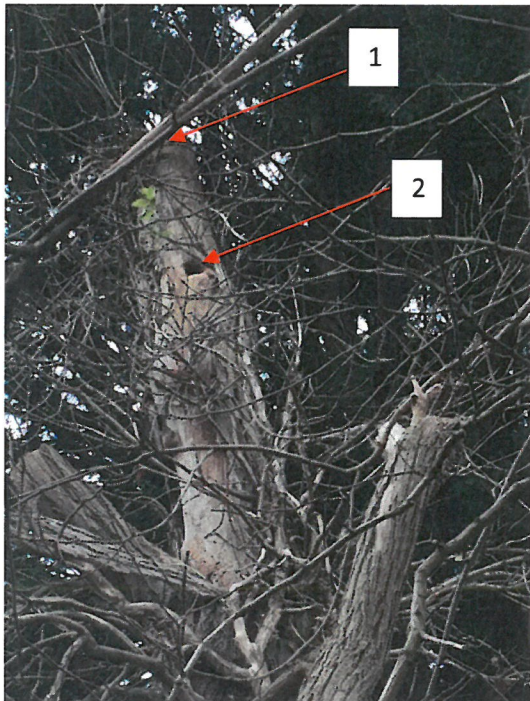
G122 0.1 - The tree is approximately 6m in height and displays dysfunctional wood extending up the main trunk from ground level. The crown has previously been subject to significant crown reduction forming truncated stems and displays poor crown architecture. At approximately 5m above ground level a nest hole is present on the eastern side indicating a decay within the trunk and possibly hollowing.

In conclusion, the tree is outwardly of poor quality and in terminal decline. Significant decay is likely to be present within the truncated stems and branches weakly attached. The tree therefore has high potential for failure within an amenity garden.

Photo 2 G122 0.1 arrow 1 – truncated stems, arrow 2 – potential nest hole

- Fell to ground level, grind out core of stump to detach roots and provide replacement planting.  
or
- Carryout climbing inspection to ascertain extent of decay and defects within upper crown. Provide recommendations as to feasibility of retention and extent of crown reduction required to retain tree as a potential standing habitat.
