tree:fabrik/ar/tf913/01

7th December 2017

LATCHMERE HOUSE, RICHMOND
False Acacia (G122)

Appendix 1 Photographs

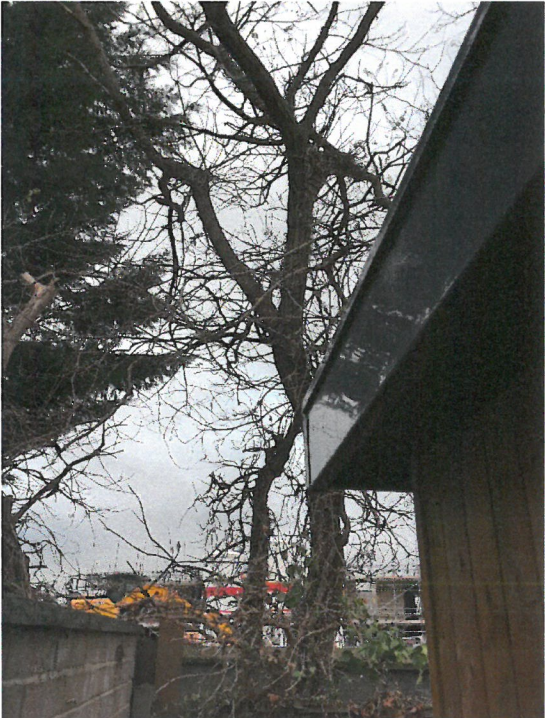
basal, lower or upper trunk. The crown displays previous crown reduction (shortening of lateral branches) with scattered deadwood distributed throughout the crown. The tree was previously heavily ivy clad and following severance of the ivy stems now forms a fragile skeleton of deadwood around the trunk.

In conclusion, the tree is outwardly of fair health and provides some screening to the development beyond. However, there is potential for failure of dead branches and debris from the severed ivy and this should be removed as part of good arboricultural management.

Photo 2 G122 0.02 Scattered deadwood & dead ivy

- Remove dead ivy.
- Remove major deadwood (>25mm diameter)
- Tip reduce by 3m to provide an average crown spread of 7m

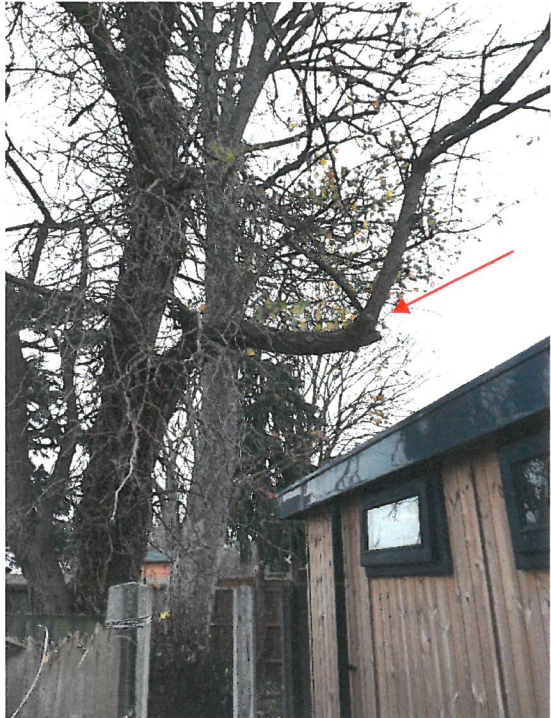
Photo 3 G122 0.03 displaying dog-legged branch following previous branch removal (indicate by arrow).

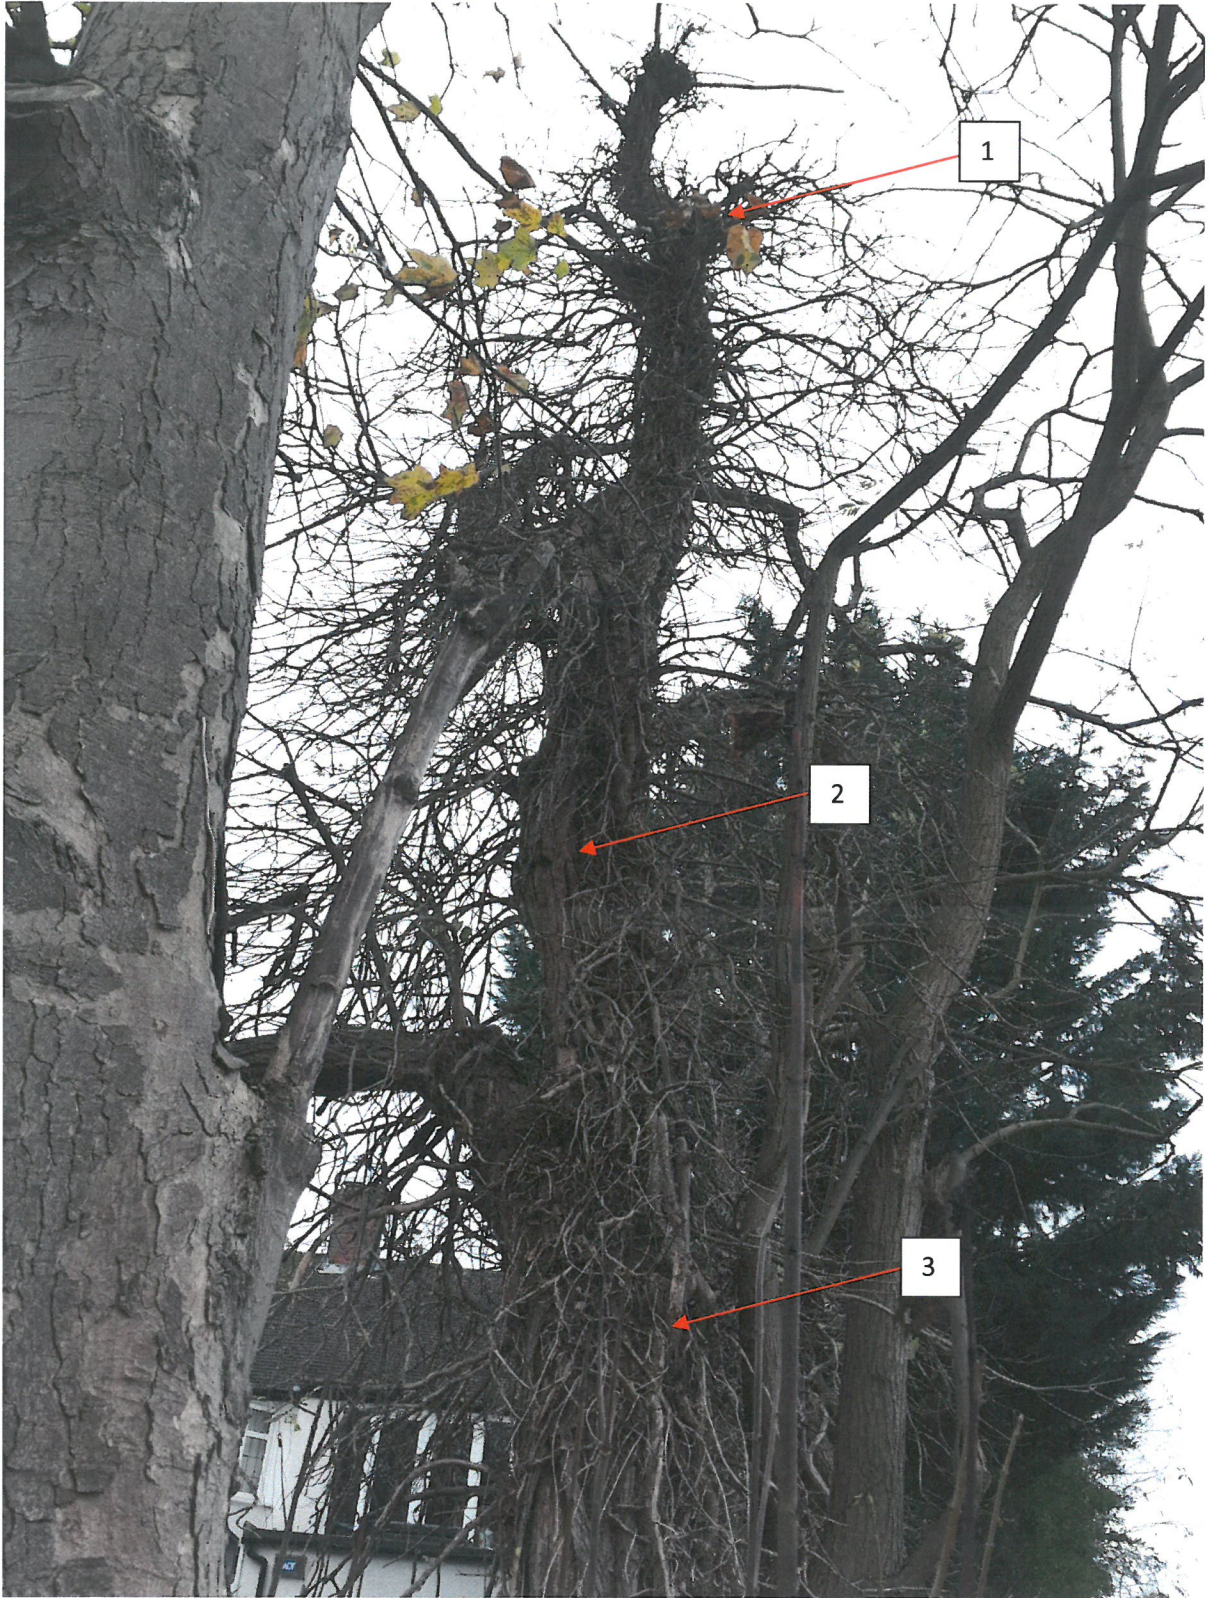
In conclusion, the tree is of poor structural condition and appears to be in gradual decline with significant trunk defects within the upper crown and deadwood. The tree therefore has a limited future life expectancy and potential for failure of the upper spire, dead branches and debris from the severed ivy. However, the tree provides some screening from the development beyond and therefore the feasibility of retention, atleast in the short term, could be explored subject to a climbing inspection to ascertain the extent of decay within the upper crown. Subject to this assessment, remedial works including reduction in height and volume to retain the tree should be considered against the impact on the trees visual amenity and its value for retention.

Photo 4 G122 0.3 arrow 1 - dead spire, arrow 2 – possible delamination of bark arrow 3 dead ivy

- Fell to ground level, grind out core of stump to detach roots and provide replacement planting.
or

- Carryout climbing inspection to ascertain extent of decay and defects within upper crown. Provide recommendations as to feasibility of retention and extent of crown reduction required to retain tree in short term.
