7th December 2017

LATCHMERE HOUSE, RICHMOND
Sycamore (T121) & Cypress

Appendix 1 Photographs

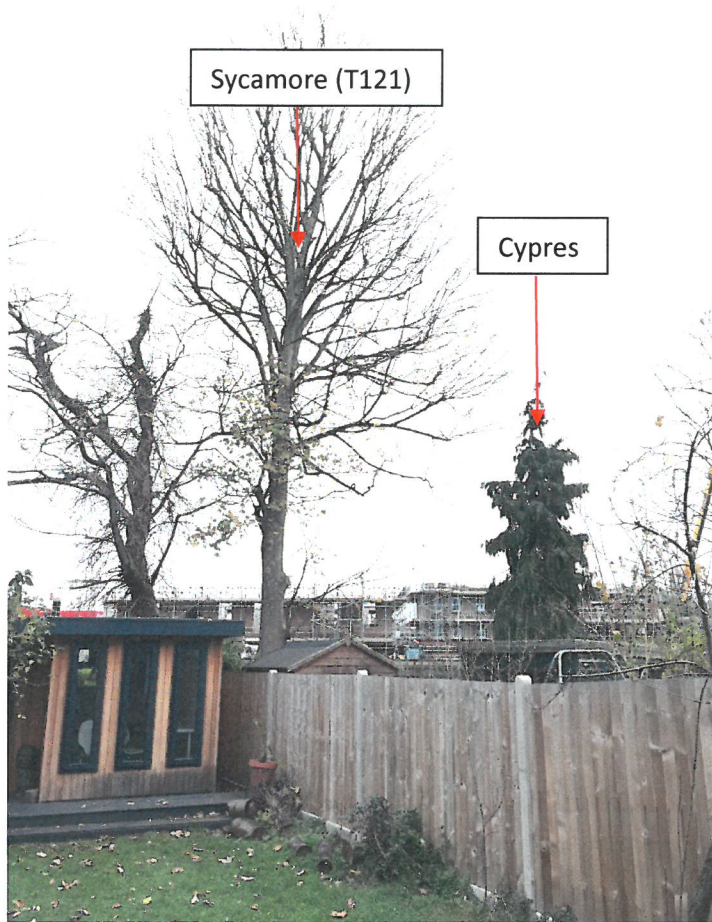
Photo 1 View from No.1 Garth Close

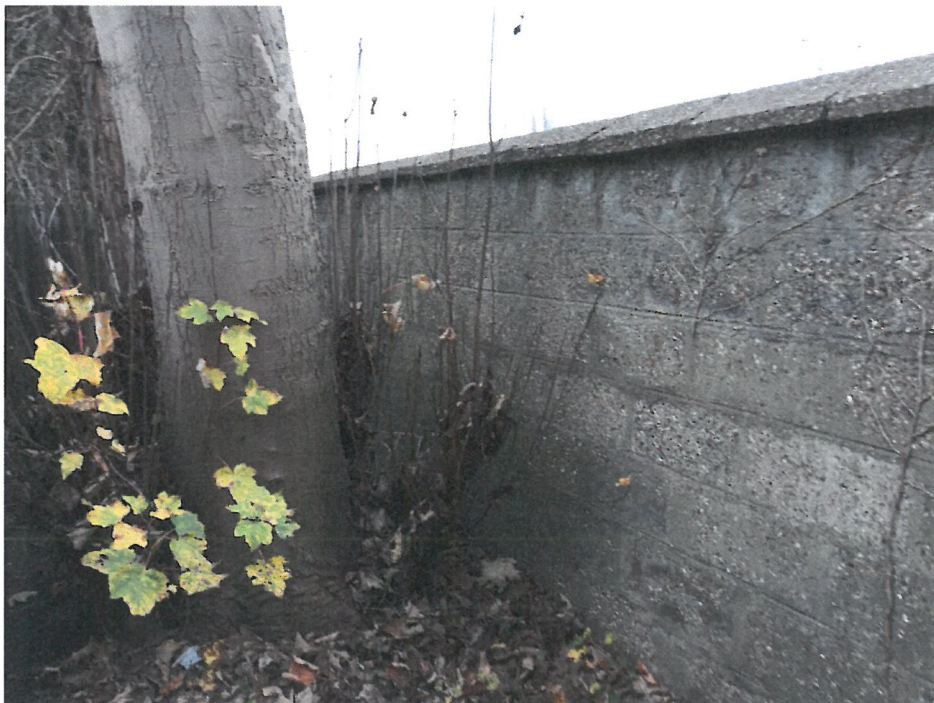
The tree is approximately 16m in height with a single trunk supporting a full crown of some 5m radius. From a visual inspection, the tree appears to be outwardly of fair health and condition with no visual evidence of root plate movement or significant visual defects or decay within the basal, lower or upper trunk.

Photo 2 Sycamore - View of base of trunk adjacent boundary wall and lower basal growth

- Remove basal growth.
- Remove epicormic growth up to 3m above ground level.

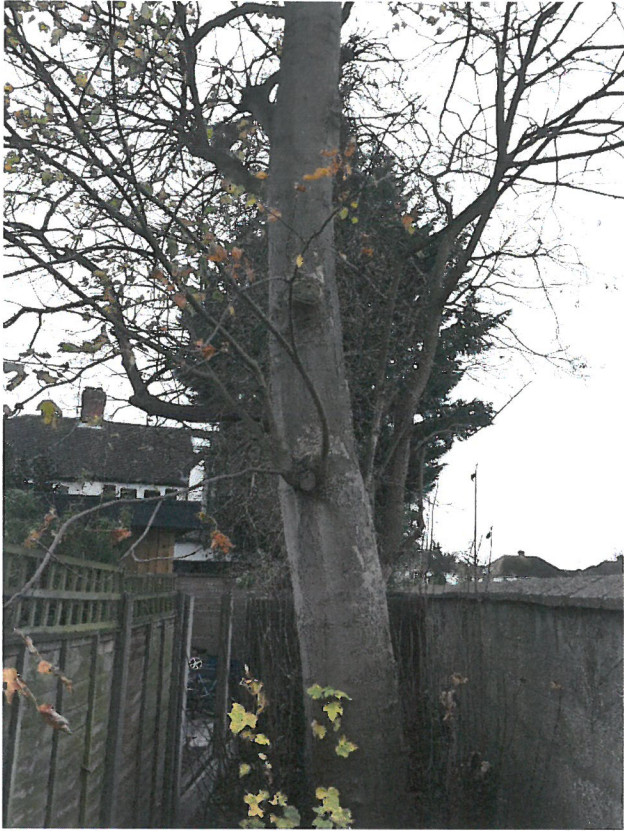
The tree displays good vigour and has been subject to previous management evidenced by lower branch wounds and previous crown reduction (shortening of lateral branches).

Photo 3 Sycamore – lower branch removal with subsequent epicormic growth

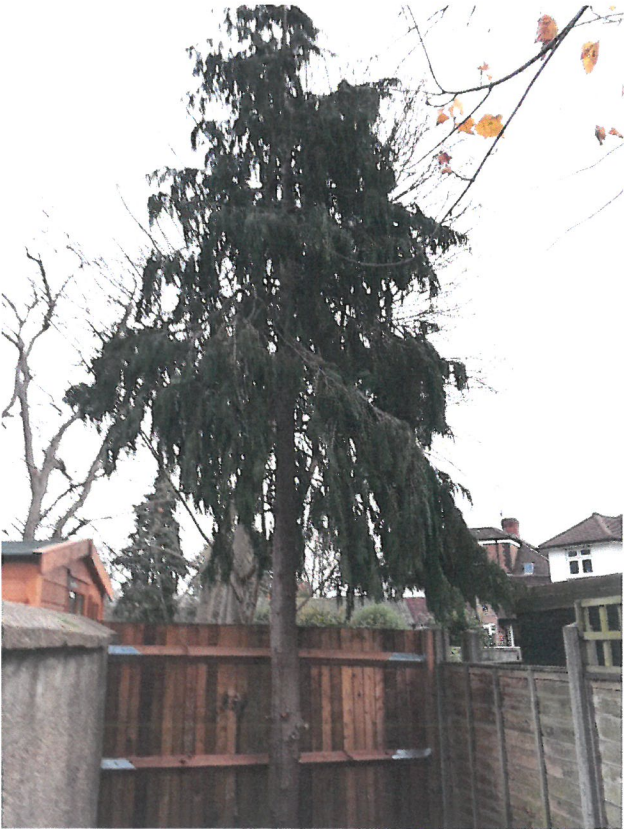
The semi-mature Cypress (*Chamaecyparis* spp) is located to the rear of No.3 Garth Close adjacent to the eastern fence and approximately 6m in height supporting a crown radius of 2m. The tree is located 1m from the boundary wall. The tree has been crown lifted through removal of the lower branches and whilst of fair health and condition is subservient to the Sycamore (T121).

Photo 4 Cypress – view of semi-mature Cypress

- No works recommended.
