**37 HAMILTON ROAD, TWICKENHAM**  
**For: Hamilton Lofts Ltd.**

**REPORT REGARDING STRUCTURAL FEASIBILITY**  
**OF**  
**REFURBISHMENT OF EXISTING VICTORIAN BUILDING,S**  
**37 HAMILTON ROAD**  
**TWICKENHAM, TW2**

**MARCH 2005**

**JOB No 04086**

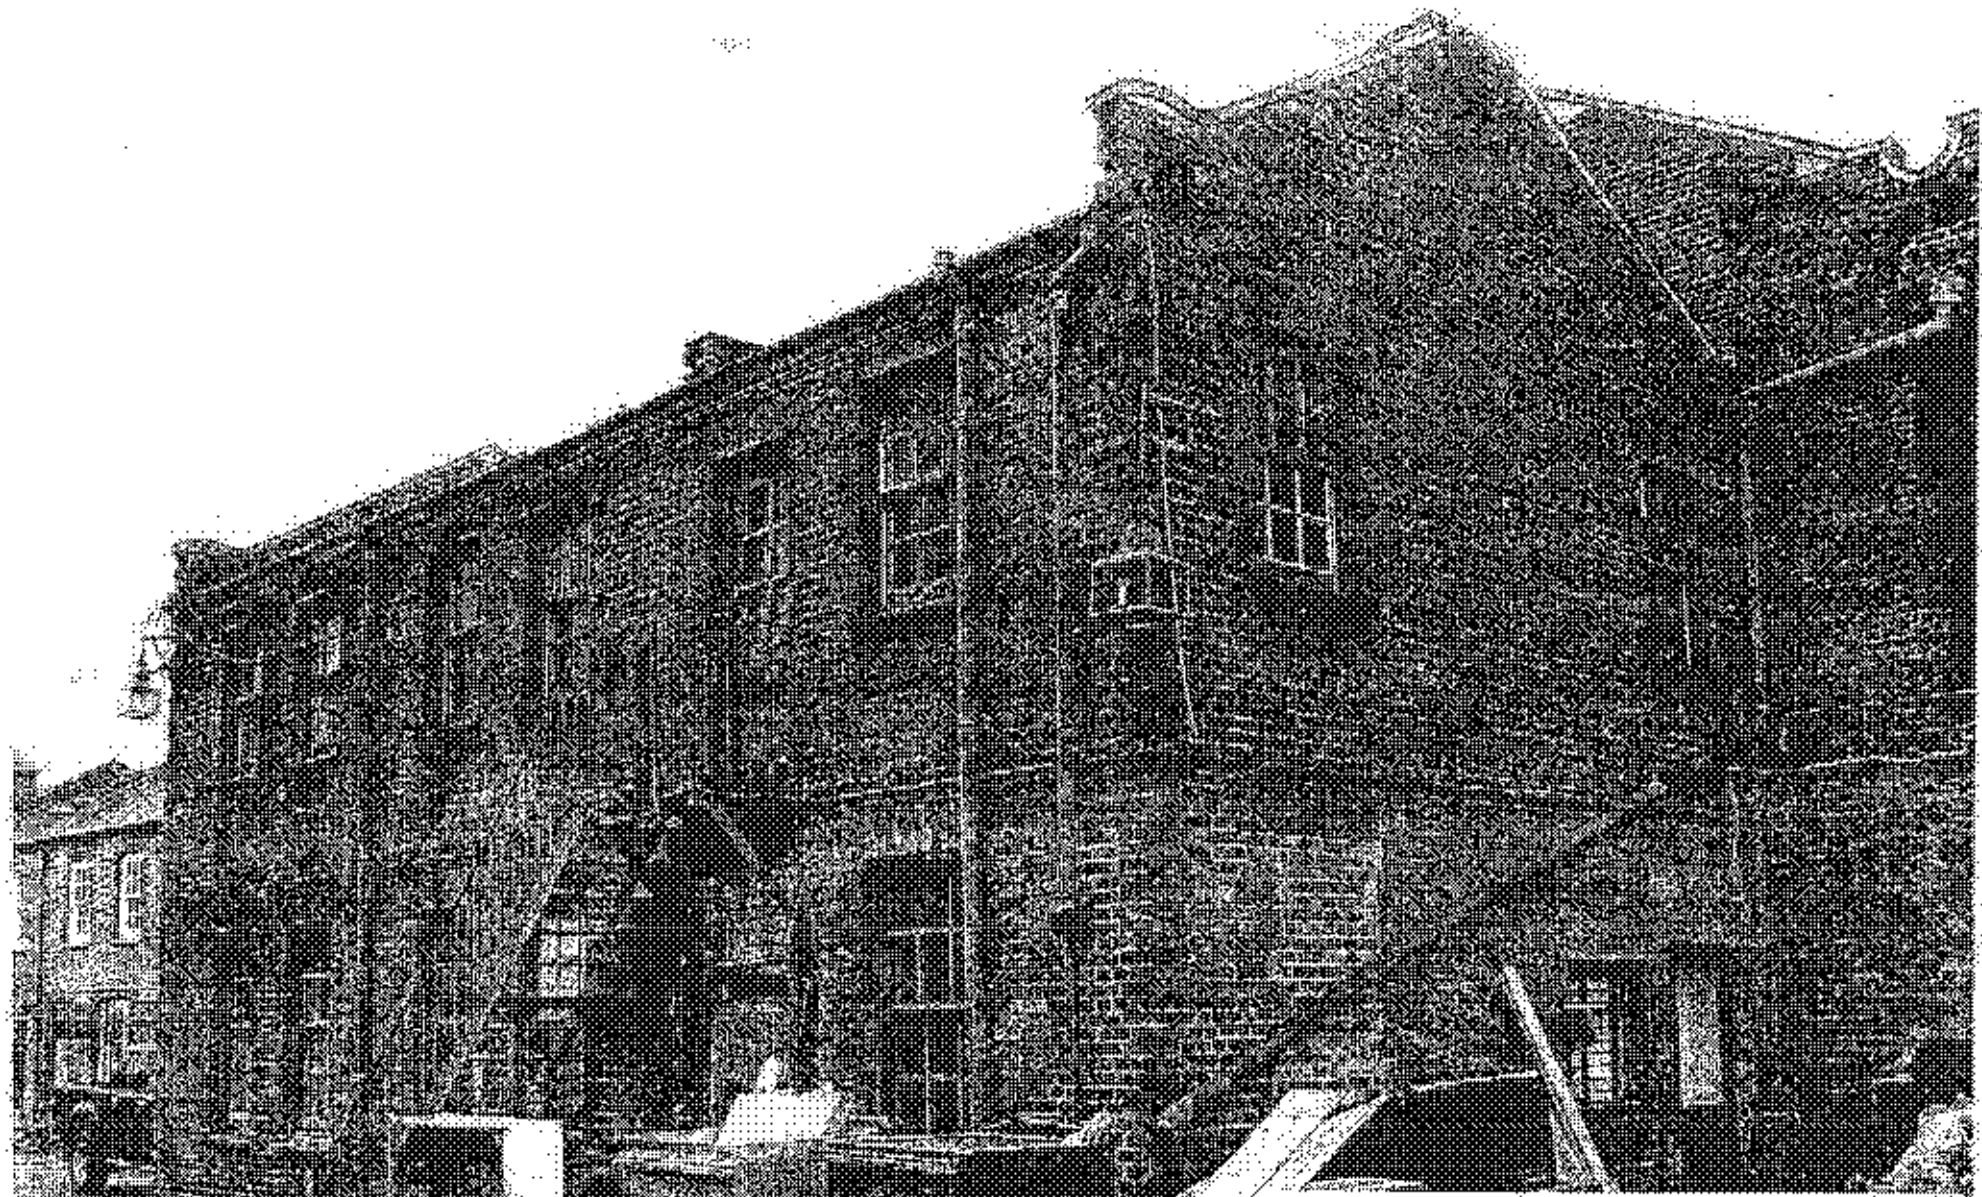
Plot 2

No significant signs of structural distress were noted to the fabric of building 1 externally.

Brickwork is generally in good order, with pointing generally reasonably maintained.

BUILDING 1

REAR VIEW

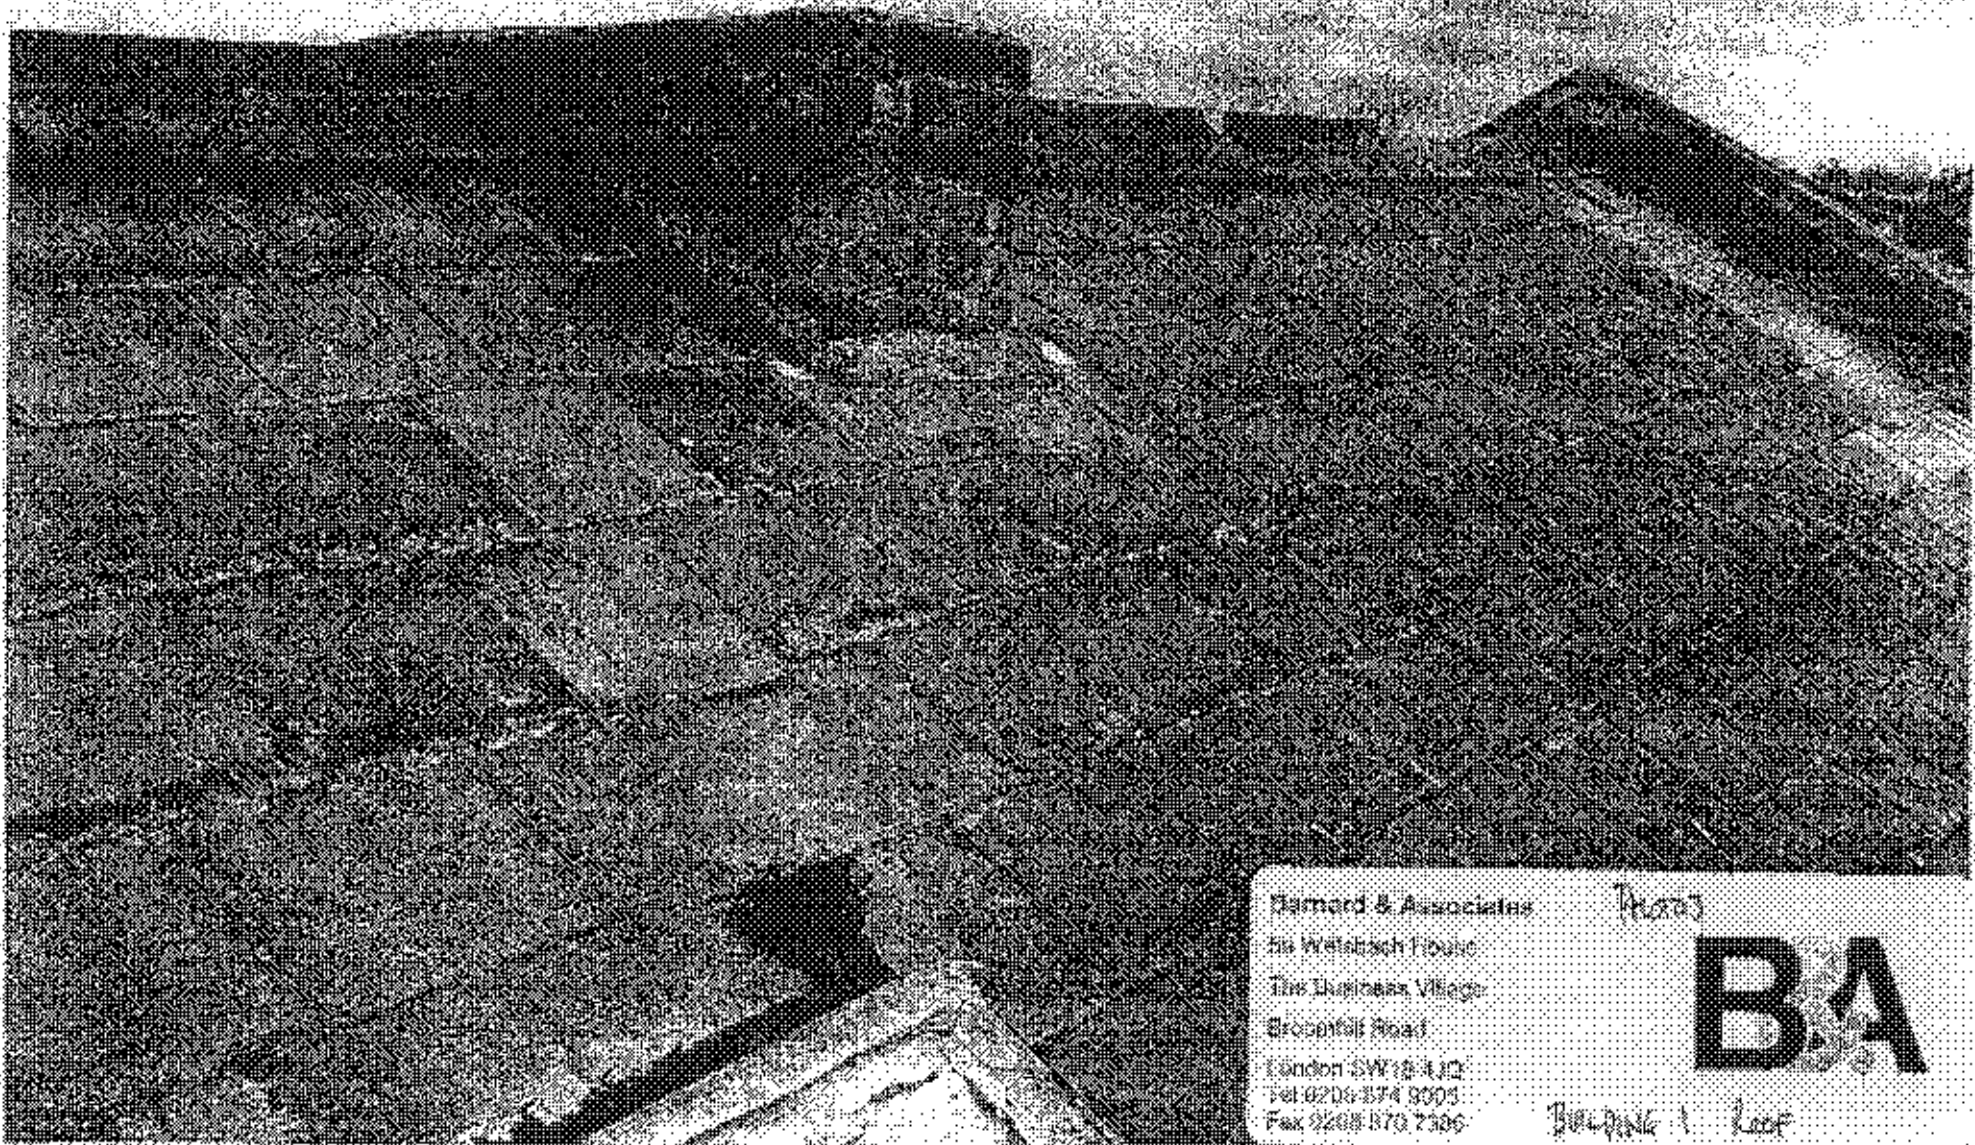
Photo 3

The pitched slated roof to the building is in good order as are the ridge tiles and gable eaves flashings (some flashings are of lead construction whilst others are of cement construction).

Building 1 Roof

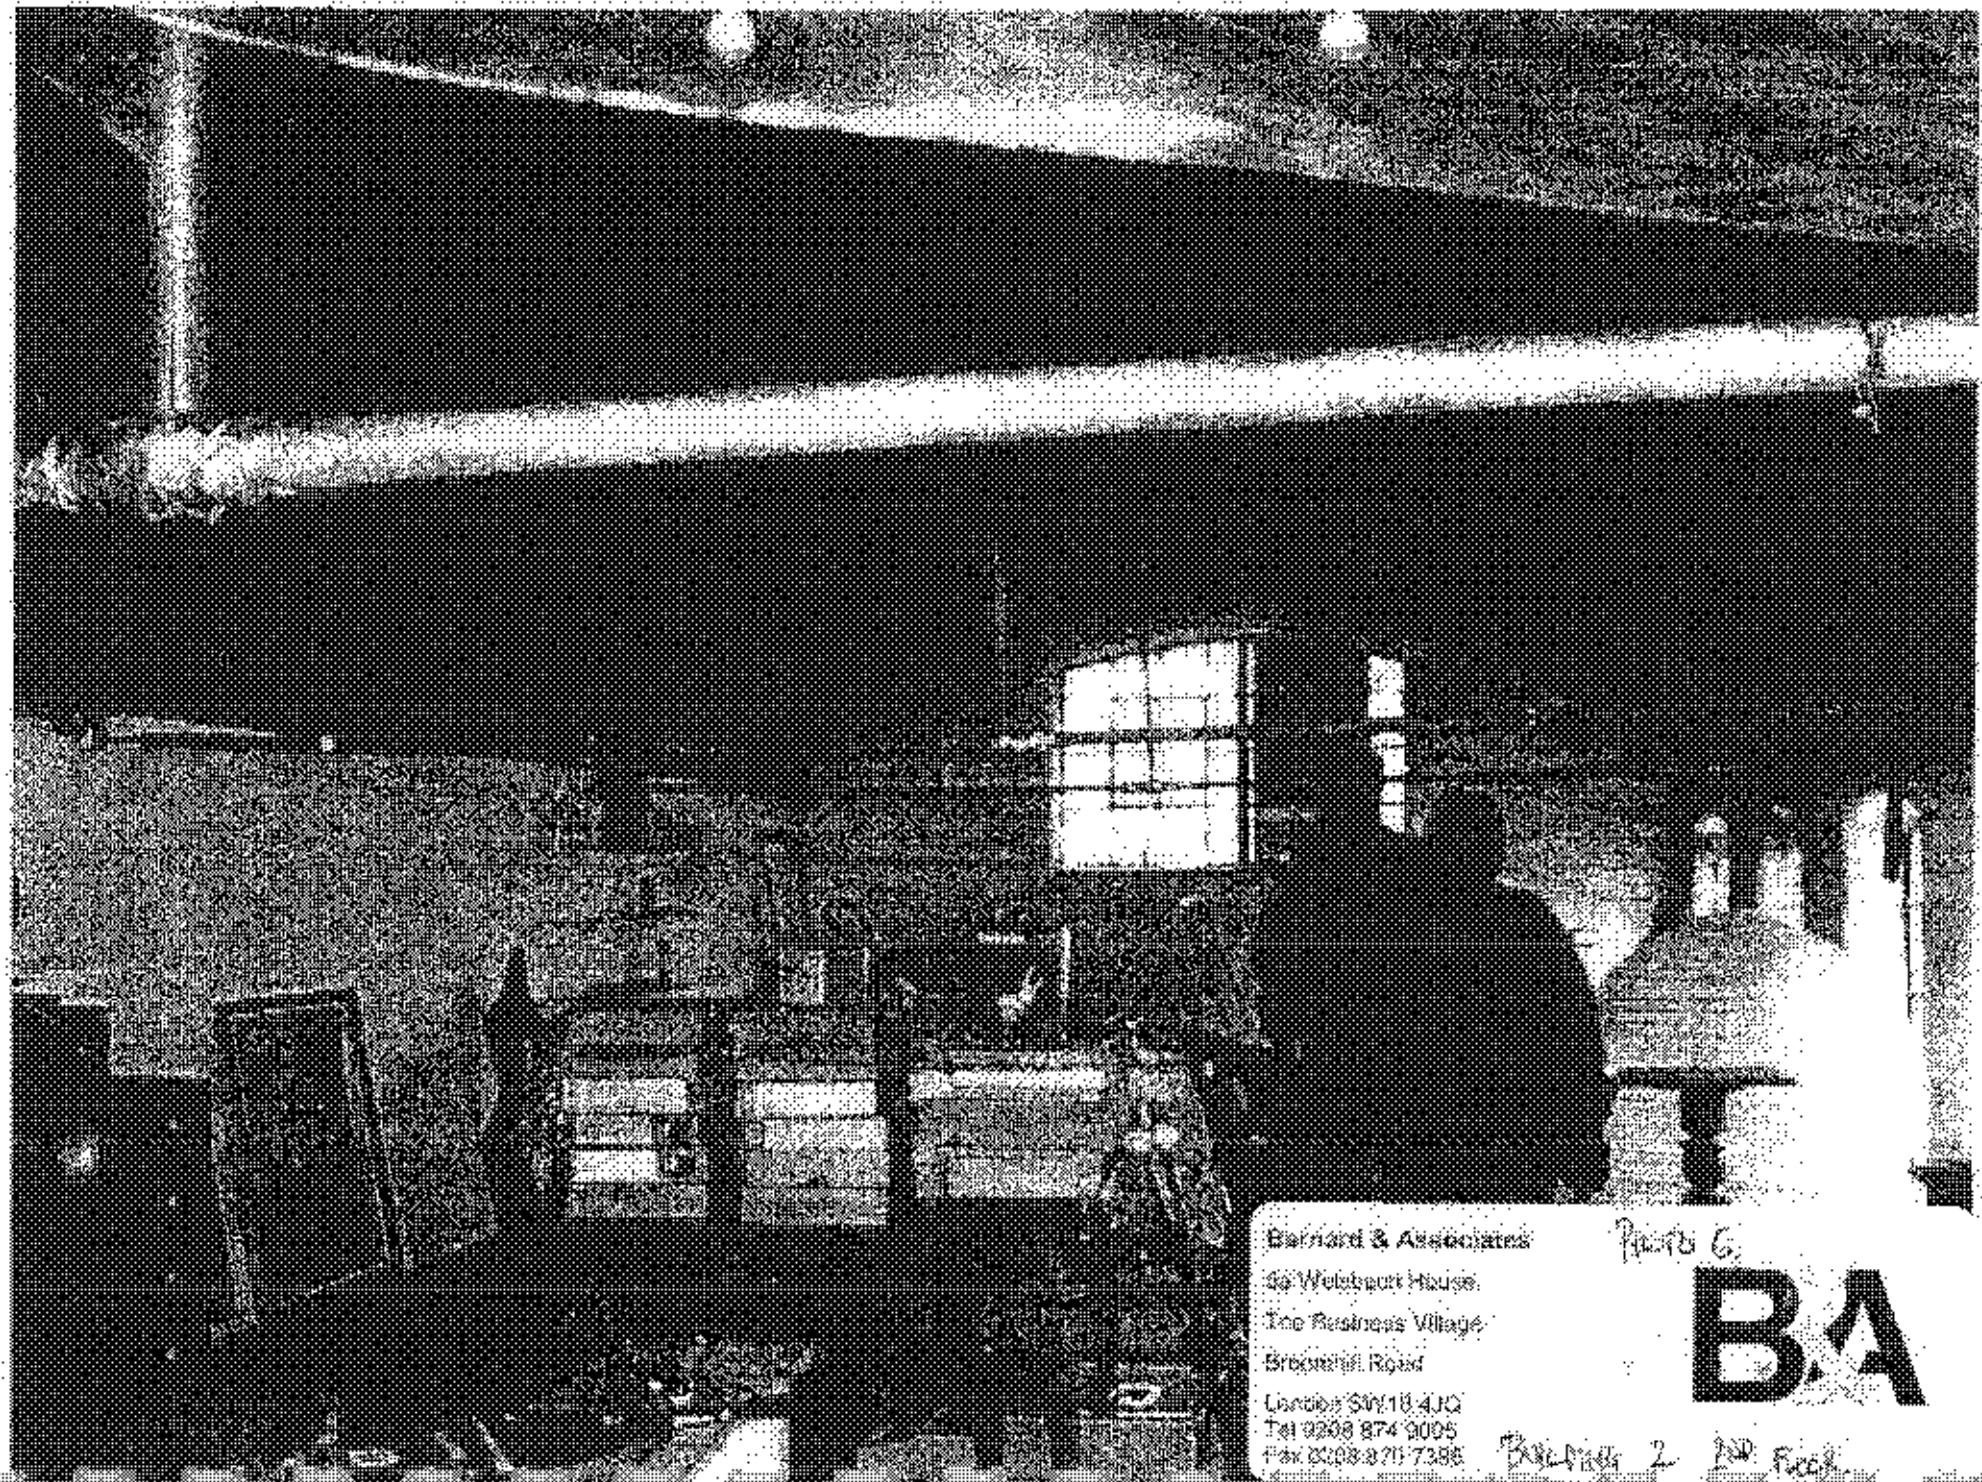
Photo 6

Within the existing building at second floor level, water was noted to be dripping into the second floor space via leaking parapet gutters.

The existing second floor structure consists of a series of steel beams spanning from front to rear of the building, over which have been laid floor joists on their side axes.

The floors are very springy under foot even when simply walking across the floor.

The floors have negligible load carrying capacity and are not capable of supporting domestic superimposed loads.

The existing second floor structure is unsound and unsafe.

Ballroom 2 2nd Floor

The existing second floor structure would need to be replaced in its entirety to accommodate residential superimposed loads.

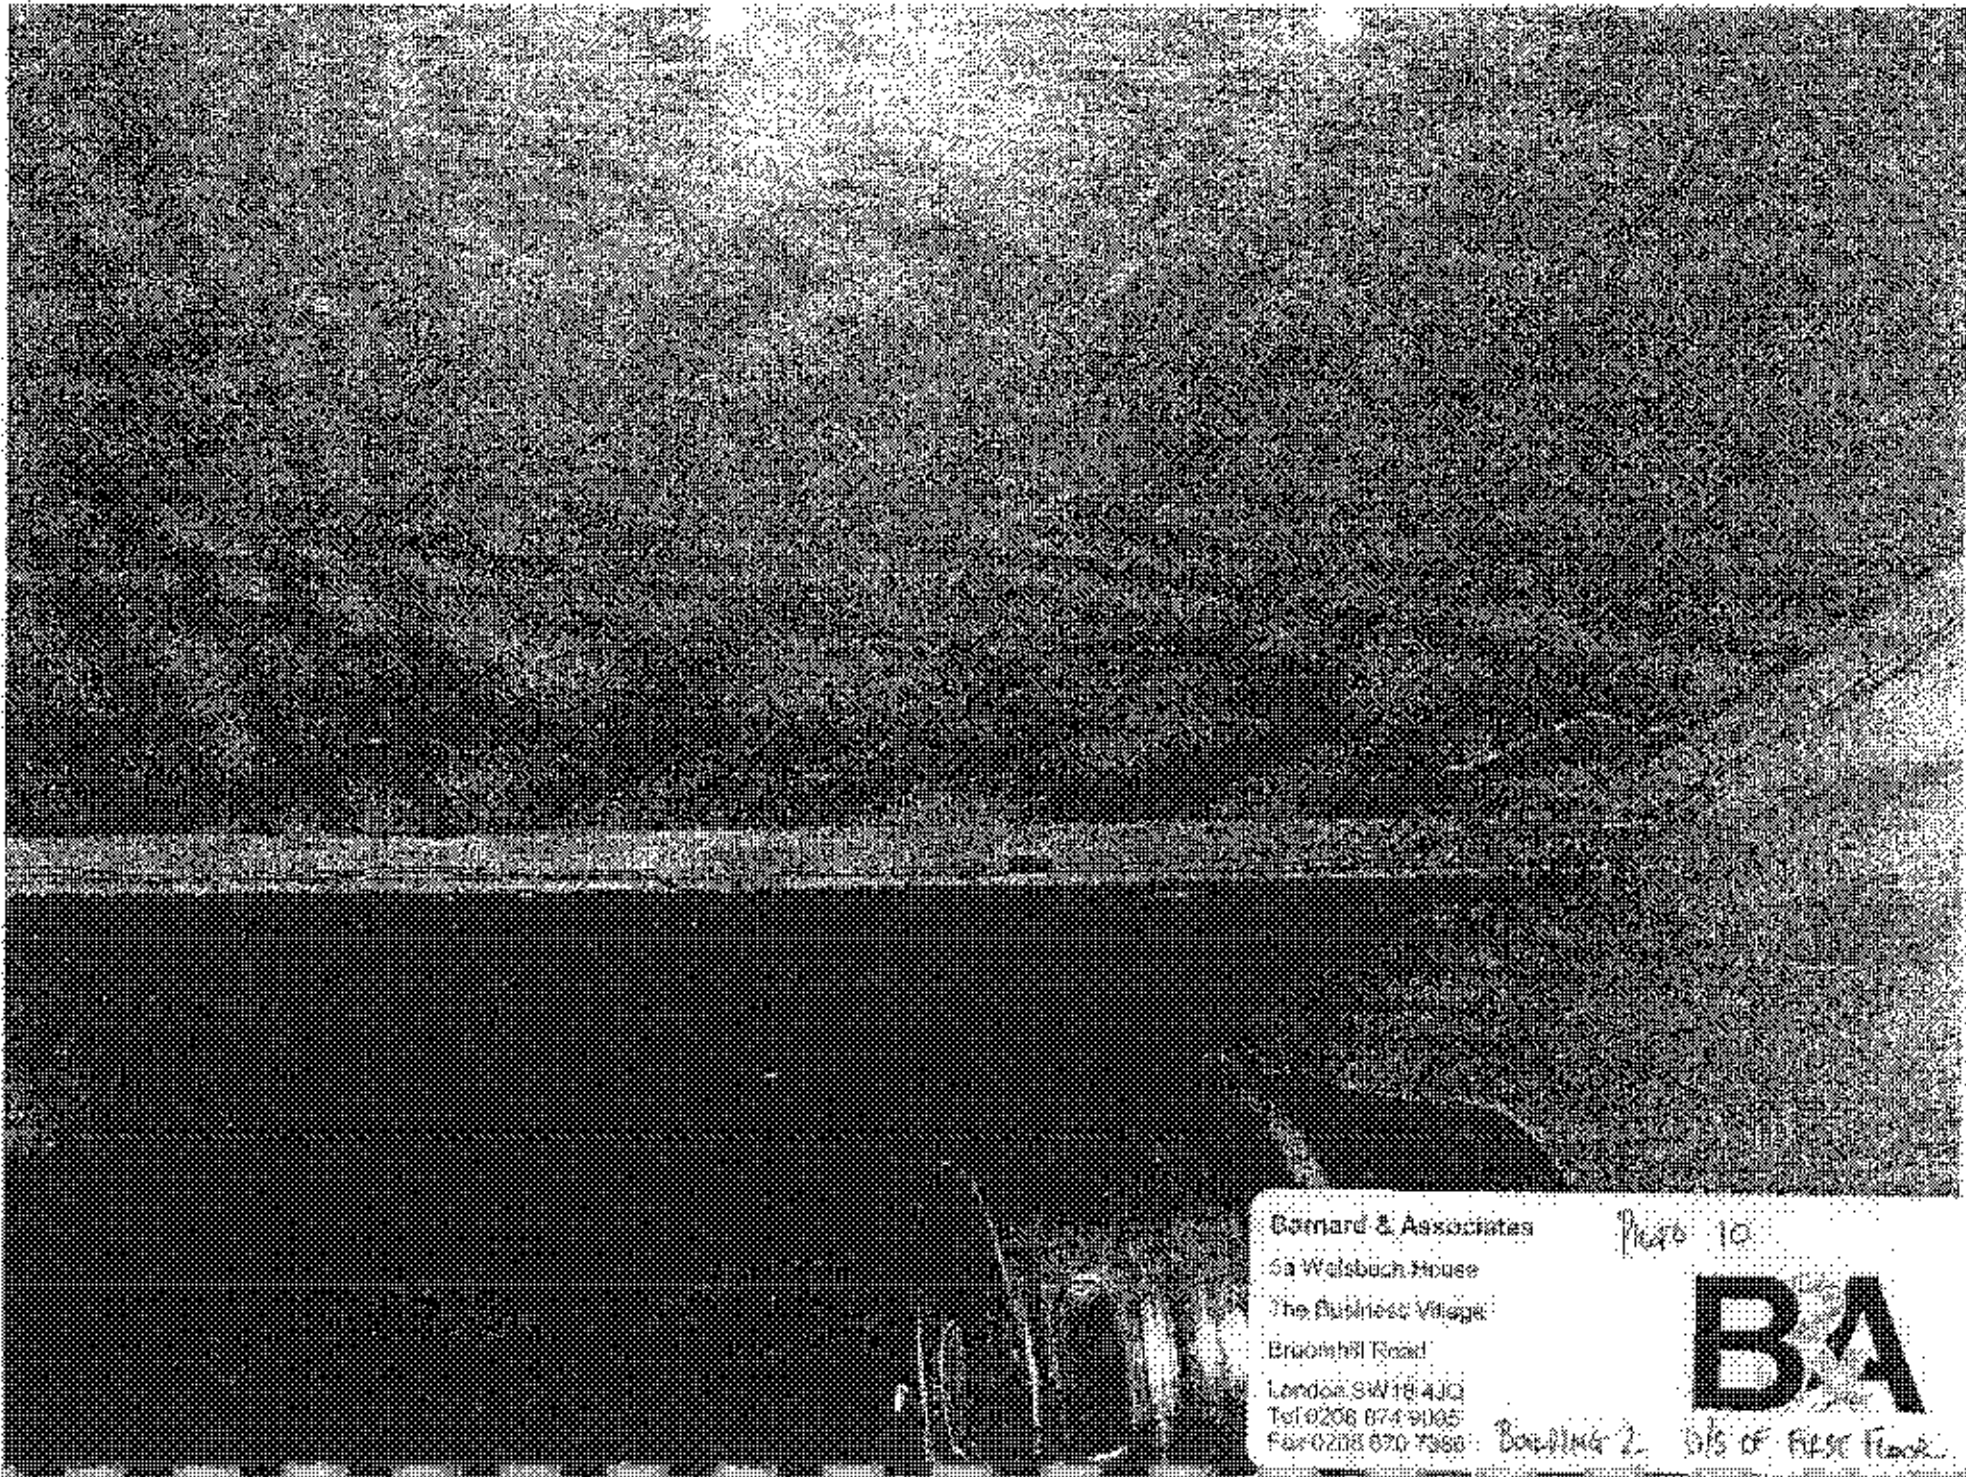
Photo 2

The internal face of the masonry wall is affected by moisture ingress with severe exfoliation of brickwork noted around window reveals

Building 2 INSIDE WORKS

in walls, EXFOLIATION OF BRICKS
