**STRUCTURAL REPORT ON EXISTING POLICE STATION**

**Station Road  
Hampton**

**CWA/19/207**

**August 2019**

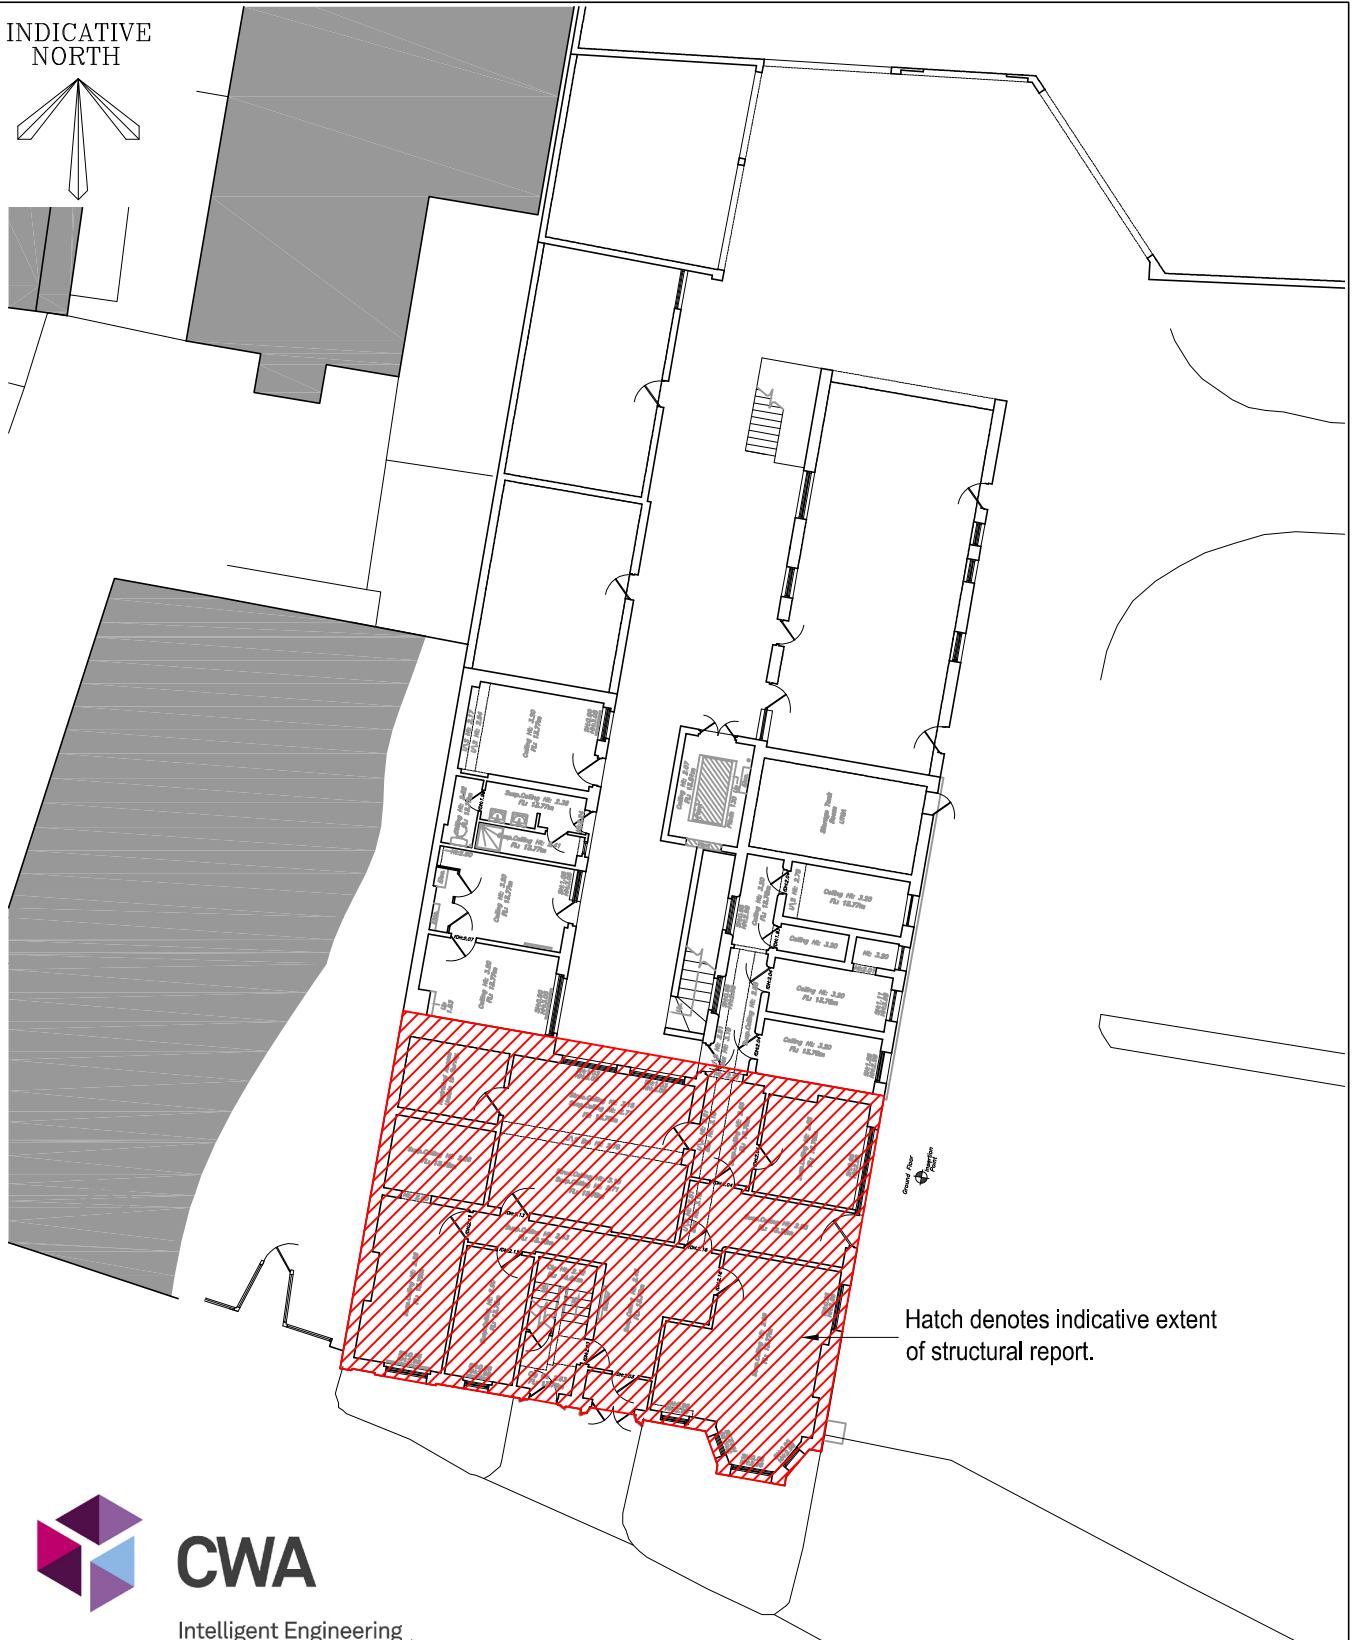
Plan Illustrating Extent of  
Structural Report

Hatch denotes indicative extent  
of structural report.

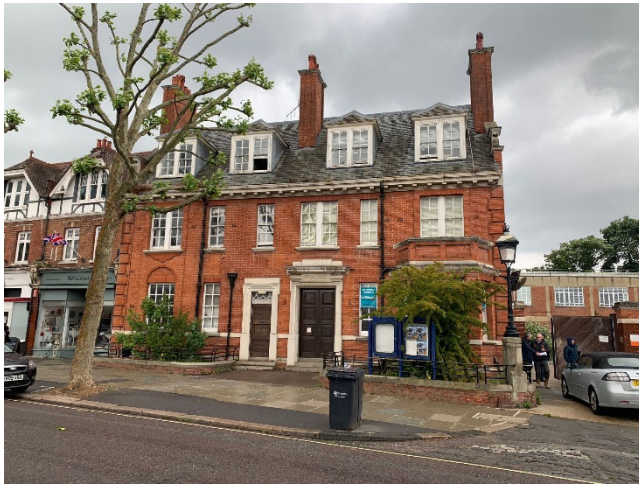
- 3.01.01.01 No structural defects of note were observed to the front elevation, with all brickwork in reasonable condition and roof lines appearing true. The requirement for minor repointing was noted in areas adjacent the main entrance door and blowing of brickwork faces was observed to the head of the bay window.

1. Front elevation

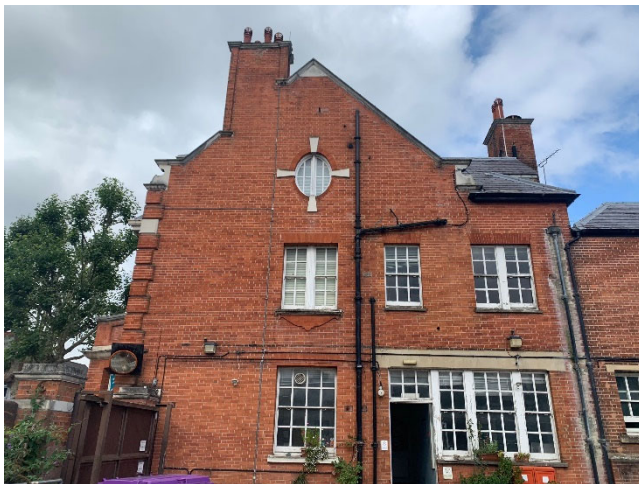
- 3.01.02.01 No structural defects of note were observed to the side elevation, with all brickwork in reasonable condition and roof lines appearing true. Water staining was noted to some areas of masonry, which is likely due to faulty rainwater goods. Consideration should be given to the repair/replacement of rainwater goods to avoid acceleration of the weathering process.

4. Side elevation

- 4.05 In the short term we would recommend that all rainwater goods to the external elevations should be repaired or replaced to ensure no further deterioration of the outside facades occurs.

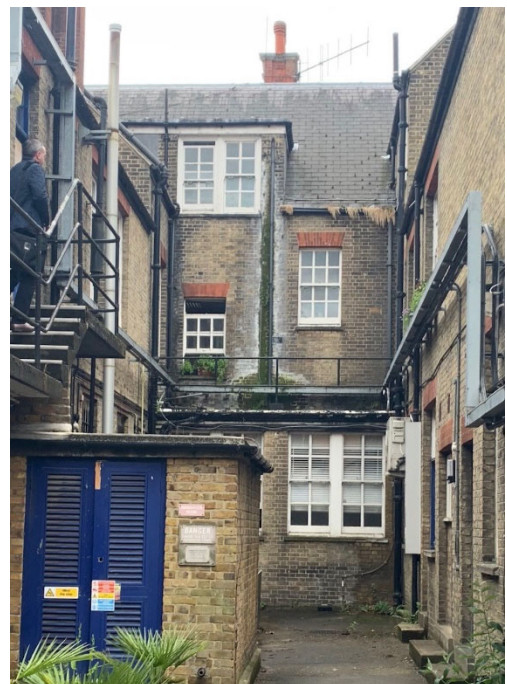
- 3.01.03.01 Given the two storey extensions only a small portion of the existing rear elevation is visible. While no structural defects were noted, water staining was observed to areas of masonry, which is likely due to faulty rainwater goods. Consideration should be given to the repair/replacement of rainwater goods to avoid acceleration of the weathering process.

3. Rear elevation

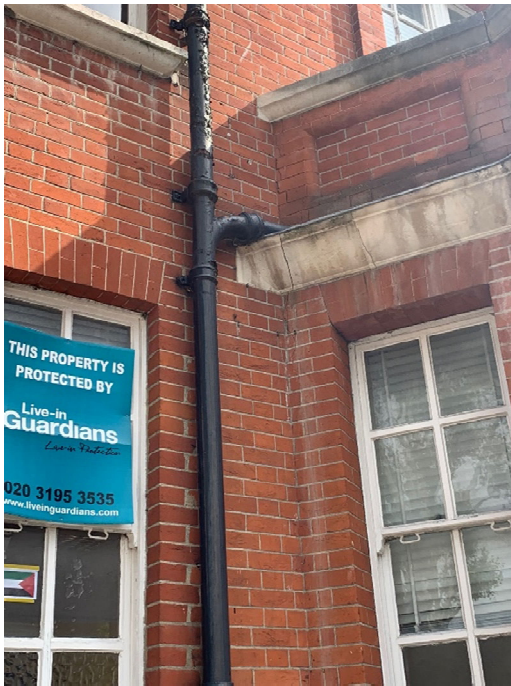
- 3.01.01.02 Vertical cracking to the masonry at the junction of the bay window and main walls was noted and whilst not structurally significant is likely to be the result of minor foundation movements of the bay construction.

6. Junction of main walls to bay window – front elevation

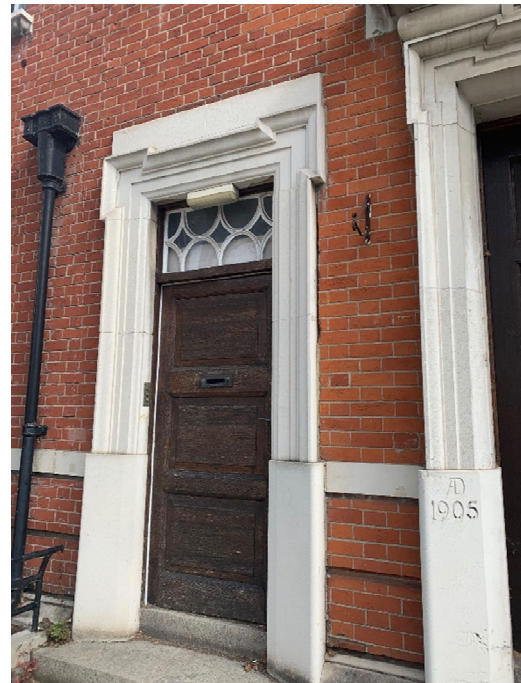
- 2.03.01 The building, constructed in 1905, (indicated on a flag stone adjacent the front entrance) is 3 storey with a pitched roof front to back.

5. Flagstone indicating date of construction

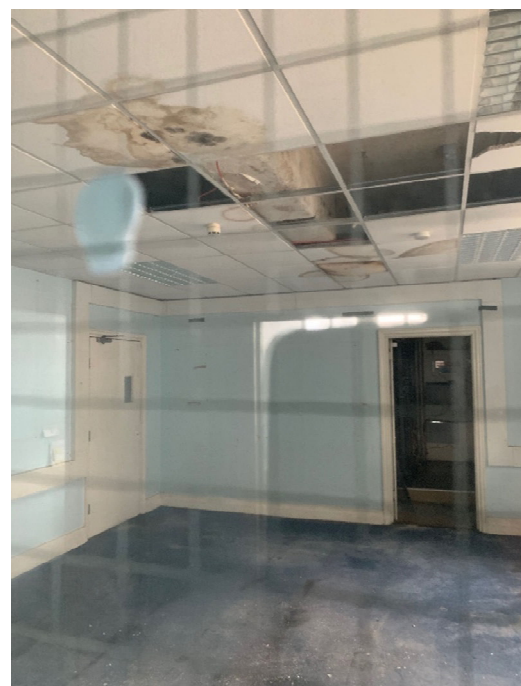
3.02.01.04 There is a small single storey flat roofed area to the rear of the building accessed where the main ground floor wall line has been removed and replaced with a new downstand beam. Excessive damp was witnessed within this area and is thought to be the result of water ingress through the flat roof coverings and potential rising damp in the external wall construction.

7. Downstand beam adjacent single storey rear extension

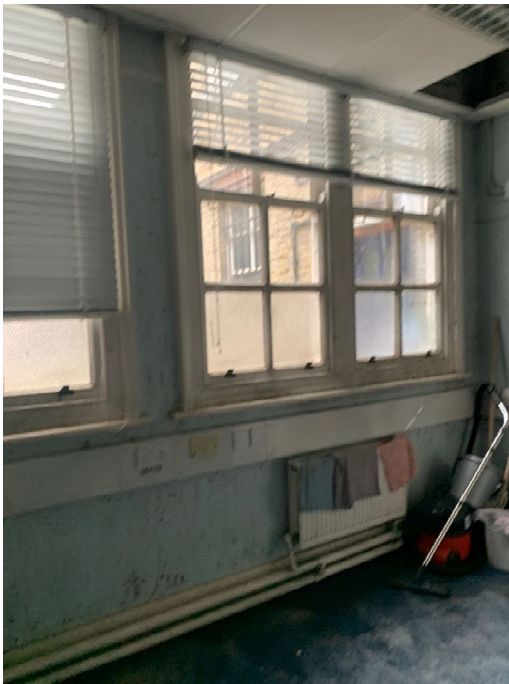
10. Rear wall of single storey extension indicating damp

- 4.04 We would also recommend at this time, given the damp witnessed during our visit that a full timber damp survey is undertaken by a relevant specialist.

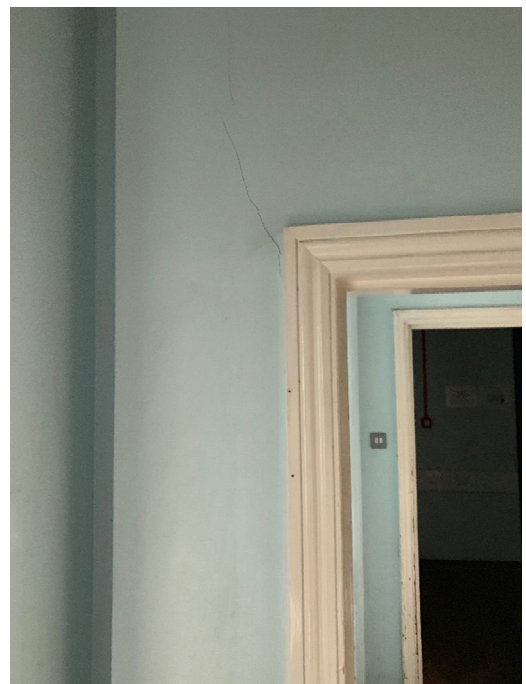
3.02.01.03 Minor cracking to plaster and finishes over doors, wall returns and recesses were noted throughout the accessible areas of the ground floor, but none were considered to be structurally significant.

11. Typical example of cracking to plaster

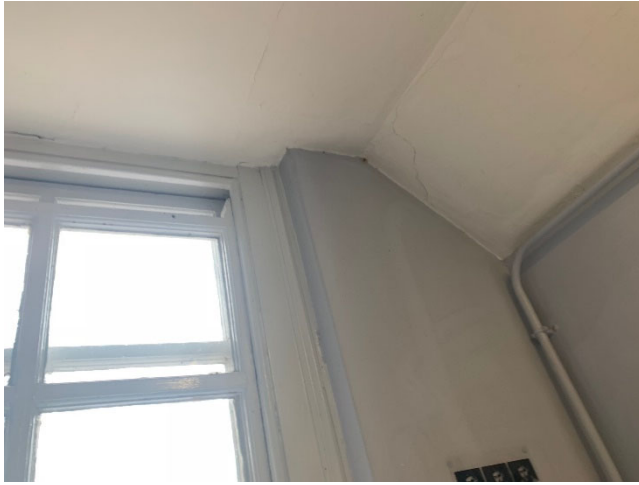
3.02.02.03 As with the ground floor areas cracking to plaster and finishes over doors, wall returns and recesses were noted throughout the accessible areas but none were considered to be structurally significant.

13. Typical example of  
cracking to plaster
