LEYDEN HOUSE
THAMES BANK
MORTLAKE
LONDON SW14 7QR

PROPOSED REPLACEMENT LOFT WINDOWS

REPORT ON EXISTING WINDOWS

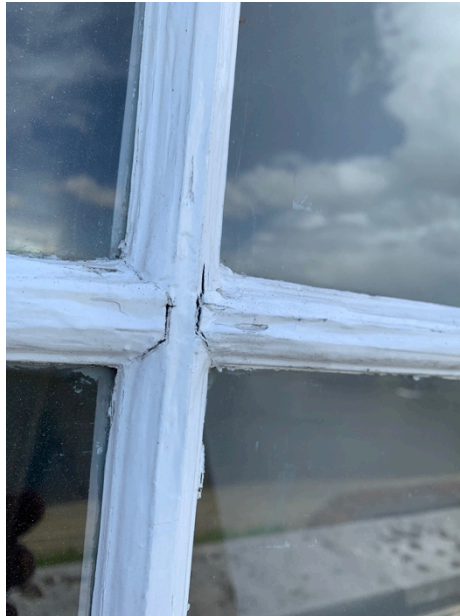
External bead: This detail is completely untypical of 18thC houses and it has clearly failed as a detail. The glass should be puttied in place.

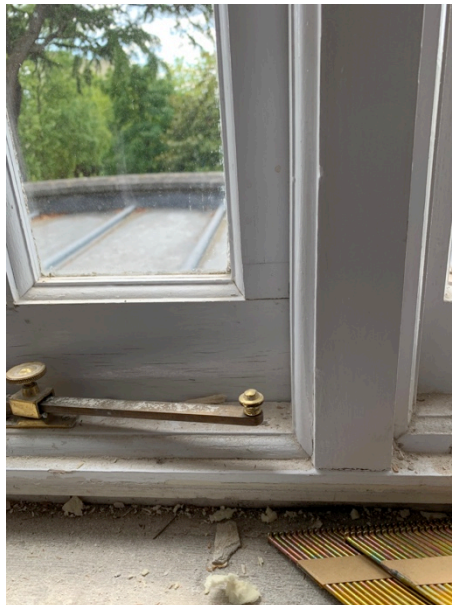
Constructional Detail: Many of the windows have been incorrectly built where the stiles stop on the bottom and top rails rather than running through to the bottom and top. Some windows have been constructed without the centre mullion shown on the above photo.

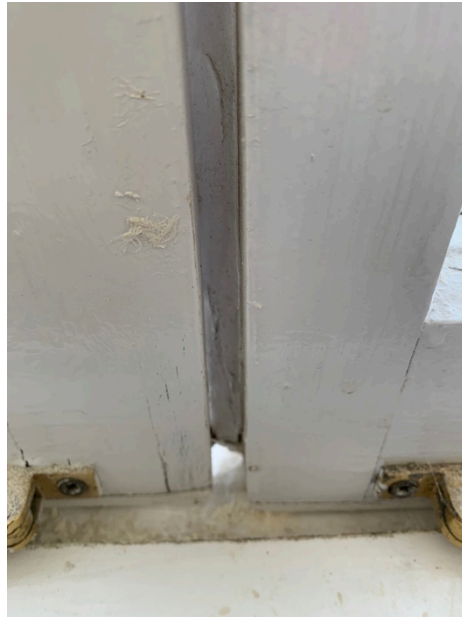
Inaccurate Construction: This photo shows the huge gap at meeting stiles. This gap is so excessive that it cannot be caused by the shrinkage of timber.
Note absence of centre mullion on above photo.

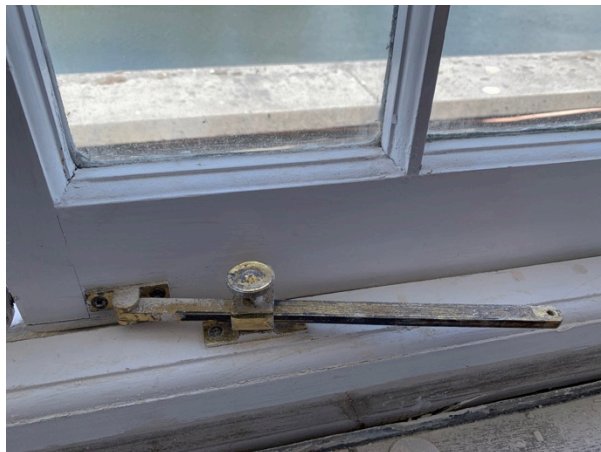
Casement Stays: These fittings are not historic and this type of sliding stay is still widely available.

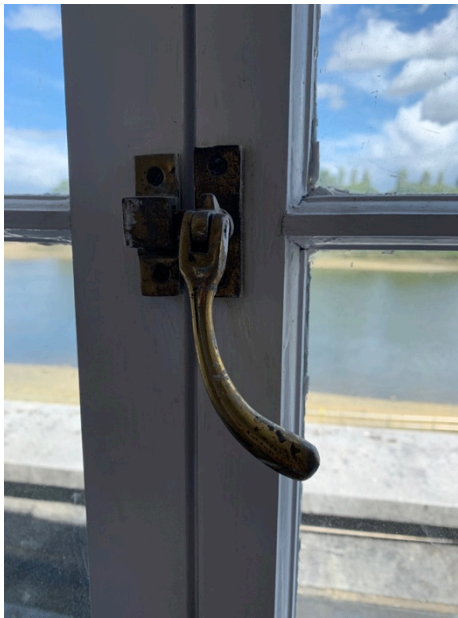
Case ment Fastener: Again this is a modern lacquered brass fitting most likely dating from 1983 when the previous owner moved in to the house. These monkey tail fittings are still widely available.

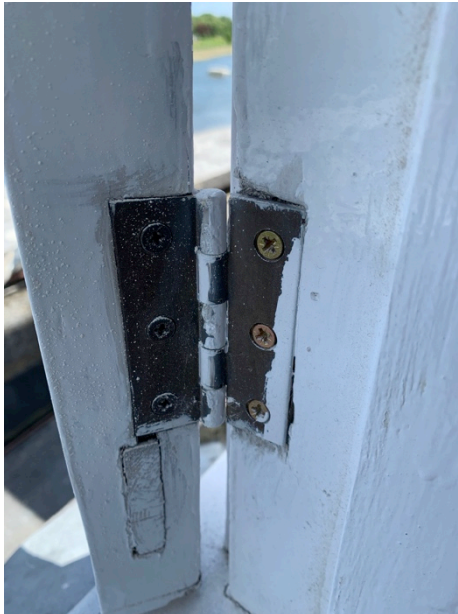
Case ment Hinges: These fittings are also brass (tarnished) whilst historic ones would have been iron. They are also fitted using modern cross headed screws rather than straight slotted screws - another modern indicator.
