# ARBORICULTURAL ASSESSMENT REPORT

<b>For:</b>	<b>Client:</b>	Sedgwick International UK
	<b>Insurer:</b>	Esure
<b>Site:</b>	<b>Policyholder:</b>	Mr & Mrs D Peasley
	<b>Risk Address:</b>	95 Elm Grove Road, London, SW13 0BX
<b>Refs:</b>	<b>PRI Ref:</b>	177722
	<b>Client Ref:</b>	9151384
	<b>Insurer Ref:</b>	4005003983

<b>Arborist Name:</b>	Will Hinde	<b>Date:</b>	12/02/2021
<b>QC:</b>	Thomas Peppiatt	<b>Date:</b>	15/02/2021

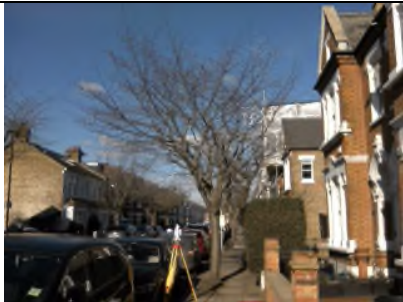
In relation to s96(6) of the Highway's Act 1980, we understand that T4 Cherry is a highway tree which is under the ownership and control of London Borough of Richmond Upon Thames Council.

Tree No:	Species	Works Required
C1	Ivy	Sever 3m section of Ivy stems and treat, giving 4m clearance from property.
SG1	Mixed species group	Fell and treat stumps of 4.5m section giving 4m clearance from property (deciduous).
T1	Acacia	Fell and treat stump (deciduous).
T4	Cherry	Fell and treat stump (deciduous).
