BUILDING SURVEY REPORT

**29, 29B & 31 HIGH STREET
HAMPTON WICK**

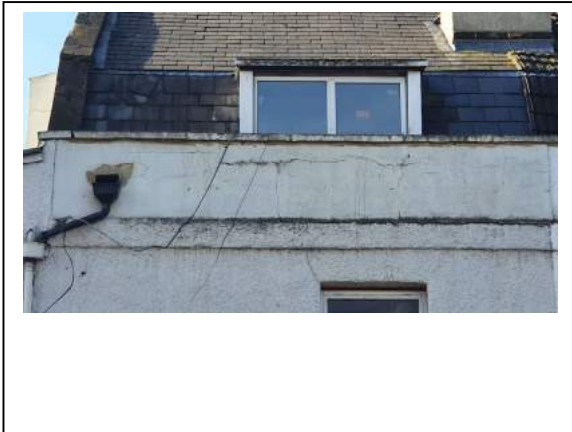
4. Failing elevation render

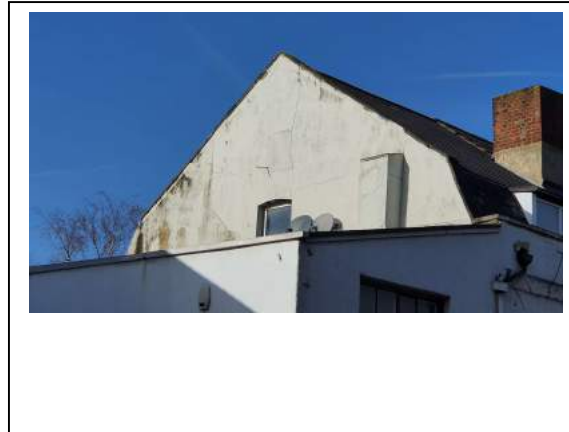
5. West elevation of No 31

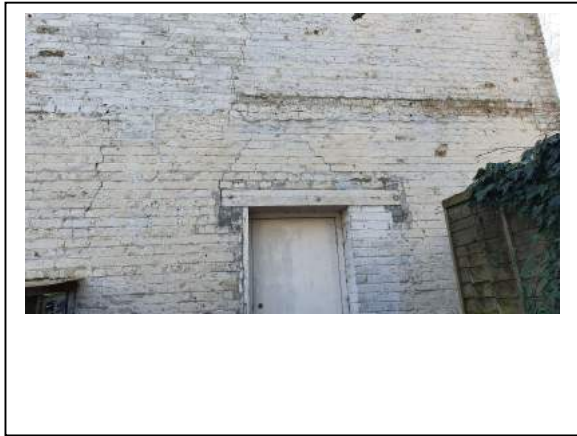
7. Cracking to elevation

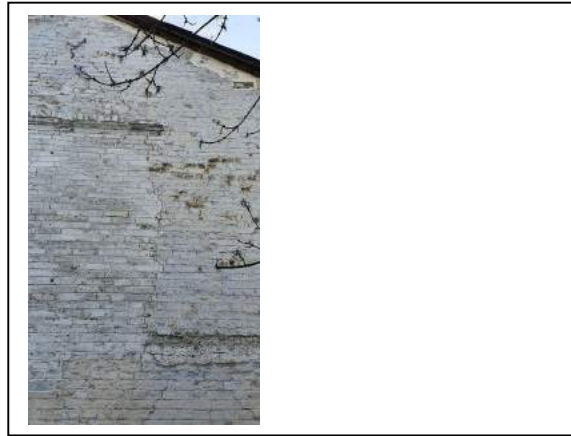
8. Cracking to elevation

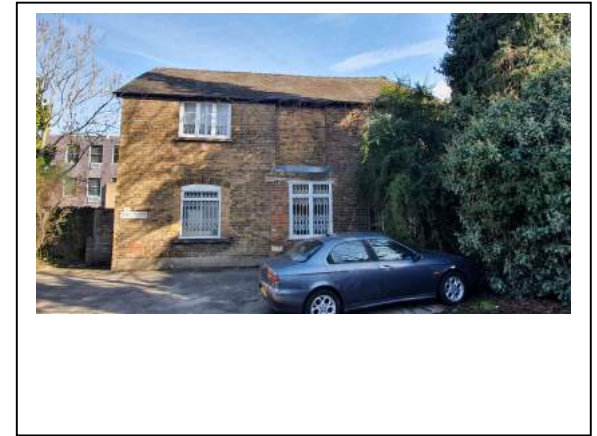
9. North elevation of 29B

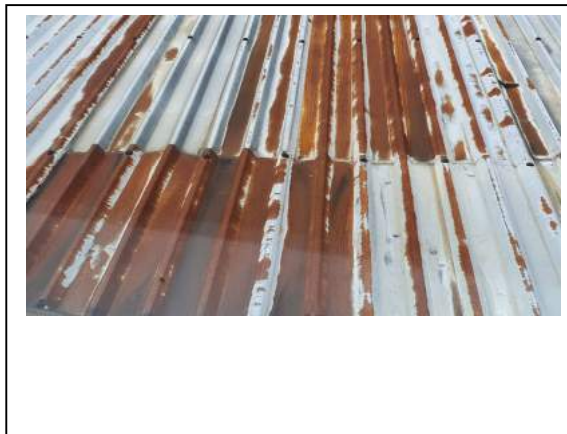
17. Corroding corrugated metal roof

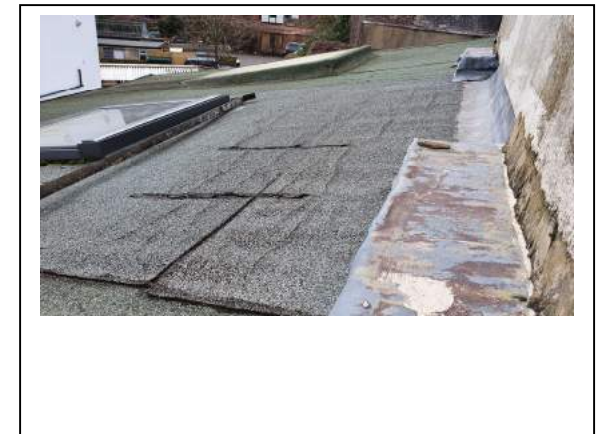
18. Poor felt roof covering to no 29 1st floor

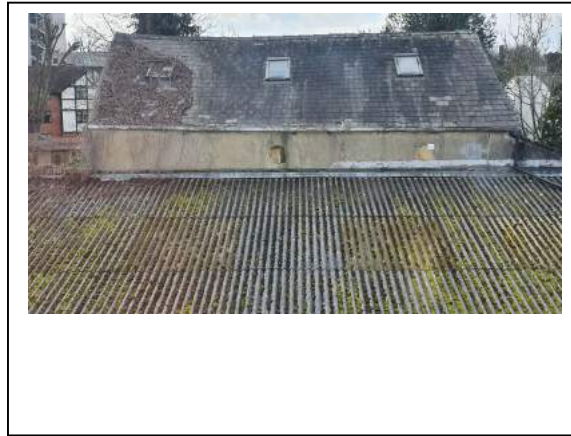
20. Asbestos sheet roof, damaged elevation and slate roof overloading roof

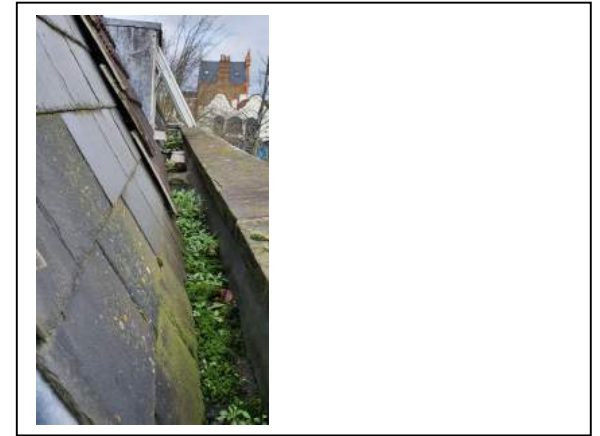
21. Hidden gutter to High St of 31

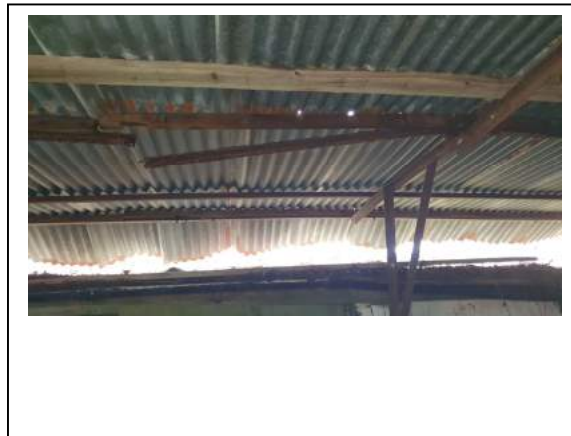
23. Failed structural members

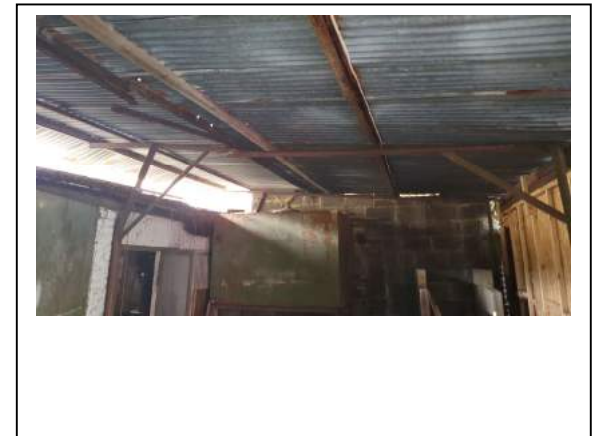
24. Failed structural members

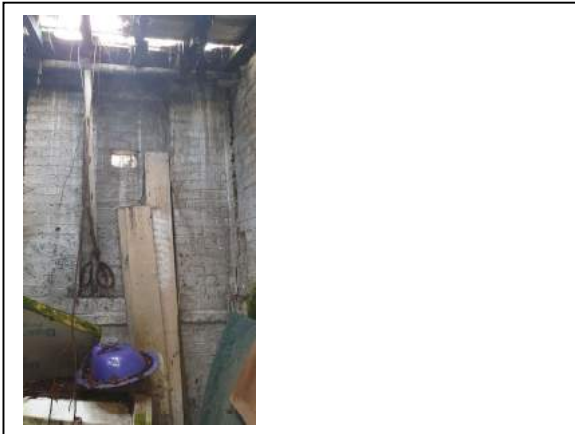
25. Failed roof & structure to storage area

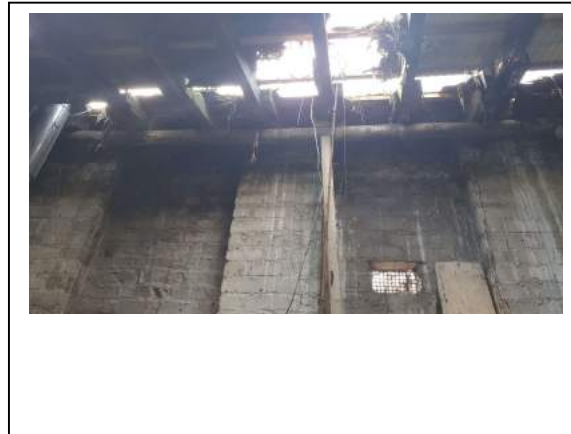
26. Inadequate structure to roof

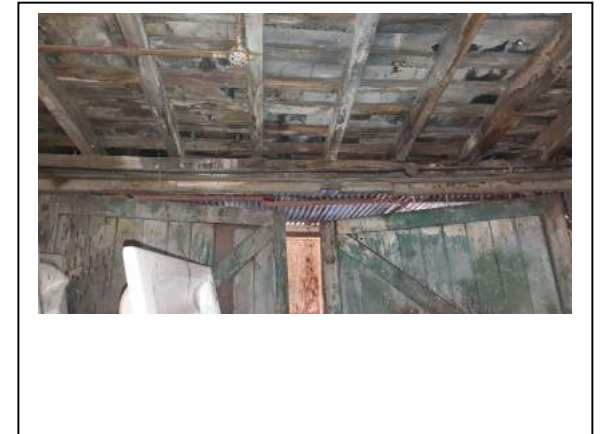
27. Failure of roof structure

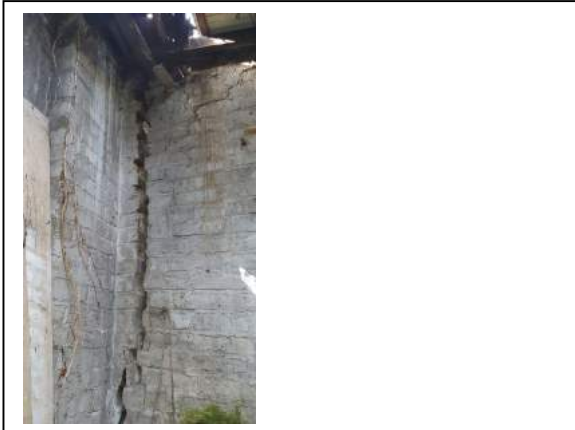
28. Significant cracking to rear / flank wall

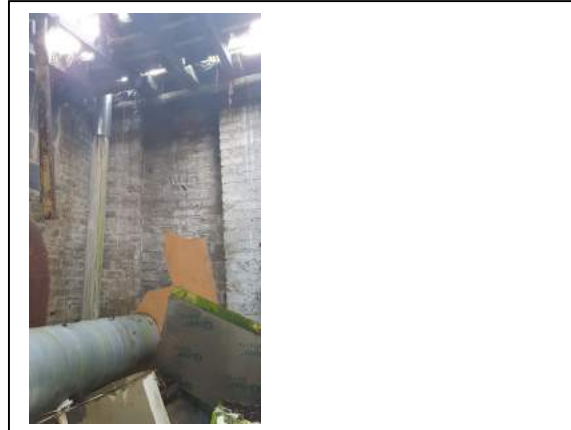
29. Poor structure and roof covering

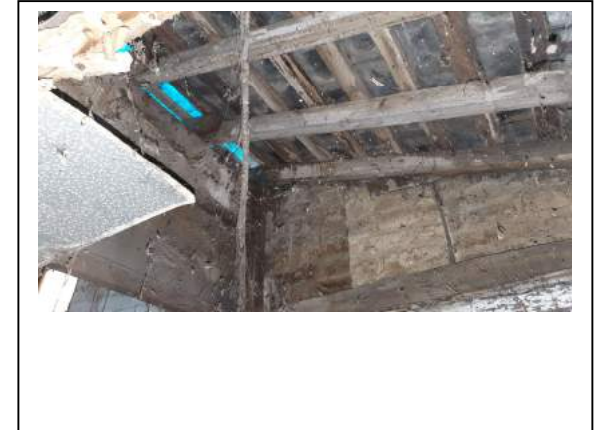
30. General poor condition of structure

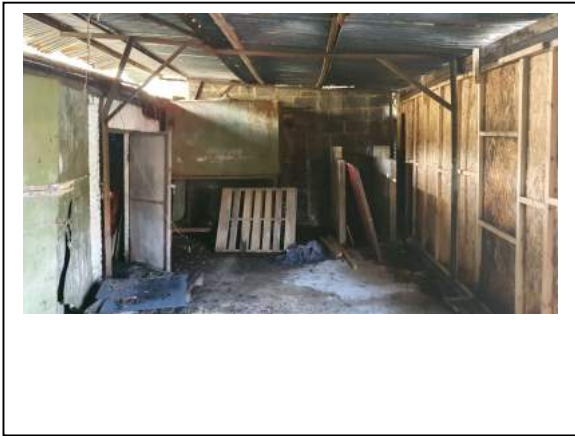
31. Chipboard elevation & doors

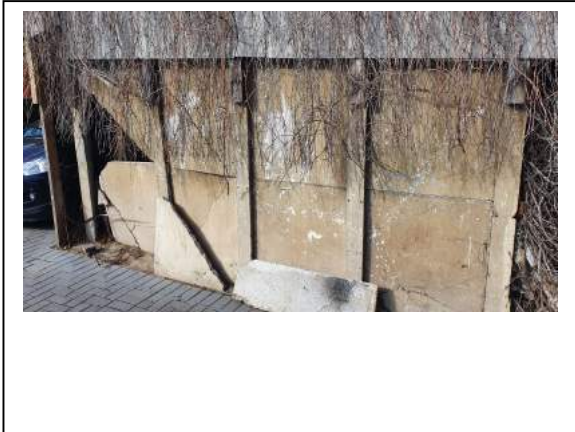
34. Failing elevation / structure

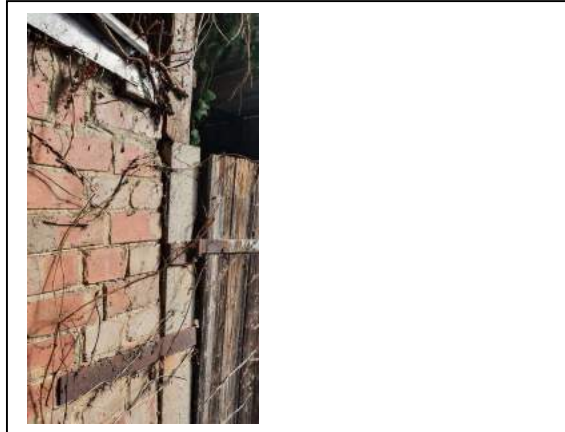
35. Movement in wall and entrance

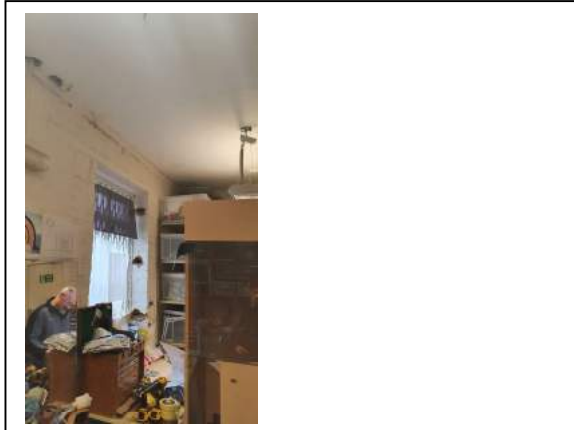
46. Damaged brickwork around window

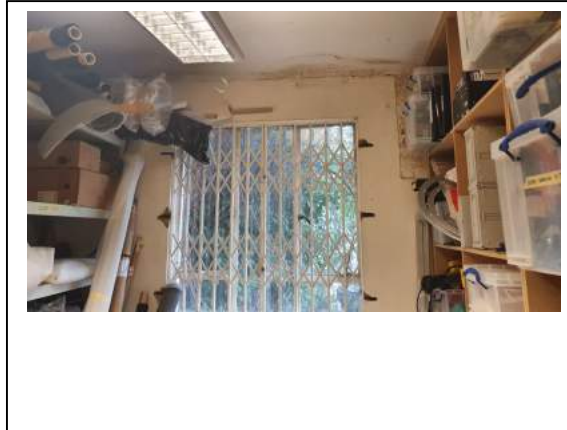
47. Damaged brickwork around window

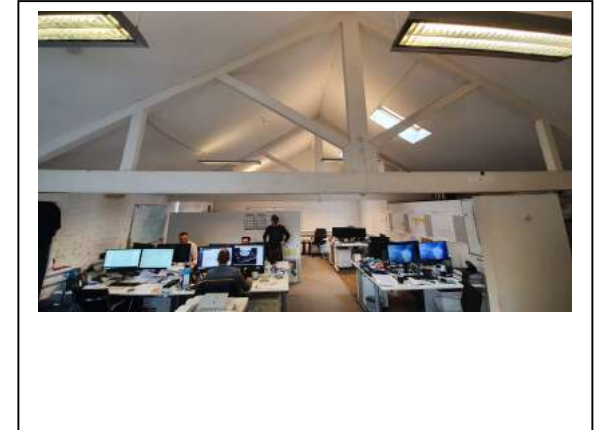
48. 1st floor 29B open rafter and beam design

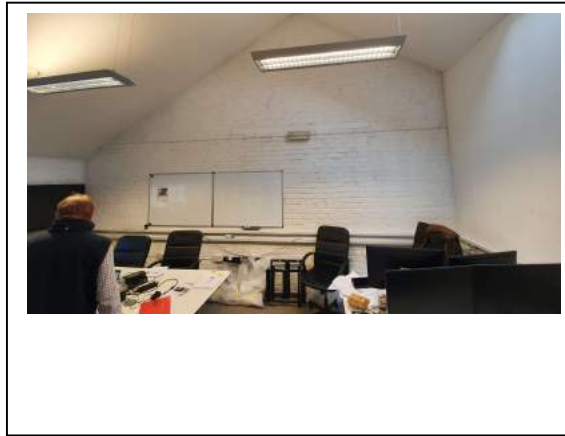
50. North wall 1st floor cracking through

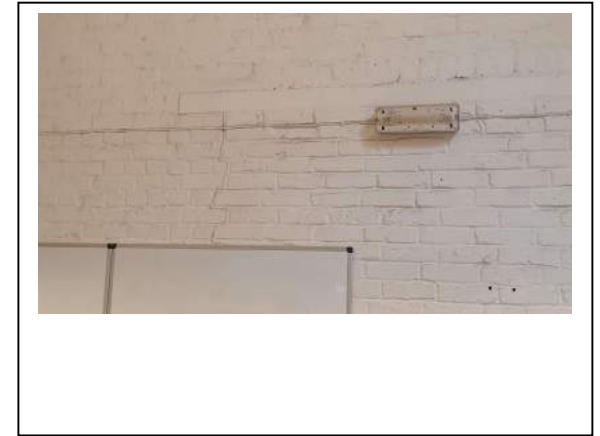
51. North wall 1st floor cracking

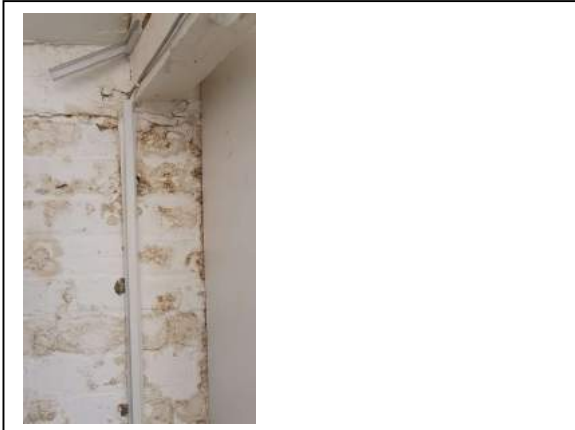
52. Water damaged internal wall 1st floor east elevation

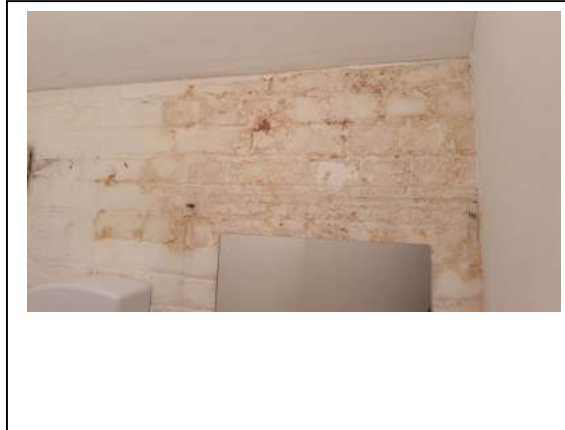
53. Water damaged internal wall 1st floor east elevation

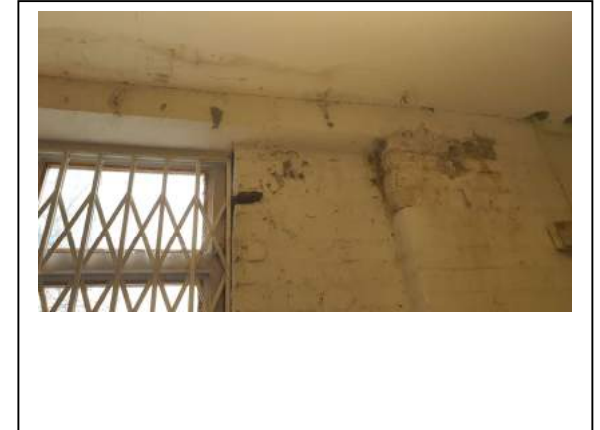
54. Water damaged internal wall 1st floor east elevation

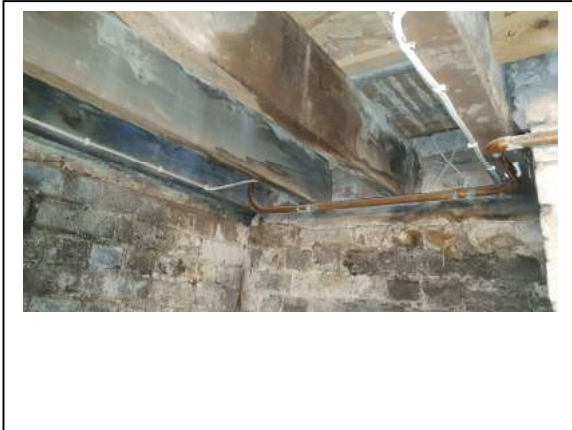
58. Water damage to ground structure no 31

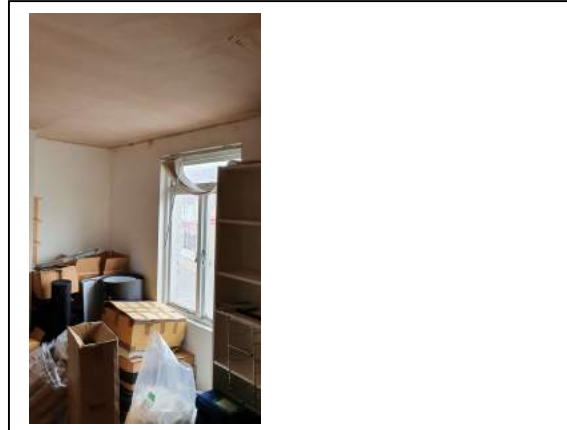
59. 1st floor – repaired and re-plastered soffit

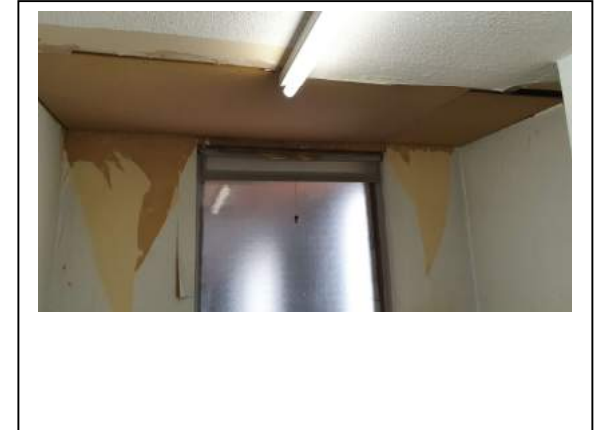
60. Repaired soffit 1st floor rear room no 31

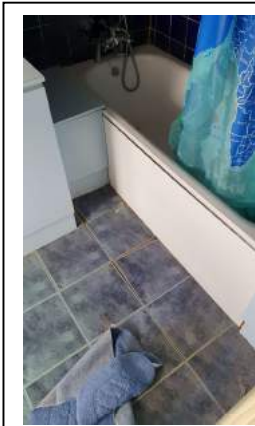
61. Poor bathroom tiling

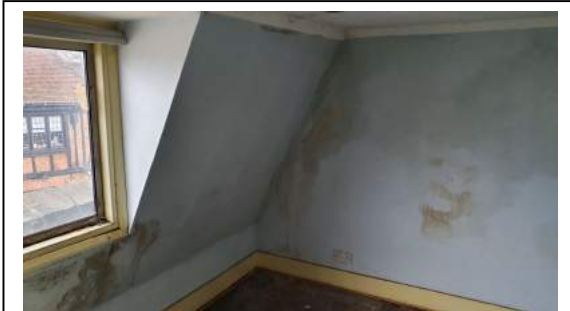
64. Water damage to walls 2nd floor no 31

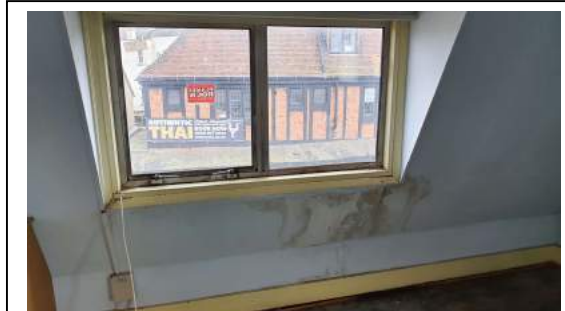
65. Water damage to walls 2nd floor no 31

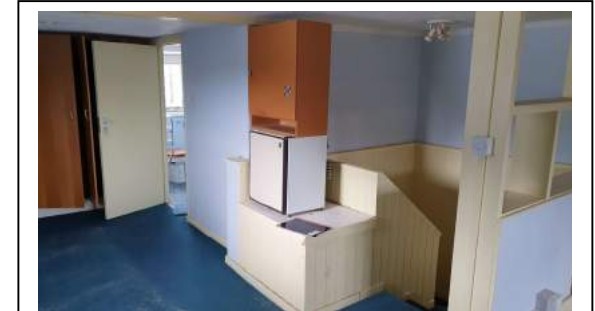
66. Open stair to 2nd floor

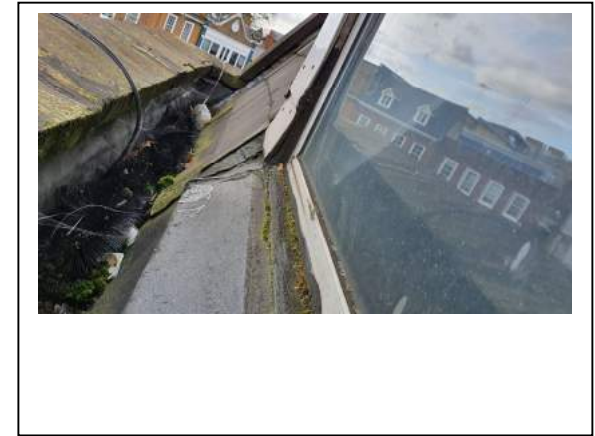
69. Blocked gutter and poor window condition no 31 2nd floor
