**Richmond London Borough Council
Elleray Community Association**

**PAS128 M3P Utility Mapping Survey
Site Report
Project No. 2111**

Prepared by:
James Ephgrave
40SEVEN Limited

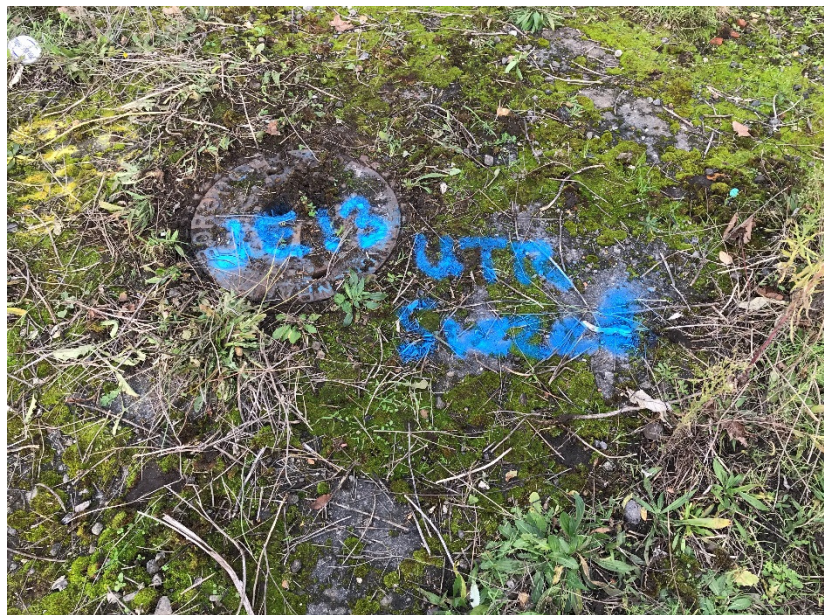
Photo 12

Description: Manhole JE13 UTR Seized.

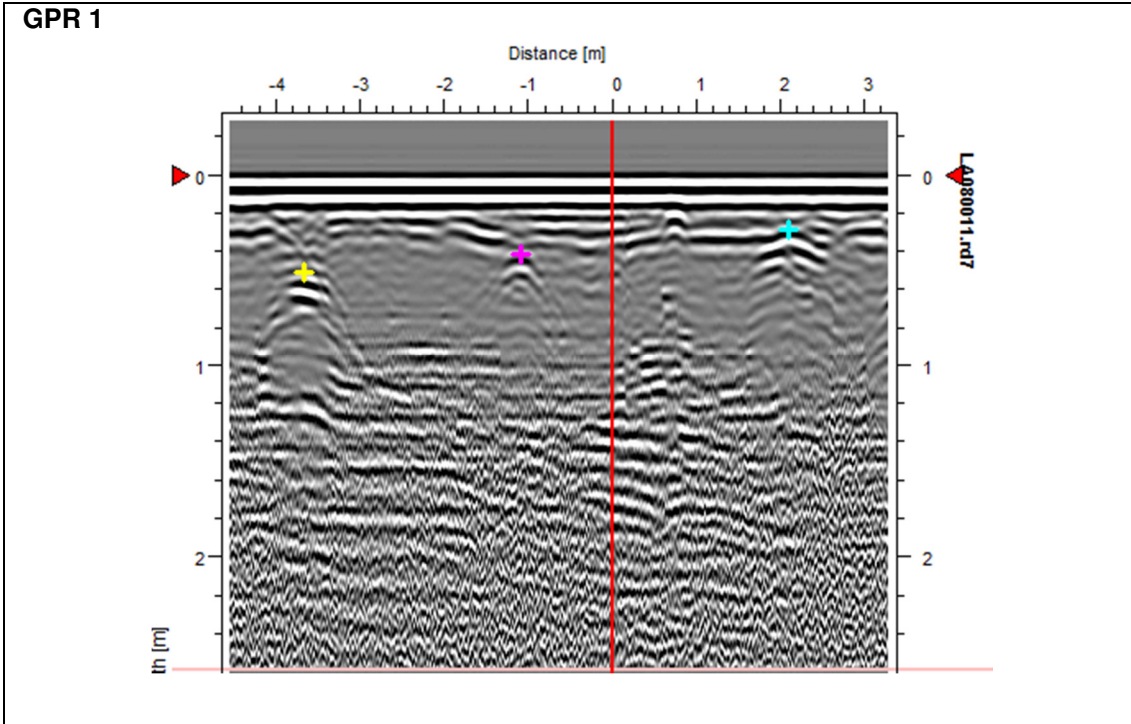
Description: Examples of GPR Images.

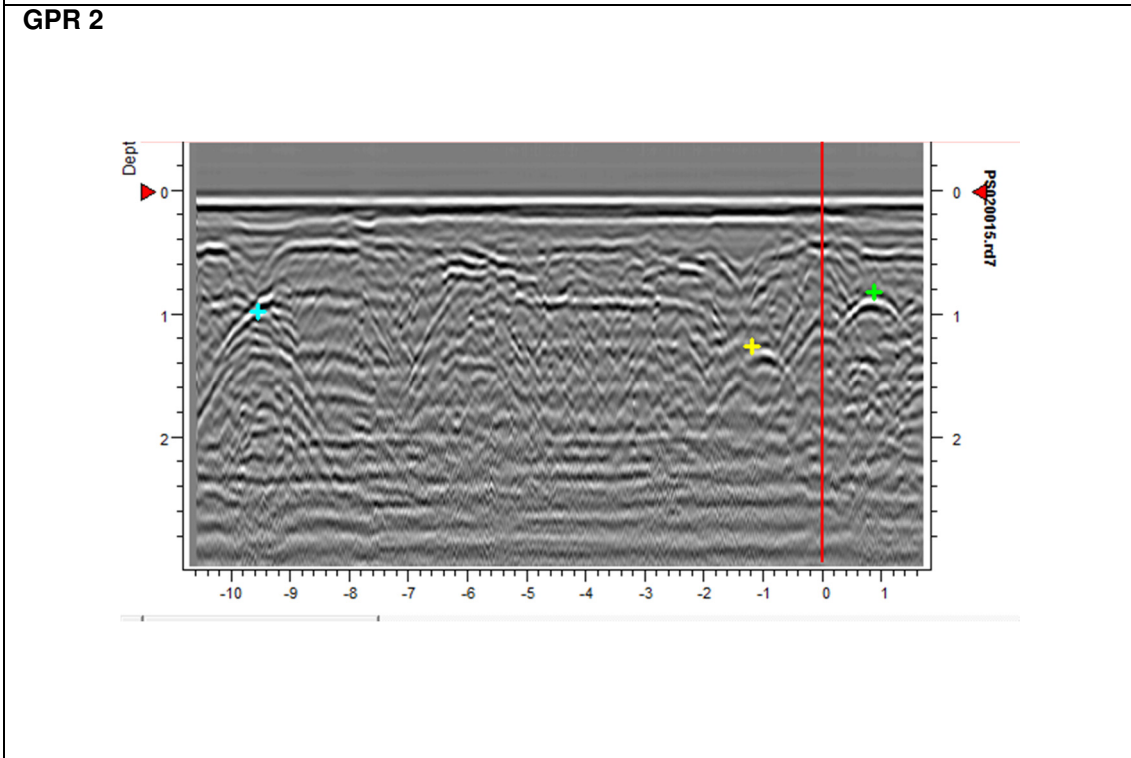
Description: Examples of GPR Images.
