Condition Survey

Project	Elleray Hall, Teddington
Client	London Borough of Richmond
Date	07 September 2018
Prepared by	Matthew McEwen

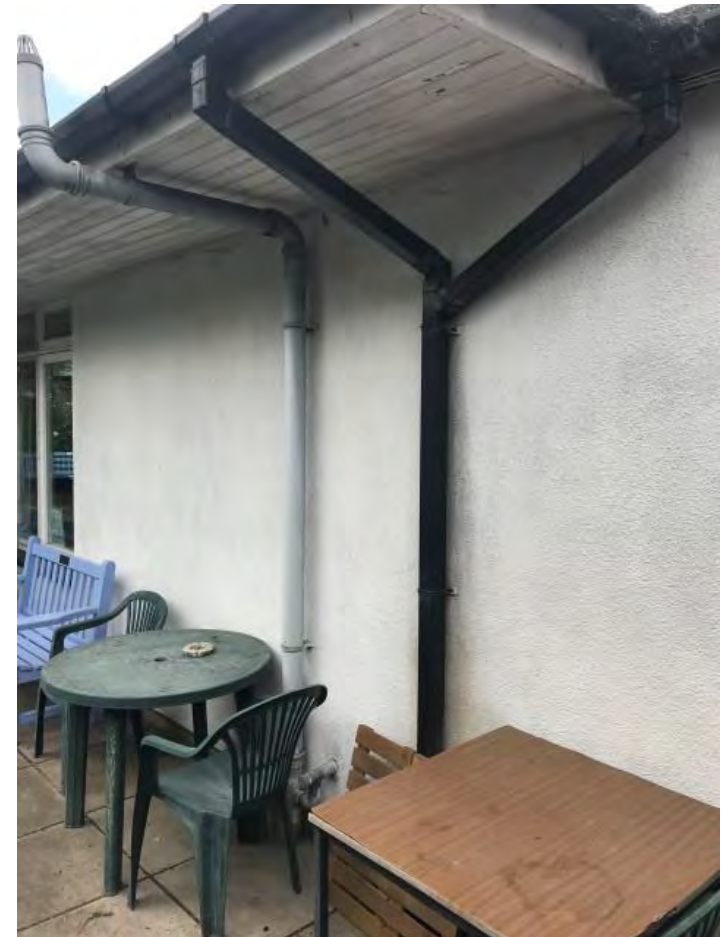
Photo (178)

2.06	N/A	Extension - Timber Windows and Cills	Painted timber double glazed windows with composite cills which are understood to comprise of a proportion of asbestos.	Windows were operated and a small number are stiff, decorations generally in fair condition with isolated areas of decay to windows. Main window to G024 is heavily decayed and replacement of window required	B	2	£1,750.00						£1,500.00	£7,500.00	10 years with replacement of window in G024	£7,500.00	N.B - Asbestos detected in cills and waste will need to be remove and disposed of in accordance with Control of Asbestos Regulations 2012.	175, 177- 180, 193- 198

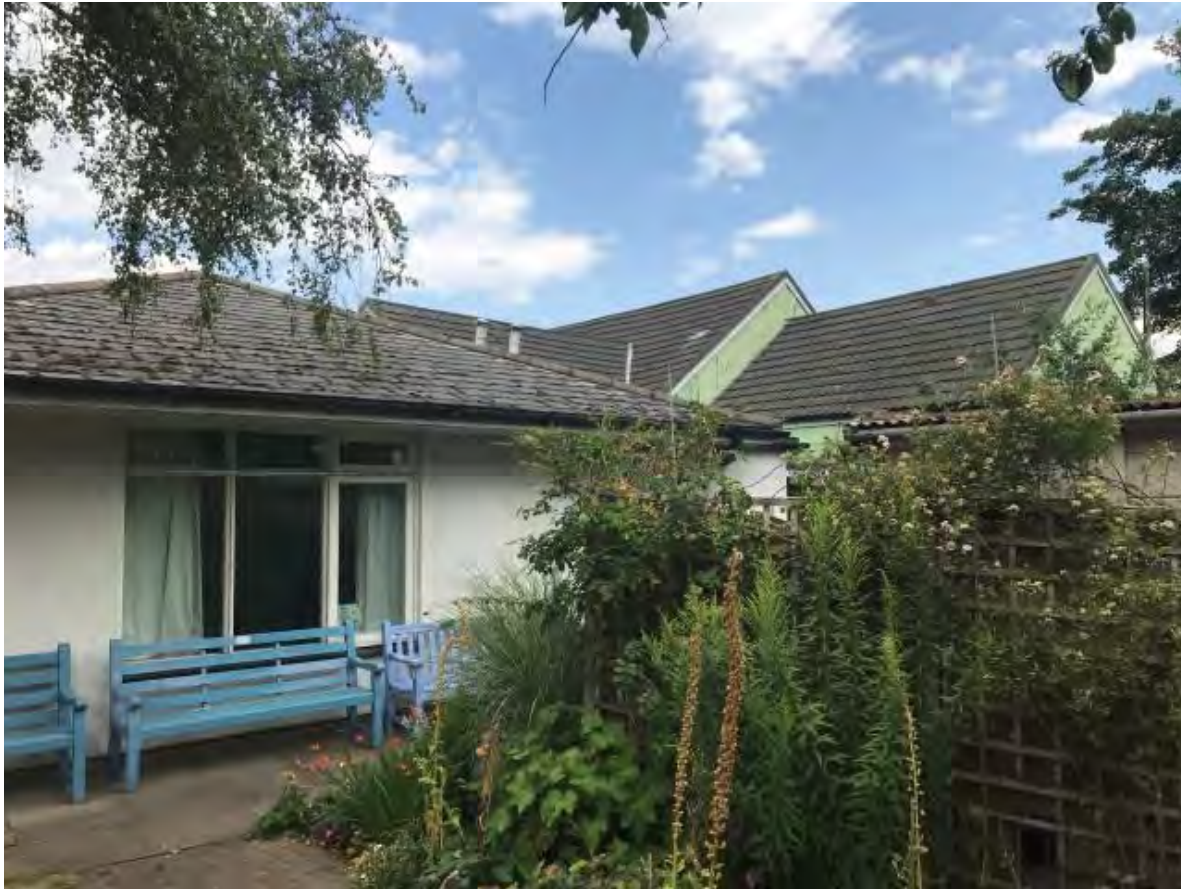
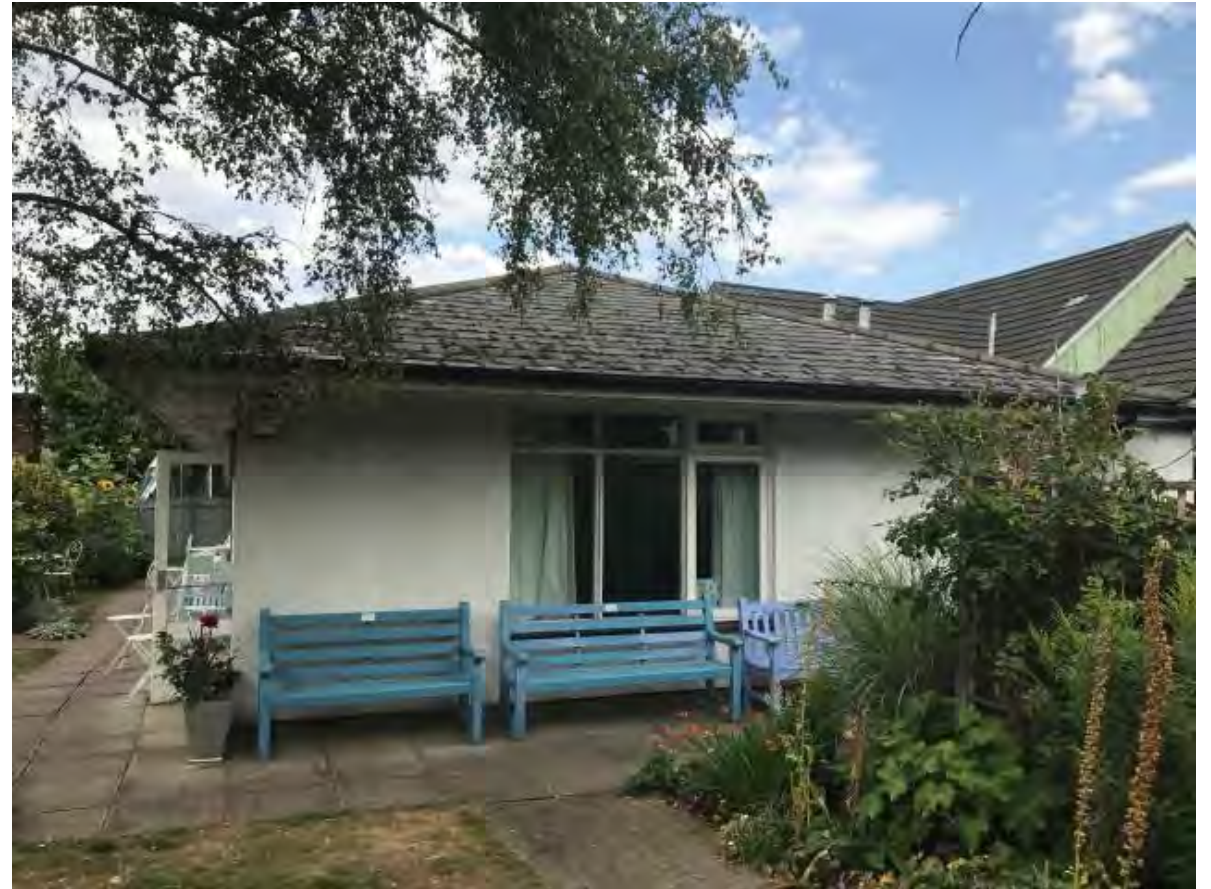
Photo (193)

1.01	N/A	Pitched Roof - Main Hall	Asbestos Cement Roof Tiles	No defects noted to roof and no internal leaks noted within pitched roof areas. Surface of tiles are moderately stained but appear in good condition with no delamination noted in visible areas of roof.	B	4								£150,000.00	10 - 15 years	£175,000.00		193,194,215 - 219

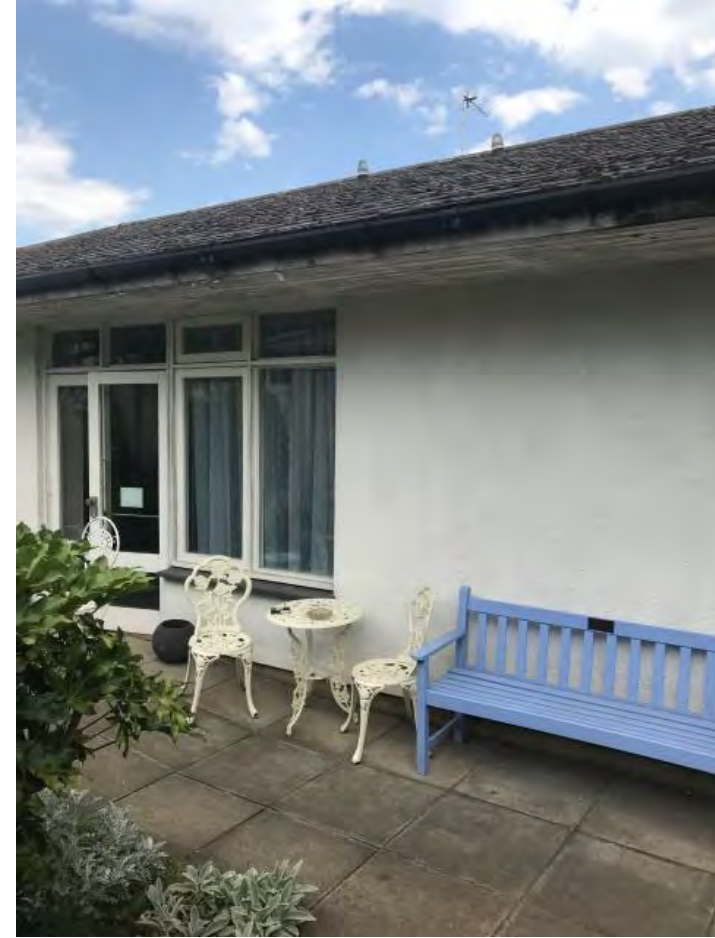
Photo (196)

2.01	N/A	Pitched Roof - Extension	Natural Slate roof	Staining noted to ceiling within G024 although leak noted as historic and patch replacement works undertaken, no other defects noted to roof. Isolated replacement of slipped tiles forecasted.	A	4							£500.00	£0.00	20 Years	£12,500.00		193-198, 246-248

2.07	N/A	Extension - UPVC Rainwater Goods	Black UPVC square downpipe and square channel section gutters.	UPVC gutters and downpipes are in fair co. one cracked gutter requires replacement to front car park. Replacement of gutters anticipated in long term as embrittlement continues.	D	2	£85.00							£1,500.00	£1,500.00	5 - 10 years with isolated repair	£1,500.00	193 -200, 206

2.08	N/A	Extension - Roughcast Render Surfaces	Roughcast render repairs to external wall surfaces.	Areas of damaged render and edge beads to window/door openings to GG5. Undertake repairs to render and replace edge beads to damaged areas and subsequently undertake redecoration of render in year 5 & 10.	B/D	2	£100.00							£400.00	£3,500.00	10 - 15 Years	£3,500.00	194-200	
Building Wide Items

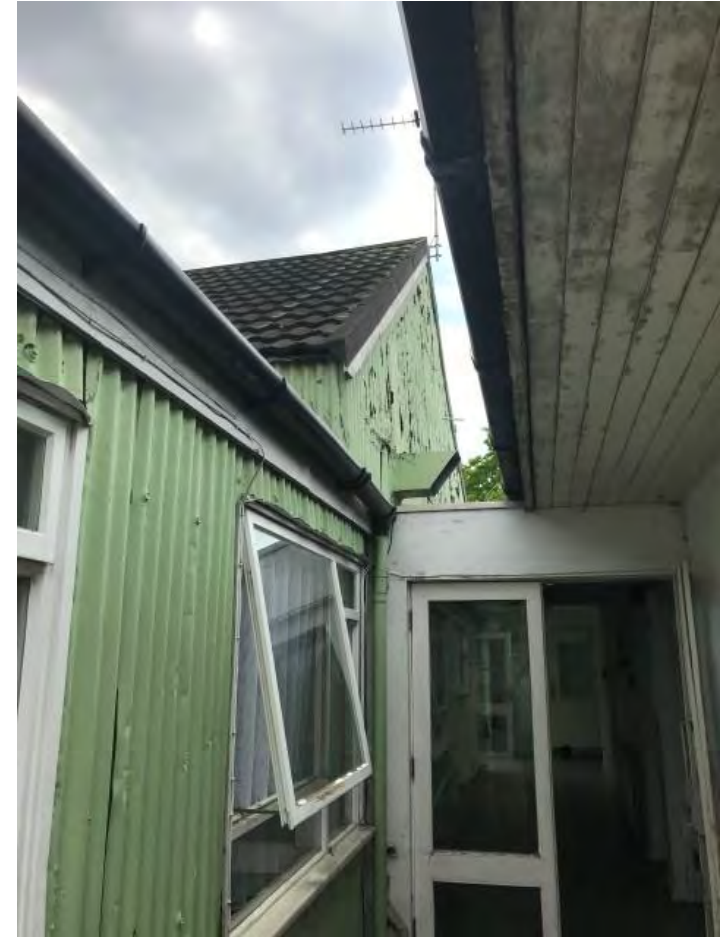
Photo (218)

1.02	N/A	Corrugated Asbestos Cement Sheets / Galvanised Steel Corrugated Sheets	Painted Asbestos Cement Corrugated wall sheets and painted galvanised corrugated steel sheets and associated edge trims and other accessories	Paint to corrugated sheets has widely delaminated, sheeting generally in good condition. Redecoration of all areas of panels and associated trims required. Number of wasp nests behind cladding sheets which require urgent removal and repair of damage and sealing of access holes.	C	4								£75,000.00	10 - 15 years	£125,000.00	Minor areas of damage to edges of Asbestos cement panels which are currently sealed with paint. Cladding to be monitored and checked for damage and repairs, sealing and cleaning of debris to be undertaken.	214-241

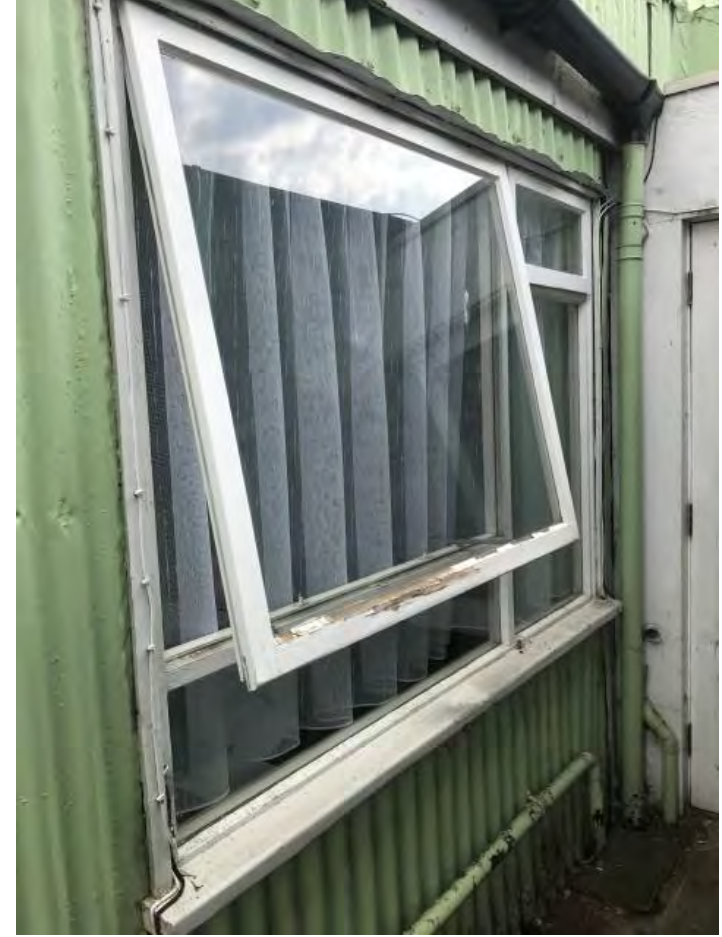
Photo (220)

1.04	N/A	Main Hall - Timber Windows and Cills	Painted timber single glazed windows and painted timber cills.	Windows widely deteriorated and widely decayed throughout, widespread repair removal and repair to timber decay required and subsequent redecoration of windows required.	D	2	£50,000.00							£50,000.00	< 2 years - Most are widely failed	£50,000.00		220,225, 227 - 228, 239-240,

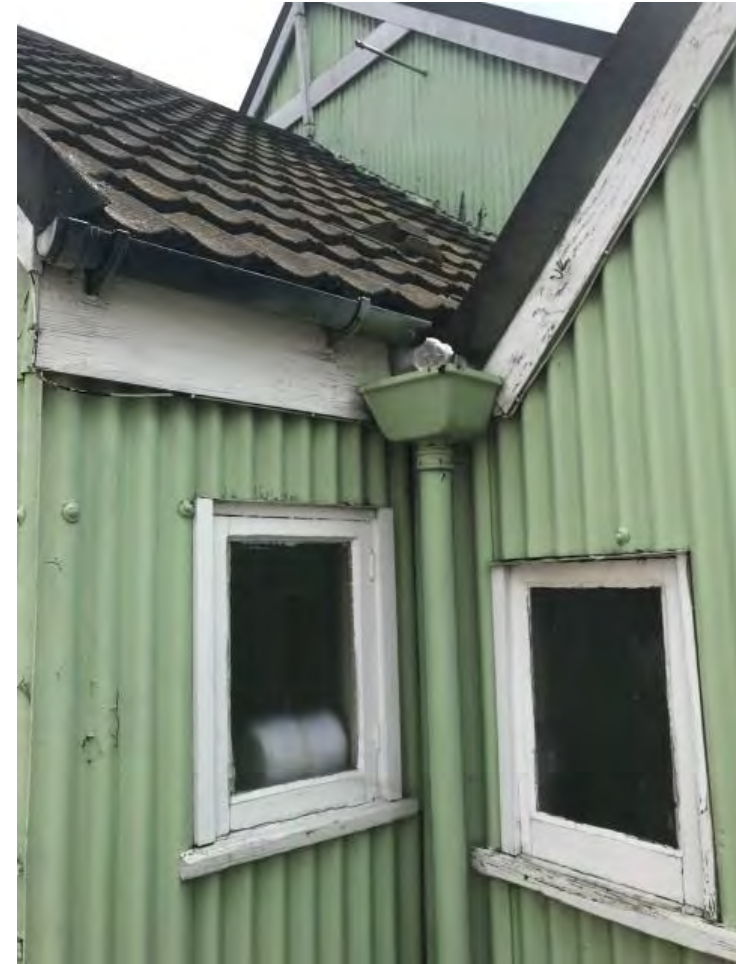
Photo (240)

1.03	N/A	Main Hall - Plastic Rainwater goods	Plastic round downpipes and half round gutters.	Gutters and downpipes in fair condition, areas of decorated downpipes are widely delaminated and require redecoration at the same time as decoration of the cladding panels. Fixing to gutters and downpipes to be checked at the time of decorating and repairing timber substrate.	B	3			£250.00				£2,250.00	£2,250.00	10 - 15 years	£2,250.00		229-231, 240

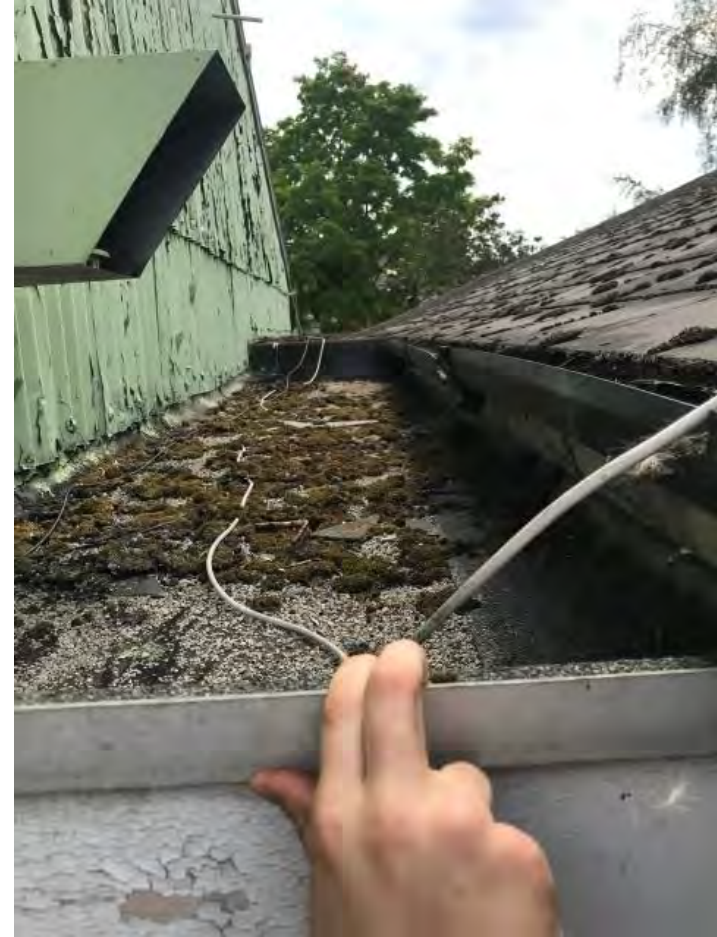
Photo (252)

2.03	N/A	Extension Corridor - Mineral Felt Roof (Between Main Hall Corrugated Sheet and Extension Pitched Roof)	Mineral Fibre felt roof with areas of lead flashing	Felt roof appears to be reaching the end of lifespan and has numerous areas of ponding and does not fall to outlets. Flat roof should be replaced with a new mineral fibre felt roof including new insulation lead to falls and including the replacement of new rainwater outlets.	C	2	£2,250.00							£2,250.00	< 5 years - leaks noted below area roof and onset failure of membrane.	£2,250.00	Replacement costs includes upgrading of insulation value and extra over detailing costs associated with the increased thickness of roofs and alterations to falls to ensure roof drains. N.B - Leaks noted to also be a result of poor maintenance on roofs and overflowing behind cladding. More regular maintenance of gutters recommended. Safe access was not possible to inspect roof by foot and the inspection was undertaken from a ladder.	251-254
