SHEEN GATE
264 Sheen Lane

A Report on the Decorative Schemes
following an Examination of the
External Timber Framing

Patrick Baty FSA

10th May 2021

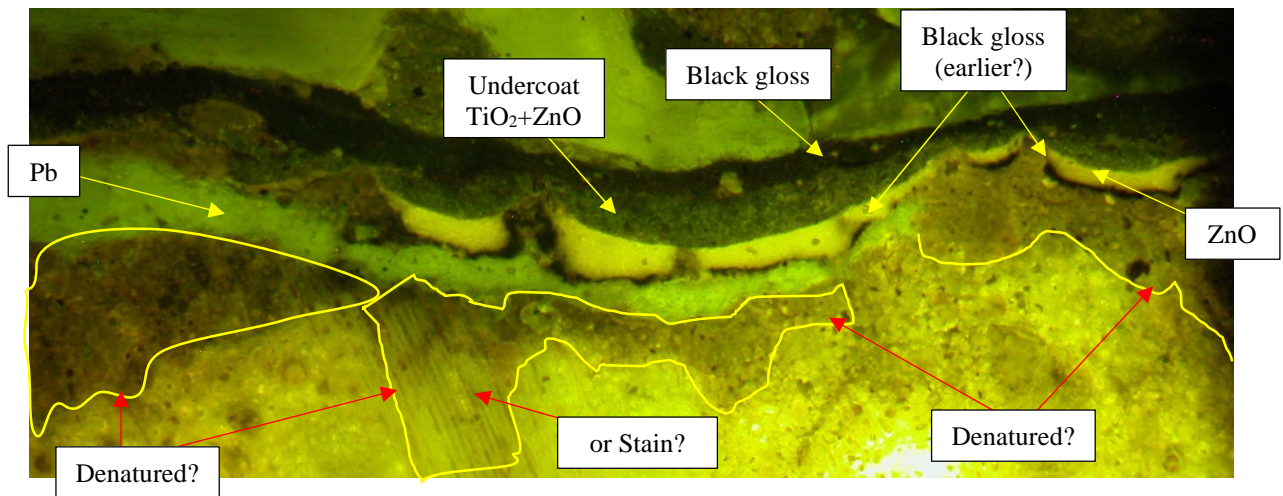
On all the samples the upper surface of the wood is darker than lower down. It is possible that this is a mid-tone stain, or it could be UV degradation. The reason for thinking the latter is that when one compares the two samples taken from either side of the diagonal brace the wood on the (south-facing) outer face (SHG/5) is darker than the protected face (SHG/4). These areas are marked 'Denatured?' in Appendix Two to indicate the uncertainty.⁴

With stained oak one can usually see clear signs of the stain penetrating the wood and travelling along the vessel elements. It is just possible that one is seeing signs of it here (see SHG/4 marked with 'or Stain?'). However, this is the only slight suggestion and seen just once.

Photomicrograph of SHG/4 (x200 under UV Light)
First Floor. South-facing balcony. East end. Diagonal brace. Inner face

Two samples from either side of the same element. The weathering on the outer-facing side can be seen clearly in the form of the jagged surface (see SHG/5). On both sides the upper surface of the wood is darker than lower down. It is possible that this is a mid-tone stain or it could be UV degradation. The reason for thinking the latter is that the (South-facing) outer face is darker than the protected face – one might presume that a stain would be bleached. At a later stage the wood was primed with an oil primer based on lead white and given a zinc-based white undercoat. A dark grey undercoat was then applied. The latter seems to have been based on a mix of titanium dioxide and zinc oxide. The finish was a black gloss. Evidence has been found of touching-in with later coats of black gloss. SHG/4 may show an earlier black gloss.

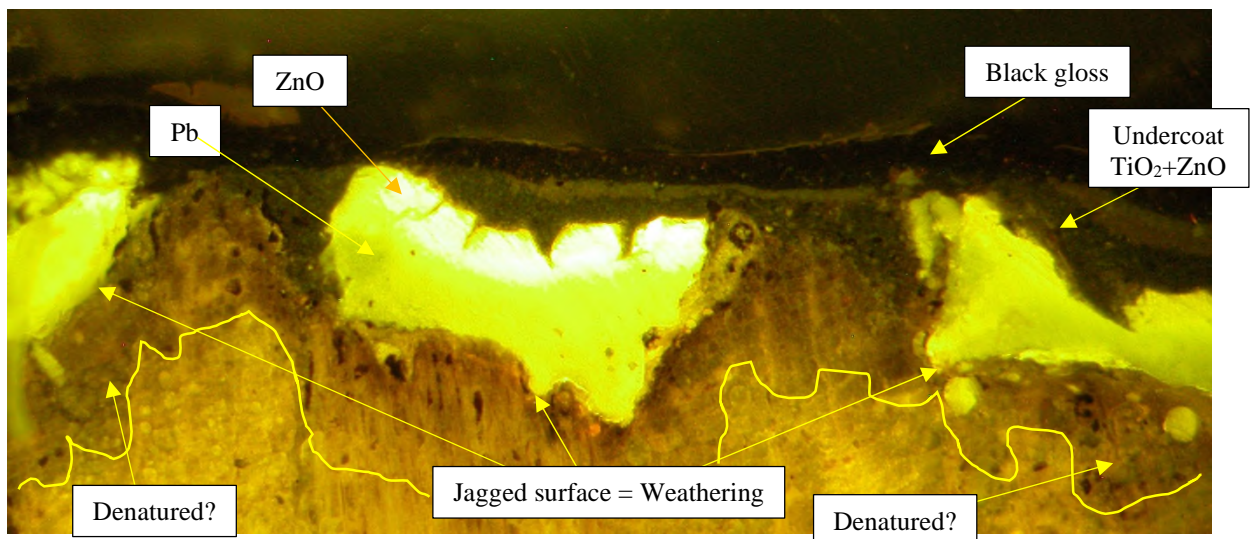
Photomicrograph of SHG/5 (x200 under UV Light)
First Floor. South-facing balcony. East end. Diagonal brace. Outer face

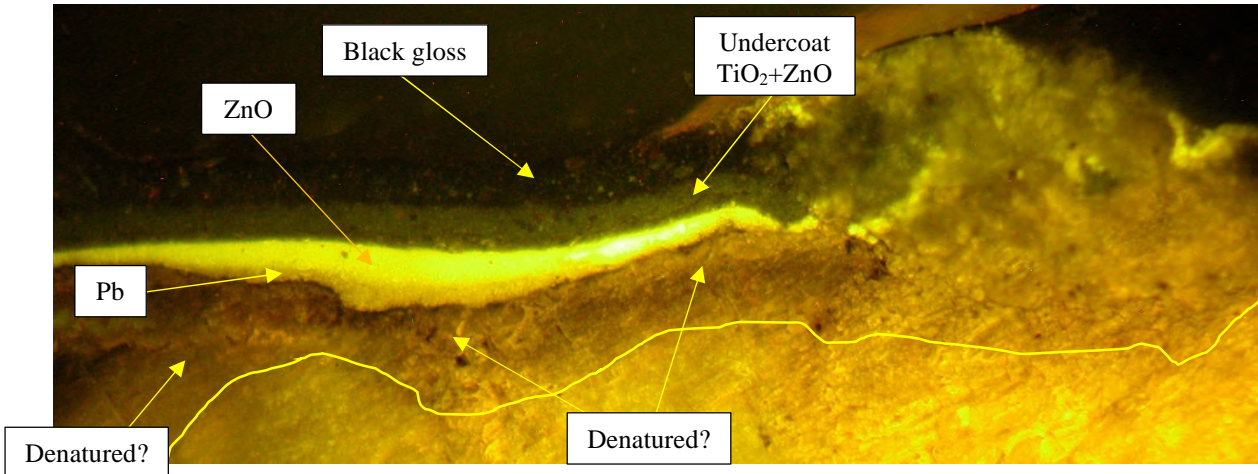
Most of the samples show that a white lead-based⁵ primer was applied at some later stage (see, for example, SHG/2). This was followed by a zinc-based white undercoat. A dark grey undercoat was then applied. The latter seems to have been based on a mix of titanium dioxide and zinc oxide,⁶ which immediately suggests a date of ca.1960 plus. The finish coat of this scheme was a black gloss. Evidence has been found of touching-in with later coats of black gloss – perhaps on two occasions. A sample taken from the balcony may show the remains of an earlier black gloss (SHG/4). The latter may be a 'flow-down' of the later gloss but, if so, it is not clear how it has found its way between the lead primer and zinc undercoat.

Photomicrograph of SHG/2 (x200 under UV Light)
 First Floor. South-facing balcony. East of centre. Top element of window frame.

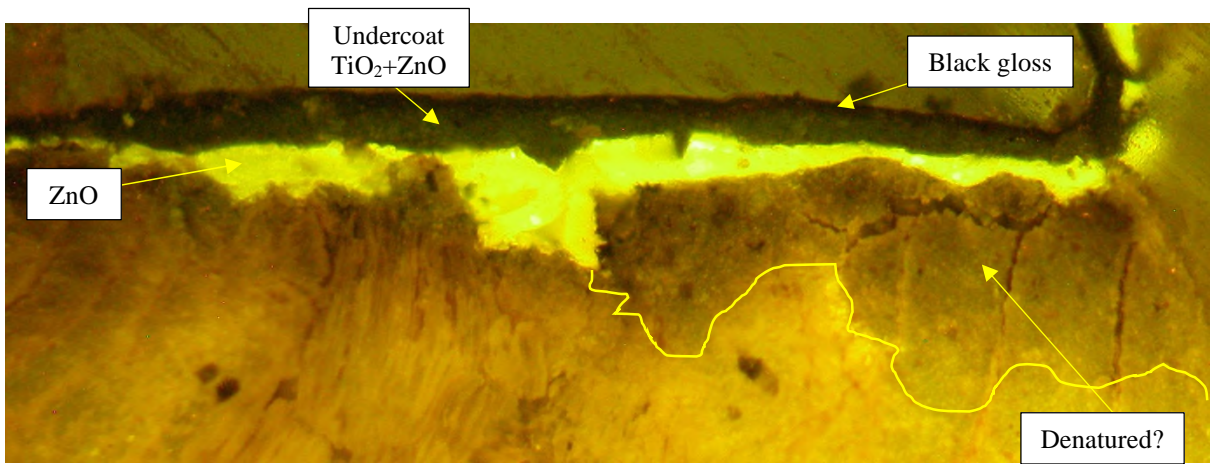
Photomicrograph of SHG/8 (x200 under UV Light)
 Ground Floor. East side. Upright to panel to RH of Front Door

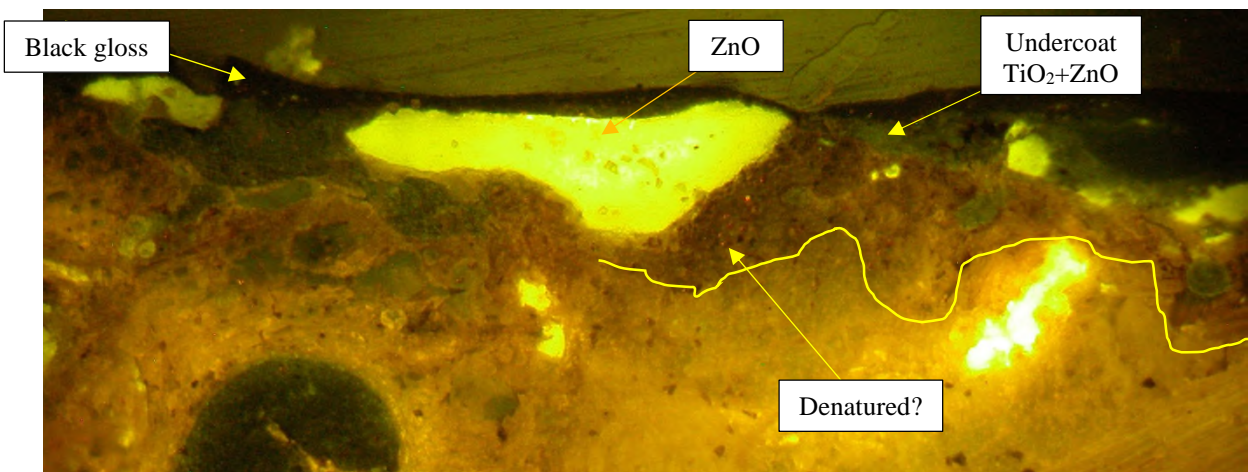
Photomicrograph of SHG/9 (x200 under UV Light)
 Ground Floor. South side. Centre Door. LH stile
