## Arboricultural Consultant's Development Site Supervision & Monitoring Report

**Date of site supervision visit: 19 January 2021**

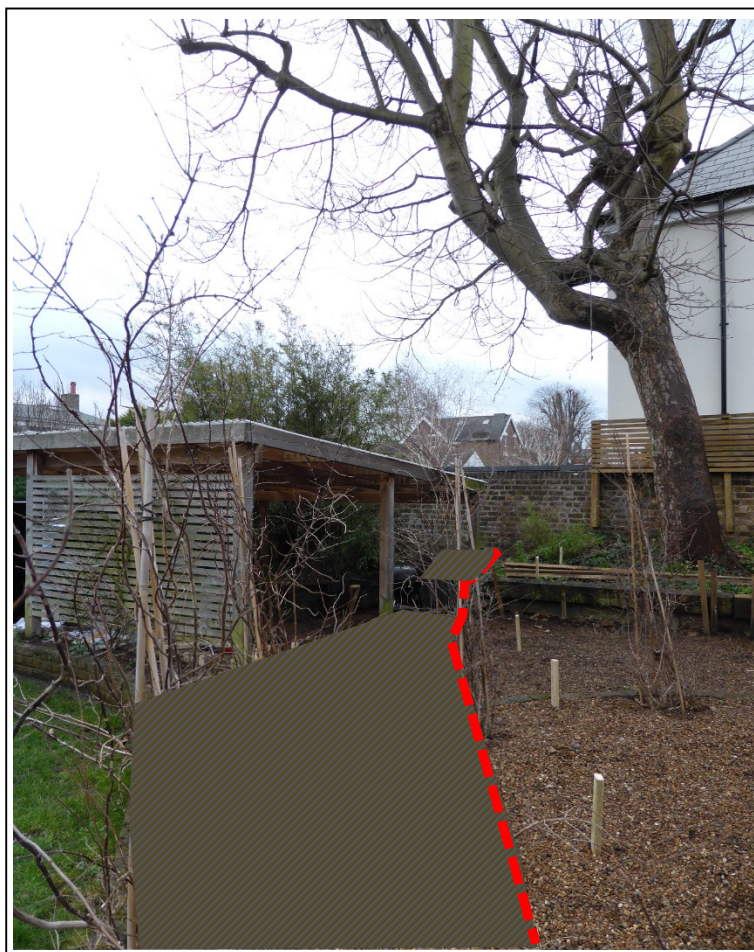
*Photo 1: Location of TPB and temporary ground protection as marked out on site*

- 1) Protection of tree root protection area (RPA).  
The RPA of T1 within the proposed construction area must be protected with a tree protection barrier (TPB) and temporary ground protection.

Location of TPB

Temporary ground protection; to be removed at completion of works

- The TPB must be installed prior to any construction activity and remain in situ for the duration of the scheme as detailed in section 7.3 and Appendix 2 of the AMS. The location of the TPB was set out by marker pegs on site, see photo 1.
- To ensure the RPA of the retained tree remains undamaged, and to prevent contamination and compaction during construction work, temporary ground protection must be installed as per section 7.4 of the AMS (ground undisturbed and protected by a geotextile fabric, and side butting scaffold boards on a compressible layer). To be installed over the area shown on photo 1 below.

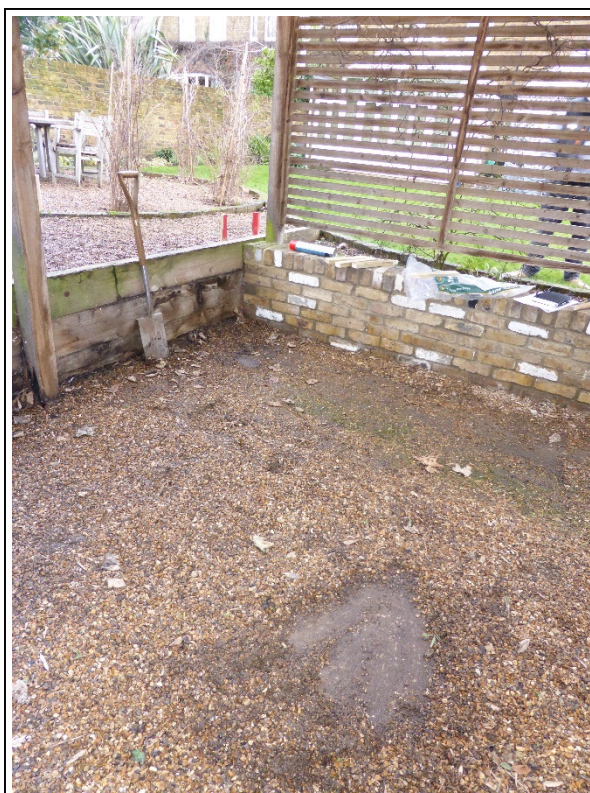
*Photo 2. The existing car port is covered with a hard surfacing of concrete*

A theoretical RPA incursion is anticipated for the excavation and foundation construction of the new garage in a section of the RPA of T1. However, site investigation has revealed that the RPA within the existing car port is covered, to its full extent, with a hard surface of concrete, see photo 2 below. This concrete surface was anecdotally revealed as being in situ when the clients, Mr & Mrs Temple, bought the property fifteen years ago. This concrete slab is to be retained intact and therefore no additional mitigation measures will be required to prevent disturbance to tree roots. The removal of the car port will therefore have no impact on the RPA of the retained tree.

- The RPA of the retained tree within the footprint of the proposed garage is covered by a concrete slab which will be retained and will continue to afford protection, and prevent contamination and compaction, during access, excavation and construction of the piles; and therefore no additional ground protection will be required.

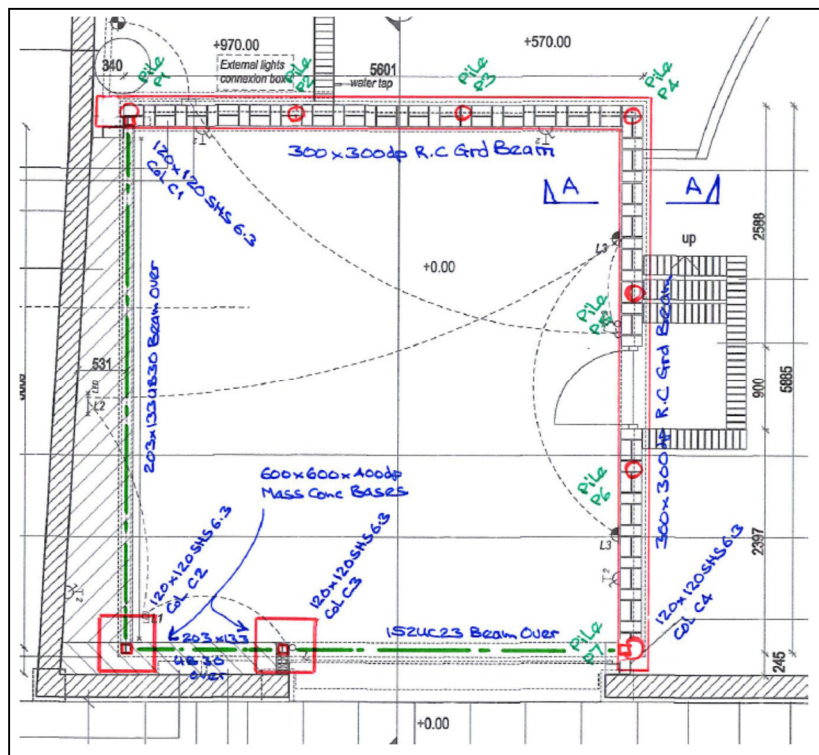
Figure 1: Extract from Drawing 13111A Rev A, sheet title 'Proposed Plan', showing construction of the rear and side walls of the garage on a reinforced concrete ground beam, supported by helical piles.

It is still proposed to construct the rear and side walls of the garage on a reinforced concrete ground beam, supported by helical piles, as per Drawing 13111A Rev A, sheet title; 'Proposed Plan', with an extract in Figure 1 below.

- The helical piles will be located as per the drawing in Figure 1 below; the concrete slab will be broken out as required to allow access for the auger, the holes should then be initially hand dug with an auger to 600 millimetres depth.

- Any roots over 25 millimetres in diameter must be cut cleanly with a suitable sharp tool (e.g. bypass secateurs or handsaw) following consultation with the AC.

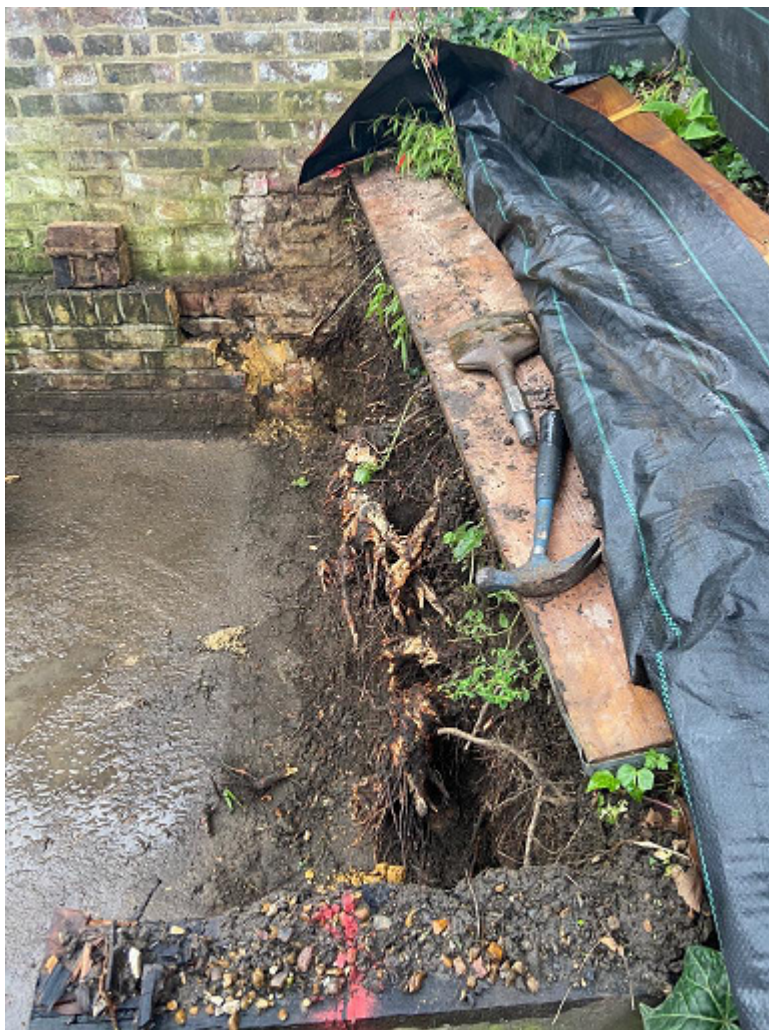
**Photograph of roots found on removal of existing retaining wall on 6 February 2021**

**06.02.2021. Query from MD:** "Good morning Paul, the builders found these as they were preparing to mark the pile position. Can they cut the small roots? Thank you Maria

**06.02.2021. Reply from PB;** "Cut cleanly with secateurs or lopping shears will be fine."
