BS 5837:2012 Arboricultural Survey

Land at Richmond upon Thames College

Presented to Clarion Housing Group

Delta-Simons Project No. 18-0573.02

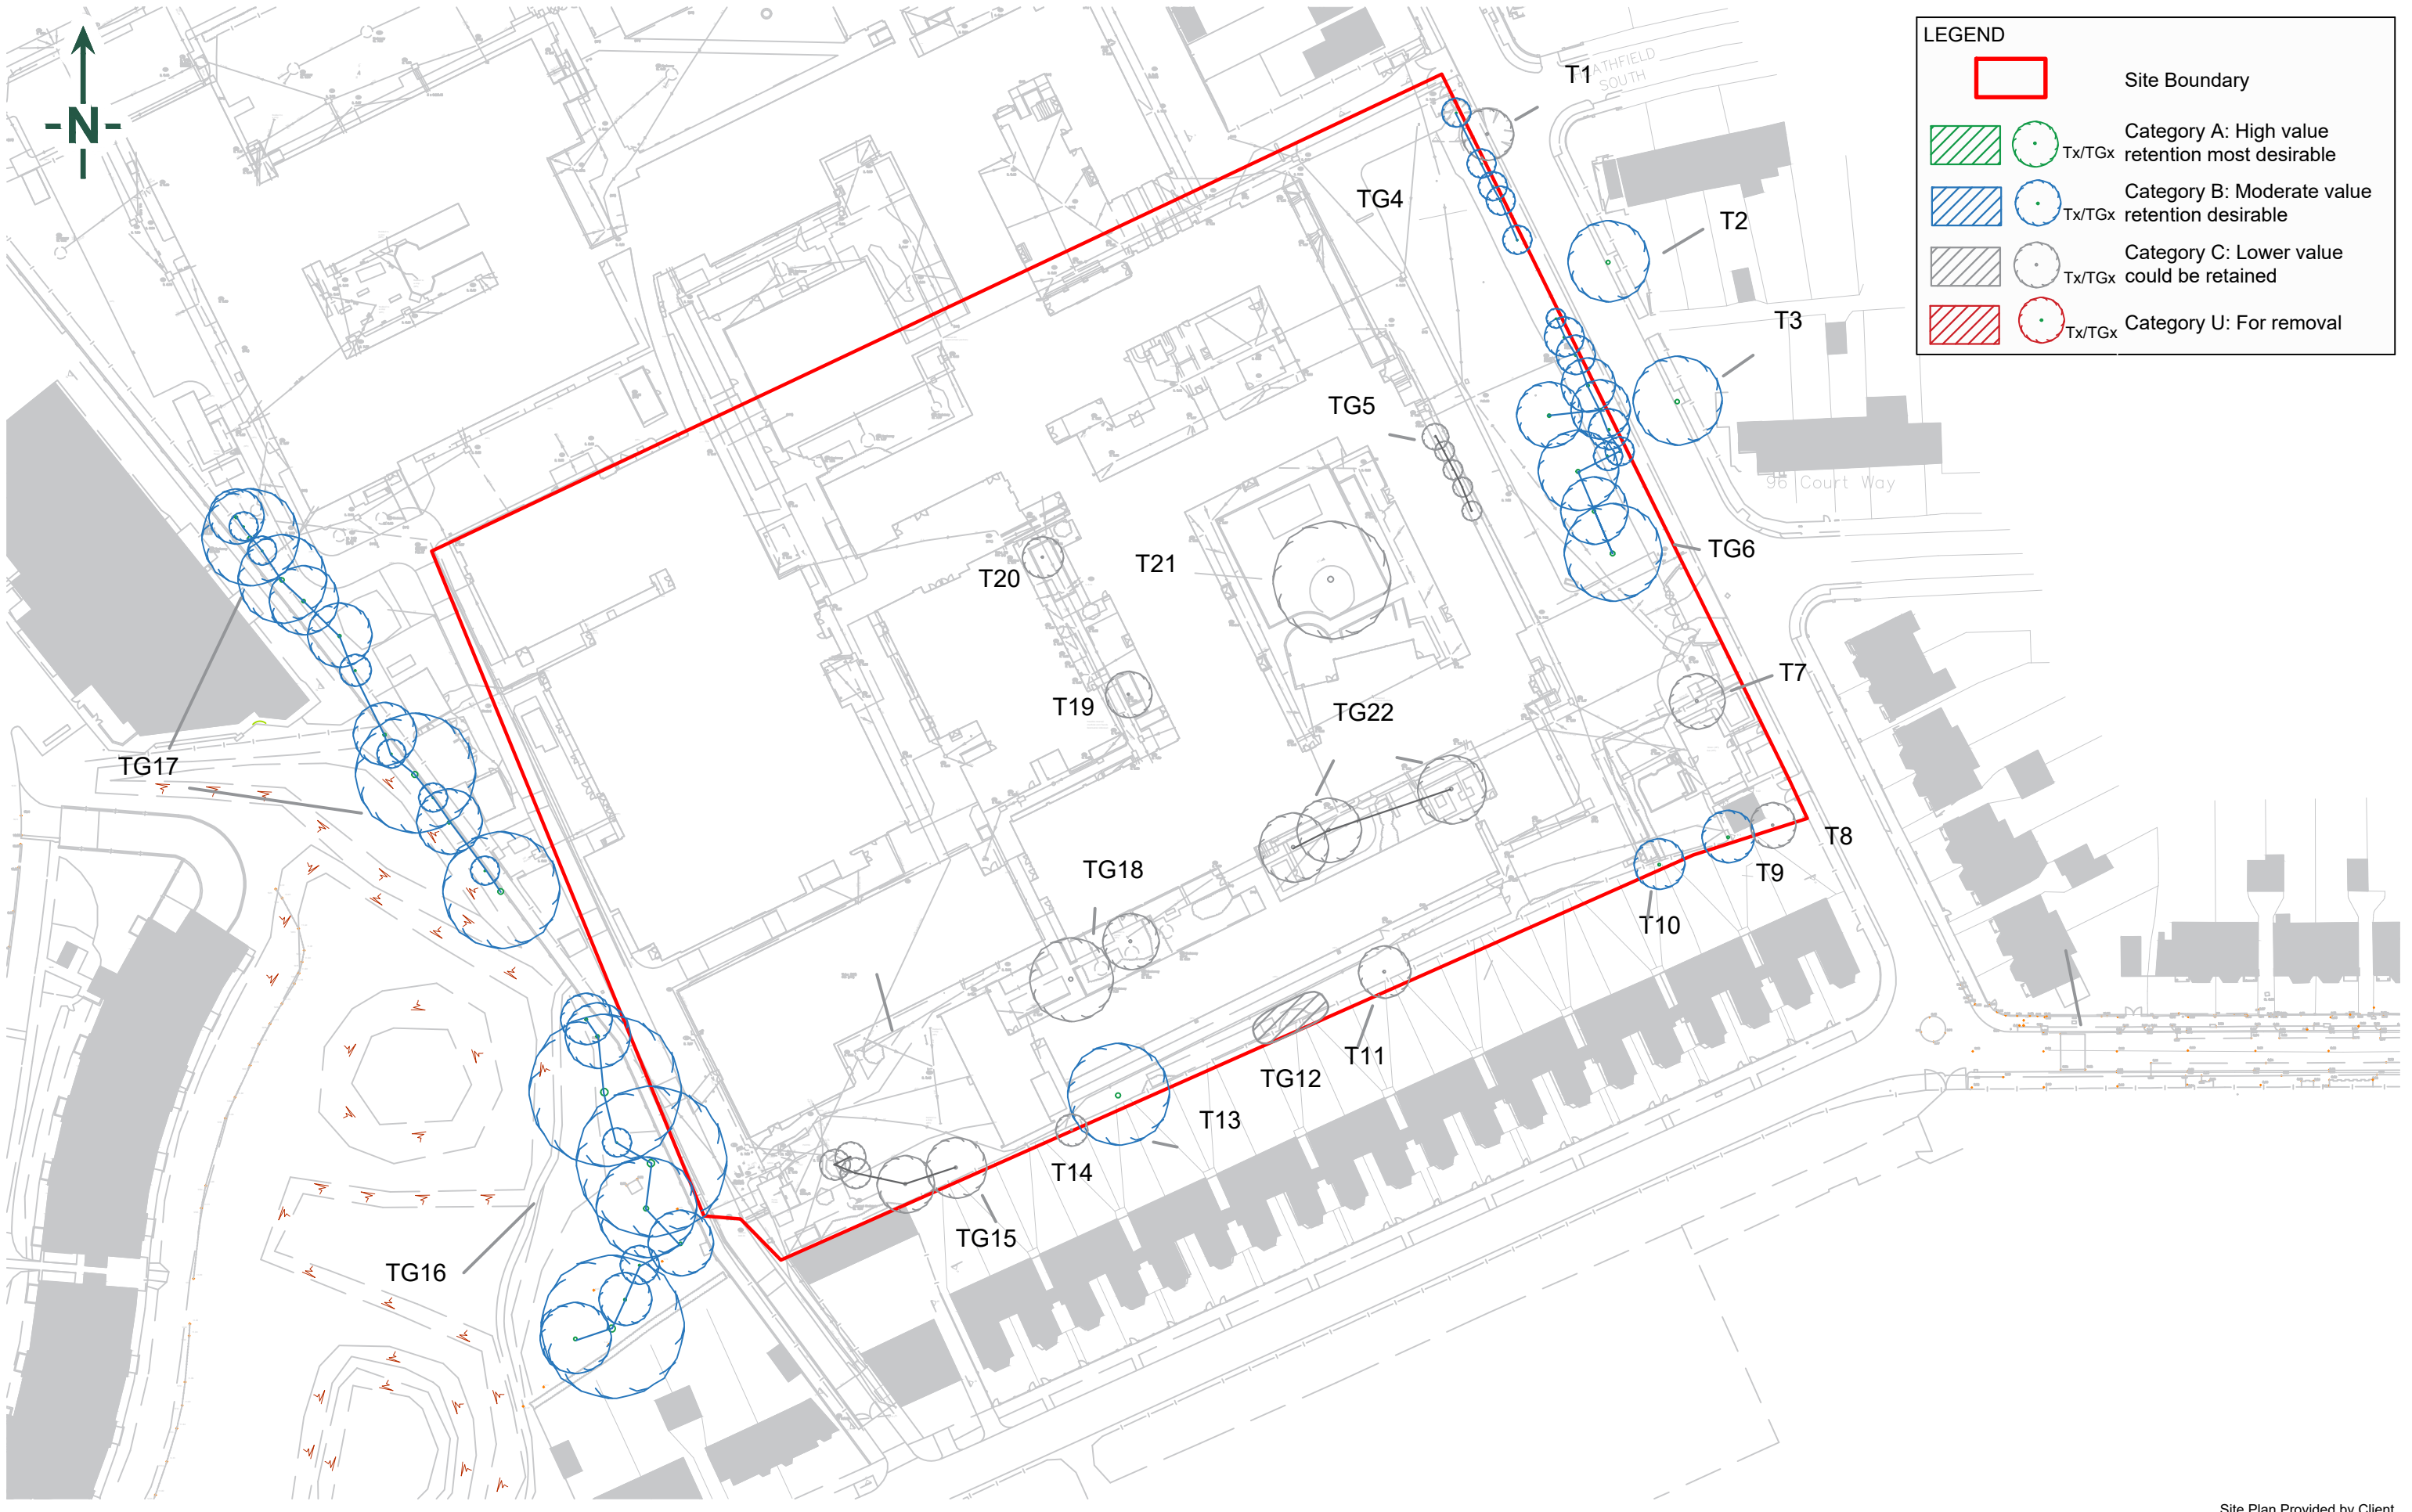
Figure 2 – Tree Survey

The tree inspection took the form of a walkover inspection completed by Peter Morrell TechArbA on 10th February 2021. Each individual tree of significance that could be impacted upon by any proposed development was identified and visually inspected and classified. The trees identified during the survey at the Site have been individually noted and identified within this Report and are shown in the Tree Survey Plan within Figures 2, and within the Photograph Section of this Report (Appendix C).

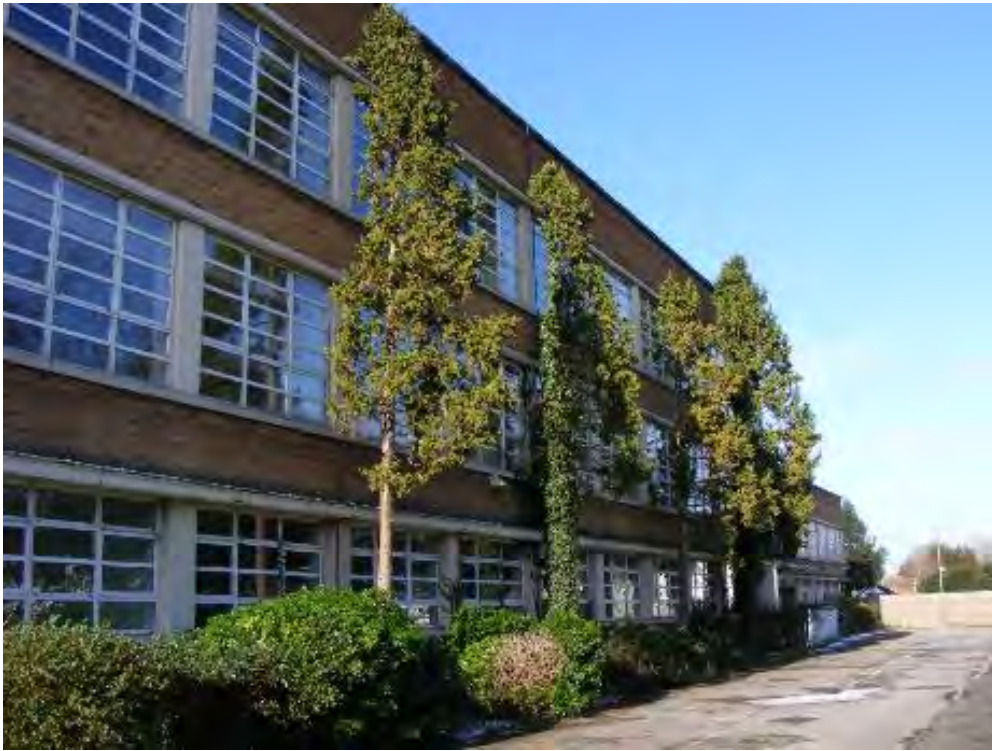
Photograph 5 – TG5

TG5	Lawson cypress	<i>Chamaecyparis lawsoniana</i>	SM	11 Av	1	340 Av	2	2	2	2	2	No visual signs of damage	Single stems. Slight lean to east	Balanced	Located adjacent to front elevation. Two trees ivy clad, Low BRP	F	<20	C2	4.2	
TG6	Alder Cherry	<i>Alnus glutinosa</i> <i>Prunus sp.</i>	M/ SM	13 Av	1	575 Av	2	5	5	5	5	Girdled roots with mower damage	Single stems. Vertical	Mutually shared canopy		F	<20	B2	6.9	
T7	Sycamore	<i>Acer pseudoplatanus</i>	SM	10	1	6 x 200	4	4	4	5	4	No obvious damage	Multiple stems at 1 m. Vertical	Balanced		F	>20	C2	6.0	
T8	Holly	<i>Ilex aquifolium</i>	SM	8	1	Est 250	4	4	4	4	4	No obvious damage	Single stem, vertical.	Conical canopy		F	20 -40	C2	3.6	
T9	Portugal laurel	<i>Prunus lusitanica</i>	SM	8	1	6 x 200	2	4	4	4	4	No obvious damage	Multiple stems from base at various angles	Rounded dense canopy.		F	20 - 40	B2	6.0	
T10	Sycamore	<i>Acer pseudoplatanus</i>	SM	8	3	350 Est	2	2	2	2	2	No visual signs of damage	Multi-stemmed. Vertical	Balanced		F	20 - 40	B2	4.20

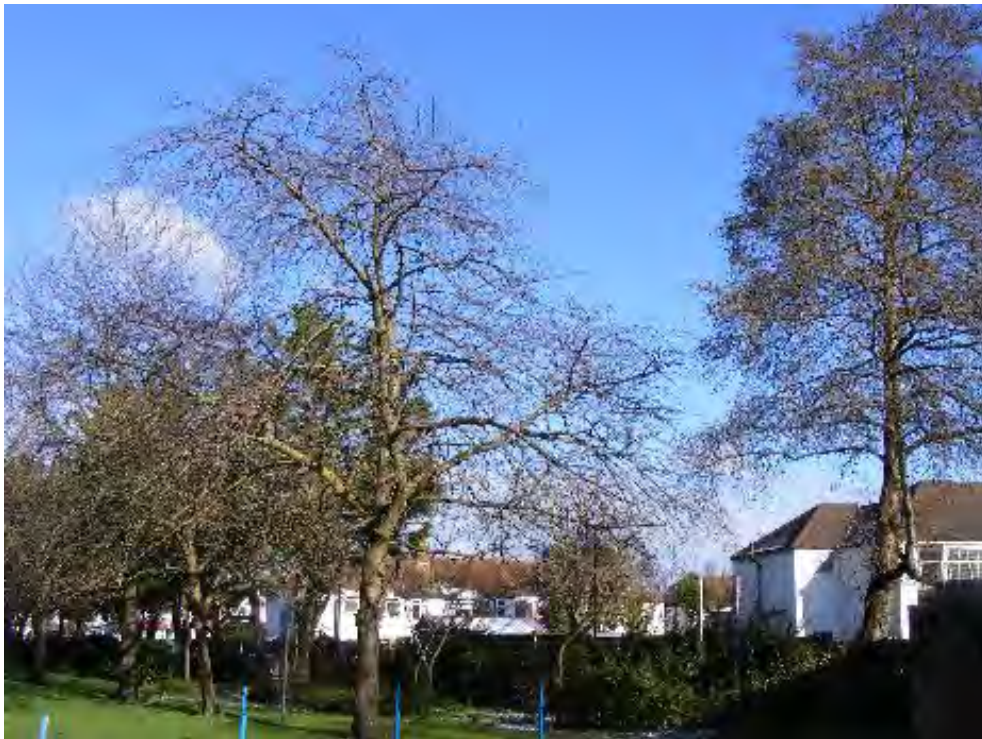
Photograph 6 – TG6

Adjacent to the Site's north-eastern boundary, TG6, a mixed deciduous group, with stature ranging from semi-mature to mature, is in varying degrees of health. The cherries in the group appear to have occasional mower damage to the root system and girdled roots.

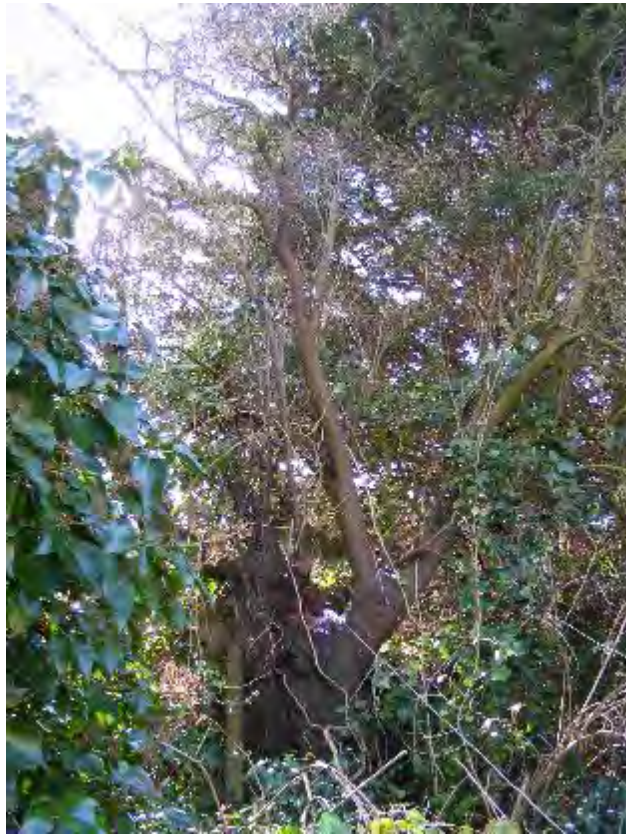
Photograph 11 – T11

T11	Purple leaved plum	<i>Prunus pissardii</i> 'Nigra'	SM	8	1	600	5	5	5	5	5	No obvious damage	Single stem, vertical	Unbalanced canopy	Impacted by surrounding vegetation	F	10 -20	C2	7.2

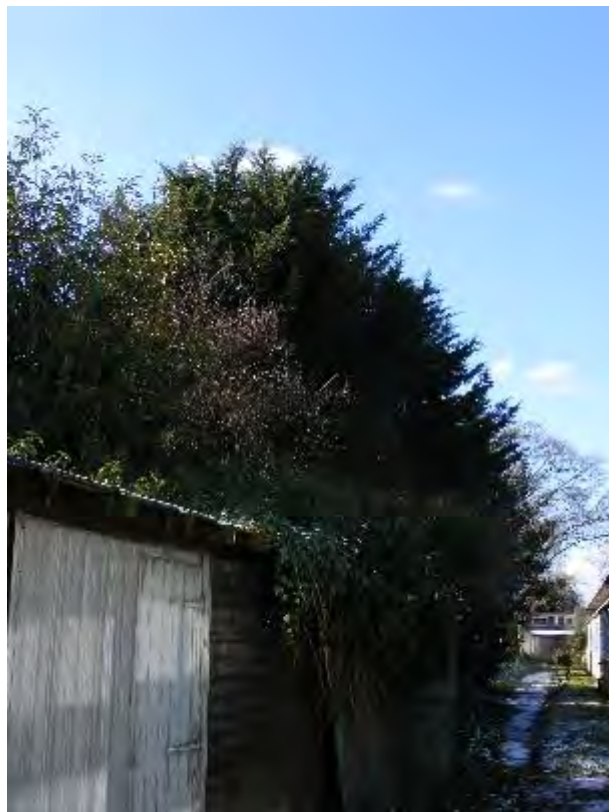
Photograph 12 – TG12

TG12	Leyland cypress Portugal laurel	<i>X Cupressocyparis leylandii</i> <i>Prunus lusitanica</i>	SM	12	M S	Av 350	0	5	5	5	5	No obvious damage	Single and multiple stems, vertical	Canopies read as one.		F	20 - 40	C2	4.2	
T13	Sycamore	<i>Acer pseudoplatanus</i>	M	14	1	825	5	9	8	6	9	No visual signs of damage	Single stem. Vertical	Unbalanced	Rot hole on stem. Low BRP	F	20 - 40	B2	9.9	
T14	Sycamore	<i>Acer pseudoplatanus</i>	SM	12	1	Est 300	4	4	4	4	4	No obvious damage	Single stem. Vertical	Open rounded canopy		F	20 - 40	C2	3.6	
TG15	Apple Purple leaved plum Silver birch Elder	<i>Malus sp.</i> <i>Prunus pissardii</i> 'Nigra' <i>Betula pendula</i> <i>Sambucus nigra</i>	SM	8 Av	1	330 Av	2	7	5	4	5	No visual signs of damage	Single stems. Vertical	Suppressed crowns by neighbouring trees	Ivy cladding on plum. Low BRP	F	<20	C	3.9	
TG16	Willow Sycamore Pedunculate oak Tree of heaven	<i>Salix sp.</i> <i>Acer pseudoplatanus</i> <i>Quercus robur</i> <i>Ailanthus altissima</i>	SM	8 Av	1	300 Est	3	3	4	3	4	Unable to assess due to access	Single stems. Vertical	Mutually shared canopy	Private trees	G	20 - 40	B2	3.6

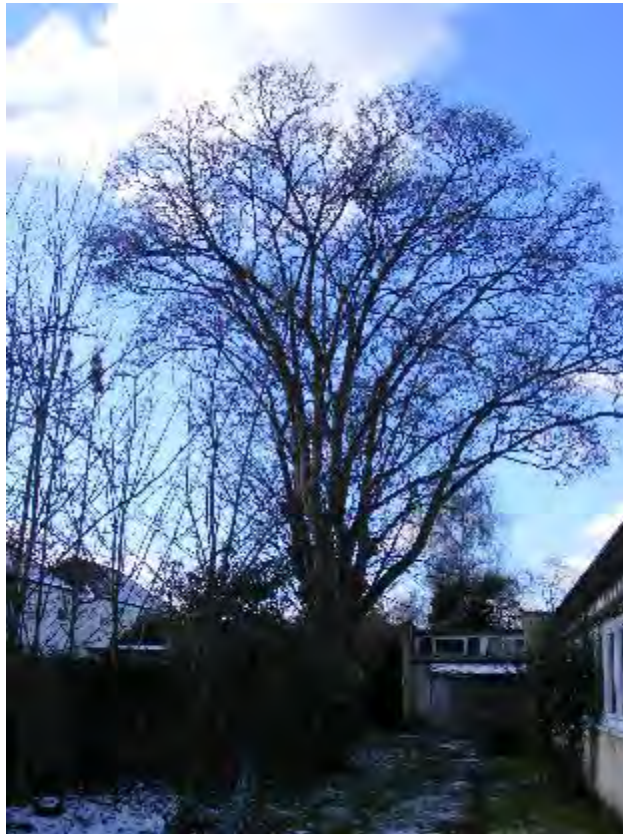
Photograph 13 – T13

Adjacent to the Site's southern boundary, T13, a mature sycamore with an unbalanced crown, which has been regularly pruned to the southern aspect, appeared to be in good health at the time of the survey, though supported a rot hole on the main stem.

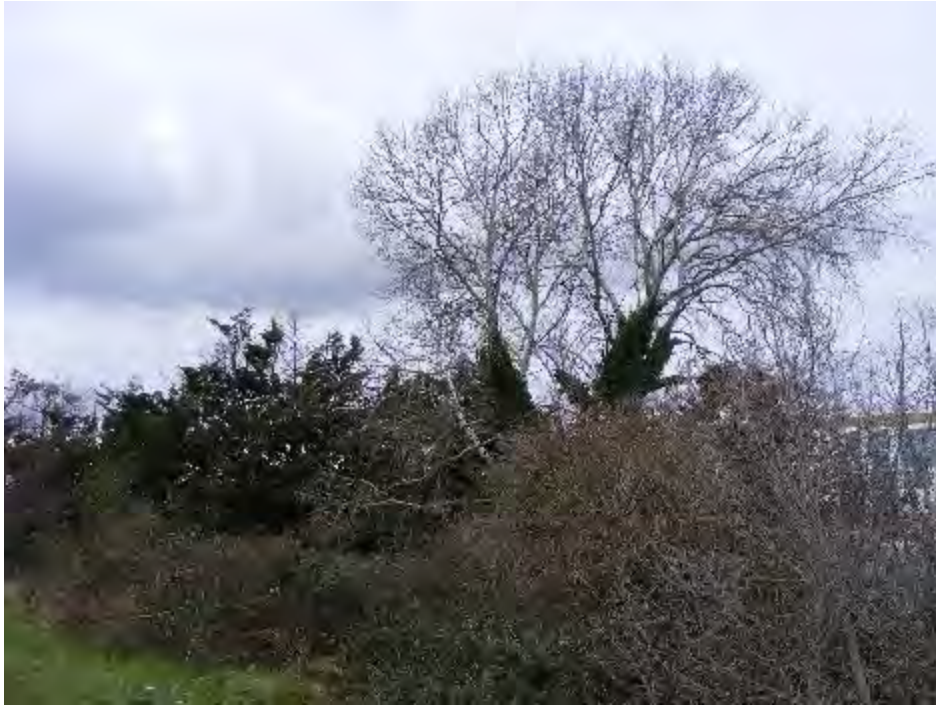
Photograph 17 – TG17

TG17	White poplar Cherry Leyland cypress	<i>Populus alba</i> <i>Prunus sp</i> <i>X Cupressocyparis leylandii</i>	M	18 Av	1	600 Av	5	9	6	8	5	No visual signs of damage	Single stems. Vertical	Unbalanced	Bifurcated at ground level. Ivy covered. Low BRP	F	20 - 40	B2	7.2	
TG18	Ash Hornbeam	<i>Fraxinus excelsior</i> <i>Carpinus betulus</i>	SM	11 Av	1	410 Av	2	5	5	4	5	No visual signs of damage	Single stems. Vertical	Balanced	Fused stems to hornbeam	F	<20	C2	4.8	
T19	Cherry	<i>Prunus sp.</i>	SM	6	1	375	2	4	4	4	4	No obvious damage	Single stem. Vertical	Open rounded canopy.		F	20 - 40	C2	4.5	
T20	Alder	<i>Alnus glutinosa</i>	SM	15	1	200	2	4	4	4	4	No obvious damage	Single stem, vertical	Conical canopy.		F	>40	C2	2.4	
T21	Cherry	<i>Prunus sp.</i>	M	16	1	450 525	2	8	8	8	8	No obvious damage	Bifurcated at base, vertical.	Rounded canopy, lifted to 2 m.		F	<20	C2	8.4	
TG22	Sycamore Cherry Goat willow	<i>Acer pseudoplatanus</i> <i>Prunus sp.</i> <i>Salix caprea</i>	SM	12 Av	1	Av 200	2	7	5	7	6	No visual signs of damage	Single stems. Vertical. Ivy clad	Unbalanced	Damage to roots and decay present on stem from root flare to 0.5 m on willow Two trees ivy clad, Low BRP.	F	<20	C2	2.40	Sever and remove ivy

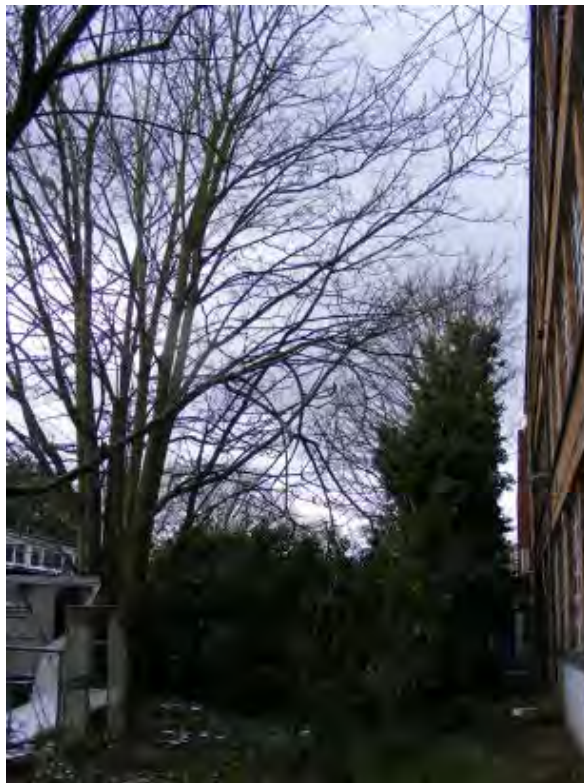
Photograph 22 – TG22

Within an internal area of the Site, a willow in TG22 supported damage to roots and decay was present on the main stem from root flare to 0.5 m.
