Client: Mr Tim Sleisinger
Project: Sudbrook Lodge, Petersham Road, Ham, TW10 5HA
Title: TREE CONSTRAINTS PLAN
TREE PROTECTION PLAN
Date: 11/09/21 Scale: 1:200 Original Paper Size: A3
Drawn: IST Checked: N/A Job Ref: AC.2021.455
Drawing Number: **TPP-01** Rev: **A**
Arbor Cultural Ltd Providing Expertise on your Trees
https://arbor-cultural.co.uk

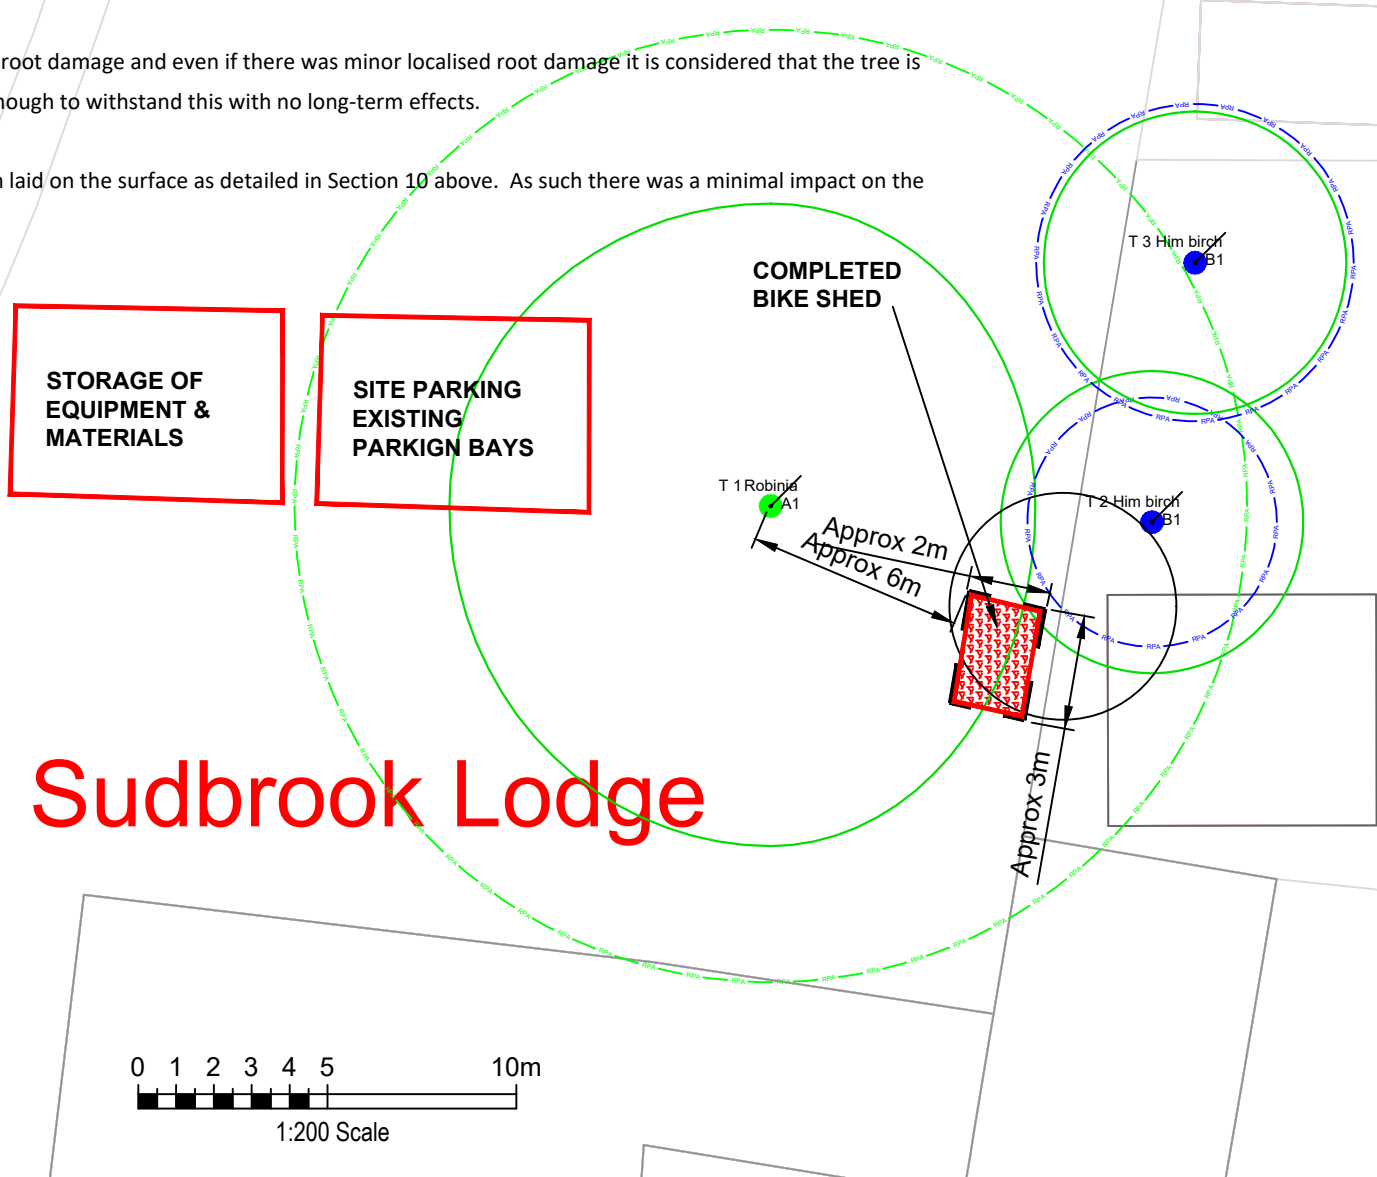
- 10.1 The entire footprint of the completed bike shed is within the RPA of T01 a Robinia. This was constructed using no-dig construction techniques, with the shallow pad foundation laid on top of the existing ground level see Image 6 to 8.

- 10.2 There would have been some localised compaction of the ground immediate underneath the slab to provide a solid base. This will have had a minimal impact on the tree T01, based on the distance for the tree, the no-dig construction techniques, the size of the foundation, and the relatively small amount of surface compaction.

- 10.3 Despite the lack of awareness of the need for ground protection measures the surrounding soil shows little sign of any compaction, indicating that the construction activity was largely limited to the existing footpath and the completed building footprint.

- 10.4 There is no evidence of any root damage and even if there was minor localised root damage it is considered that the tree is large enough and healthy enough to withstand this with no long-term effects.
