**Sand Arena Extension - Ham Polo Club,
Richmond**
Arboricultural Assessment

Client: Ham Polo Club Ltd
18th September 2021 – Issue 2
Ref: GL1457

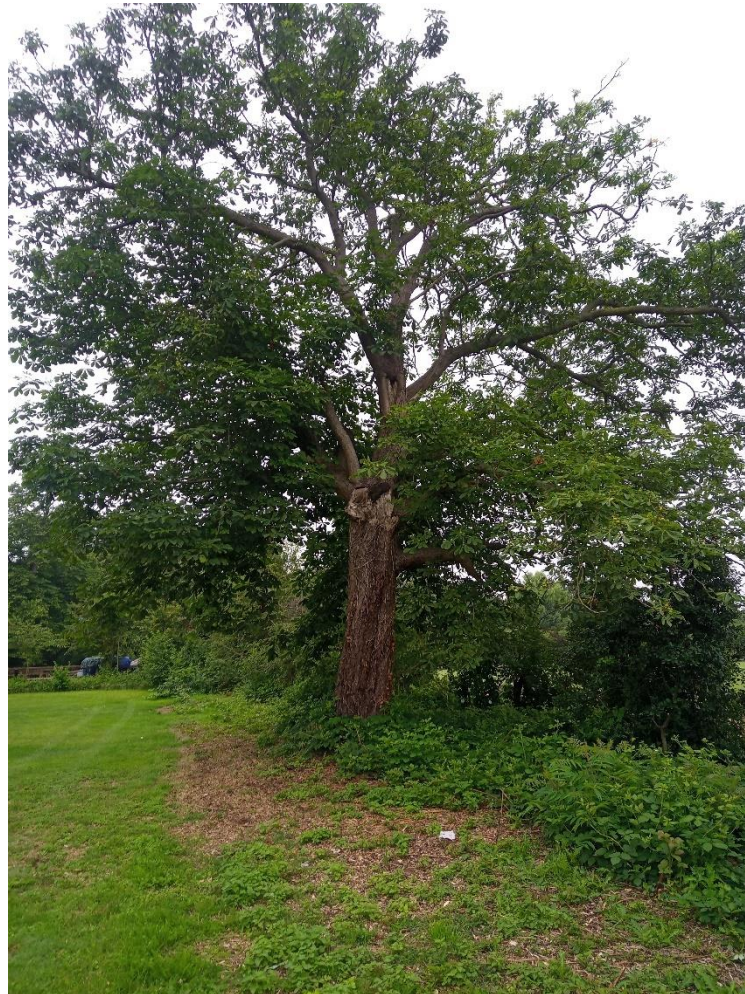
Image 1: Displaying T002 - previous points of failure and associated wounds are visible, together with slight sparsity in upper crown foliage and pronounced asymmetric form.

- 3.3 T002 is a mature horse-chestnut located on the west site boundary. Foliage is slightly sparse in areas. The tree exhibits frequent stem exudations on the lower stem, symptomatic of horse-chestnut bleeding canker *Pseudomonas syringae pv aesculi*. There

is a large tear wound c. 600mm diameter visible at the crown break, 4m above ground level on the south side. It is evident a codominant leader was lost and the resultant crown is heavily asymmetric and the failure wound a significant entry point for disease and decay. An additional failure wound is visible at 6m on the southern side. The tree requires crown reduction to address the resultant crown asymmetry and reduce risk of future stem and branch failures. The tree is considered category C1 and has an estimated remaining contribution of 10+ years.

- 4.2 The development requires the removal of one tree recorded in this survey, T002. As set out in section 3, this is a low quality category C1 horse-chestnut. The tree has suffered significant damage in the past and requires crown reduction that would further restrict its size, quality and any associated amenity value. Its loss is therefore considered to be minor.
- 4.3 An area of hawthorn scrub requires removal to facilitate the construction of the sand arena. This equates to approximately 102m². This removal represents a loss of vegetation and habitat from the site that should be replaced in equal measure as part of the development proposal.

- 5.2 The following tree surgery operations are to be completed prior to any construction works commencing on site. They are to be completed by an appropriately qualified and insured arboricultural contractor and in strict accordance with British Standard 3998:2010 Tree Work – Recommendations.
- 5.3 No individual trees require removal to facilitate the development. An area of hawthorn scrub requires removal and it is proposed to fell tree T002. These works shall be carried out as illustrated on **GL1457 04**.

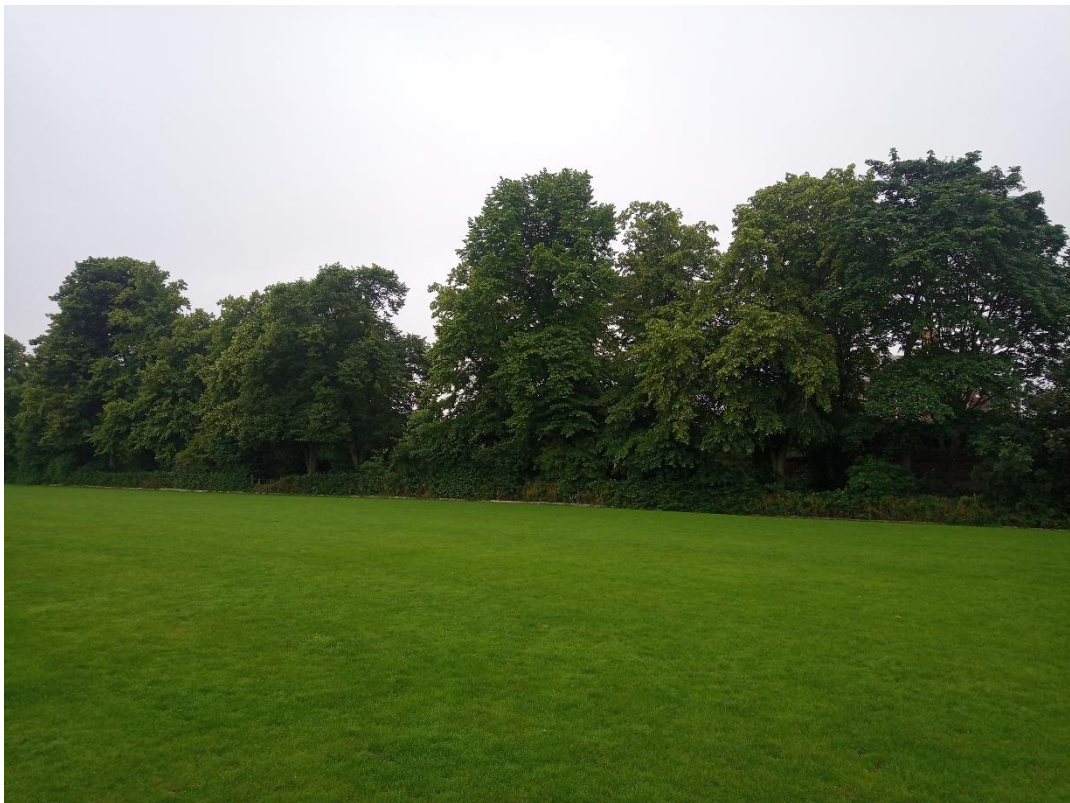
3.4 G003 comprises part of an avenue of lime which lines Melancholy Walk, a footpath cycleway between the west site boundary and east boundary of Ham House. The trees were in full leaf when inspected and as such assessment of detailed aerial defects was inhibited. All trees appeared in good physiological condition and attract significant value as a formal arboricultural feature with high associated amenity value and cultural value, due to their relationship with Ham House.

Image 2: Displays group G003.

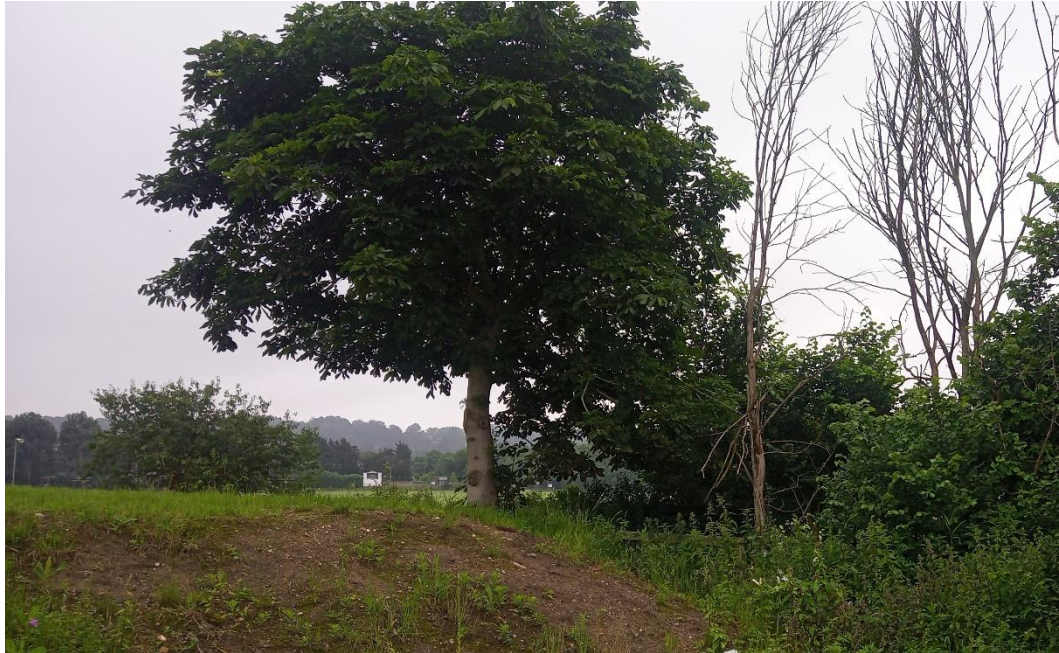
- 3.5 T004 is a small horse chestnut located on an earth mound towards the south-east corner of the site. It is a young tree in good vigour and without defects. It is considered category B1.

Image 3: Displaying T004, with a small area of scrub and dead elm to the right.
