Client							
THE ROYAL PARKS							
Project Name Richmond Park Boundary Walls rep Wall backing Roehampton Vale Drawing	airs						
Elevation, Location plan, Sections (Chohole to Beverley Brook)							
Scale 1:200, 1:1250 & 1:20 @ A1							
Drawn by GH/MOF December 2021 Checked by

HOFA 17 01. 106 -

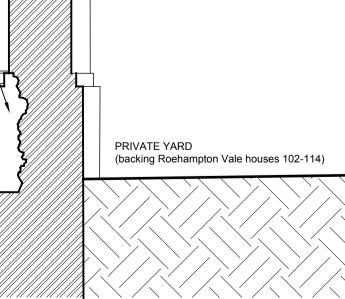
Brick plinth missing or spalling away fromthe wall due principally to embedded ivy and buddleia rooting in the brickwork where the pointing has previously failed. PUBLIC FOOTPATH

roots to be treated with a brush applied bio-cide. After brick removal brush down exposed wall and remove all embedded soil and debris. Following soil removal DoFF clean lower wall at maximum pressure and temperature to remove all pathogens, lichen, moss spores seeds etc and kill off algae colonization. Rebuild brick work in Flemish Bond as existing. Where the condition of the background brickwork allows cut out and piece in header brick to bond with existing. Otherwise following approval use stainless steel Ancon SPB ties to improve the bond and incorporate bed joint stainless-steel

reinforcement in the topmost brick course. Provide a mortar fillets to protect the top of the plinth to shed water, debris and seed build up.

Remove existing Buddleia. Take down displaced brickwork and extract or cut back all embedded roots. Cut back roots to be treated with a brush applied bio-cide.

Rebuild brick work in Flemish Bond as existing reusing salvaged bricks . Where the condition of the background brickwork allows cut out and piece in header brick to bond with existing. Liaise with Richmond Park Management TRP Projects and Householders regarding access and protection for the duration of the works
