HERITAGE DESIGN AND ACCESS STATEMENT

Project: Richmond Park Wall backing Roehampton Vale
Client: The Royal Parks
Title: Heritage Design and Access Statement
Date: December 2021

Ref/File No:3.1

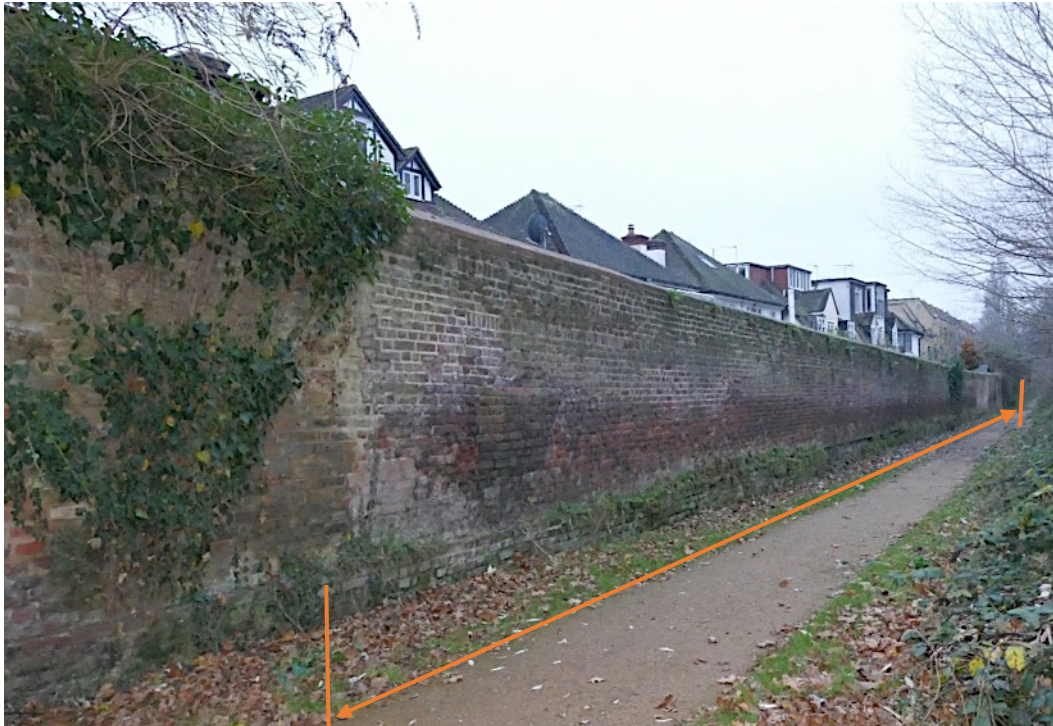
Figure 1:- General view of the area of wall and plinth scheduled for repairs indicated by orange arrows.

The brick plinth of the Wall is collapsed and generally parting from the main structure due to a combination of aggressive plant colonisation (nettles, ivy and buddleia) and mortar failure. The wall here faces to the northwest and being relatively low-lying and sheltered the base of the wall remains damp and supports extensive moss and algal growth. The collapsed section extends for approximately 30 metres, Further sections of some 20-30 metres are partly collapsed or failings at the top of the plinth. Examination of the collapsed brick fabric suggests that the plinth has failed previously and has been rebuilt/refaced.

Rebuilding of the collapsed and loose sections of the plinth using salvaged bricks with some new matching bricks to make up losses. New and salvaged bricks will be blended to avoid banding variations. New bonding bricks and stainless-steel bed joint reinforcement and ties will be incorporated to improve the bond with the existing. A mortar fillet will top the plinth to mitigate water traps and build-up of seedlings in organic debris.

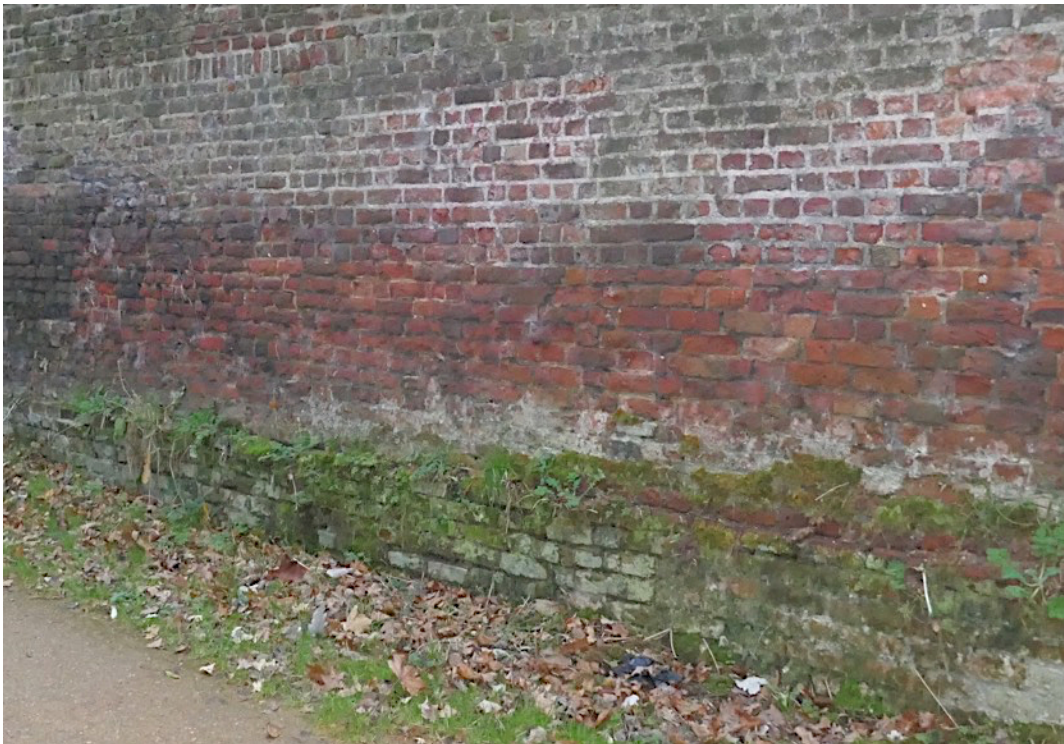
Figure 2;-The mortar bedding in the plinth is completely degraded. The bricks are generally loose but are bound in place by roots and friction.

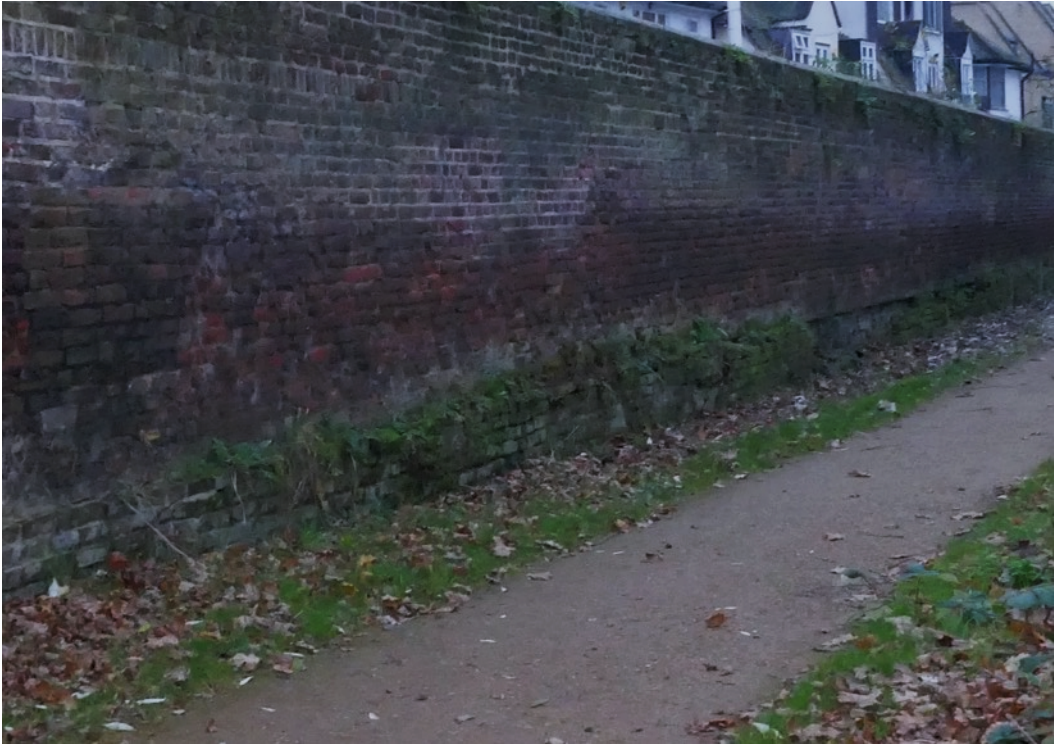
Figure 3;-The bricks in the near plinth are loose as in the previous picture. Further to the right the plinth has fallen away.

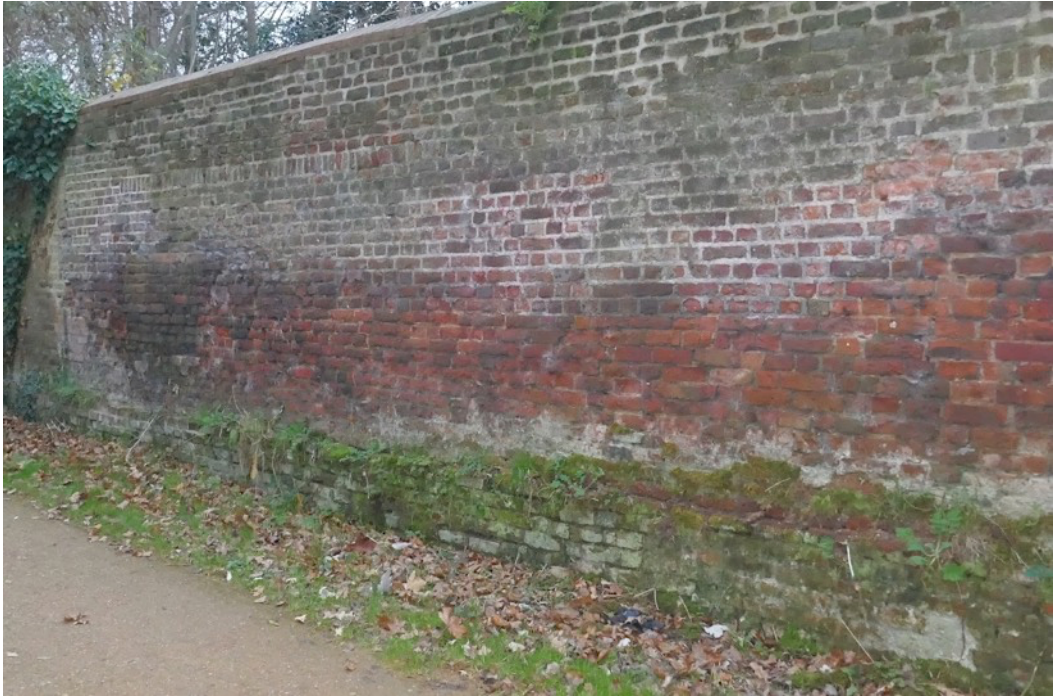
Figure 4;- Another example of brickwork failure in the plinth where the brick remain in place held by the plant roots.

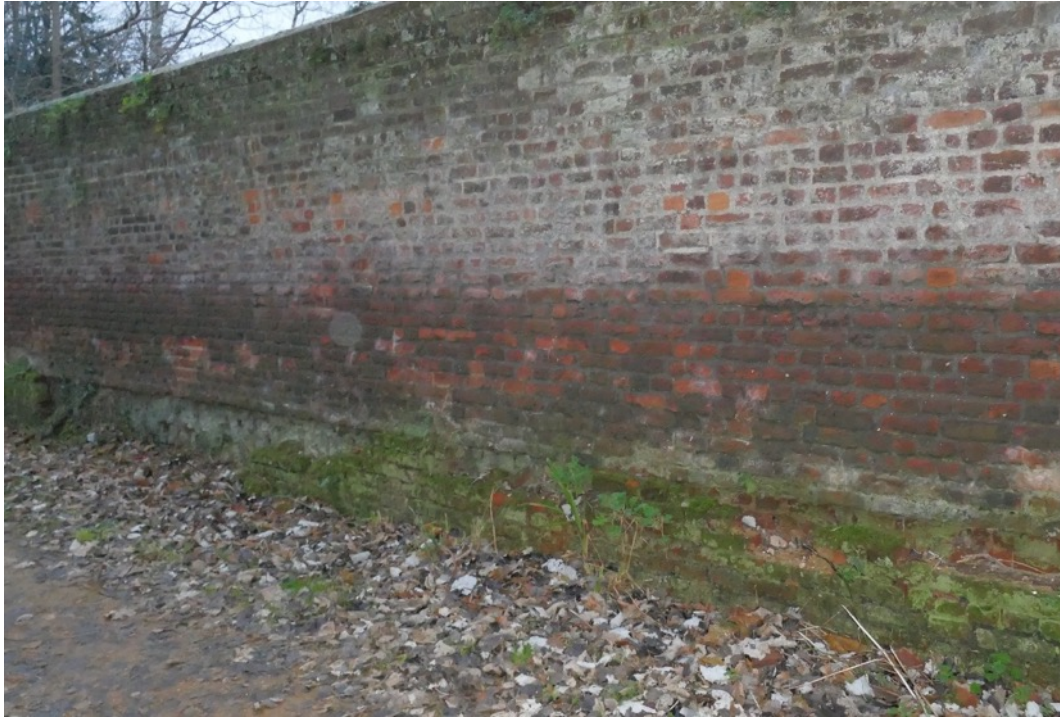
Figure 5;- The plinth has completely fallen away on the left of the picture. The expose core of the wall is heavily colonised with green algae.

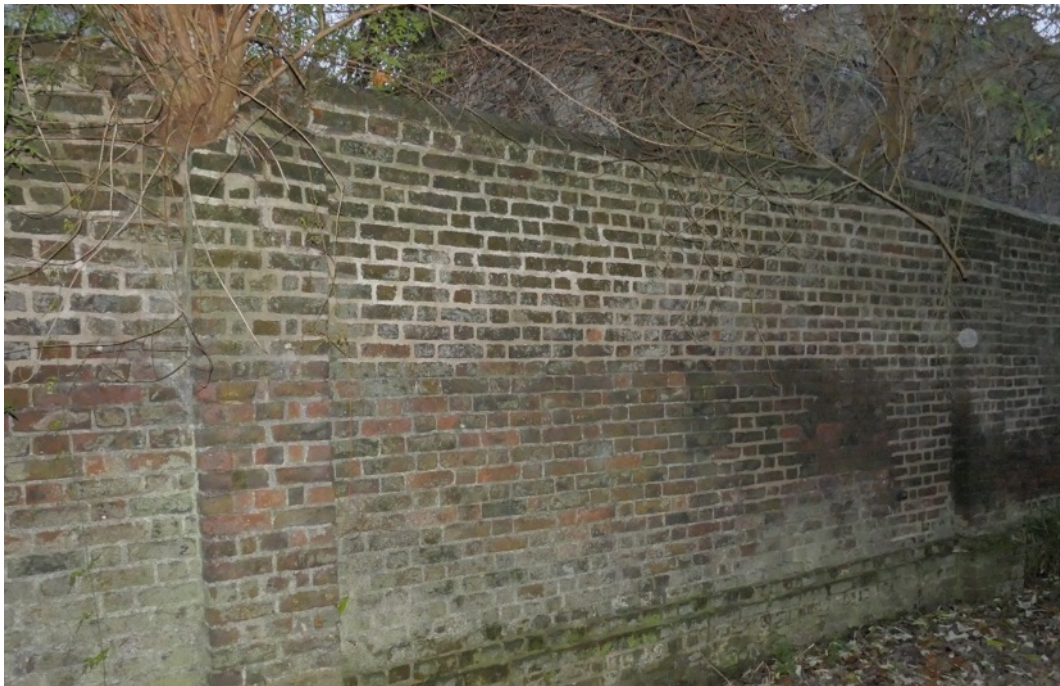
Figure 6;- Embedded semi-mature buddleia plants in top of the wall above the piers have cracked and loosened the brickwork in the wallhead.

Rebuilding the top of the wall as existing in 3no. isolated areas where deeply embedded Buddleia roots are cracking and dislodging the brickwork
