CONDITION SURVEY OF THE FLOOD DEFENCE WALL*

Condition Survey of the Thames River Wall

Stag Brewery

14 December 2016

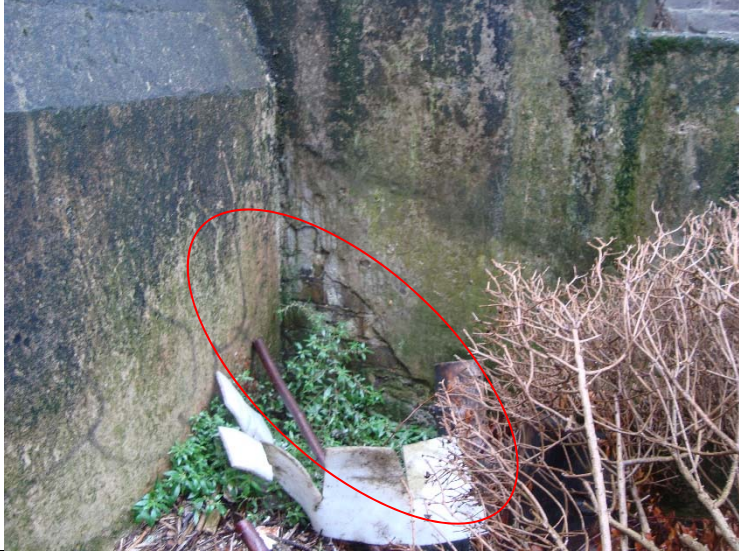
Name	Photograph
<p>P01</p> <p>Render spalled off bricks at the base of the stairs</p>

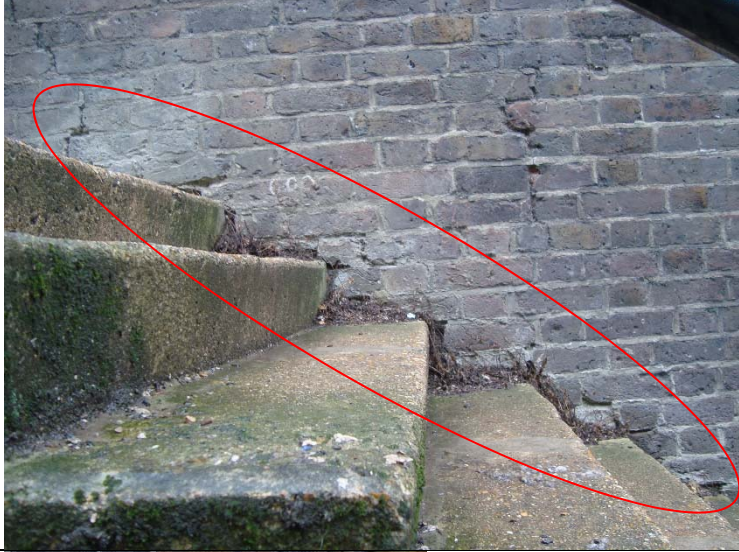
<p>P02</p> <p>Loss of mortar on the face of the brick wall above the stairs</p>

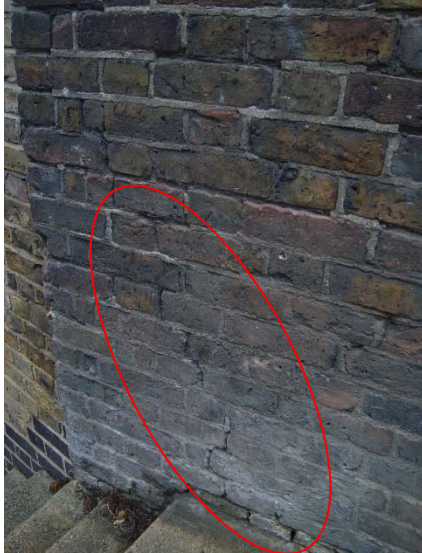
<p>P03</p> <p>Crack propagating upwards from the top of the stairs</p>

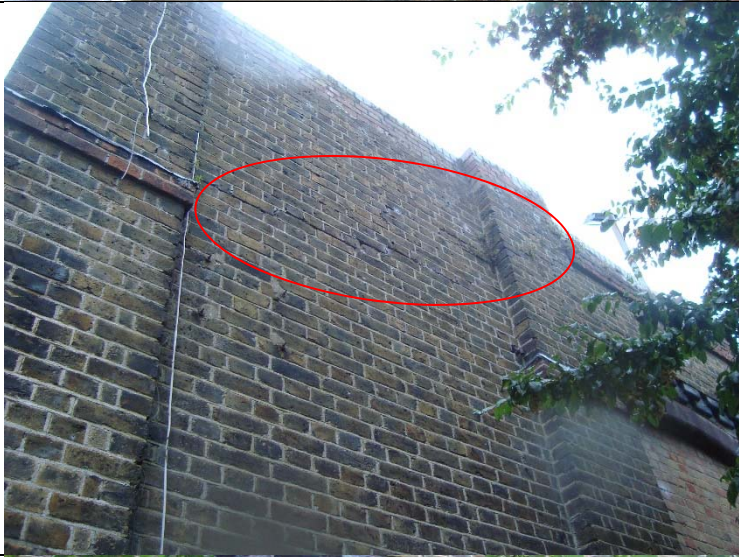
A photograph of a brick wall corner. A red oval highlights a diagonal crack that runs from the bottom left towards the top right across the corner. There is some graffiti on the wall.
P11 Crack running diagonally

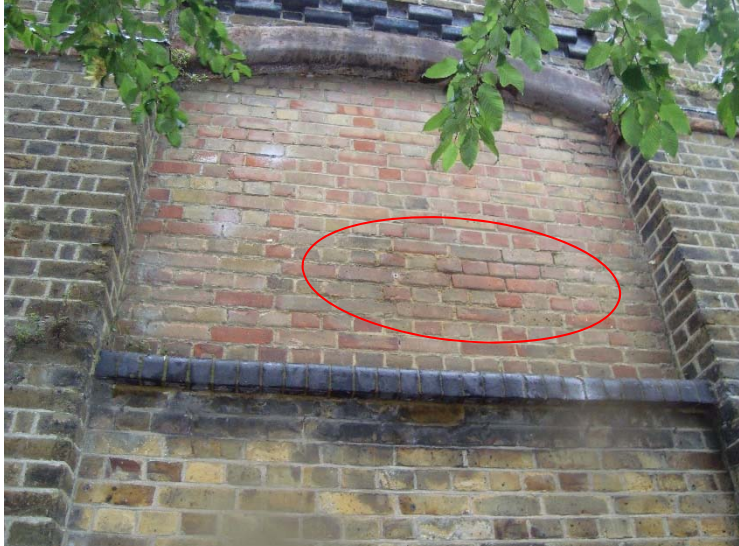
A photograph of a brick wall corner, viewed from a slightly different angle than P10. A red oval highlights a diagonal crack running across the corner.
P12 Loss of mortar on brick face

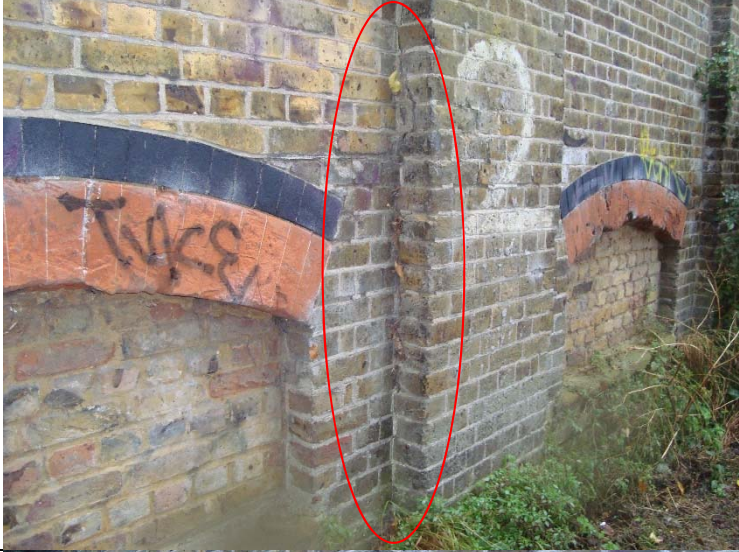
P14 Crack

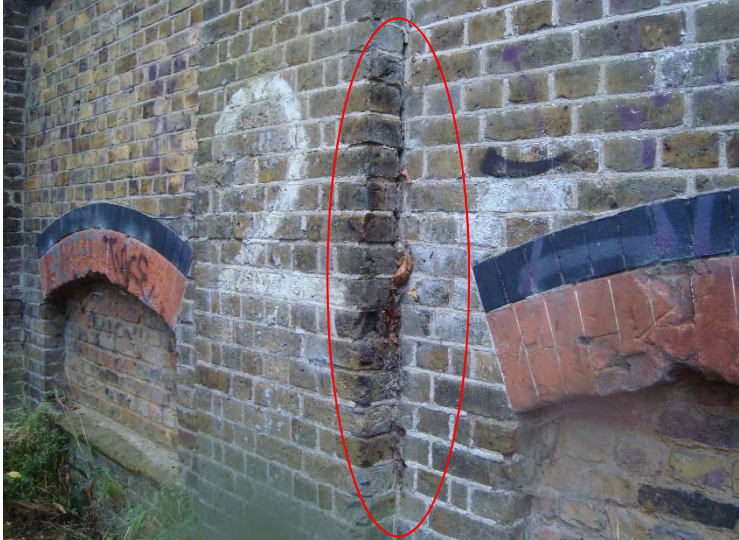
P15 Crack

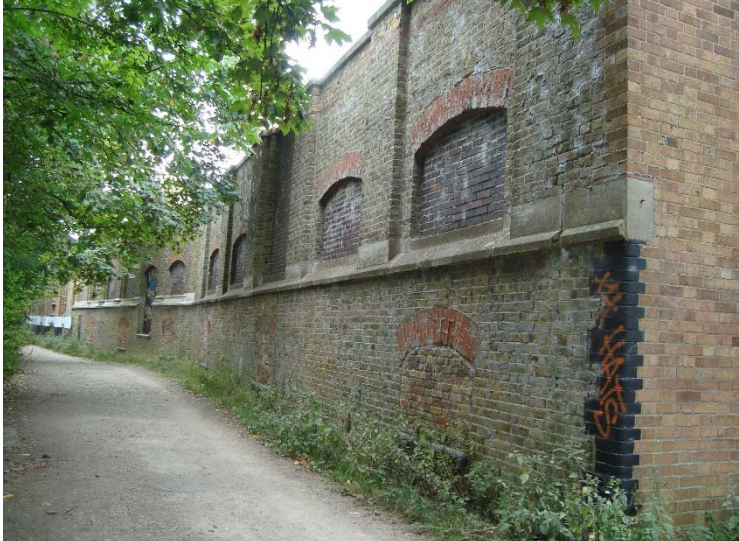
<p>P27</p> <p>Bricked window edges minor spalling</p>

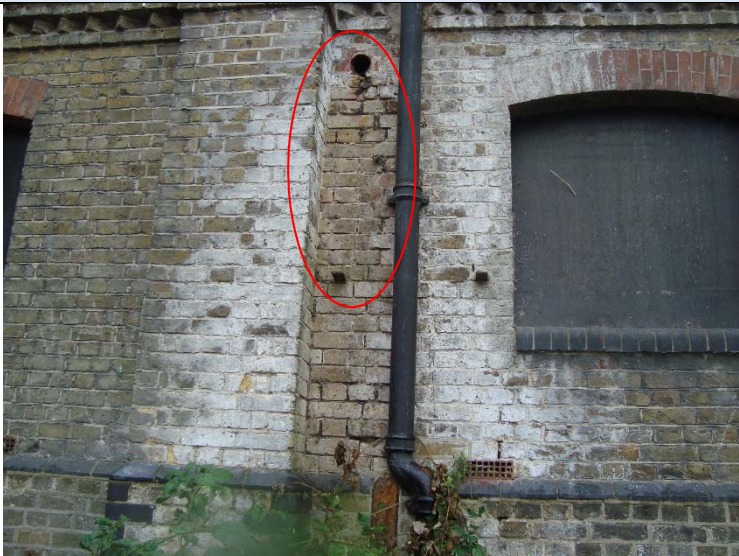
Name	Photograph
<p>P40</p> <p>Mortar loss below metal pipe in brick wall</p>

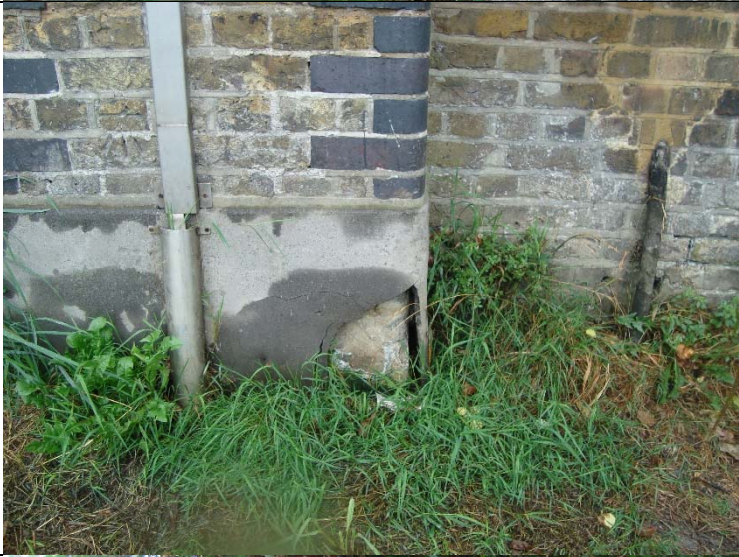
<p>P41</p> <p>Loss of render along bottom face of wall</p>

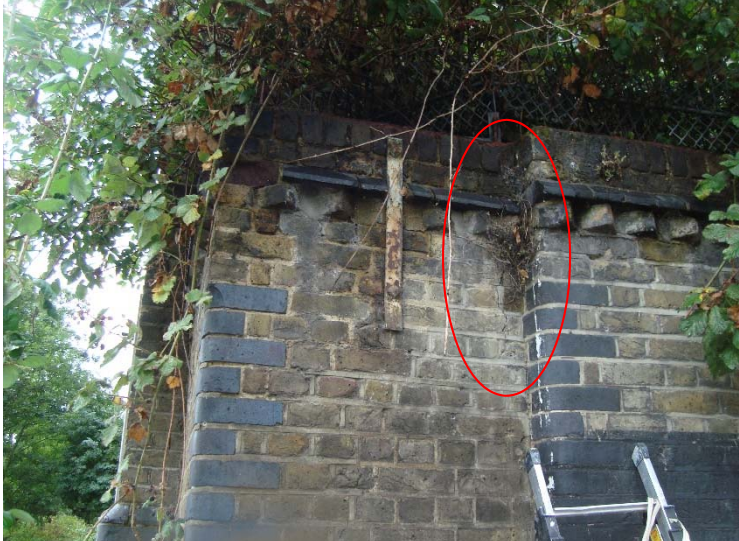
<p>P42</p> <p>Crack at the top of the wall</p>

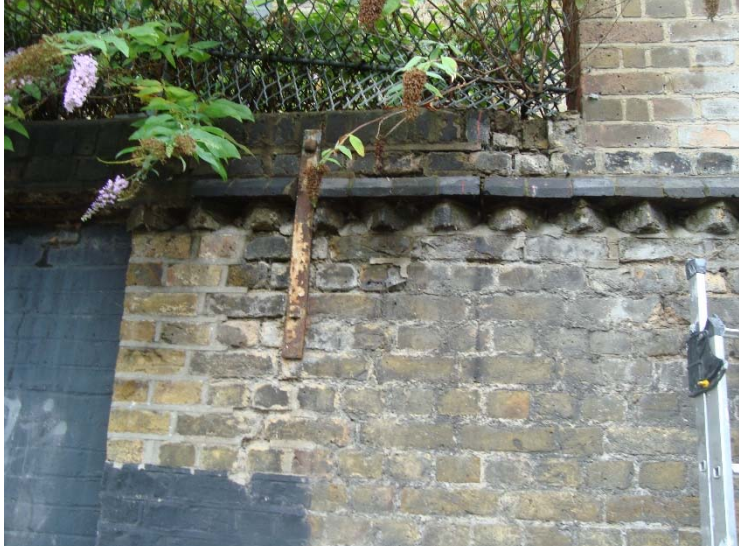
Name	Photograph
<p>P43</p> <p>Loss of mortar along bottom face of brick wall</p>	 
<p>P44</p> <p>Loss of mortar along bottom face of brick wall</p>	 
<p>P45</p> <p>Mortar loss and spalling bricks</p>

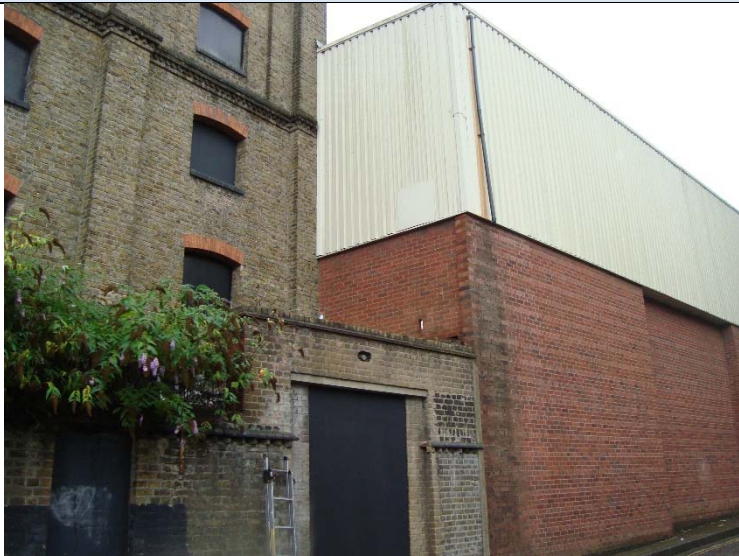
Name	Photograph
<p>P46</p> <p>Brick staining due to the outlet of a pipe above</p>

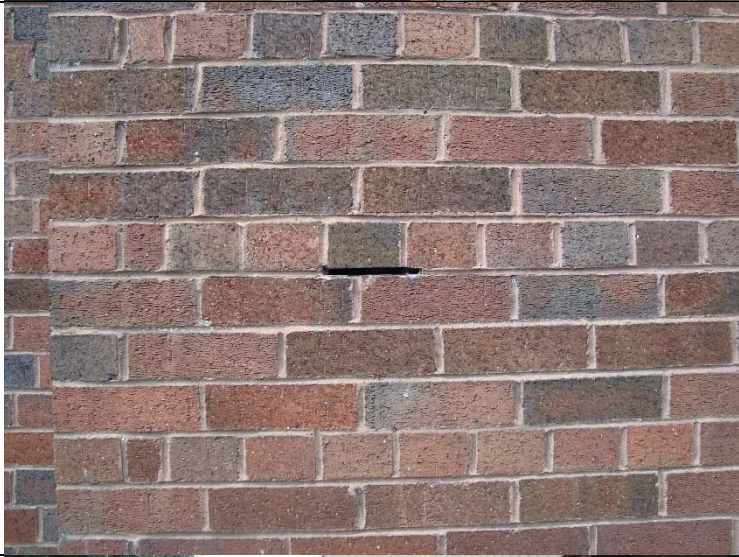
<p>P47</p> <p>140mm long hole through brick wall</p>

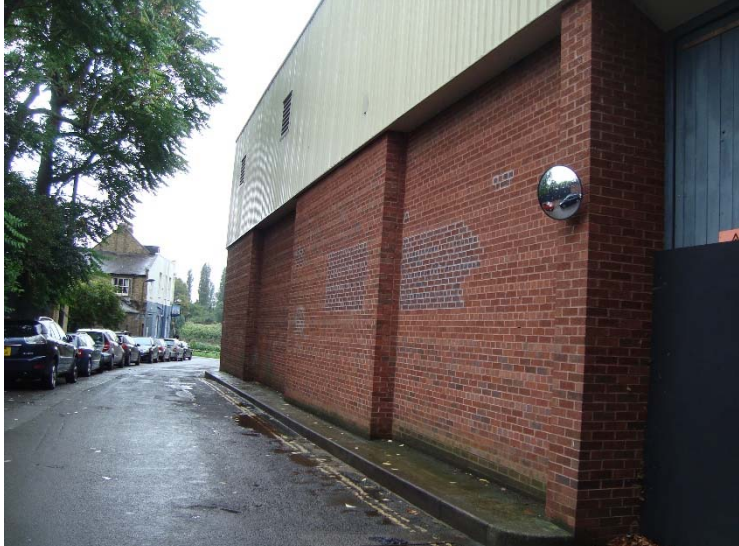
<p>P48</p> <p>Existing repaired brickwork</p>
