BUILDING SURVEY

**25 HAM FARM ROAD
RICHMOND
SURREY
TW10 5NA**

24th June 2021

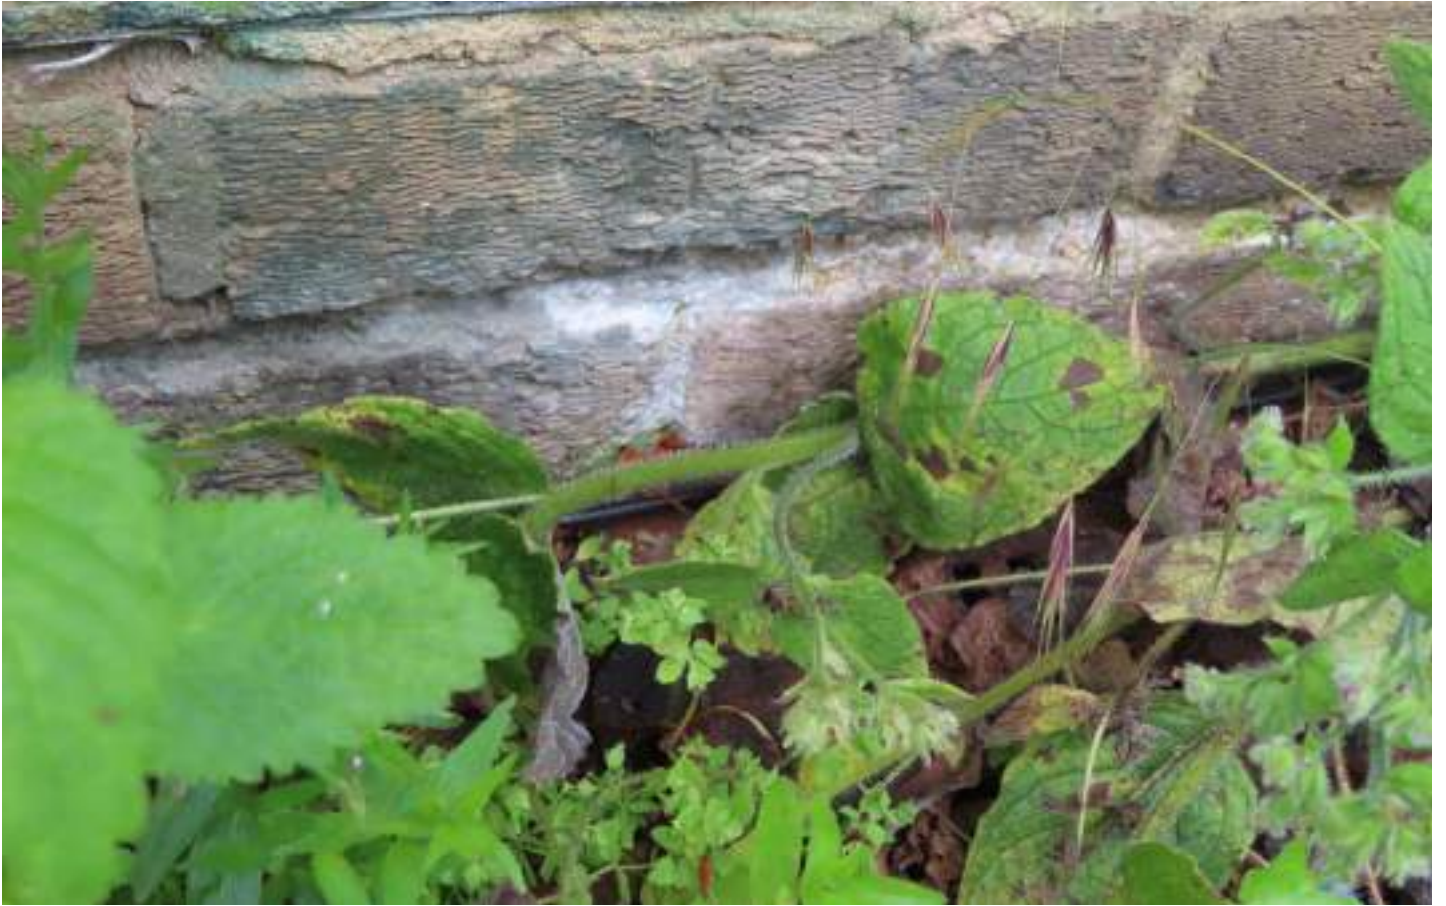
IMG_0875.JPG

- 3.05 The external wall structures to the property are in only fair condition. Due to the effects of ground movement most likely on the account of the close proximity of the Willow tree referred to above, there is fracturing present in the walls below the front right-hand window illustrated in photograph 0874. The brick jointing and pointing to the footing brickwork close to ground level is also eroded and in a partially decayed condition. Cross-refer to photograph 0875. It is likely that this damage may progress in the future.

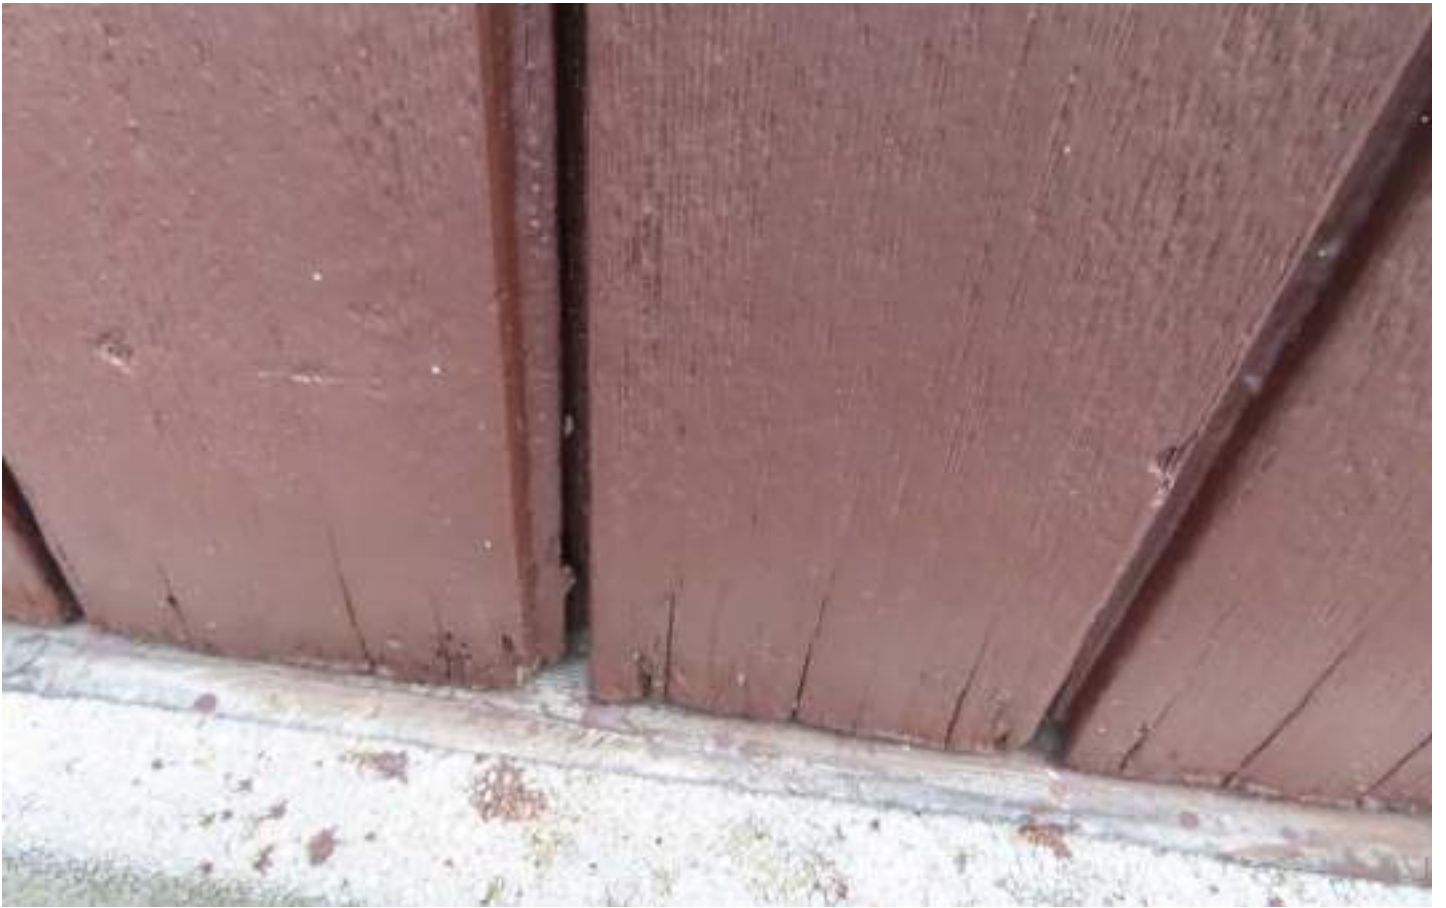
IMG_0881.JPG

- 3.09 The external boarded elements of construction are in poor condition, being open jointed and partially rotted. Cross refer to photograph 0881. Complete renovation or replacement with suitable timber boarding or other appropriate cladding is recommended.

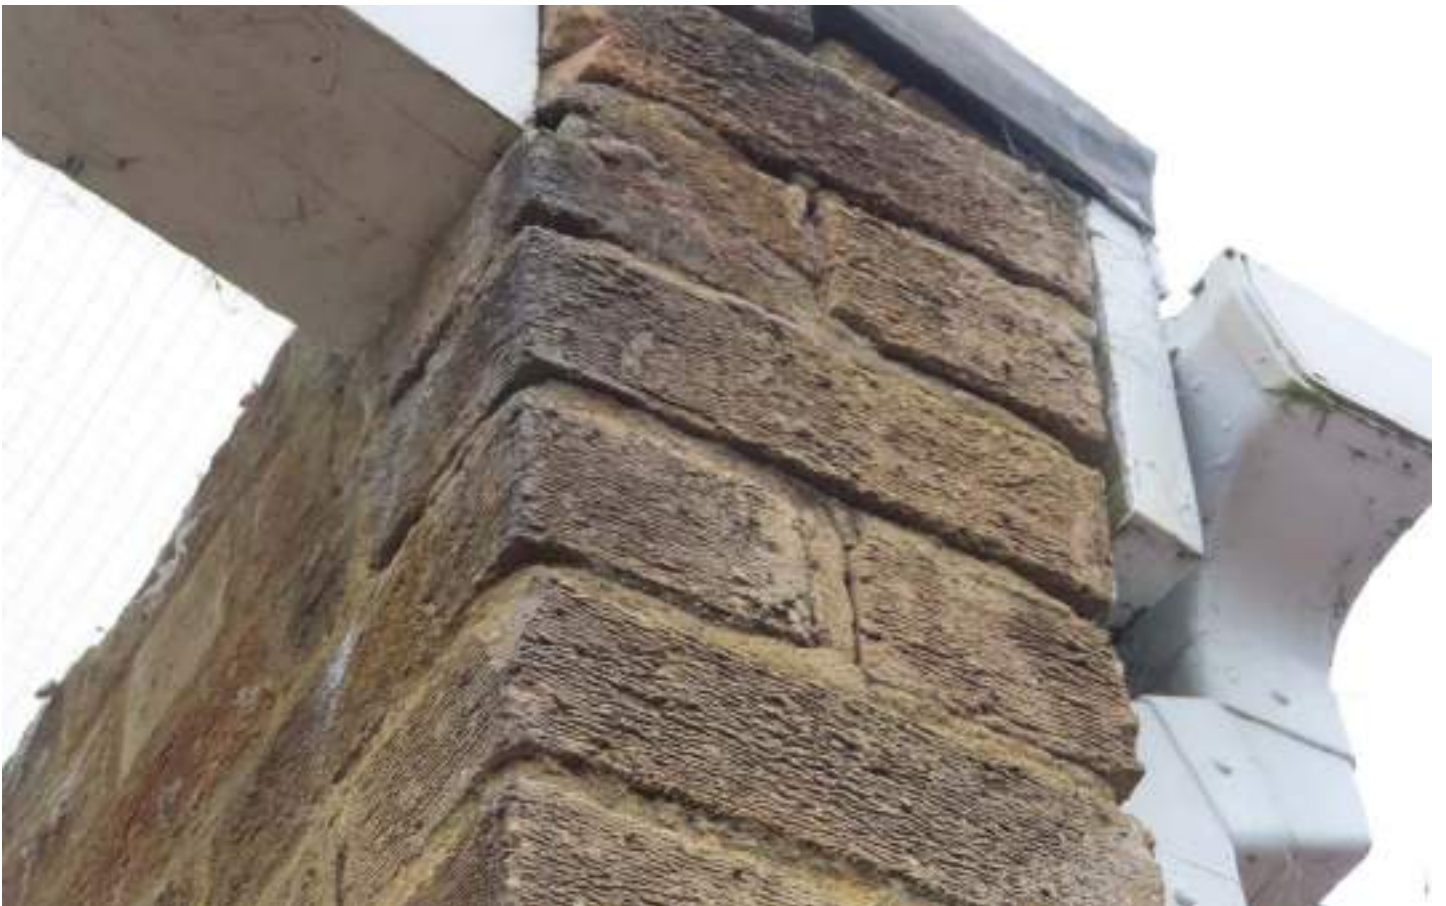
IMG_0882.JPG

- 3.10 An area of brickwork supporting a covered glazed area close to the utility room and garage doorway, the brickwork is structurally fractured and weakened due to inadequate lateral restraint and the effects of general weathering. Cross-refer to photograph 0882. This brickwork requires reconstruction to match existing.

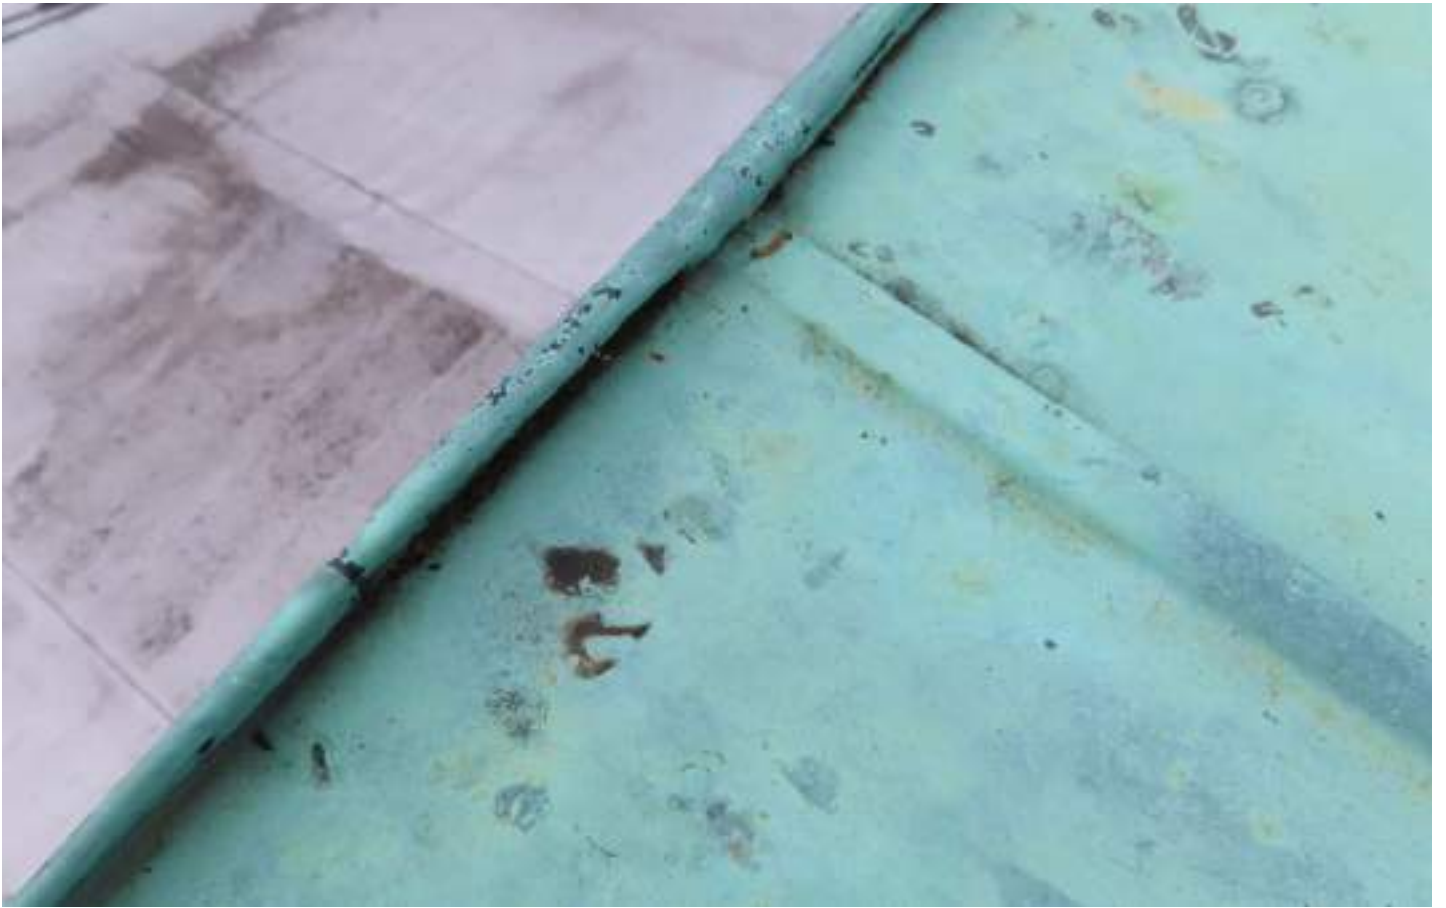
IMG_0887.JPG

The copper roof coverings are aged and reaching the end of their lifespan. On detailed examination the copper sheet was found to be embrittled and deformed especially at the eaves of the roof. Cross-refer to photographs 0887, 0895 -0897. In particular, photograph 0886 illustrates excessive unevenness in the copper roofing symptomatic of the effects of thermal movement and associated stress. These roof finishes have reached the end of their lifespan.

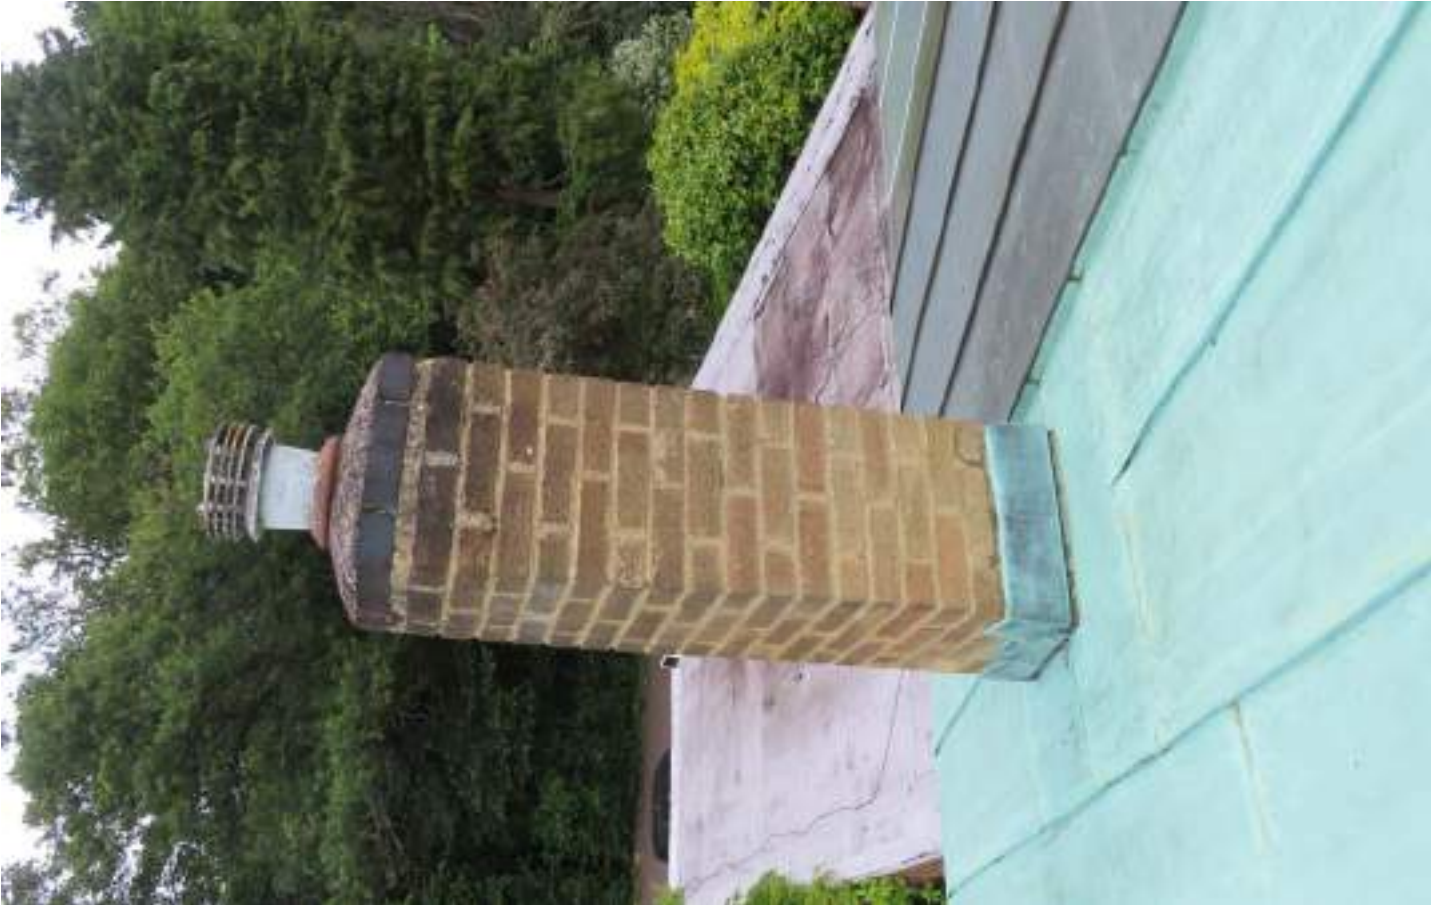
IMG_0891.JPG

With reference to photographs 0891 and 0893, the chimney stacks are in serviceable and satisfactory condition.

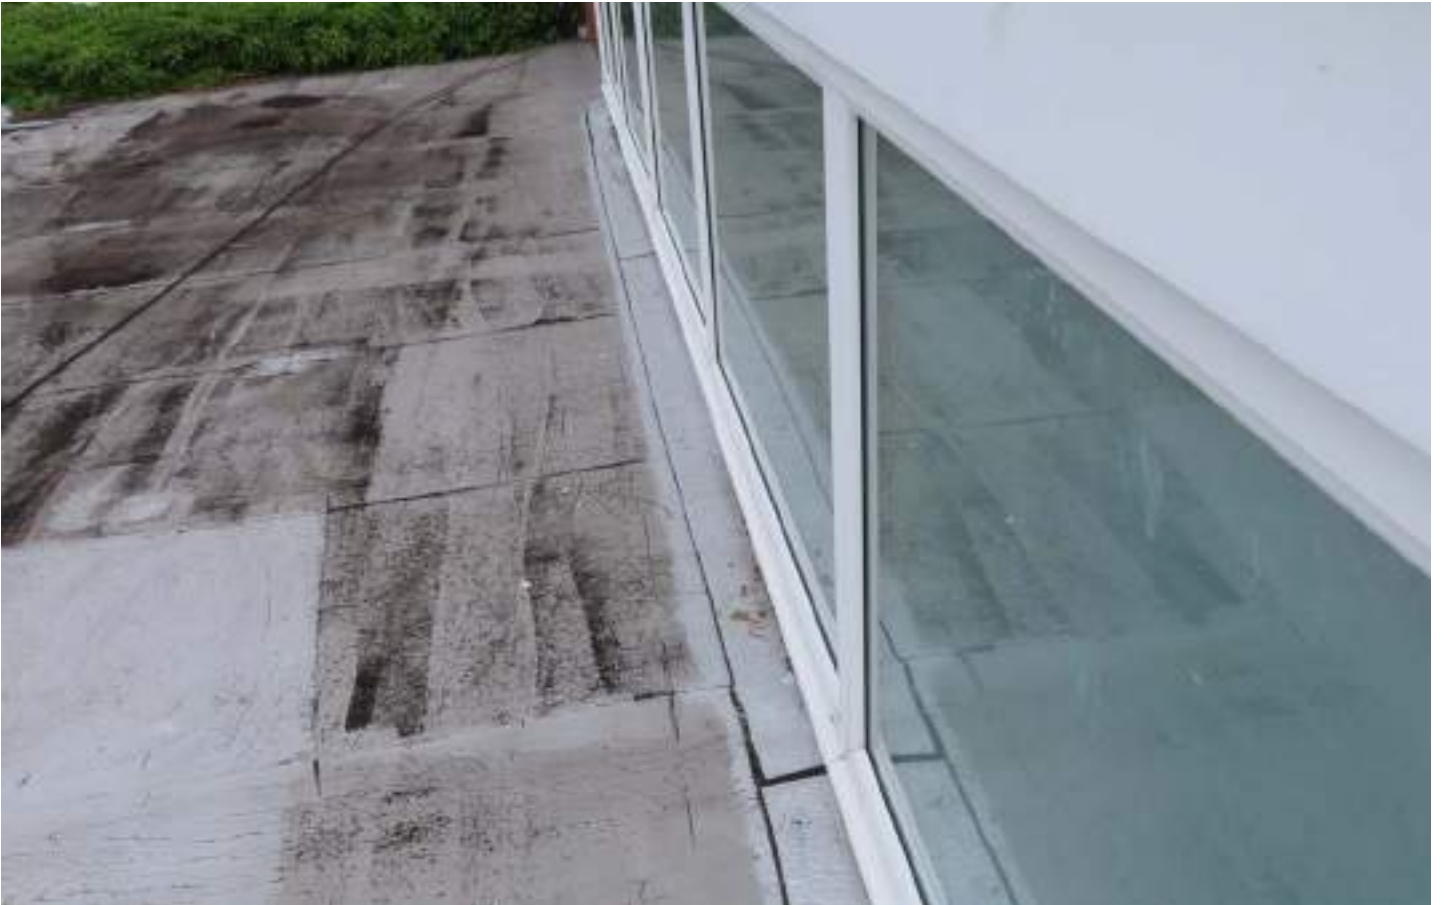
IMG_0892.JPG

The external weathering membrane is composed of felt overlaying mastic asphalt. This is in a severely distressed and defective condition, being heavily blistered. Cross-refer to photographs 0892 – 0894 and 0894. The roof covering requires complete replacement as its lifespan has now expired. Again, the replacement to the roof finish necessitates compliance with approved document L of the Building Regulations.

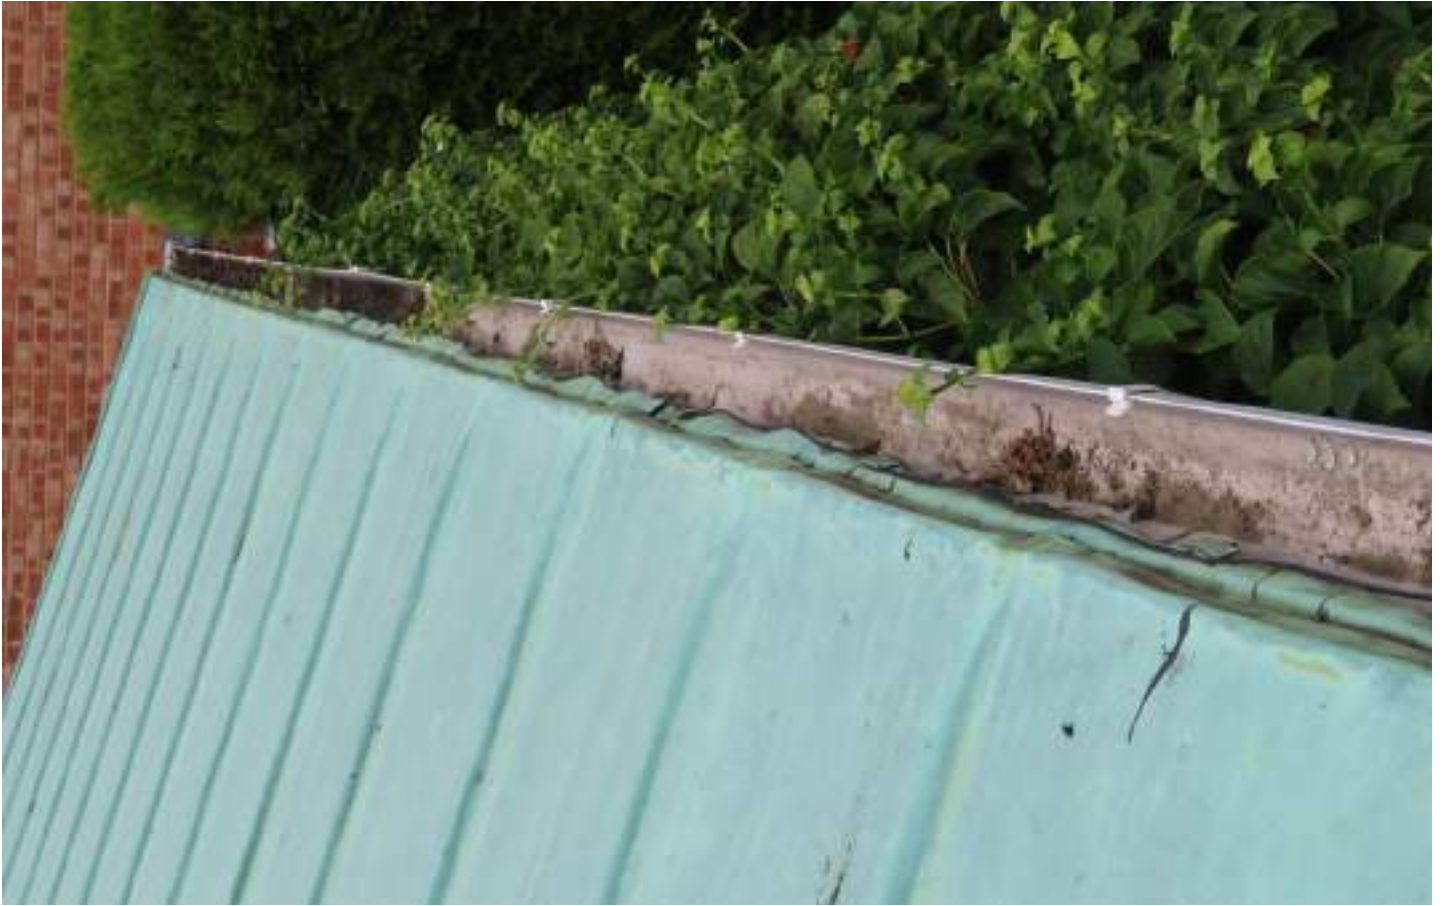
IMG_0895.JPG

The eaves gutters to the property are composed of uPVC. Due to deficient falls and adjustment, these are choked with vegetation debris and mulch. Cross-refer to photographs 0895 and 0897. On account of the age of some components to the main pitched roof, the guttering is embrittled and near the end of its lifespan. Other elements to the rear of the property are in better overall condition and are regarded as serviceable. However, on account of the decayed condition of the fascia boards to which the gutters are fixed, the guttering will need to be dismantled and refixed to facilitate overhauling and repair to the fascia boards as recommended above.

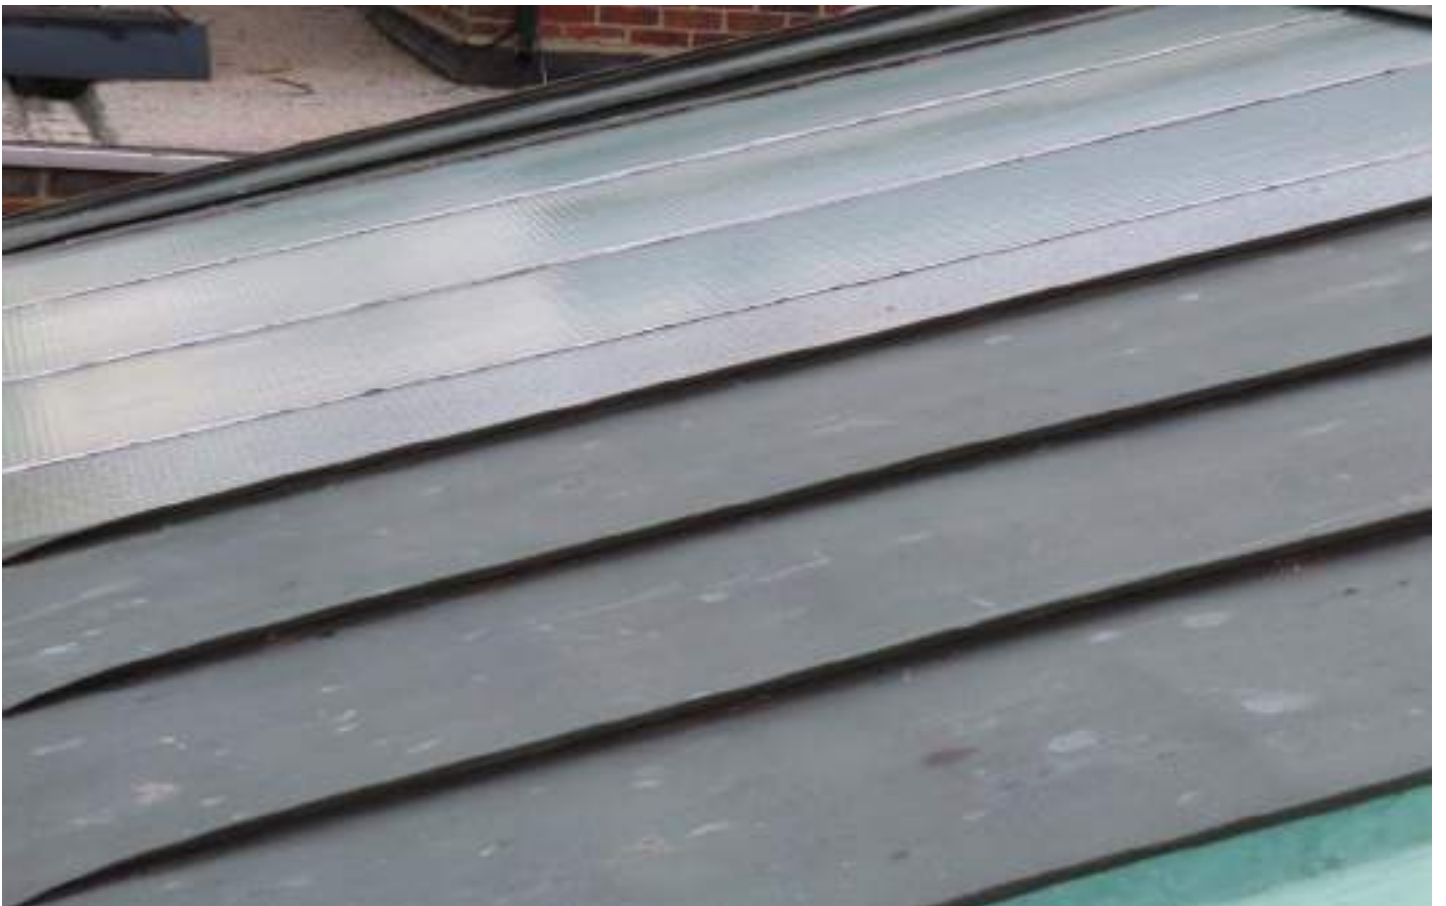
IMG_0898.JPG

To the left-hand flank of the property in the vicinity of the garage and utility room doorways, there is a glazed roof comprising timber glazing bars supporting Georgian wired cast glass glazing. These components are in only fair condition with dilapidation present to the glazing- bars resulting from timber decay and flawed architectural detailing. The glazed roof requires general renovation and repair or alternatively complete replacement to a modern specification that will minimise future maintenance liability. See photograph 0898.

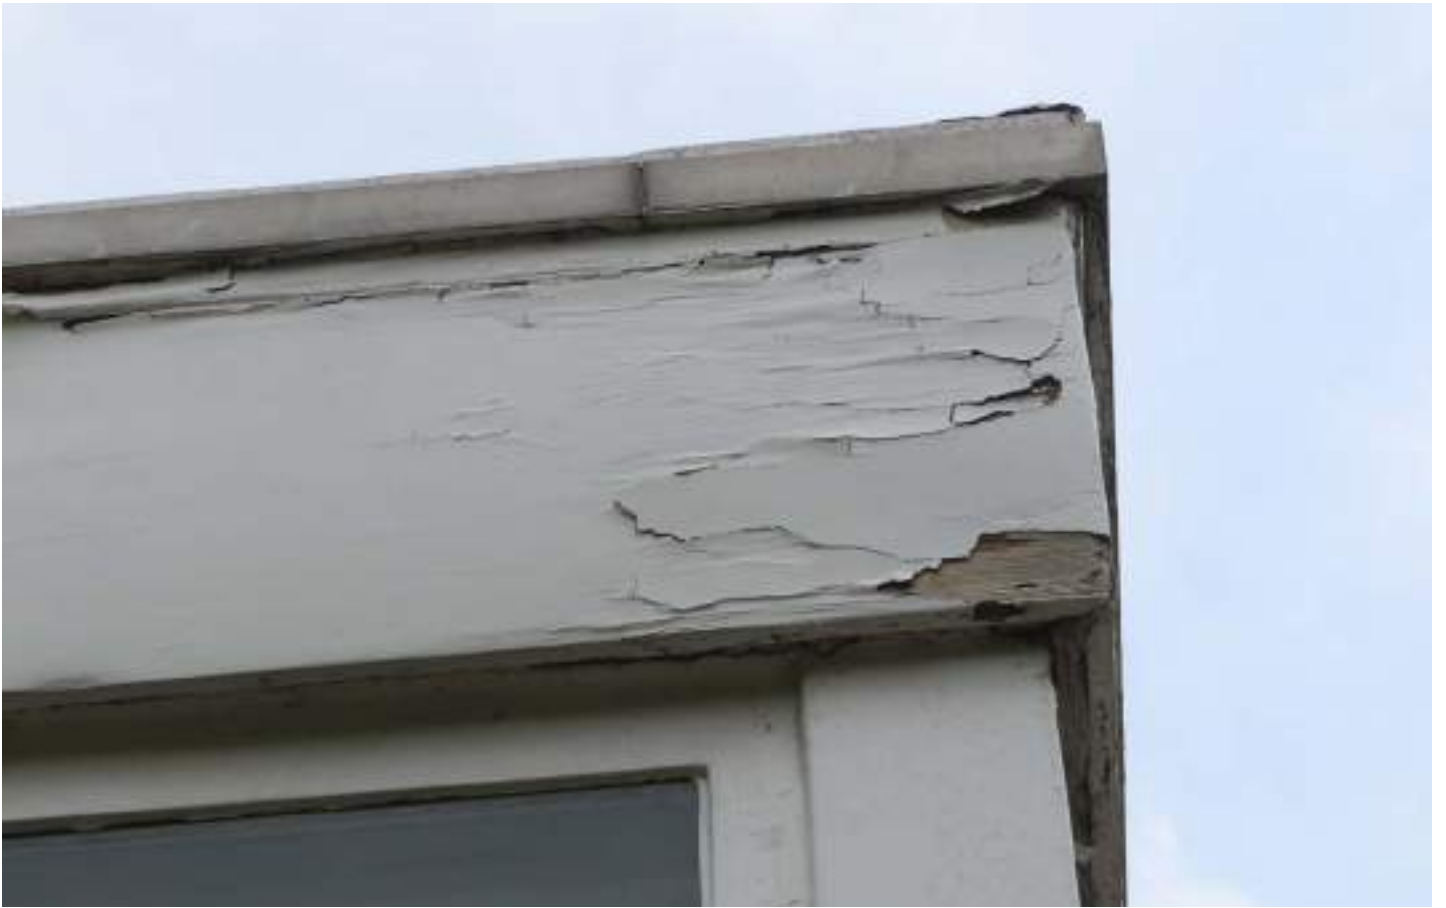
IMG_0903.JPG

The fascia boards provided around the perimeter of the main roof are of painted timber construction. With reference to photographs 0801, 0903 and 0904, these are in a distressed and unsatisfactory condition, requiring major overhauling or alternatively complete replacement.

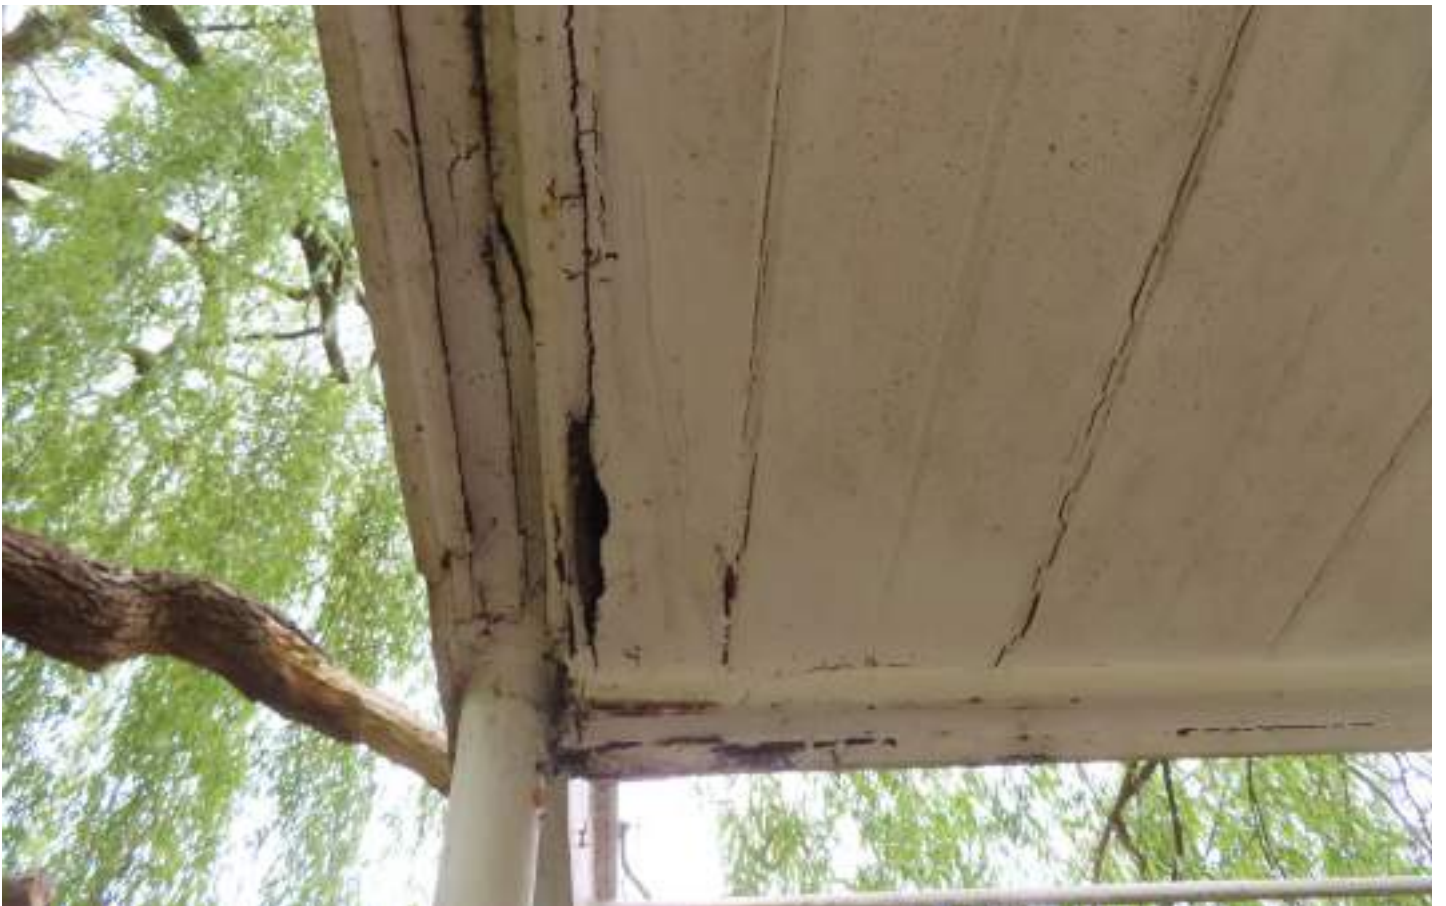
IMG_0904.JPG

The gazebo is supported by two tubular steel stanchions. The upper extremity to these is corroded and requires repair (photograph 0904).

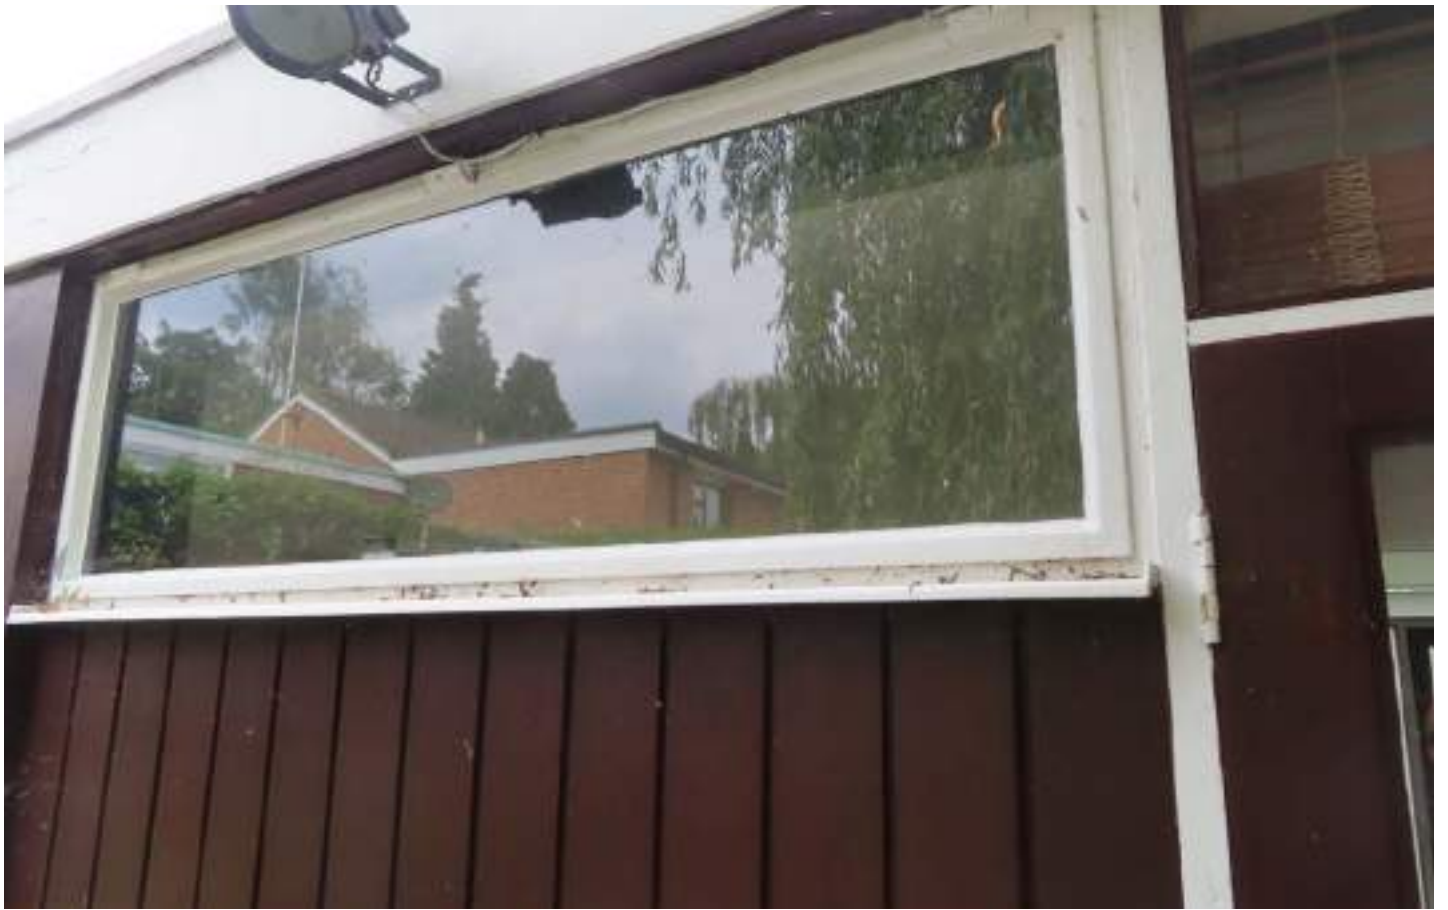
IMG_0905.JPG

The windows are composed of single glazed stained and painted softwood and steel "Crittall" framed components (photograph 0905). The steel framed windows are likely to date back to the property's original construction. Most have been paint sealed shut and are unserviceable incapable of operation. The components are also excessively stiff consequential to their age and require major renovation or complete replacement. Since this type of window does not incorporate thermal break or any thermal insulation provision, these are inherently susceptible to condensation and are regarded as unsatisfactory in a modern environment. Further, their condition is mediocre. The glazing putties are partially decayed with age (photograph 0906).

Taking all factors into account, there is an essential need for the fenestration to the property to be replaced (save for the garage door). This is no longer regarded as serviceable or capable of renovation to meet modern day standards of safety, amenity and thermal performance/energy efficiency.

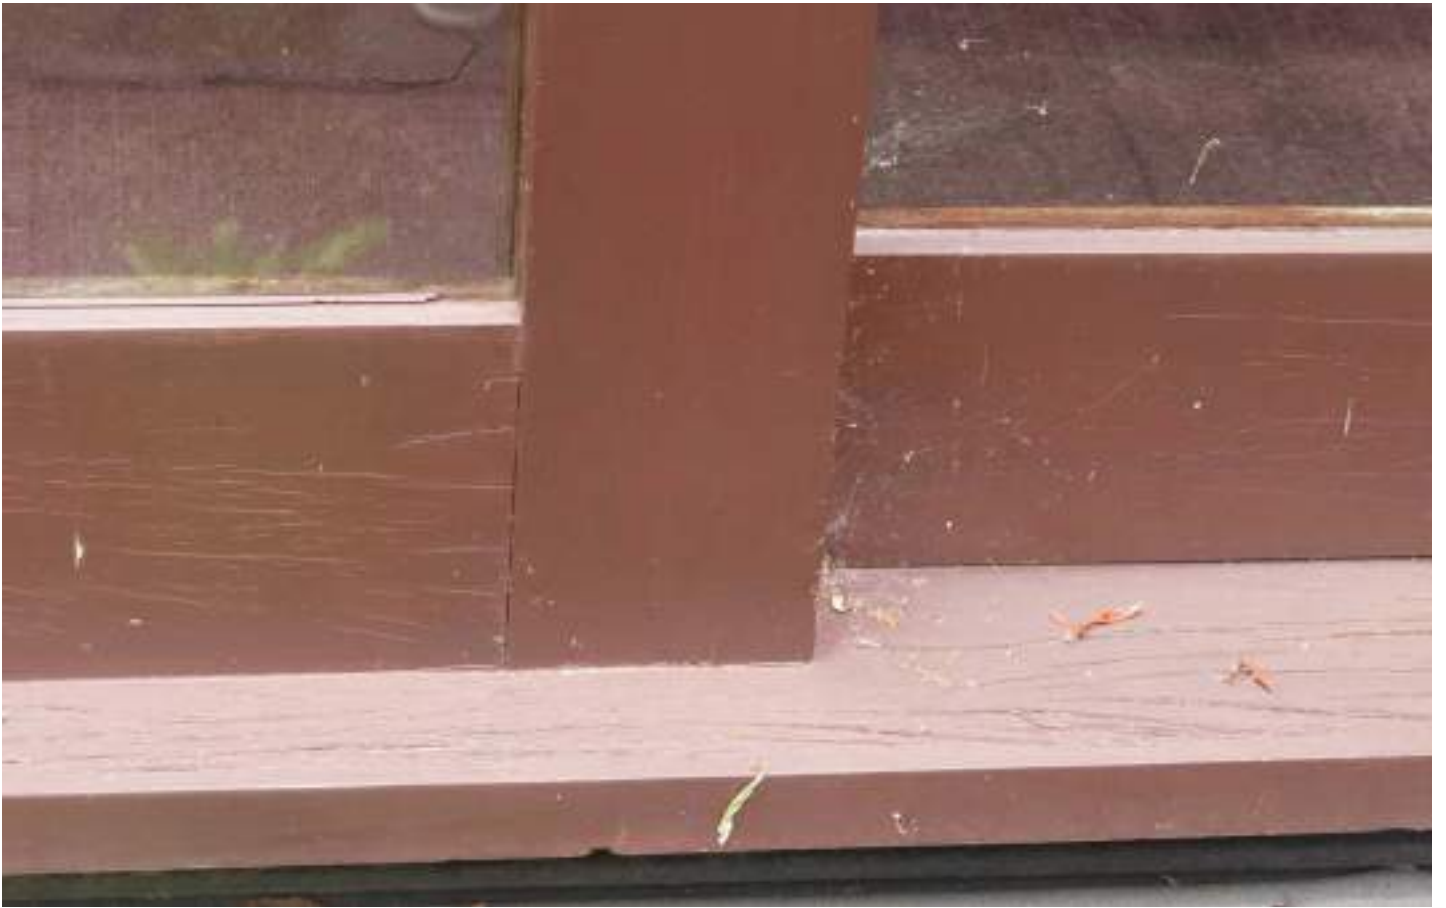
IMG_0907.JPG

The exterior doors are similarly of poor specification and regarded as unsatisfactory. Single glazing has been used and does not appear to be of a safety type. Some timber decay has become established at component joints which have parted. Cross refer to photograph 0907.

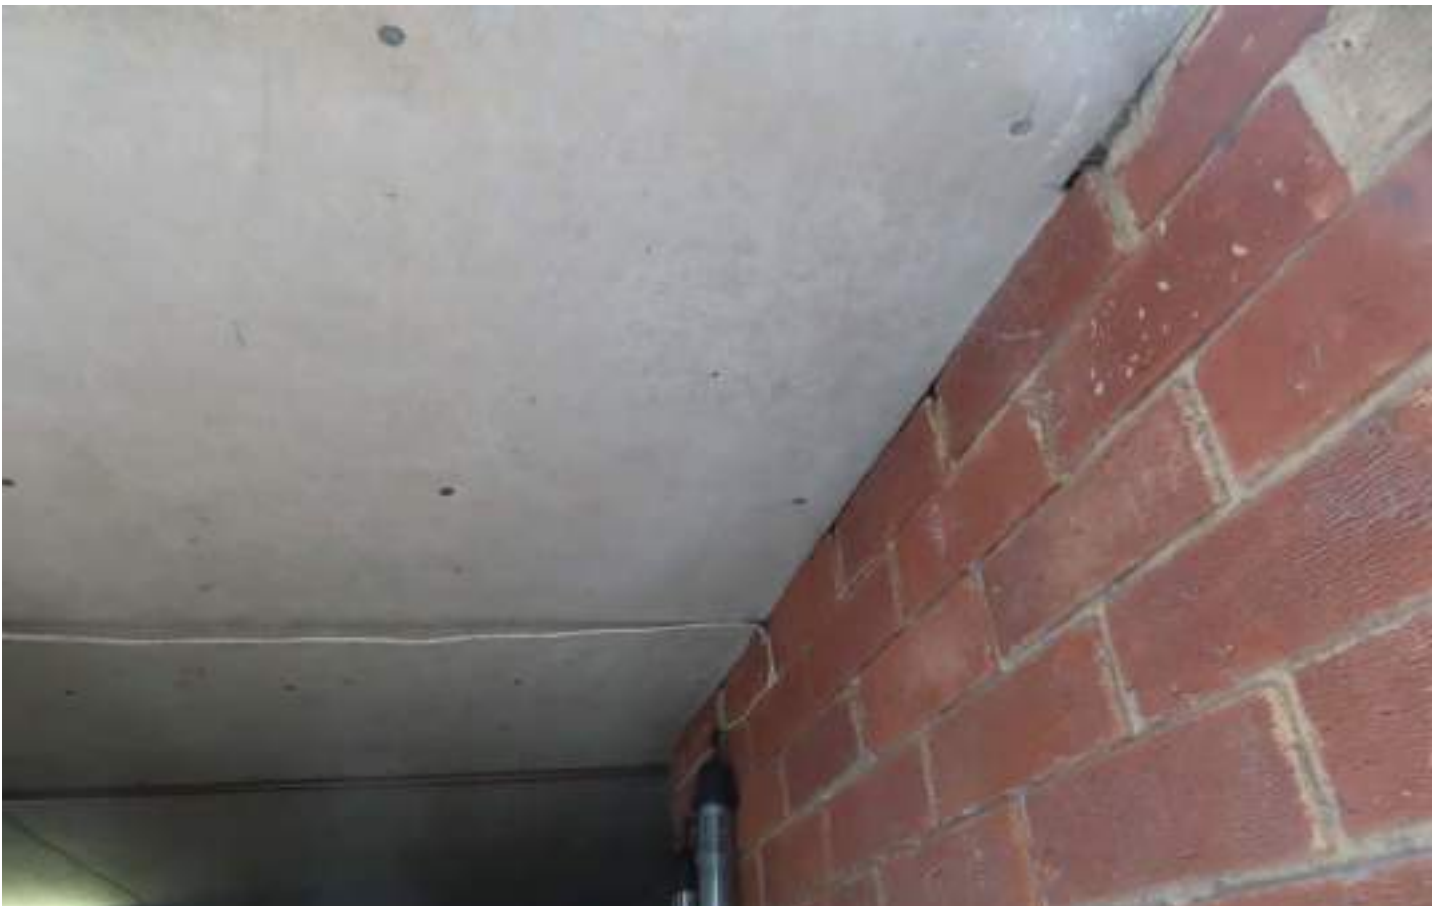
IMG_0908.JPG

The ceiling to the garage is composed of a cementitious board strongly resembling asbestos cement (photographs 0908 0909 and 0913. The latter is known to be hazardous to health and accordingly further specialist testing is recommended to establish its exact identity. If proven to be asbestos (likely), its replacement by a licensed specialist is recommended since this may release free asbestos fibres into the atmosphere of the outbuilding creating a significant risk to health. The work must be carried out by a licensed specialist pursuant to statute.

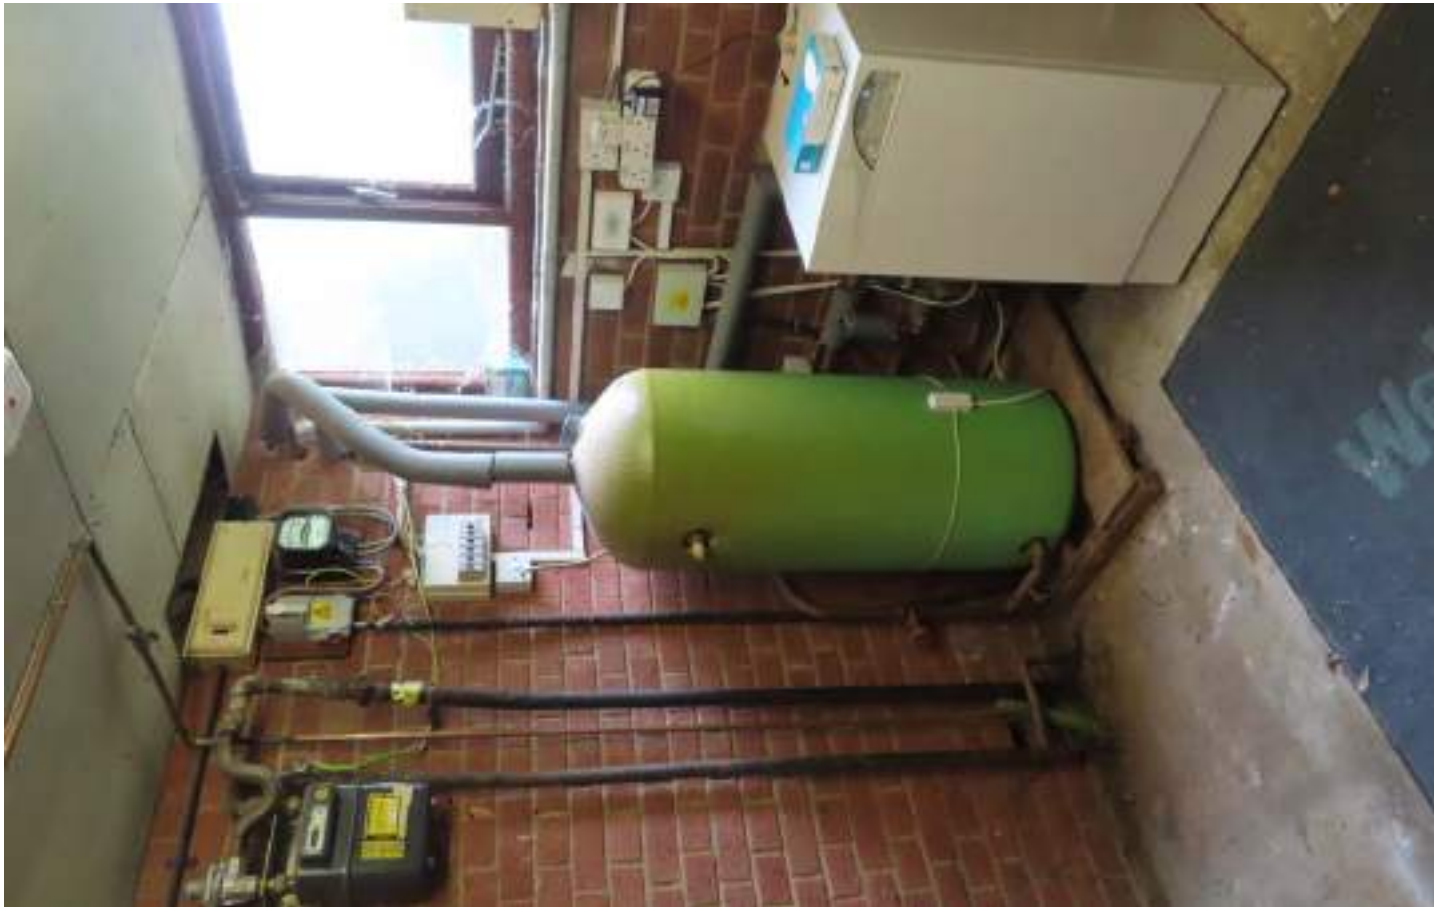
IMG_0911.JPG

The electrical service utilises PVC sheathed cable. The consumers control panel and meter are located in the garage - see photograph 0911 and 0913. The electrical installation does not comply with current regulatory standards defined in the IEE Regulations 18th Edition. Further, the electrical installation is regarded as insufficient since the number of socket outlets provided internally is very limited indeed and has necessitated the widespread use of multiple power socket extenders that may overload the system. The electrical accessories are aged and may be electrically unsafe. Earthing facilities appear limited and insufficient.

A simple water services system has been installed utilising a hot water cylinder indirectly heated by an elderly floor mounted gas fired boiler in the garage (photograph 0911). Both components appear to have reached the end of their lifespan. The cold-water storage tank could not be located. Heat is distributed by elderly steel radiators (ant heated towel rail) which also are likely to be reaching the end of the life expectancy (photograph 0916 and 0917). Radiator valves are defective on account of their age. The system's controls are limited and regarded as inadequate by modern standards. A detailed study has not been carried out on account of the survey parameters.

It is recommended that the electrical system is checked and tested by an NICEIC approved electrical contractor with a view to substantial upgrading and extension of the system. It is likely that this may necessitate complete replacement of the electrical system with a modern compliant system compliant with Part P of the Building Regulations.

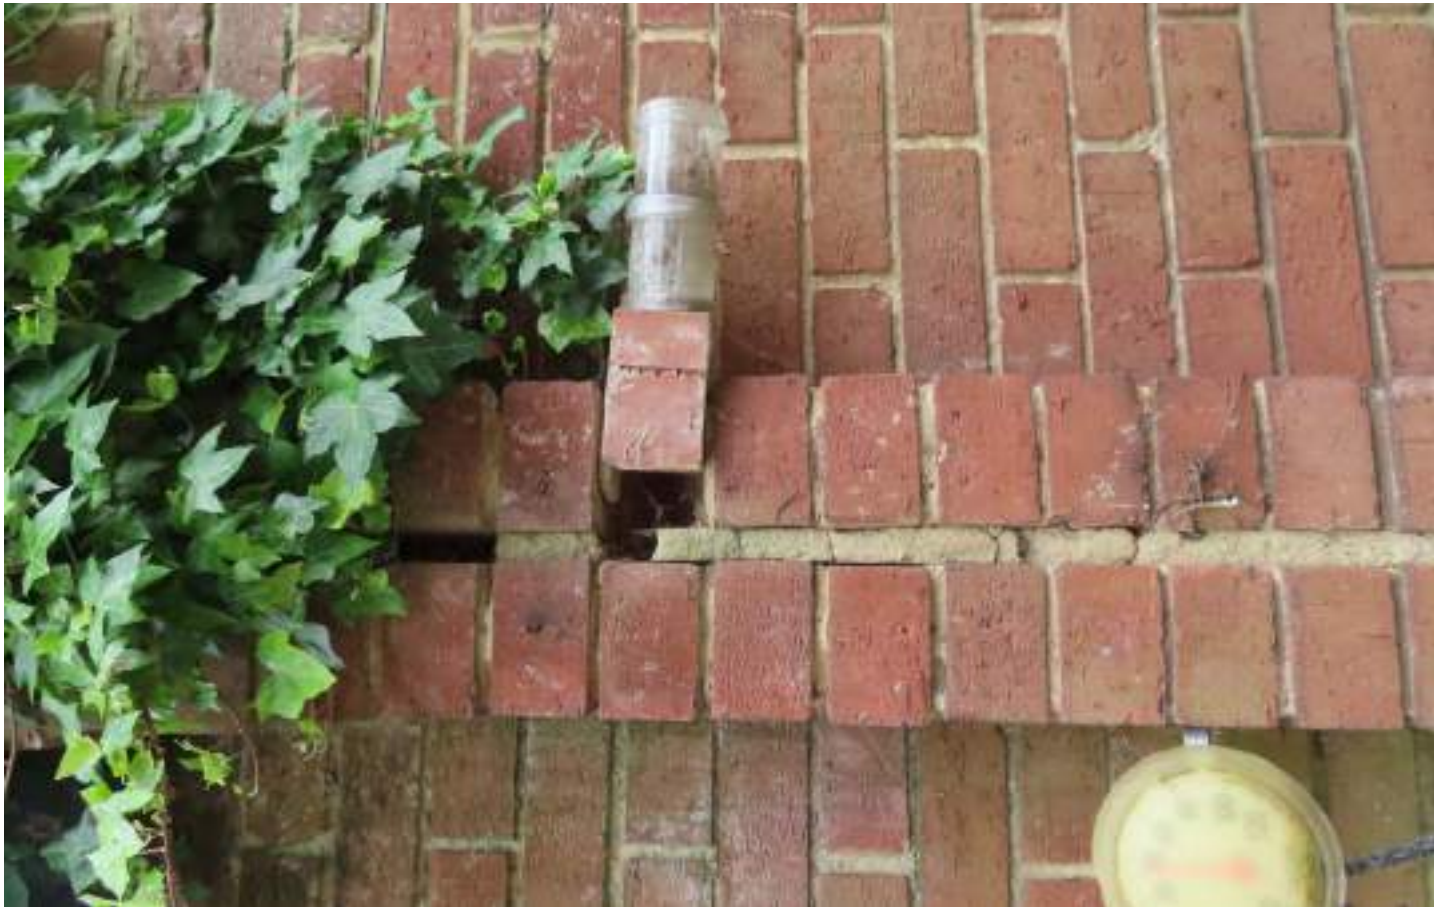
IMG_0923.JPG

The boundary wall on the No. 27 south-eastern side of the property with reference to photographs 0920 and 0923 is in a distressed and damaged condition, requiring partial rebuilding.
