BUILDING SURVEY

**25 HAM FARM ROAD
RICHMOND
SURREY
TW10 5NA**

24th June 2021

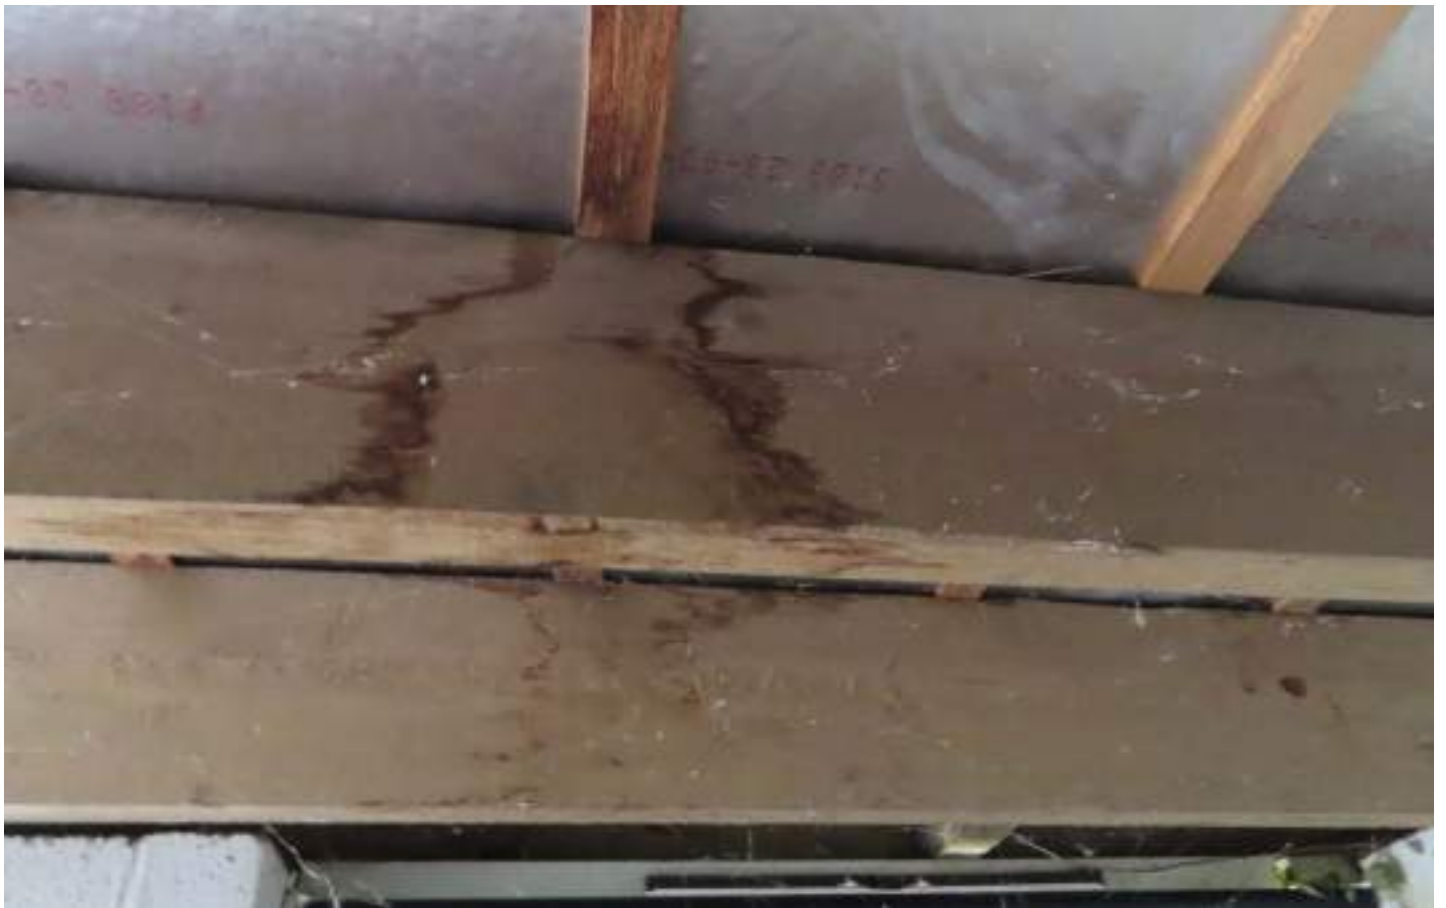
IMG_0925.JPG

With reference to photographs 0927 - 0929, the built-up felt roof finish is in a distressed and wholly defective condition necessitating its replacement. The perforate condition of the roof finish has most likely resulted in water seepage into the structure that should be fully investigated since this may significantly increase the risk of timber decay (photograph 0925).

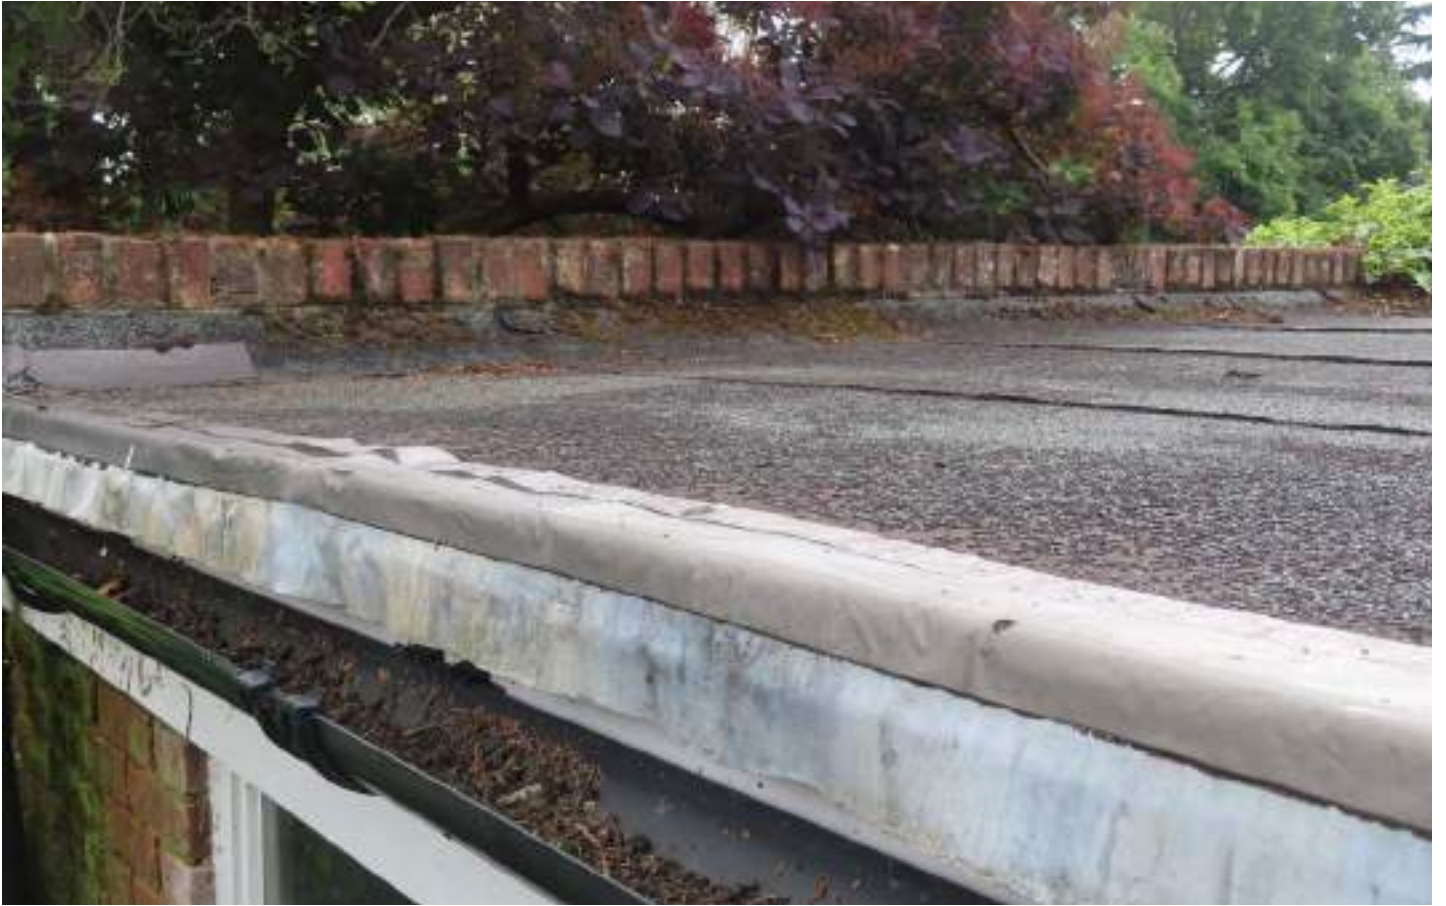
IMG_0929.JPG

On each flank of the outbuilding, there are vertical projections to the main flank enclosing walls. These parapet structures are decayed and in mediocre/poor condition, requiring partial rebuilding, renovation and repair. Cross-refer to photographs 0928 and 0929.

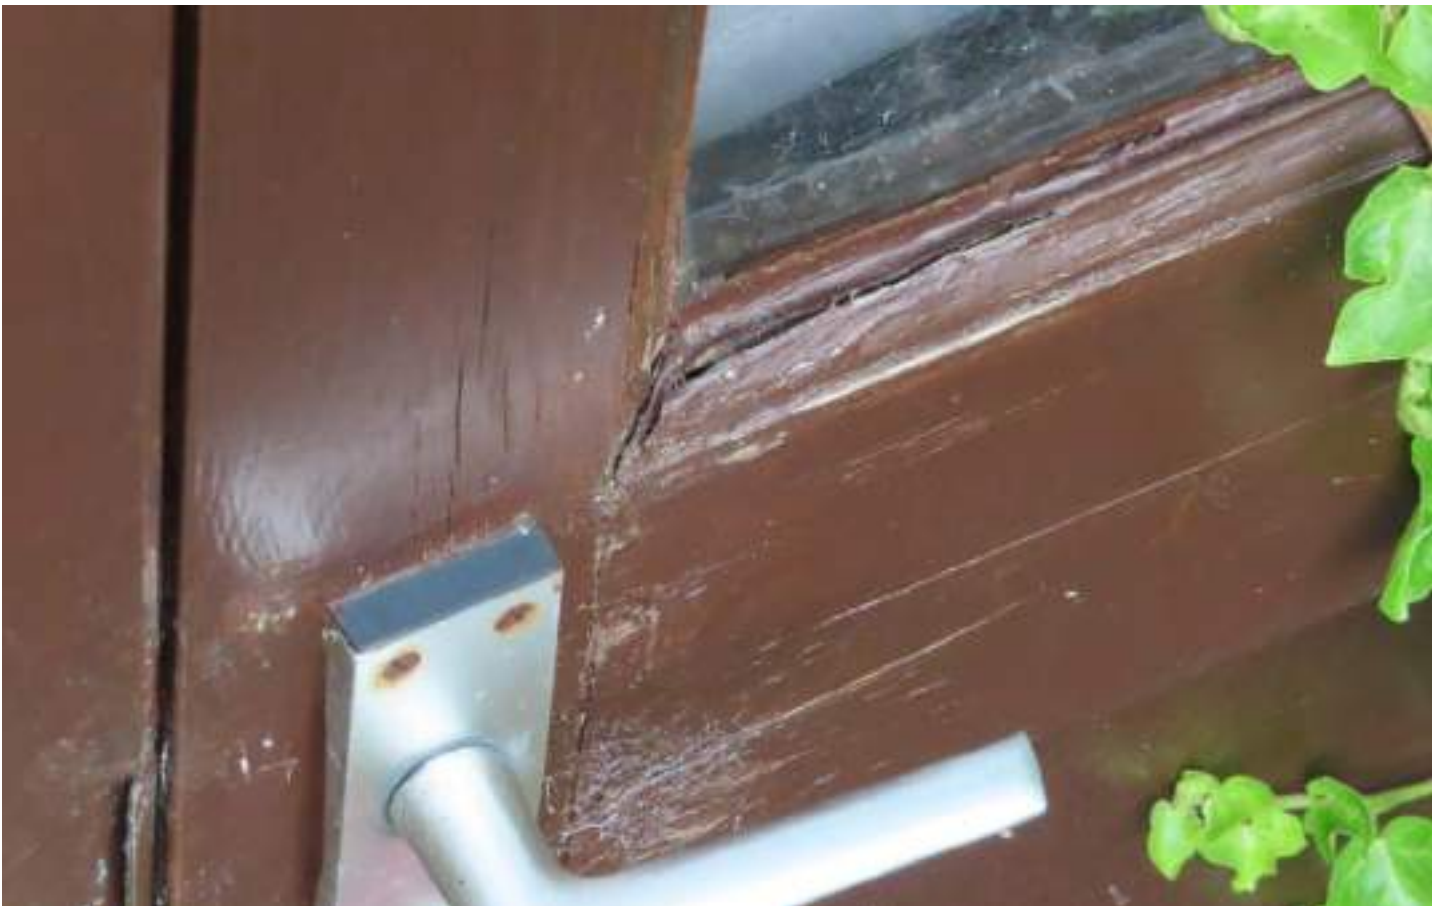
IMG_0930.JPG

The fenestration to the outbuilding is in mediocre condition with reference to photograph 0930. The components have deteriorated and partially rotted with age. Single glazing has been installed which is thermally inefficient and will cause significant heat loss/gain as well as an increased propensity to condensation.

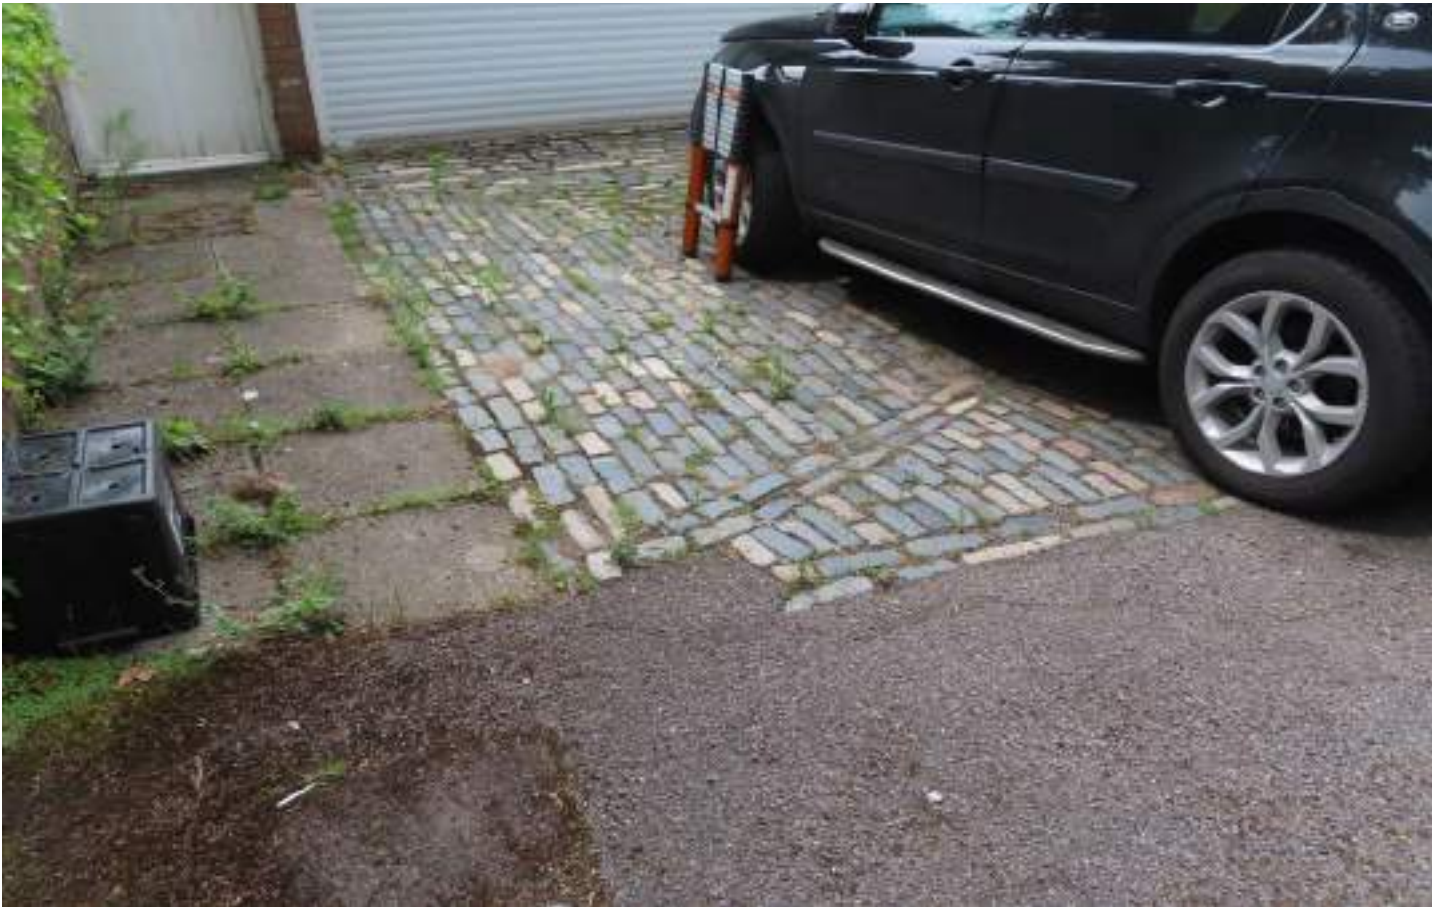
IMG_0931.JPG

The left-hand side of the driveway has been covered in polished stone sets in a tradition style. However, on account of inadequate founding. The surfaces are substantially irregular and settled. It is likely that this condition has precipitated ponding of the surfaces during prolonged wet weather since there is clear visible evidence of silt and detritus often associated with ponded areas. Extensive renovation and repair to the paved areas is therefore required to alleviate this problem. Cross-refer to photographs 0931, 0932, 0933 and 0936.

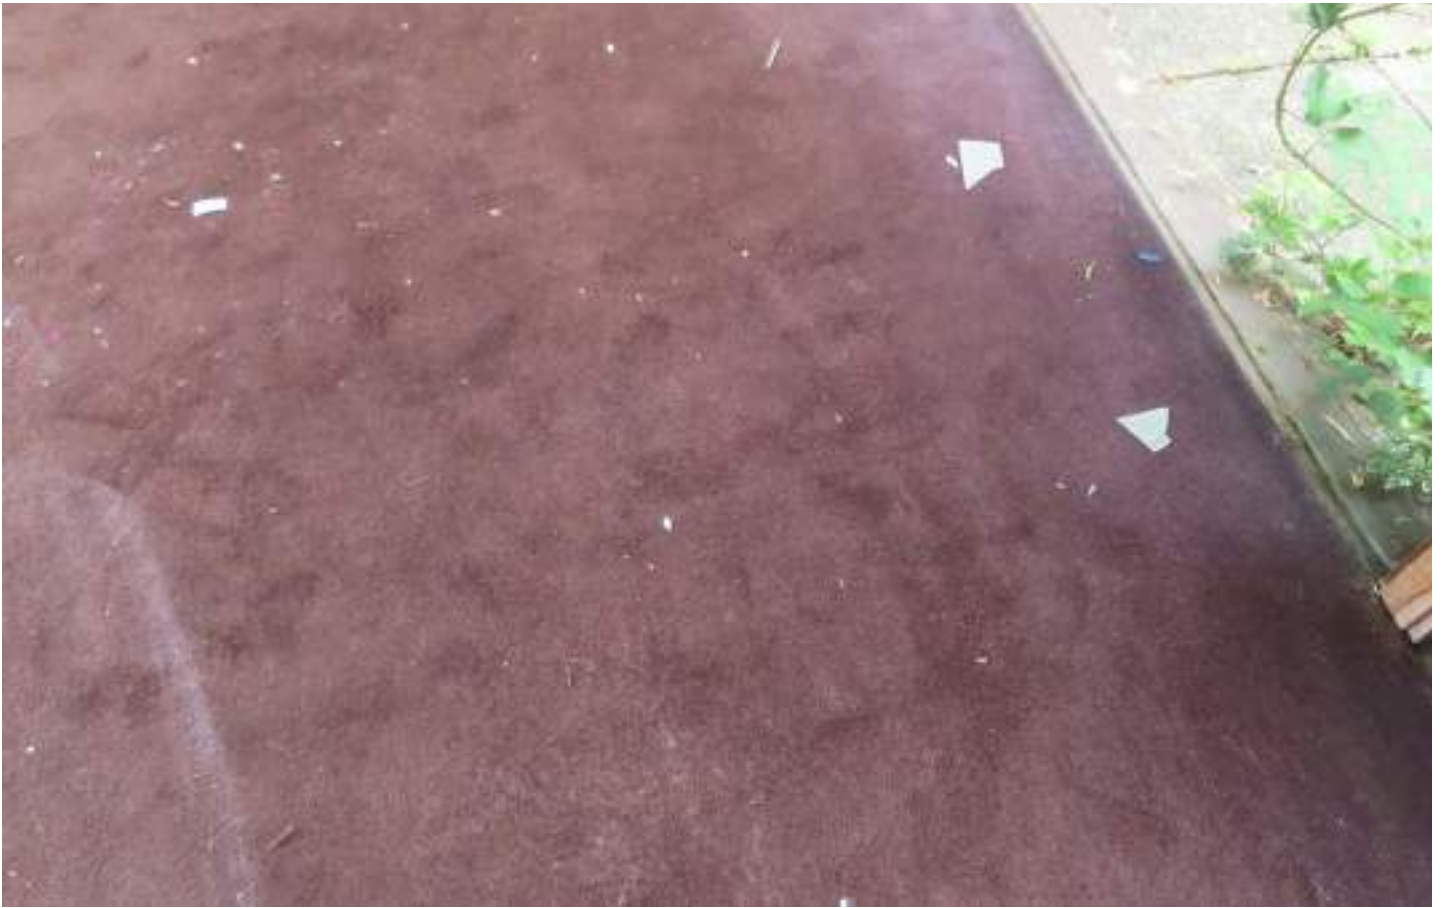
IMG_0935.JPG

Moisture meter tests were also carried out to the solid floor construction throughout the property. High levels of moisture were recorded in the utility room (photograph 0914) and rear living room (photograph 0935) and has caused the carpet finishes to become stained. The reason for this damp penetration requires further investigation. It is likely that this is the result of a shortcoming or defect in the damp proof membrane that should exist within the floor construction. In this type and age of property, the damp proof membrane is composed of painted bitumen which can become defective with age. Accordingly, it will be necessary to implement repairs to the damp proof membrane involving hacking up of the interior screed finish.
