Kneller Hall School

Dukes Education

Condition Report
STRUCTURAL / CIVIL ENGINEERING

L221004-AKSW-ZZ-XX-RP-S-0010

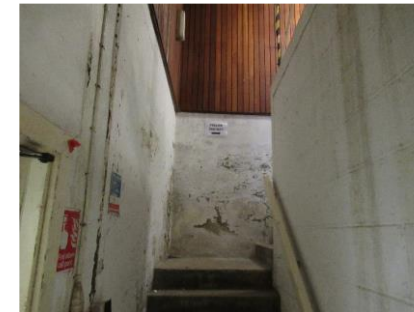
In the basement deterioration to render indicative of water ingress is evident (Jones Lang LaSalle IP, Condition Survey Report - Kneller Hall, 2020).

Water ingress to the basement is likely to be due to failed or inadequate waterproofing.

Photo 1 Water damage to right side basement stair in the main Kneller Hall west wing building (Photo taken from Jones Lang LaSalle IP, Condition Survey Report - Kneller Hall Guard House, 2020)

- Masonry walls that are built off timber joist floors and that show signs of cracking to be removed. Any replacement or new internal walls should be of lightweight construction (e.g. stud).
- Access to be gained to roof void and timber roof structure inspected for signs of degradation.
- Waterproofing specialist to examine basement and make recommendations for controlling moisture ingress.

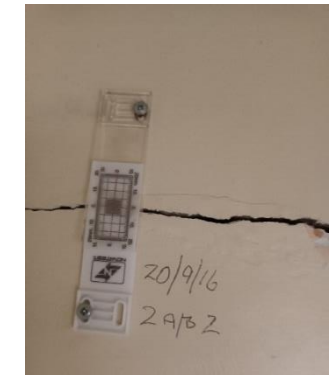
Cracking to masonry walls has been observed to the upper floors of the west wing. These walls do not continue down through the building and appear to be blockwork partitions constructed off the timber floors. In some locations, movement gauges have been installed across cracks. Based on the dates noted on the walls adjacent to these, they appear to have been installed approximately 5 years ago and show between 0 and 3mm of movement.

The blockwork partition walls appear to be supported by the timber floors. It is likely that the floors have deflected under the weight of the masonry and that this has led to the cracking in the walls. The relatively low movement shown by the movement gauges over a long period of time indicated that the movements are not progressing significantly.

Photo 2 Movement gauge showing minimal further movement to one of the solid walls at level 3 Kneller Hall main house (west wing)

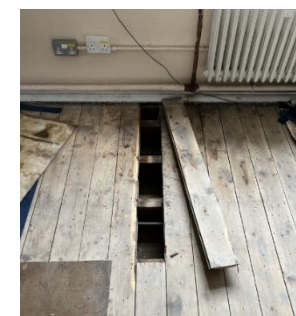
Photo 3 Opening up works showing existing floor joists at the first floor in the Guards House

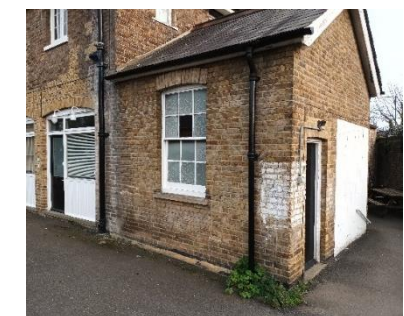
A brick arch above one of the windows at the rear single storey room has failed and cracking can be seen extending from the bottom corner of the window below. There are signs that the adjacent drainage pipe may not have been functioning adequately in staining on the brickwork.

Repair to the failed arch is not thought to be feasible using steel brick ties as there is no masonry above the arch.

Photo 4 Failed Brick Arch above sash window at the rear storage room in the Guards House

- Failed brick arch to be reconstructed or replaced with a proprietary steel lintel and brick reinstated.
- Cracking to masonry to be repaired.
- Rainwater goods and roofing to be inspected and cleared/repared as appropriate.

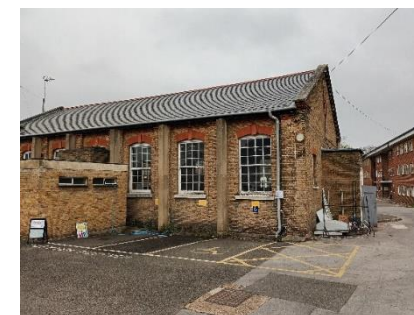
Past remedial work is visible in the form of external piers on the truss lines to both sides of the building. A record drawing from the 1970 shows that the piers are concrete encased steels (back-to-back channels) which anchor remedial ties to the trusses. The concrete encasement to the piers is showing signs of spalling in some locations. Concrete to the top of one of the piers was removed in order to inspect the steel which, in this location, were not significantly corroded.

The existing remedial works (ties and piers) are likely to have been installed in order to prevent spread of the trusses, with the external piers anchoring the ties and, possibly, reinforcing the masonry walls. Although the steel within the piers exposed as part of the opening-up works was not significantly corroded, the spalling would indicate that corrosion may be progressing to lower parts of the piers.

Photo 5 Remedial piers formed of encased steels (back-to-back channels) which anchor remedial ties to the trusses in the Band Practice Hall

- Underpinning to be carried out to building to prevent further settlement of the foundations. Either traditional mass concrete underpinning to sound, natural ground; or a piled underpinning system (mini-piles/screw piles) adequately fixed to the existing foundations to support the structure.
- Once foundations have been stabilised, the cracking to the masonry should be repaired.
- Spalling concrete encasement to the remedial piers to be removed and the steel inspected for corrosion. Any corrosion to be removed by mechanical means and concrete encasement reinstated with a corrosion inhibited cementitious repair mortar. Alternatively, concrete encasement can be removed entirely and an alternative form of corrosion protection suitable for external steel applied.

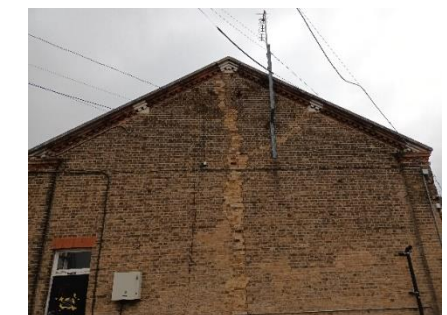
The structure shows evidence of significant movement as there is a large vertical crack to the rear elevation and a large diagonal crack to the internal dividing wall. These cracks appear to emanate from the interface with the basement wall. Evidence of multiple attempts to repair the crack in the rear elevation can be observed, however, none of these have been successful.

The foundations to the building are not performing adequately across the building. The cracking is likely to be caused by differential settlement between the basement and the adjacent areas, the basement structure likely founded on stronger ground than the adjacent foundations.

Photo 6 Significant vertical crack to the external gable wall at the rear of the Band Practice Hall
