**THAMES YOUNG MARINERS,  
RIVERSIDE DR, LONDON**

**PRELIMINARY BAT ROOST  
ASSESSMENT**

Report No: RT-MME-157100-04

Date: April 2022

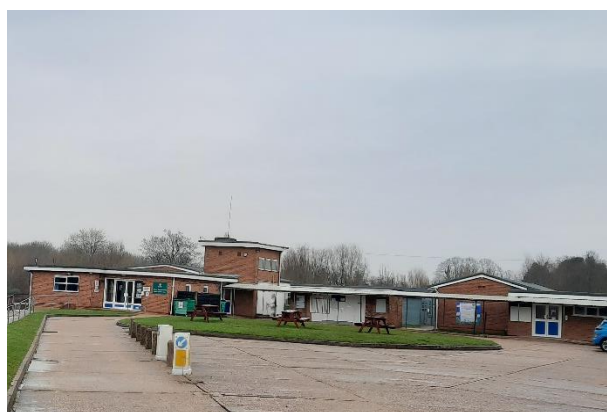
**Plate 4.1: Building 1 (Main Building – Southern Elevation)**

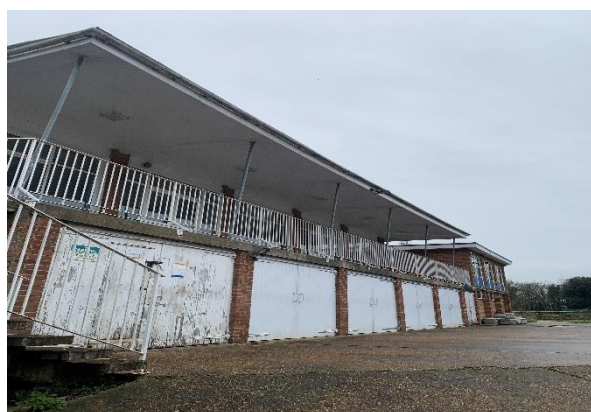
**Plate 4.2: Western Elevation Of Building 1 (Main Building)**

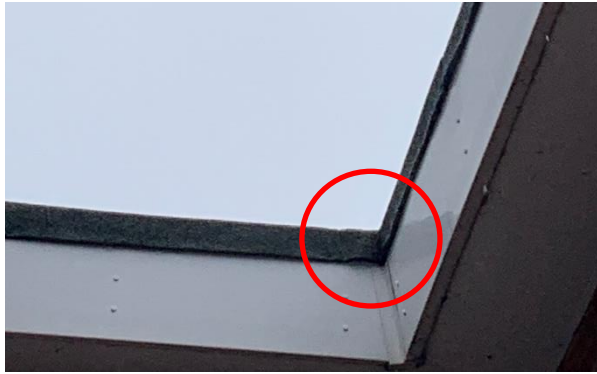
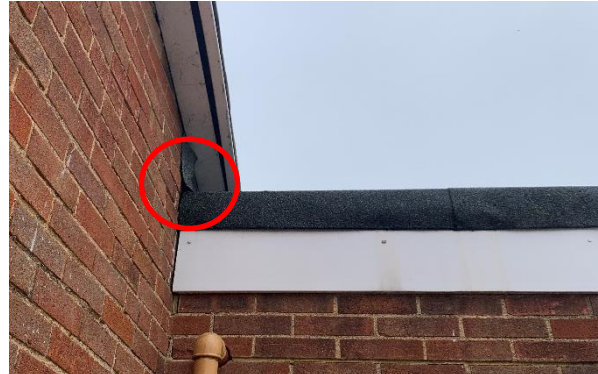
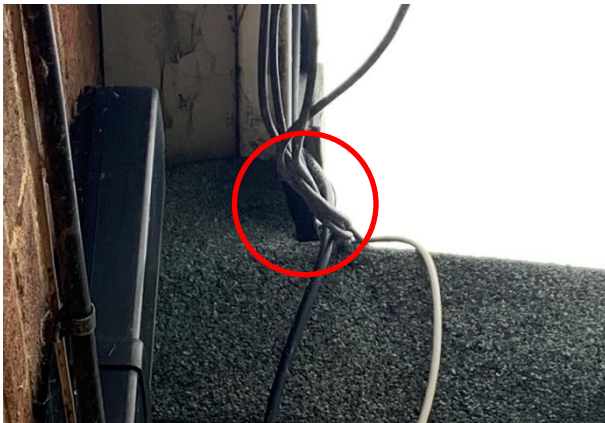
An area of lifted roofing felt was present on the western and eastern aspects of the building (Plate 4.3 to 4.5). In addition, on the eastern aspect of the building, gaps in the soffit board were noted, which could permit entry into an enclosed space behind the soffit/fascia board (Plate 4.6, 4.7). Areas of damaged brickwork were also present on the northern extent of the building (4.8, 4.9). In addition, a bat box was present on the south-facing wall of the residential dwelling.

Plate 4.3: Lifted Roofing Felt (Western Aspect)

Plate 4.4: Lifted Roofing Felt (Western Aspect)

Plate 4.5: Lifted Roof Felt (Eastern Elevation)

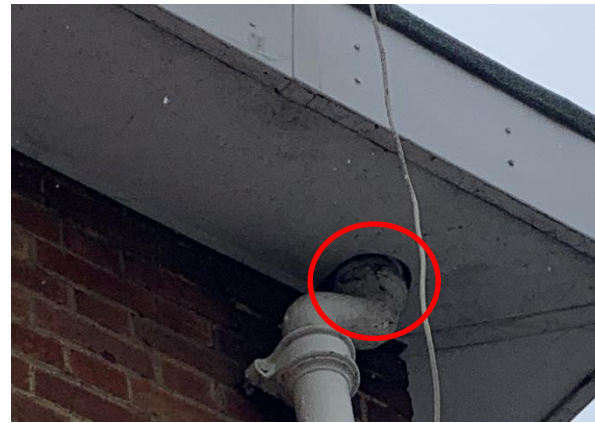
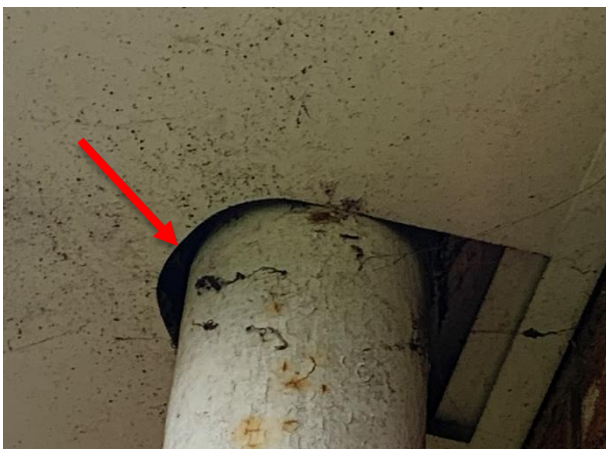
Plate 4.6: Gap in the Soffit (Eastern Elevation)

Plate 4.7: Gap in the Soffit (Eastern Elevation)

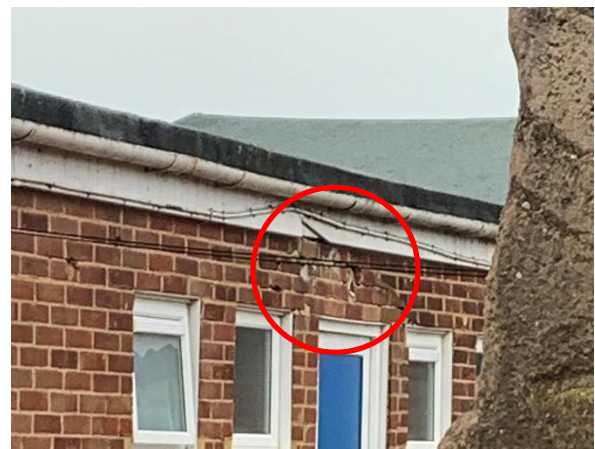
4.8: Damaged Brickwork (Northern Elevation)

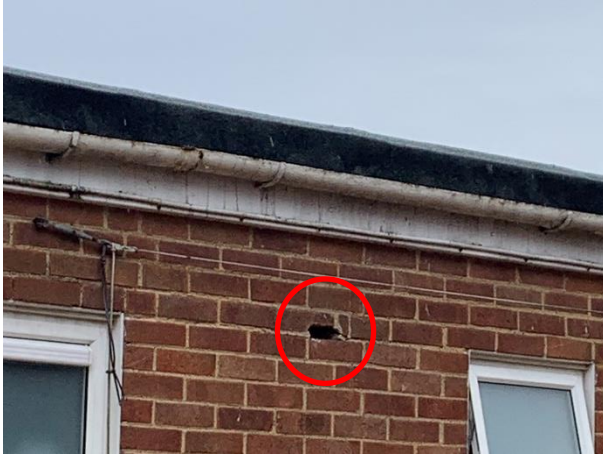
**Plate 4.9: Hole in the Brickwork (Northern Elevation)**

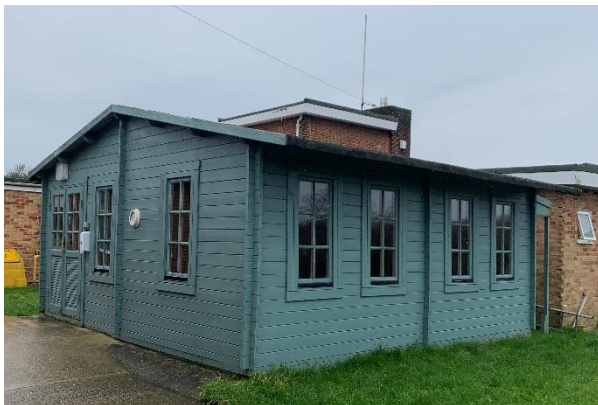
**Plate 4.10: Building 2 (Wooden Cabin - North-Eastern Aspect)**

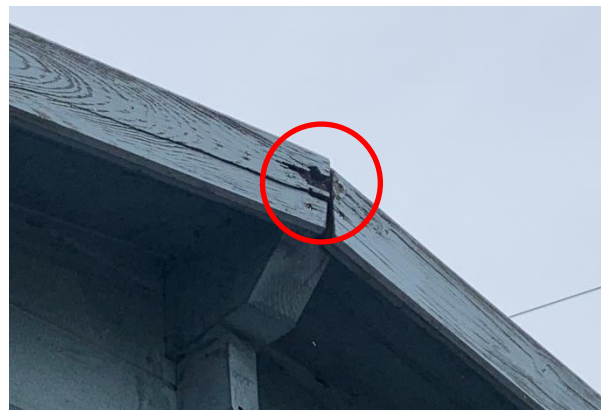
One of the wooden beams at the west-facing roof apex was damaged and presented a potential access point under the roofing felt (Plate 4.11). No evidence of bats, e.g., droppings, urine staining, feeding remains or scratch marks, was recorded during the external inspection of the building.

**Plate 4.11: Damage to Wooden Roof Apex (Western Aspect)**

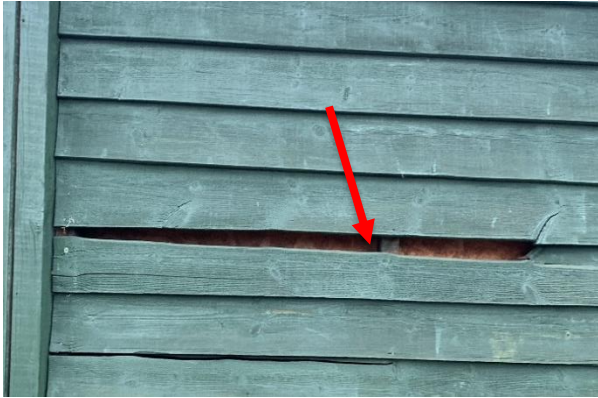
Building 3 was in generally poor condition. Much of the wooden cladding was damaged or missing, there was holes at the eaves, loose fitting joints and cracks in the brickwork (Plate 4.12-4.16). The damage observed in the wooden cladding led to an enclosed area between the wooden cladding and internal ply lining.

Plate 4.12: Missing Wooden Cladding (Southern Aspect)

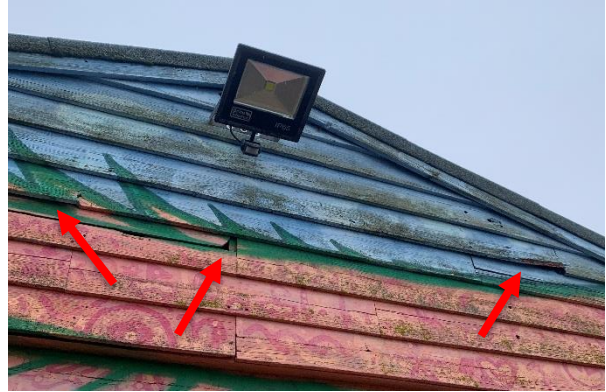
Plate 4.13: Damaged Wooden Cladding (Eastern Aspect)

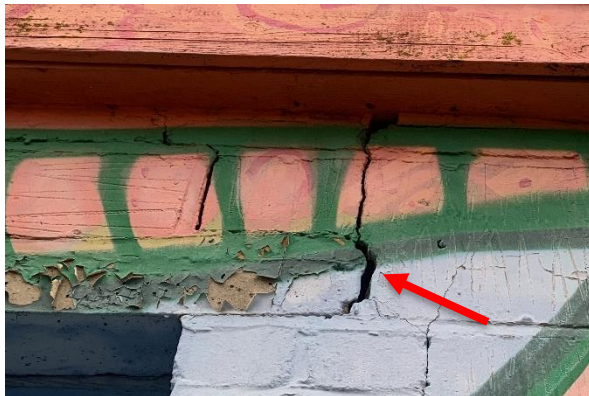
Plate 4.14: Damaged Brickwork (Eastern Aspect)

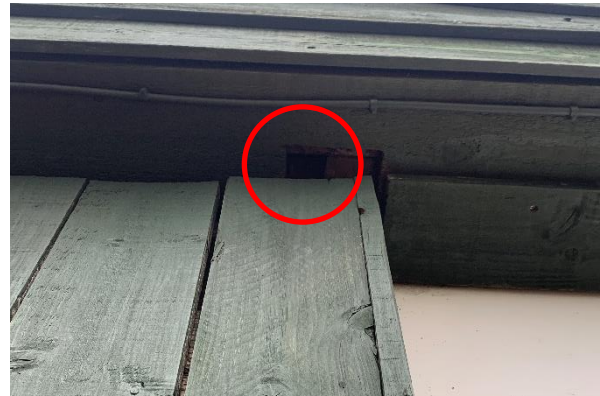
Plate 4.15: Loose Fitting Joins (Southern Aspect)

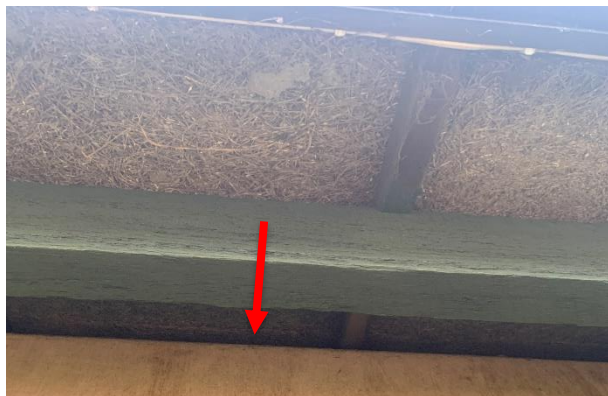
Plate 4.16: Gaps At The Eaves (Southern Aspect)

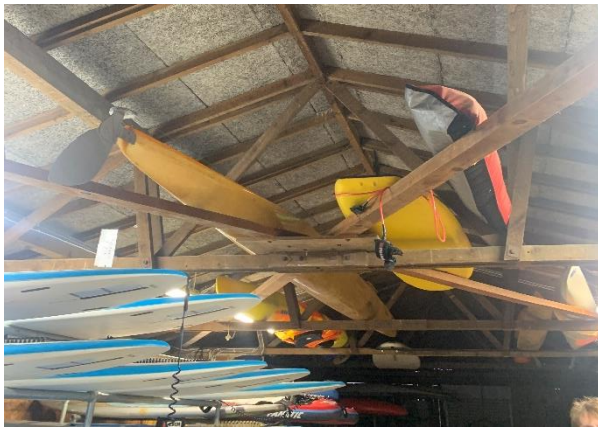
The interior of Building 3 consisted of a large open space with exposed treated timber roof beams (Plate 4.17). The building was poorly insulated with only the ceiling possessing any form of insulation. There were holes in the ceiling insulation, but none appeared to extend into significant enclosed cavities capable of supporting larger numbers of bats (Plate 4.18). No evidence of bats, e.g., droppings, urine staining, feeding remains or scratch marks, was recorded during the internal inspection of the building.

Plate 4.17: Interior of Building 3

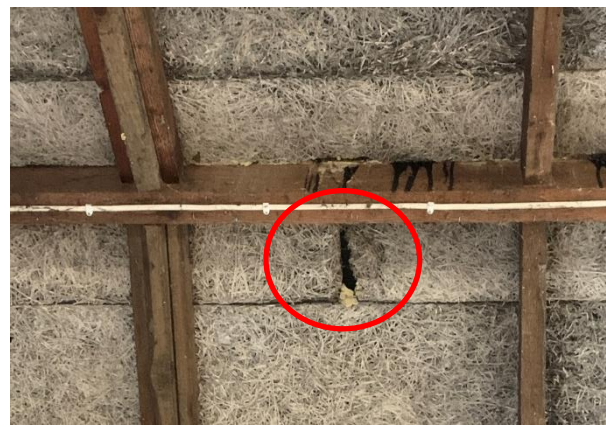
Plate 4.18: Gap in The Ceiling Insulation

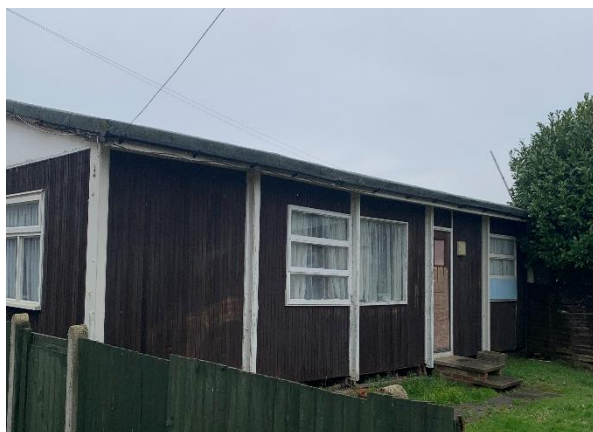
Building 4 consisted of a single storey wooden building with a pitched felt roof (Plate 4.19). The building had a series of single glazed windows with wooden frames. The building was in generally poor repair at the time of the survey. The external vents on the north-facing wall had sustained damage, granting access into the internal space (Plate 4.20). A pipe hole was also present on the east-facing wall, and appeared to extend into the wall structure (Plate 4.21)

Plate 4.19: Building 4 (Cedar House)

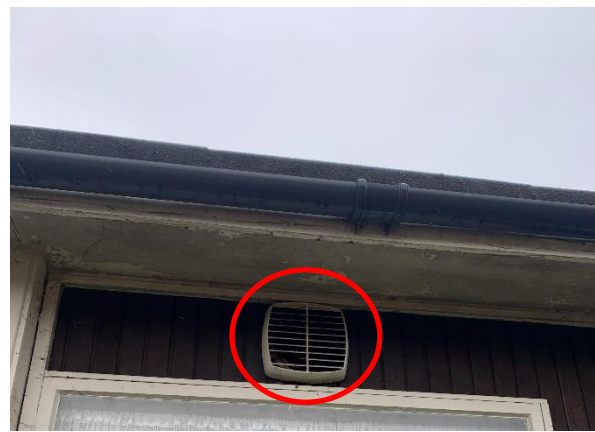
4.20: Damaged Roof Vent (Northern Aspect)

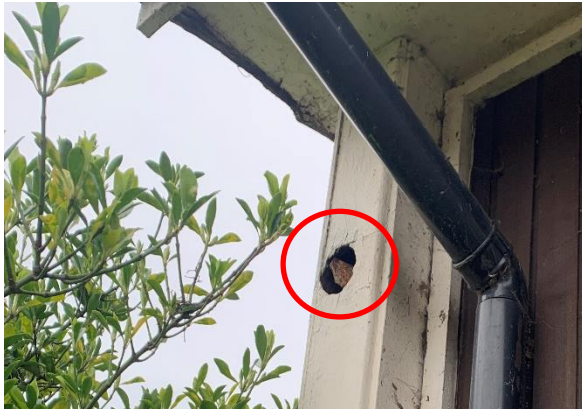
**Plate 4.21: Pipe Hole (Northern Aspect)**

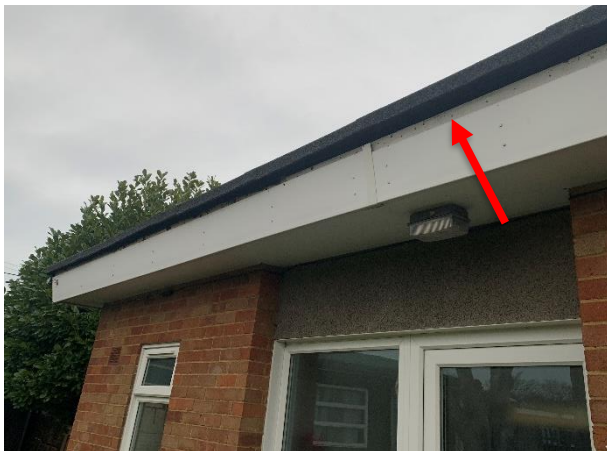
Areas of lifted roofing felt were present at all aspects, presenting limited opportunities for bats to roost under the roofing material (Plate 4.22). A pipe hole was identified in the soffit box at the southern extent of the property (Plate 4.23).

**Plate 4.22 Lifted Roofing Felt (Western Aspect)**

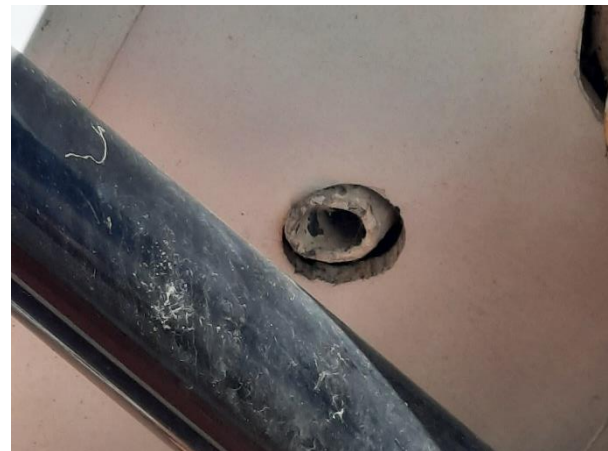
**Plate 4.23: Pipe Hole (Southern Aspect)**

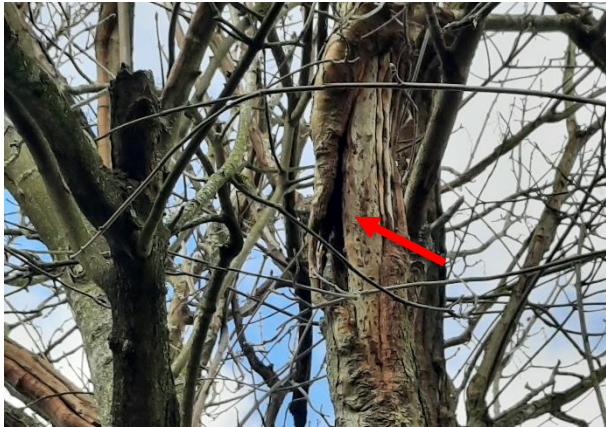
Tree No.	Species	Description	BCT Suitability Class
T2	<i>Acer pseudoplatanus</i>	A 12 m tall semi-mature sycamore. Loose bark was identified at 6m, and several broken branches were noted at 8m (Plate 4.24)	High
T69	<i>Acer pseudoplatanus</i>	A semi-mature 10m tall sycamore with 2 tear out wounds at 6m and one tear out wound at 8m. All features appeared to extend (Plate 4.25).	High
T70	<i>Acer pseudoplatanus</i>	A 10 m semi-mature sycamore with knot holes and a tear out wound at 5m (Plate 4.26).	High
T71	<i>Acer pseudoplatanus</i>	A 13m tall mature sycamore with tear out wounds at 6m. This feature appeared to extend (Plate 4.27).	High
T87	<i>Crataegus monogyna</i>	A mature 10 m hawthorn with a tear out wound at 6m (Plate 4.28)	High
T93	<i>Robinia pseudoacacia</i>	A mature 15 m false acacia with loose bark cavities throughout (Plate 4.29).	Moderate
T96	<i>Robinia pseudoacacia</i>	A mature 15 m false acacia with loose bark cavities throughout (Plate 4.30).	Moderate

Plate 4.24: T2 With Loose Bark At 6m Height.

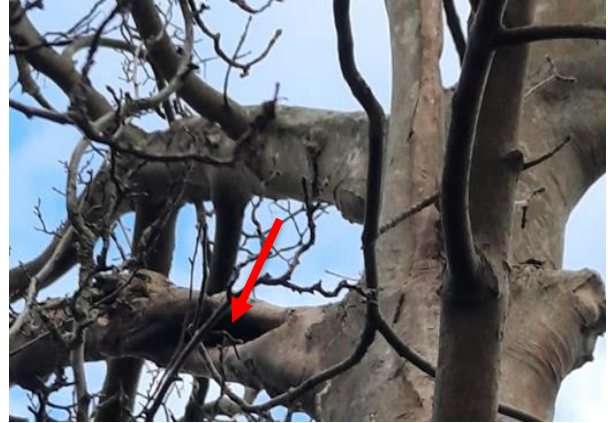
Plate 4.25: T69 Tear Out Wound At 6m

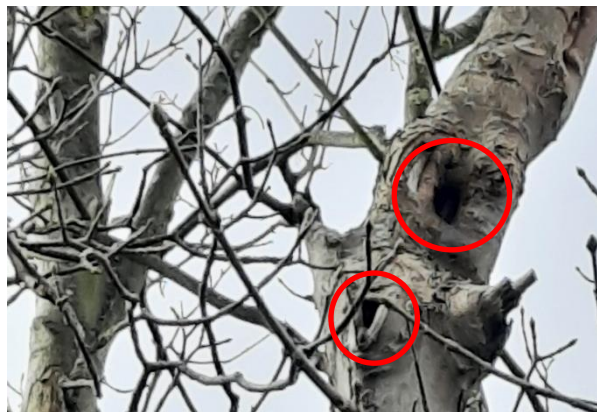
Plate 4.26: T70 Knot Holes At 5m.

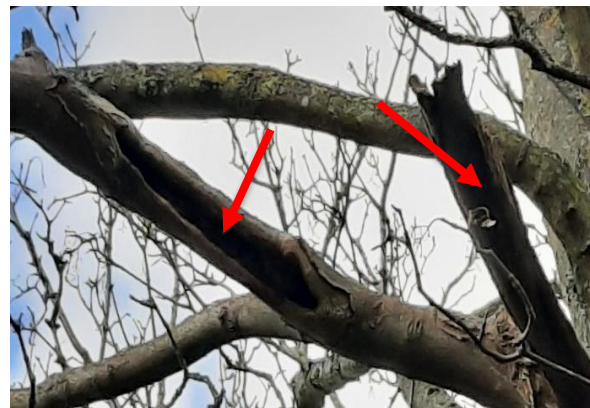
Plate 4.27: T71 Tear Out Wounds At 6m

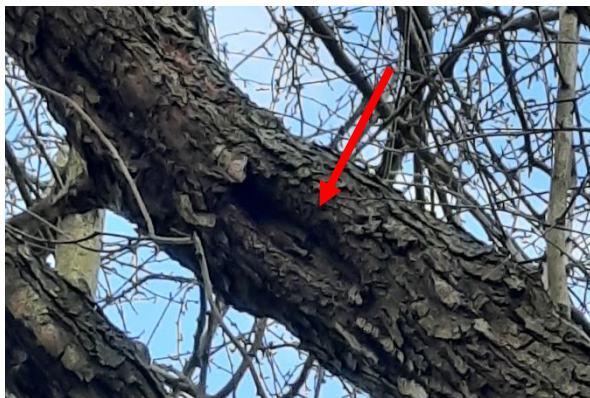
Plate 4.28: Hawthorn with Tear Out Wound.

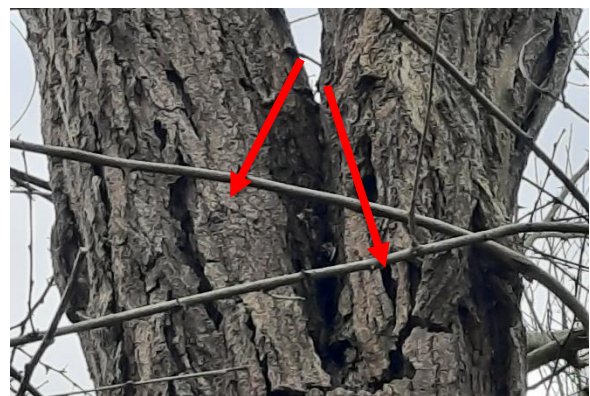
Plate 4.29: T93 Loose Bark.

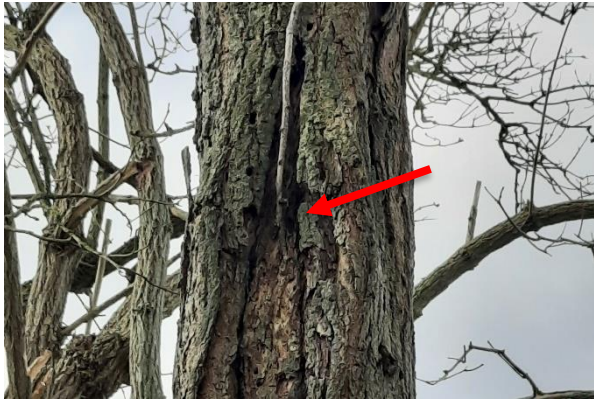
Plate 4.30: T96 Loose Bark.

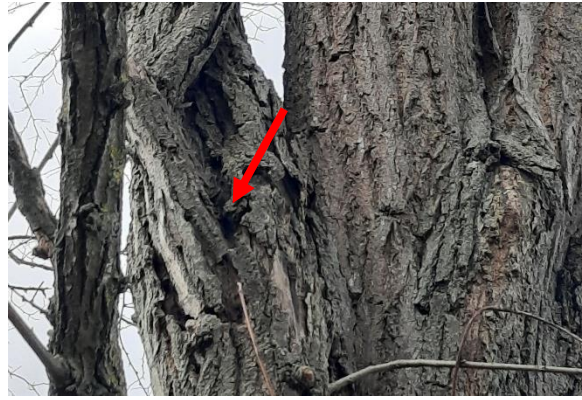
T97	<i>Robinia pseudoacacia</i>	A mature 15 m false acacia with loose bark cavities throughout (Plate 4.31).	Moderate
T98	<i>Robinia pseudoacacia</i>	A mature 15 m false acacia with loose bark cavities throughout (Plate 4.32).	Moderate
T139	<i>Prunus sp.</i>	An 8 m tall semi-mature prunus sp. A bat box had been installed at a height of 3 m (Plate 4.33).	High
T140	<i>Acer pseudoplatanus</i>	A 10 m tall semi-mature sycamore. 2 bat boxes had been installed at a height of 4 m (Plate 4.34).	High
T141	<i>Acer pseudoplatanus</i>	A 10 m tall semi-mature sycamore. 2 bat boxes had been installed at a height of 4 m (Plate 4.35).	High
T160	<i>Salix sp.</i>	A mature 10 m salix sp with a knot hole and new growth splits at 8m (Plate 4.36).	High
T162	<i>Salix sp.</i>	A mature 5 m Salix with a large tear out wound at 3m height (Plate 4.37)	High
T163	<i>Salix sp.</i>	A mature 8 m Salix with five woodpecker holes between 4-8m (Plate 4.38).	High

Plate 4.31: T97 Loose Bark

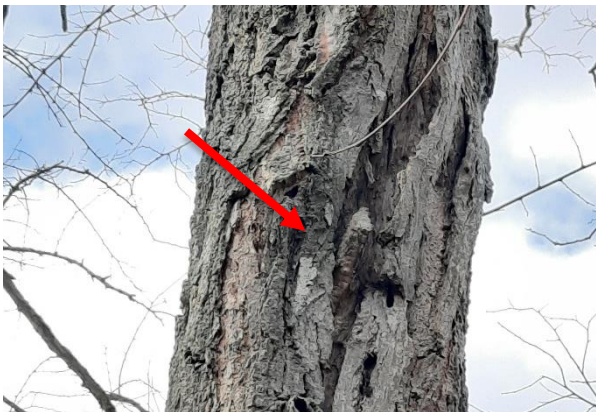
Plate 4.32: T98 Loose Bark.

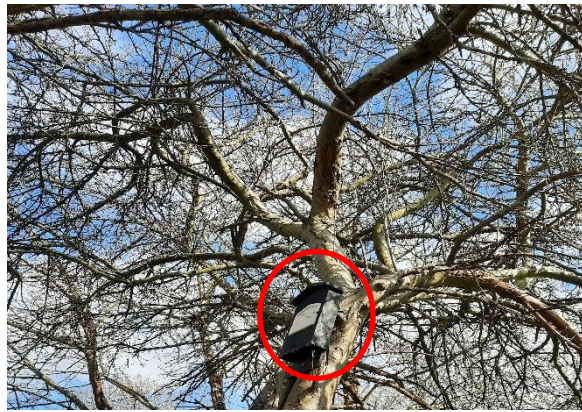
Plate 4.33: T139 With A Bat Box.

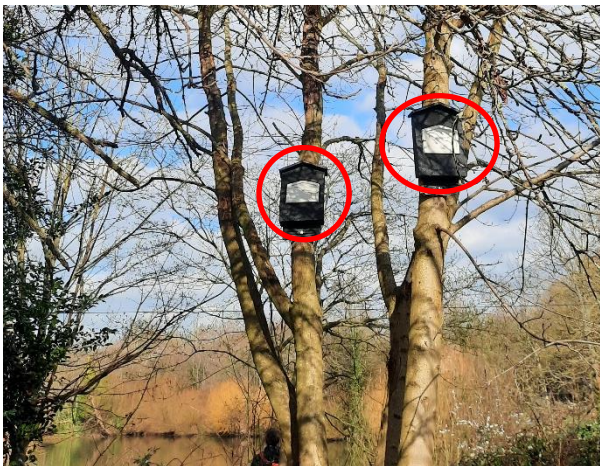
Plate 4.34: T140 Bat Boxes At 4m.

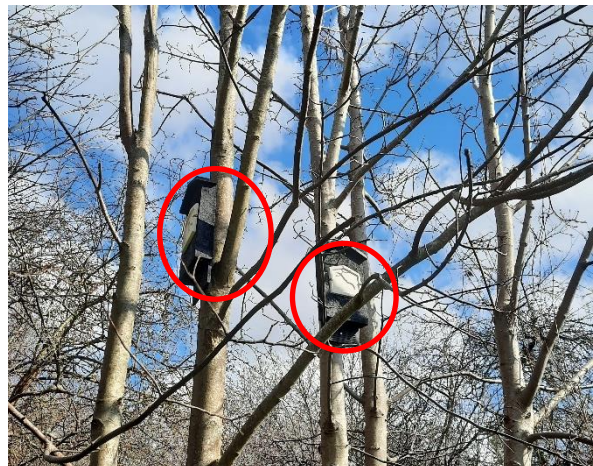
Plate 4.35: T141 Bat Boxes At 4m.

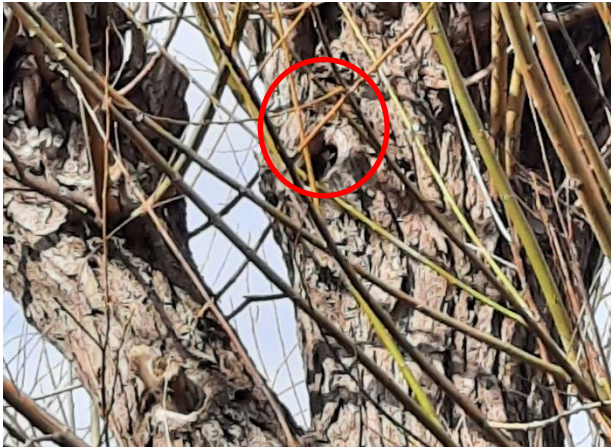
Plate 4.36: T160 Knot Hole At 6m.

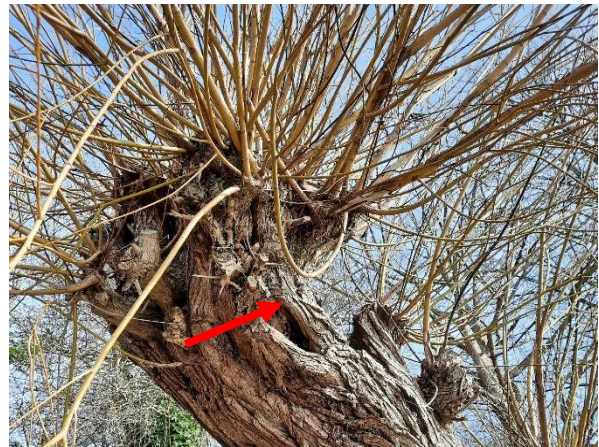
Plate 4.37: T161 With Tear-Out Wound.

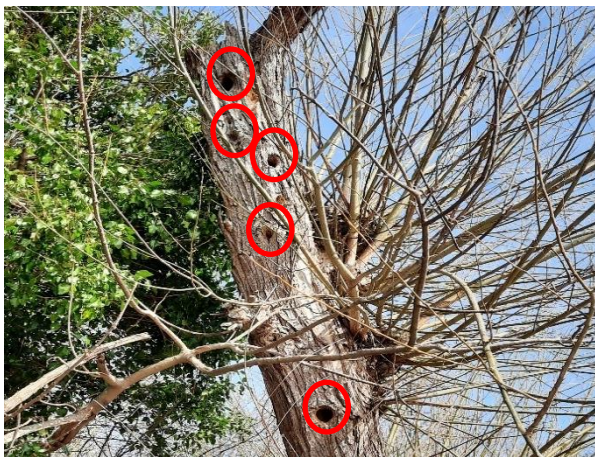
Plate 4.38: T163 With Five Woodpecker Holes.

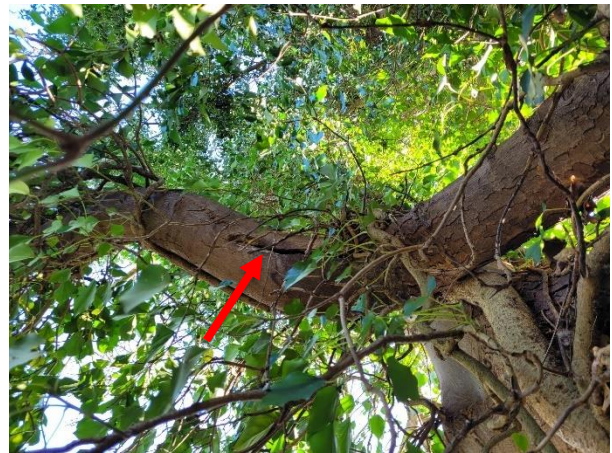
Plate 4.39: T248 Branch Split At 3m.

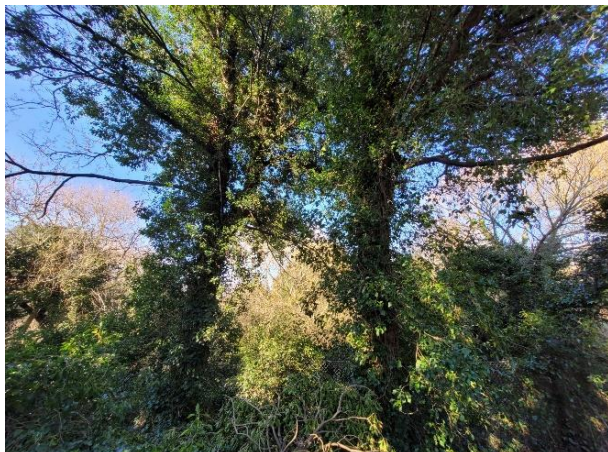
Plate 4.40. T249 And 250 Dense Ivy Cover

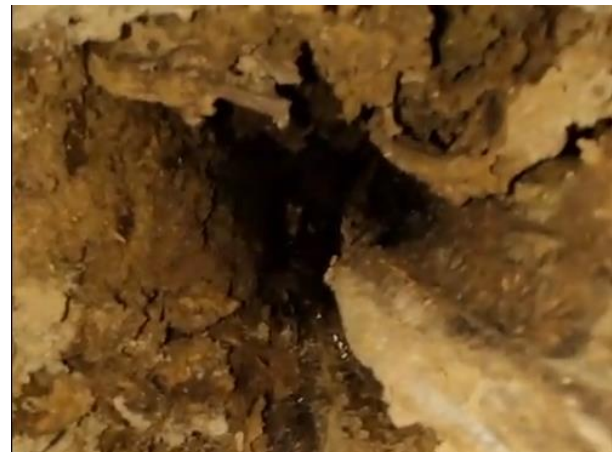
T247	<i>Salix sp.</i>	An 8 m tall mature willow with a large cavity extending beyond the reach of an endoscope into the trunk at 1.5 m (Plate 4.41).	High
T248	<i>Acer pseudoplatanus</i>	A mature 20 m tall sycamore with a crack in the lower south facing limb at 3 m. Dense ivy cover was present on the trunk (Plate 4.39).	High
T249	<i>Acer pseudoplatanus</i>	A 15 m tall mature sycamore with moderate ivy cover (Plate 4.40).	Moderate
T250	<i>Acer pseudoplatanus</i>	A 15 m tall mature sycamore with moderate ivy cover (Plate 4.40).	Moderate

Plate 4.41. T247 Cavity within trunk
