REPORT 61351/S/1

SHELDON HOUSE, TEDDINGTON

INVESTIGATION OF MASONRY WALLS

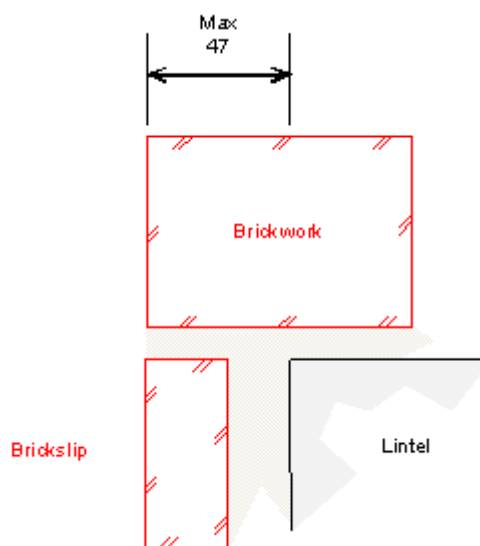
The brick forming the outer leaf is of standard width and sits on the concrete lintel. Up to 47mm of it overhangs the lintel and this may cause strain on the slips below and wall above - see sketch below.

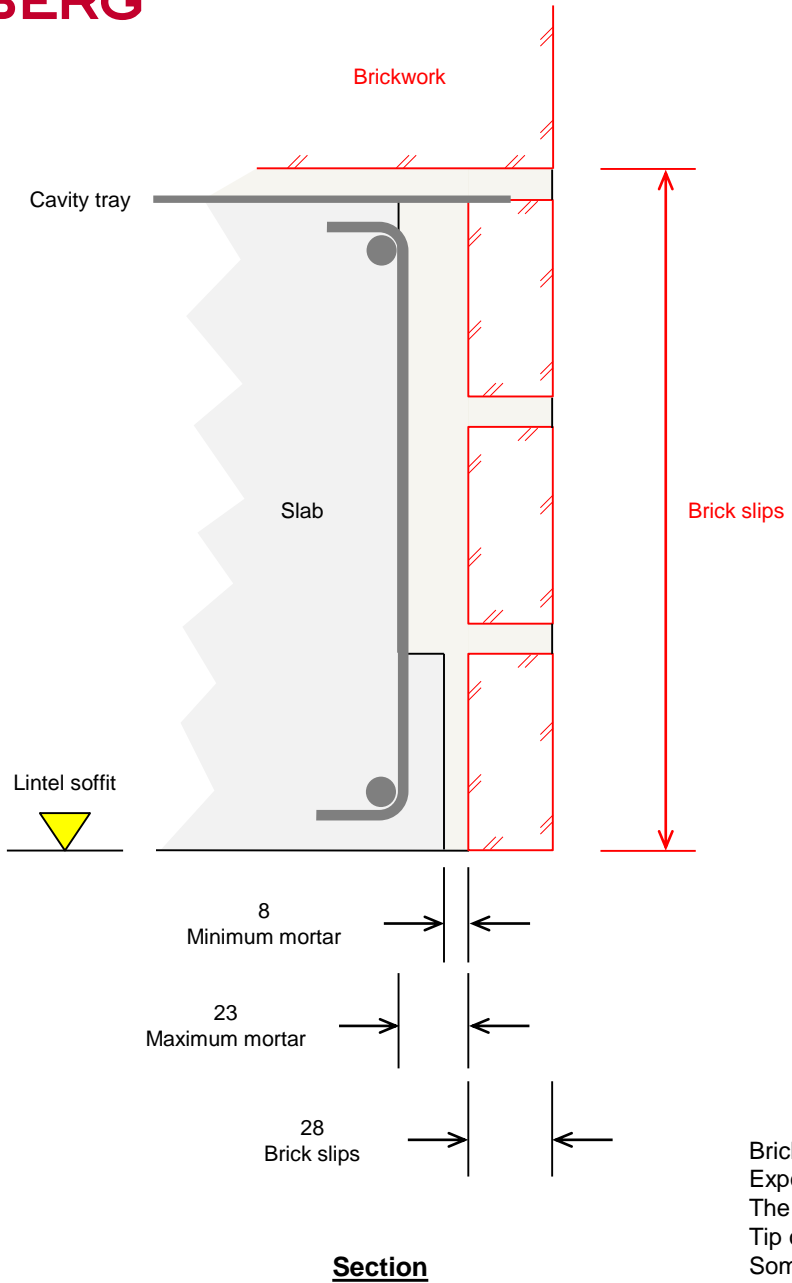
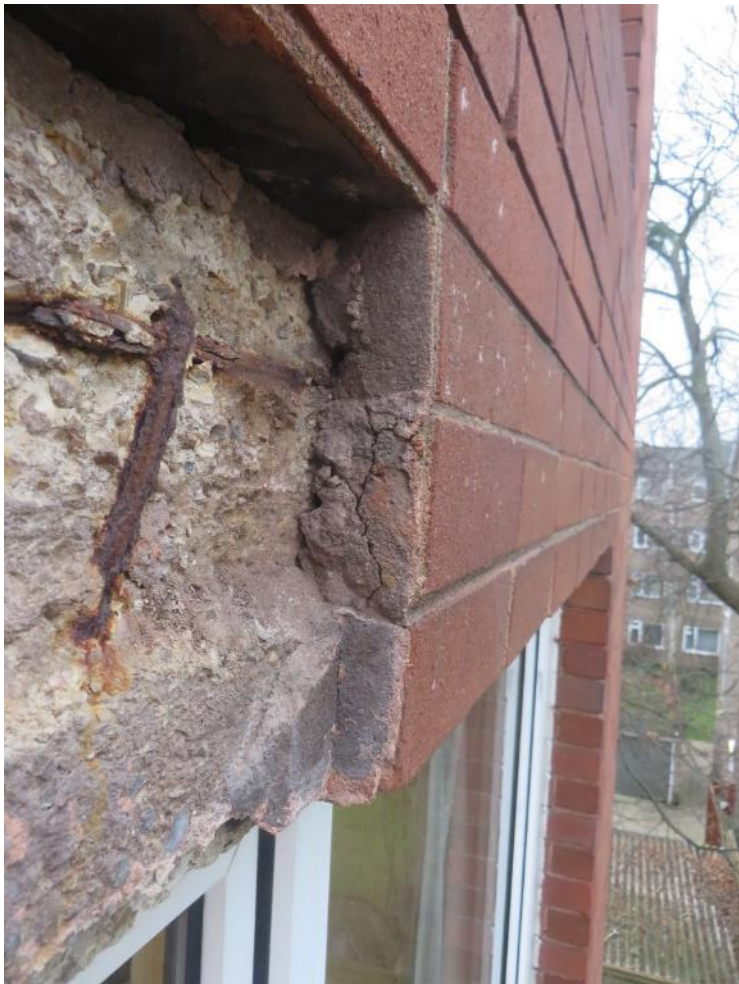
Figure 2. Location 1. Rear Elevation. Third Floor. Window Lintel. Brick Slips Removed.

Brick slips over the window lintel partially removed (by others)
 Exposed corroding reinforcement visible.
 The concrete cover (nominal 5 to 10mm) appears to have been mechanically removed / broken away.
 Tip of cavity tray exposed.
 Some remaining brick slips sound hollow. Slips away from the lintel were sound.

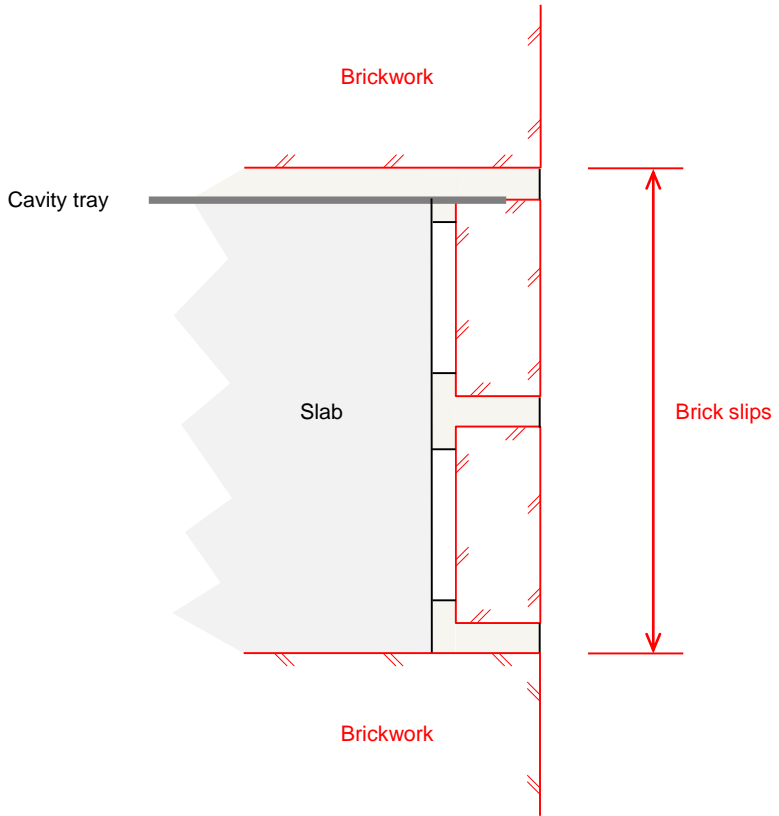
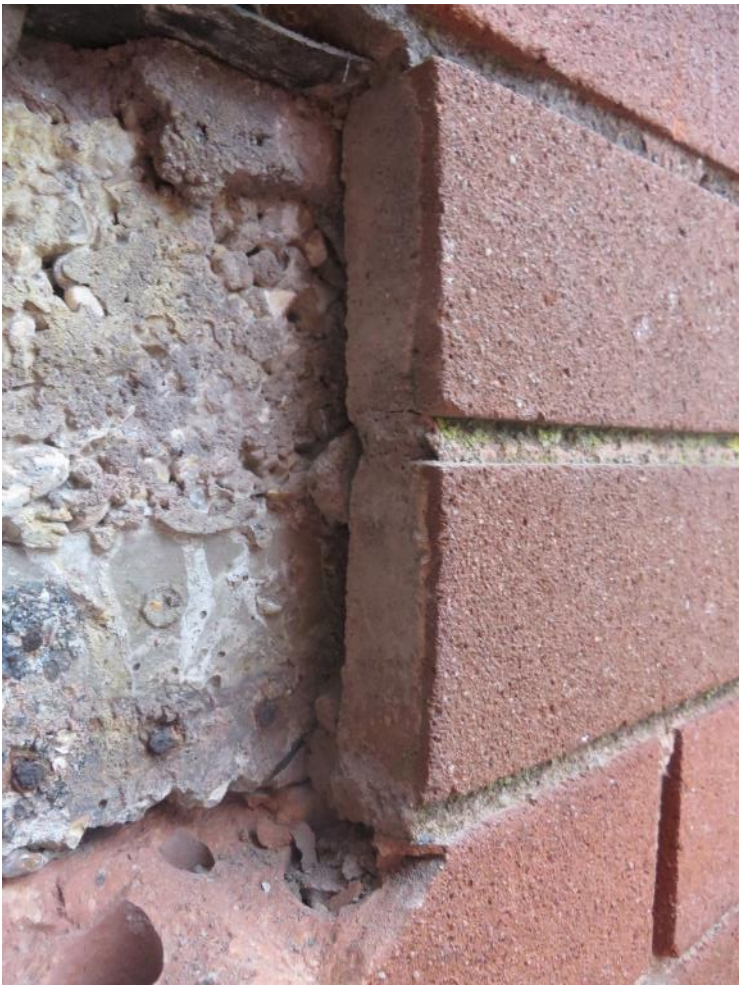
Figure 3. Location 2. Rear Elevation. Third Floor. Slab Edge. Brick Slips Intact.

Brick slips over the slab edge removed. Only two slips compared to three on the lintels. Exposed slab edge had a rough concrete finish. Unable to locate reinforcement. Mortar behind slips only "dabs" Tip of cavity tray exposed.

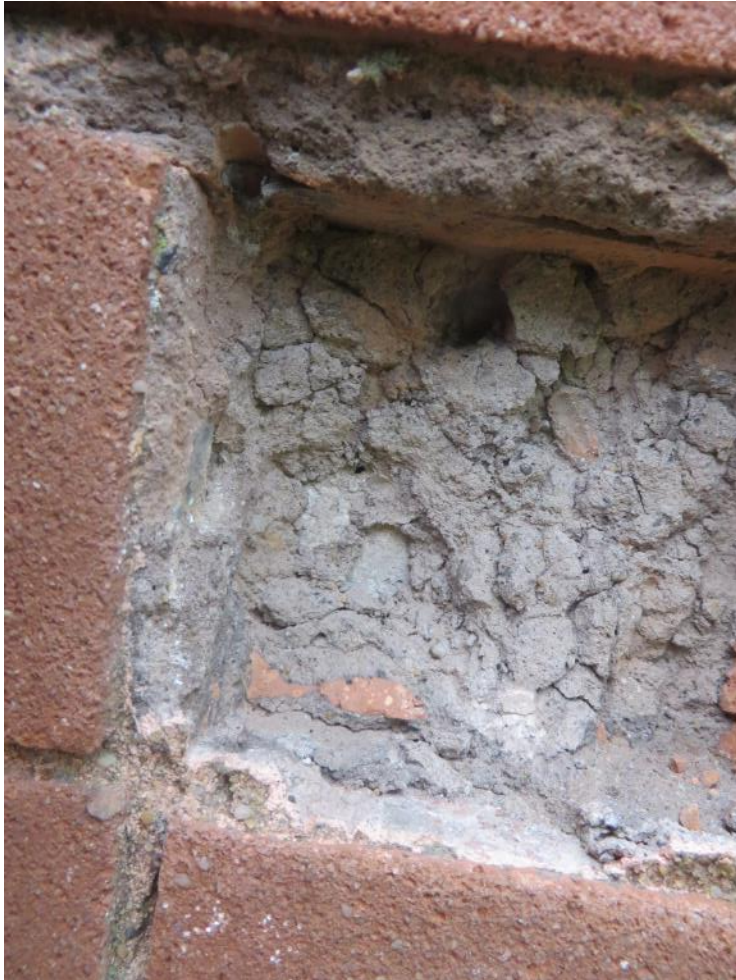
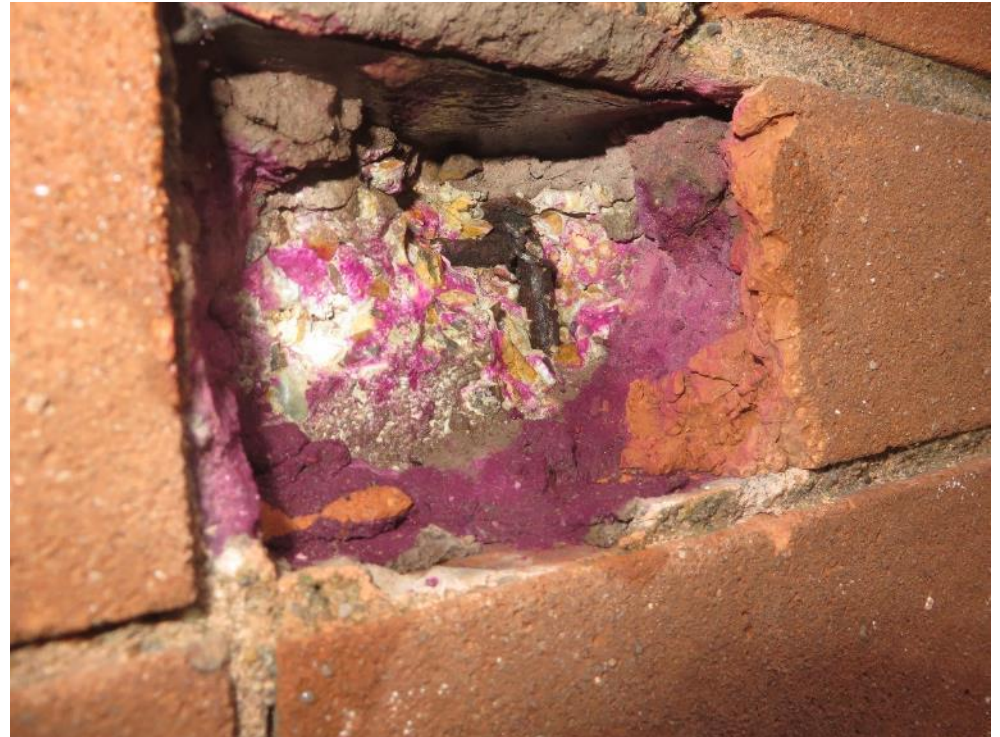
Figure 4. Location 3. Rear Elevation. Fourth Floor. Window Lintel. Brick Slips Intact.

A hollow sounding brick slip, over the window lintel was partially removed. The seventeen millimetre vertical mortar bed behind the slip was uniform and moderately hard. The concrete forming the slab edge behind was soft or spalled. Upon removing the concrete, corroding reinforcement at thirteen millimetre cover was exposed. Depth of concrete carbonation exceeded cover. Tip of cavity tray exposed.

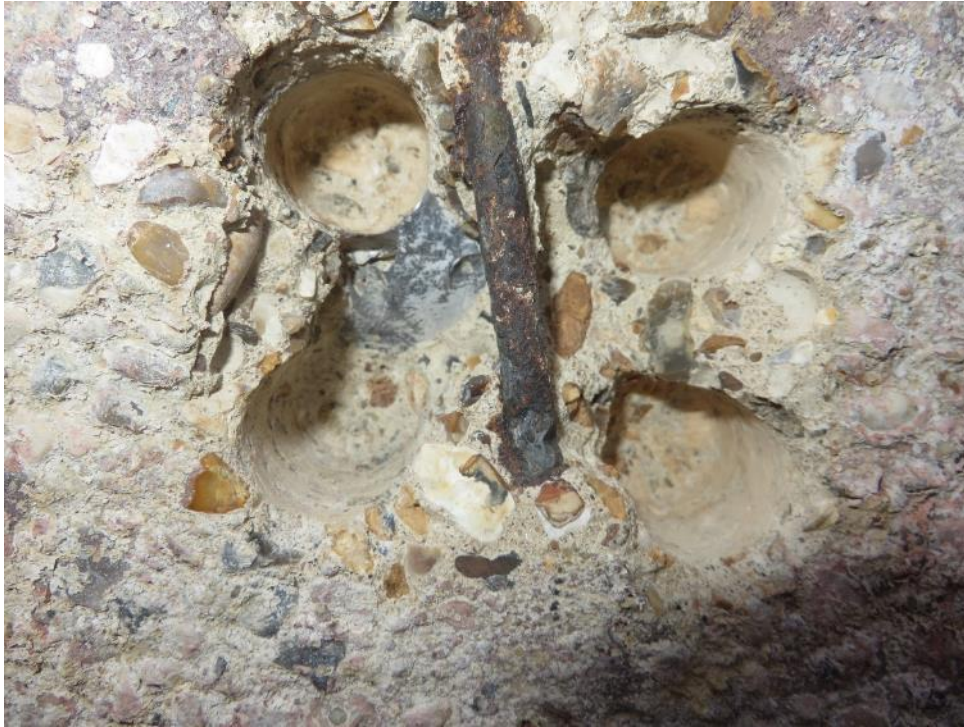
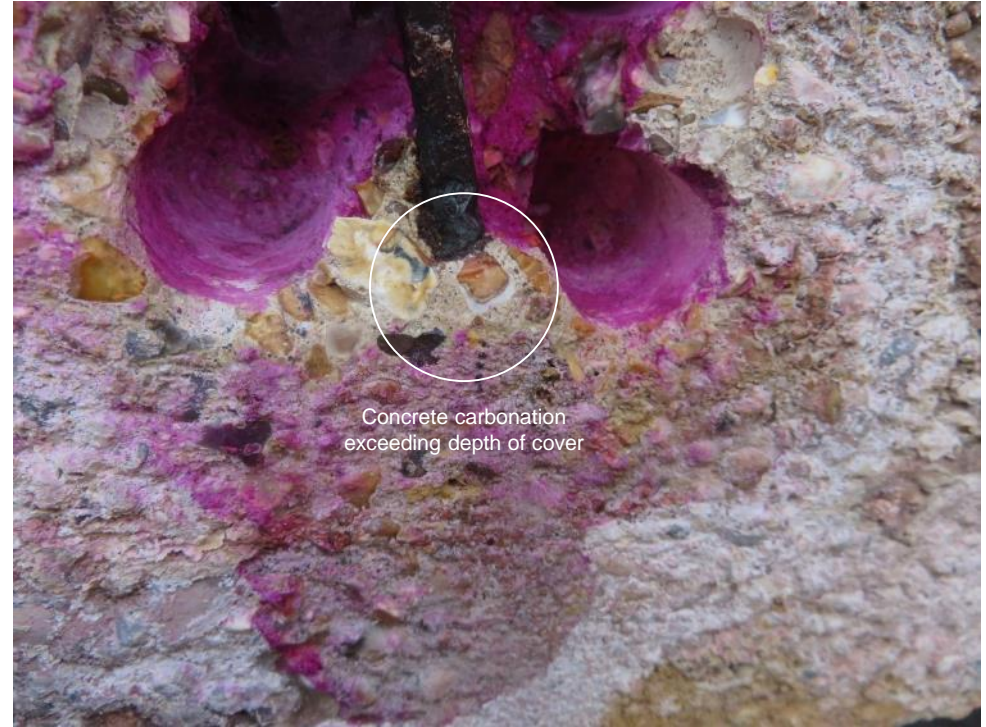
Figure 5. Location 4. Rear Elevation. Third Floor. Window Lintel. Brick Slips Removed.

Brick slips over the window lintel removed (by others)
 Concrete cover to the reinforcement was 8mm.
 The concrete carbonation depth exceeded cover.
 Surface corrosion on the reinforcement.

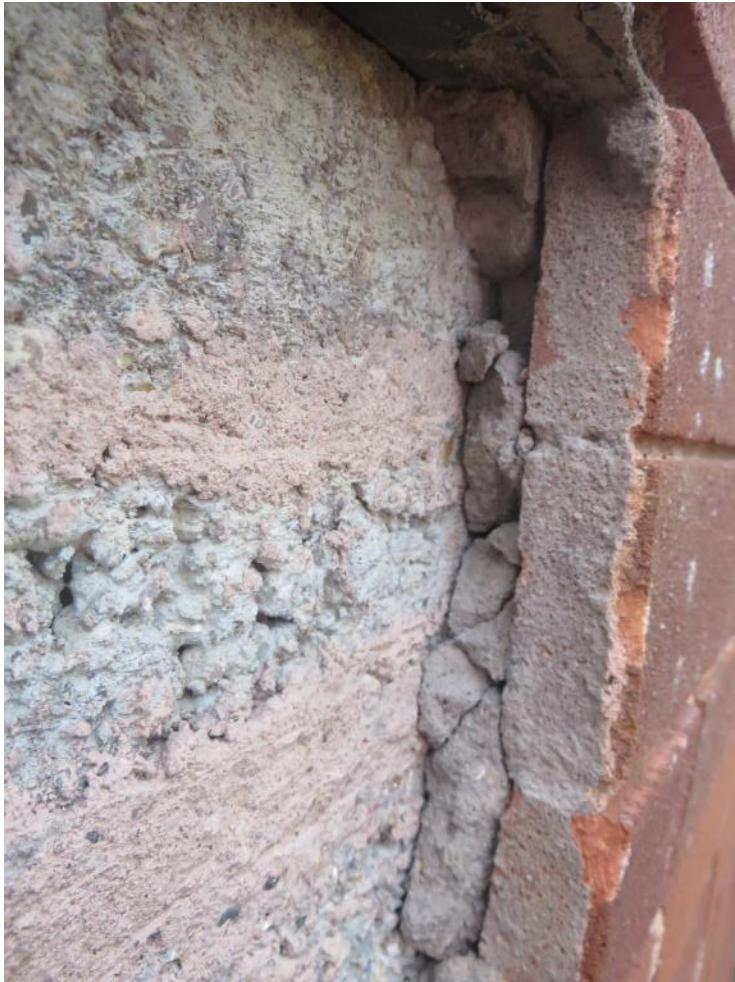
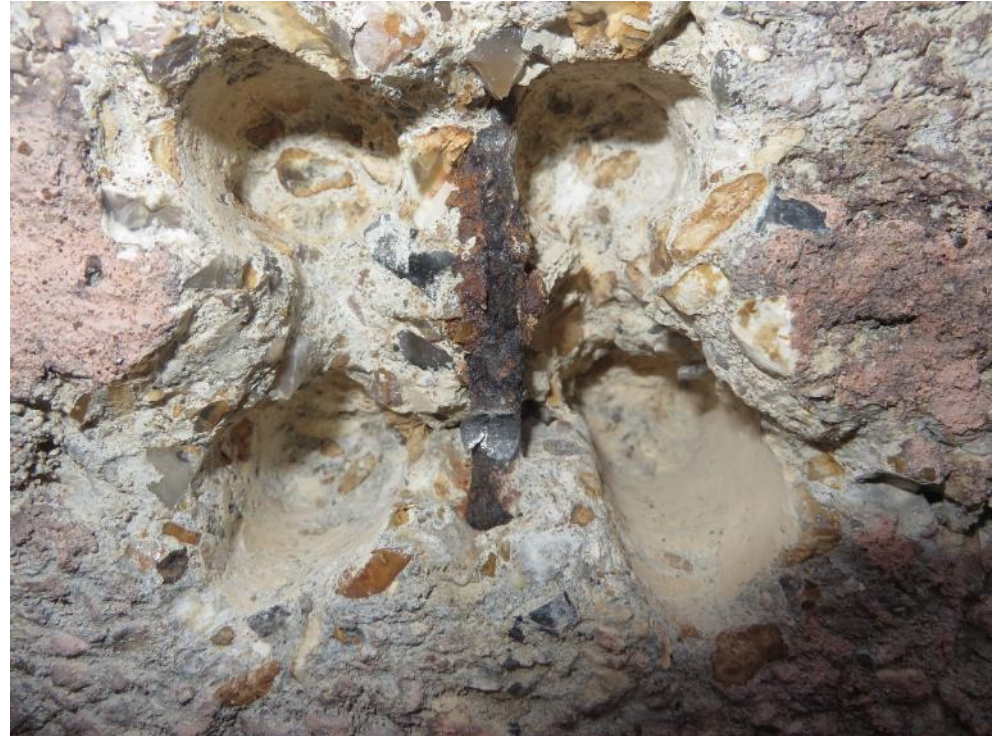
Figure 6. Location 5. Rear Elevation. Second Floor. Window Lintel. Brick Slips Removed.

At 2No. locations a gap was noted between the concrete lintel and the vertical mortar joint and the slips were “bulging” out i.e. the slips were debonded from the concrete substrate - see Figures 6 and 7.

Brick slips over the window lintel removed (by others)
Top 1mm of mortar in the vertical slip joints, and mortar remnants on the concrete, pink in colour.
The reinforcement exposed at the concrete breakout had severe corrosion.
Some corrosion products were leaching out in to the surrounding cement paste.
The depth of concrete carbonation exceeded cover. Cover was 14mm, Carbonation 30mm.
The remaining slips at the end of the lintel were well mortared / vertically bedded.
Tip of cavity tray visible.

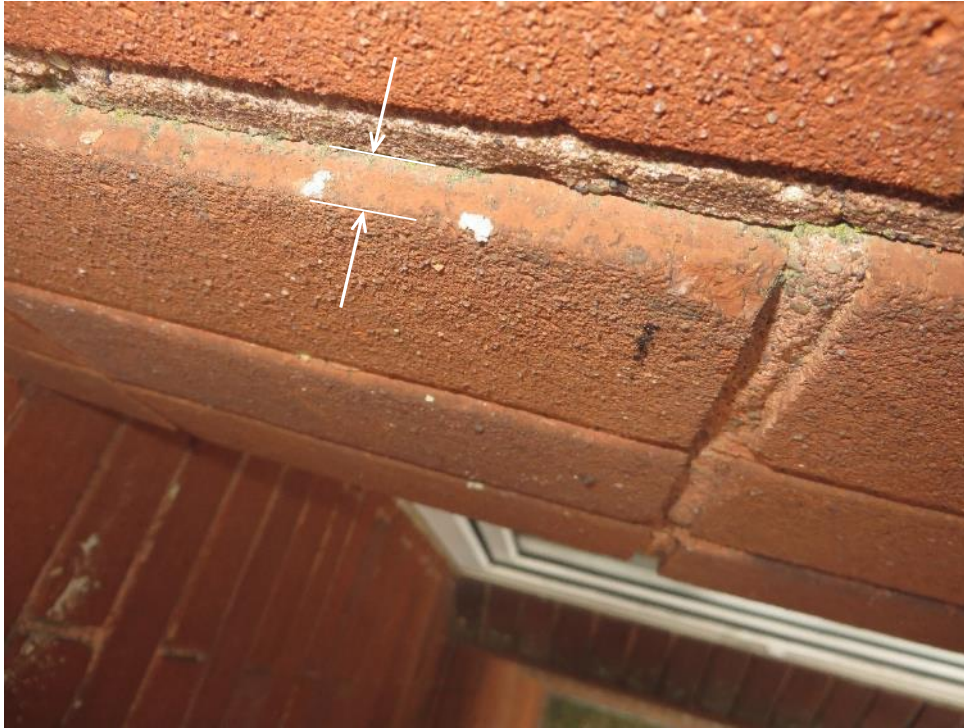
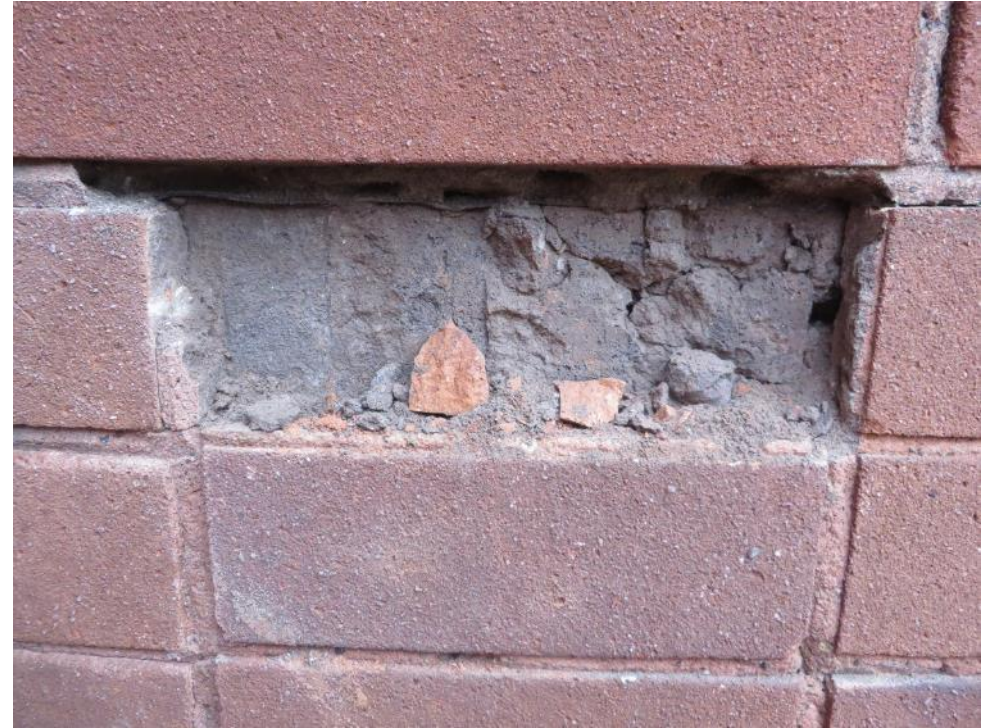
Figure 7. Location 6. Rear Elevation. Fourth Floor. Window Lintel. Brick Slips Intact.

Brick slips over the window lintel visually bulging out.
Vertical bedding joint well mortared.
Concrete behind, believed to have spalled over the reinforcement.
The reinforcement at 10mm concrete cover had surface corrosion.
The depth of concrete carbonation exceeded cover.
Tip of cavity tray exposed.

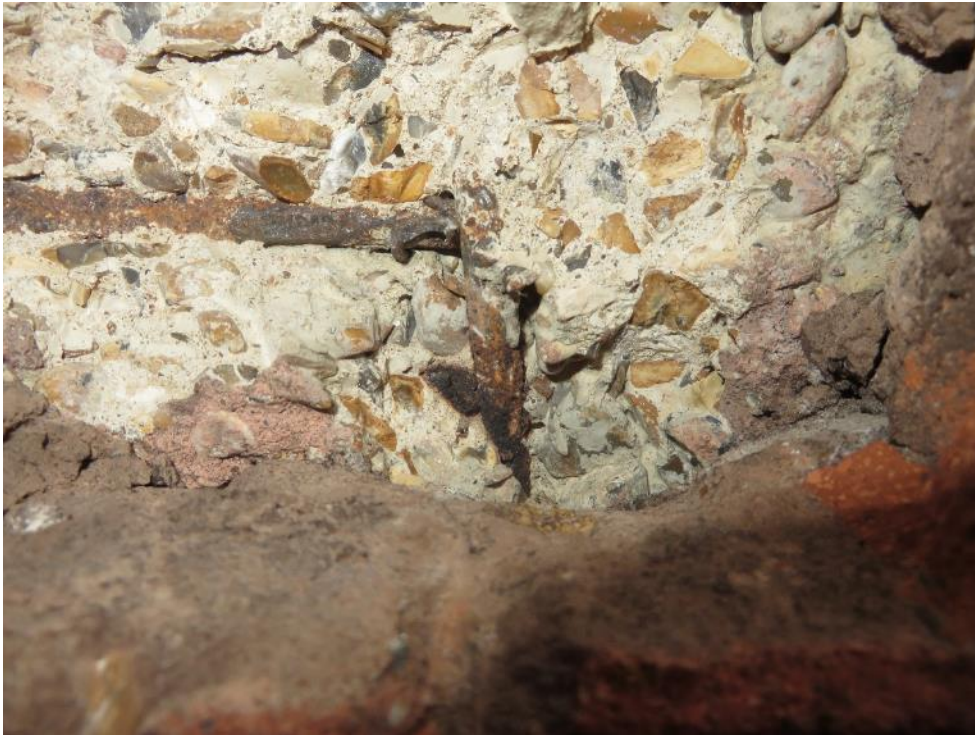
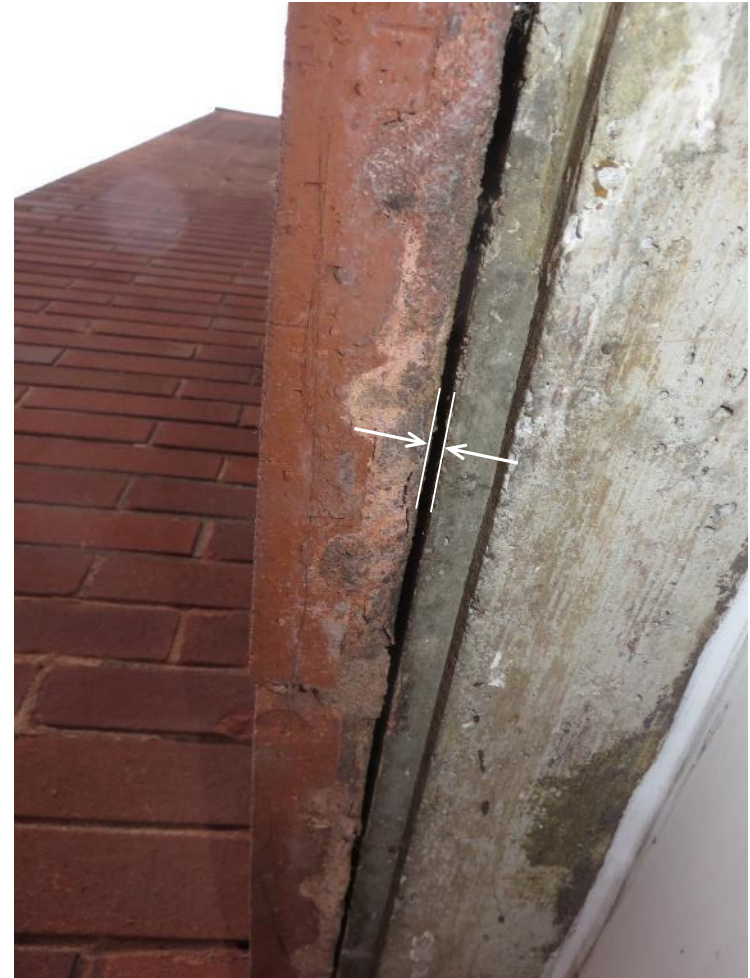
Figure 8. Location 6. Rear Elevation. Fourth Floor. Window Lintel. Brick Slips Intact.

The reinforcement had surface corrosion.

Visible gap between the concrete lintel and the vertical bedding mortar.

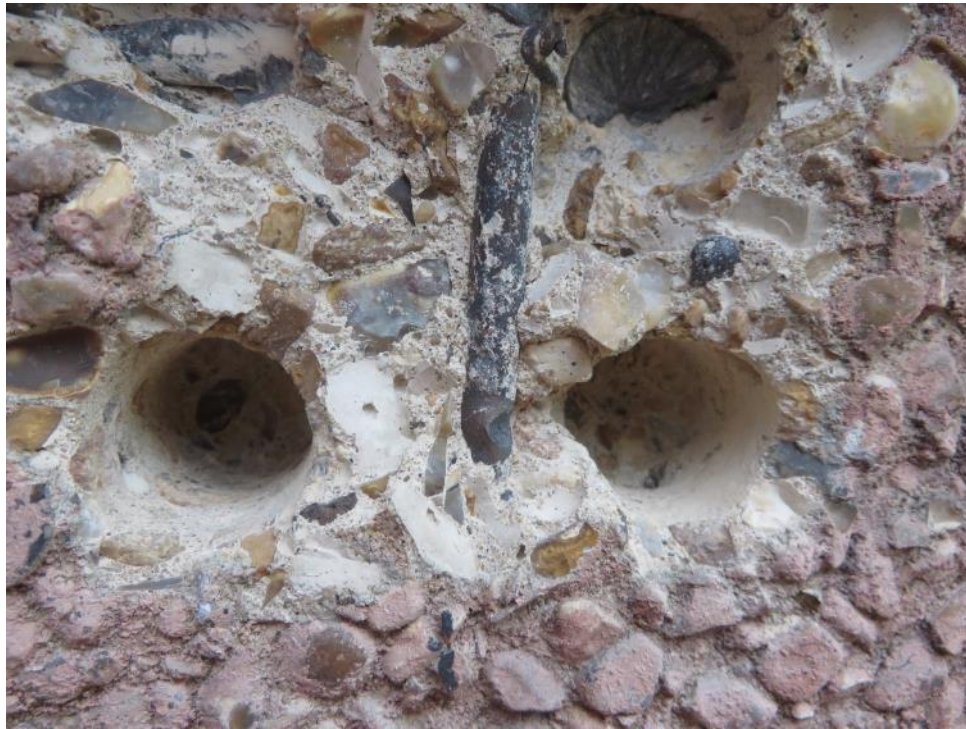
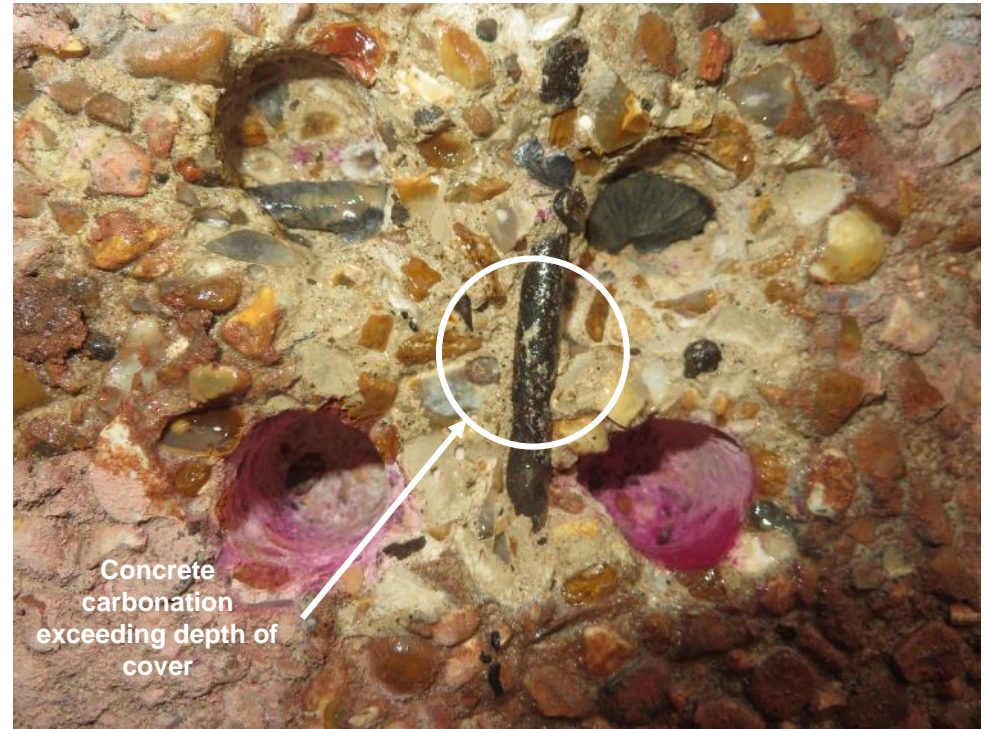
Figure 9. Location 7. Rear Elevation. Third Floor. Window Lintel. Brick Slips Removed.

Concrete carbonation exceeding depth of cover

The reinforcement had 10mm concrete cover.
 The reinforcement was clean.
 The depth of concrete carbonation exceeded cover.

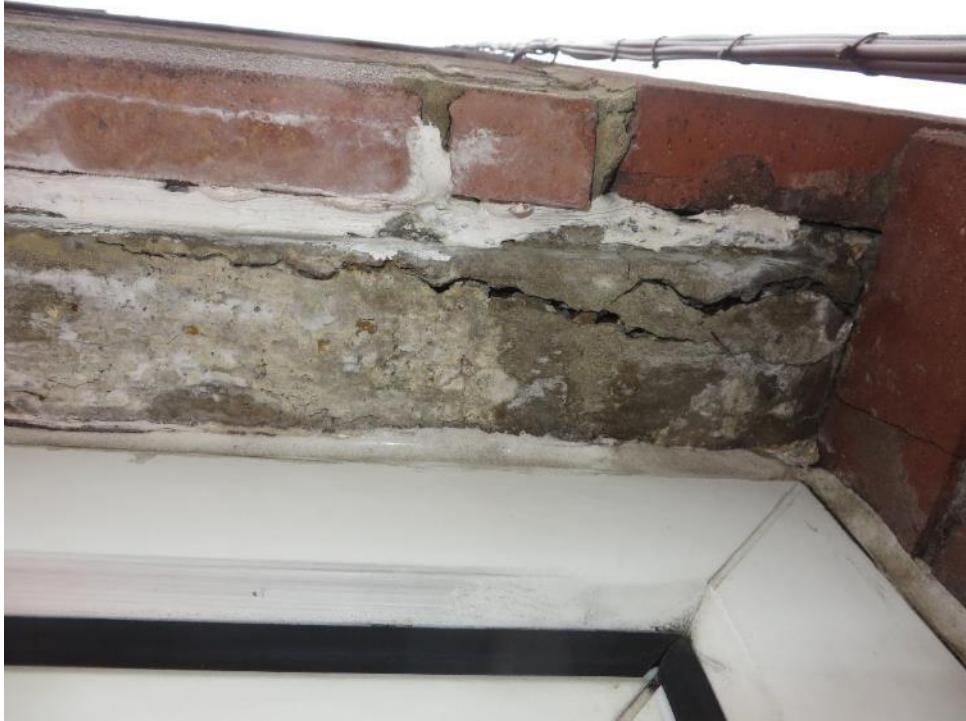
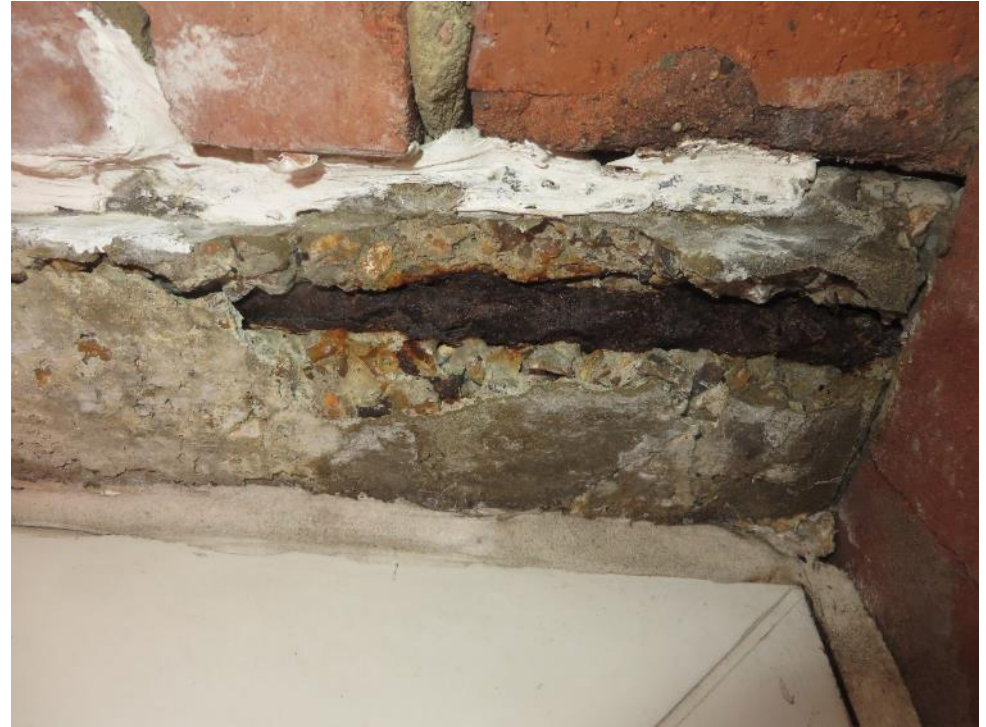
Figure 10. Location 8. Rear Elevation. Fourth Floor. Window Lintel. Brick Slips Intact.

The brick slips had been previously replaced.
Concrete lintel behind severe cracking and spalling.
Corroding reinforcement under.
Slips sound hollow.
Fifth floor above slips replaced, hollow sounding at the end of the lintel.

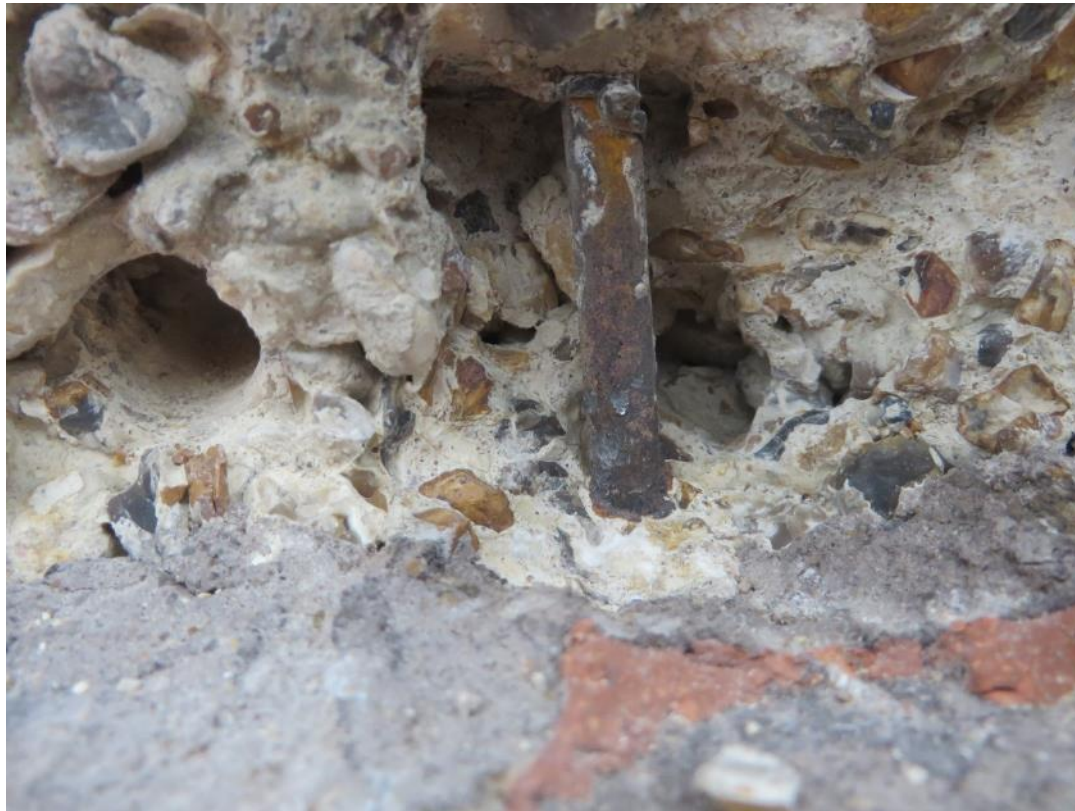
Figure 11. Location 9. Rear Elevation. First Floor. Window Lintel. Brick Slips Intact.

The brick slips sounded slightly hollow.
Concrete lintel behind had slight surface honeycombing and a rough exposed aggregate finish.
Brick slips and vertical bedding mortar 40mm thick.
Concrete cover was 12mm and the exposed bar had surface corrosion.
Carbonation depth exceeded cover.

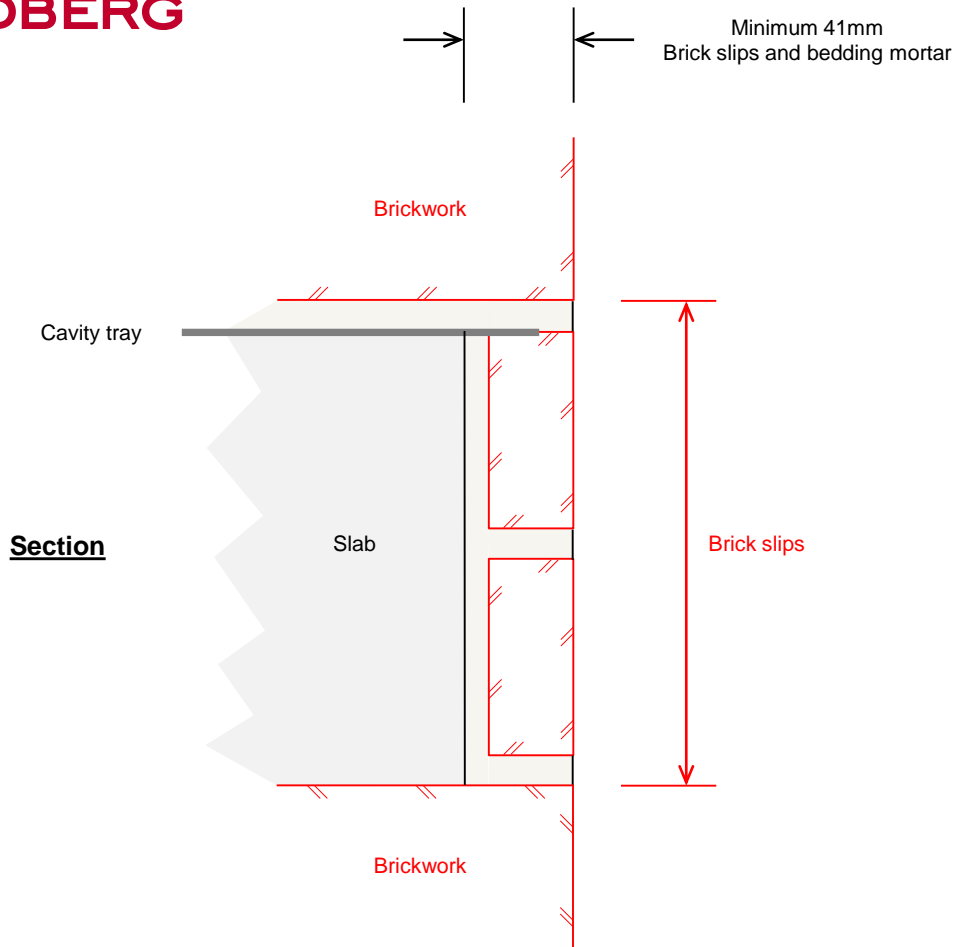
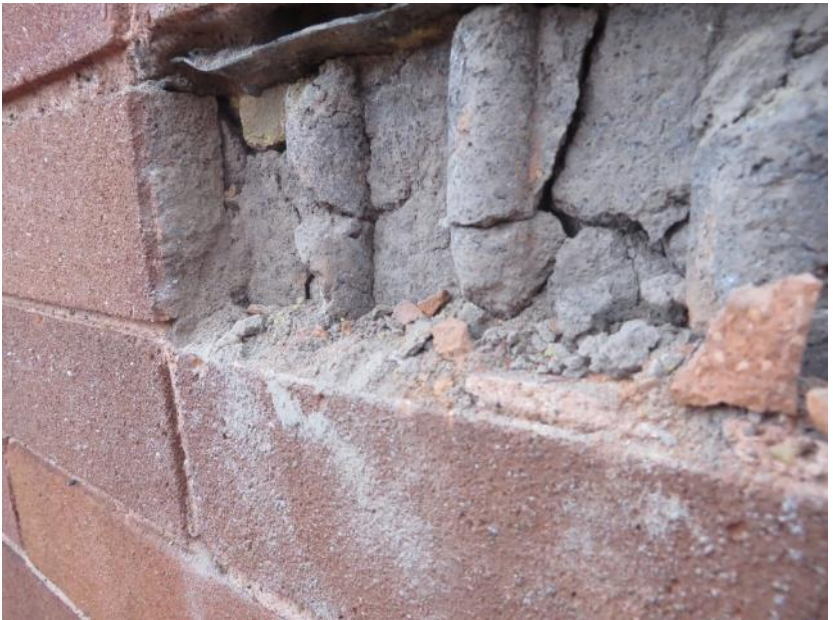
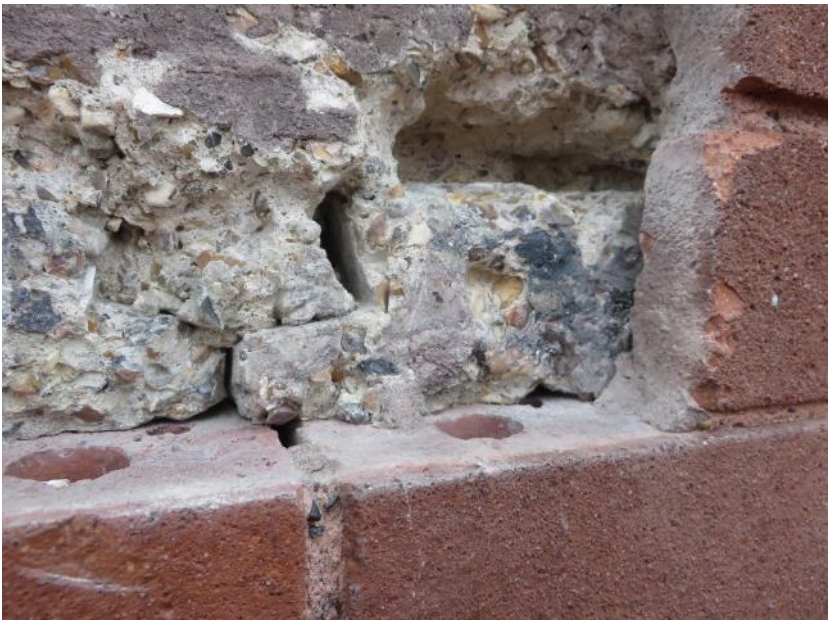
Figure 12. Location 10. Side Elevation. Fourth Floor. Slab Edge.

Brick slips over the slab edge removed. Only two slips compared to three on the lintels.
Slips removed over an isolated hollow sounding area.
Exposed slab edge had a rough concrete finish. Possible joint in concrete.
Unable to locate reinforcement.
Vertical bedding joint well mortared.
Tip of cavity tray exposed.

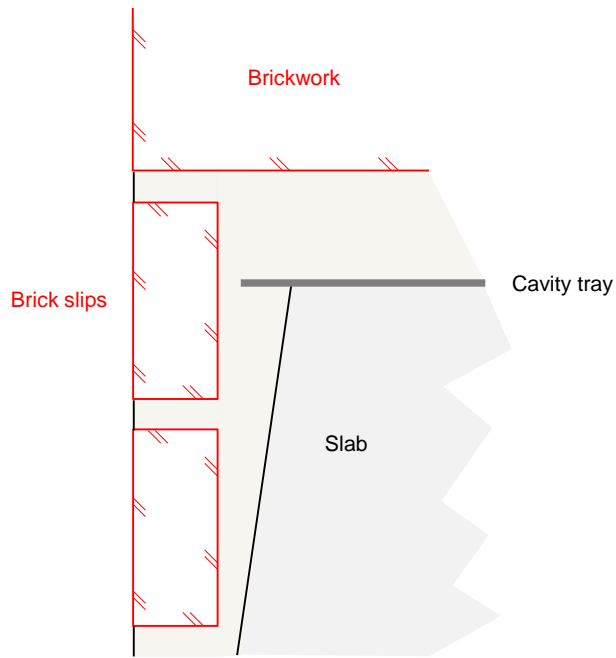
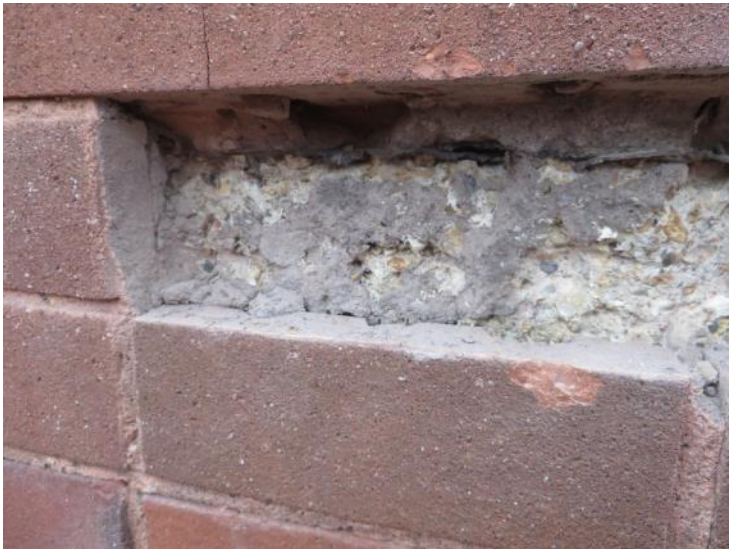
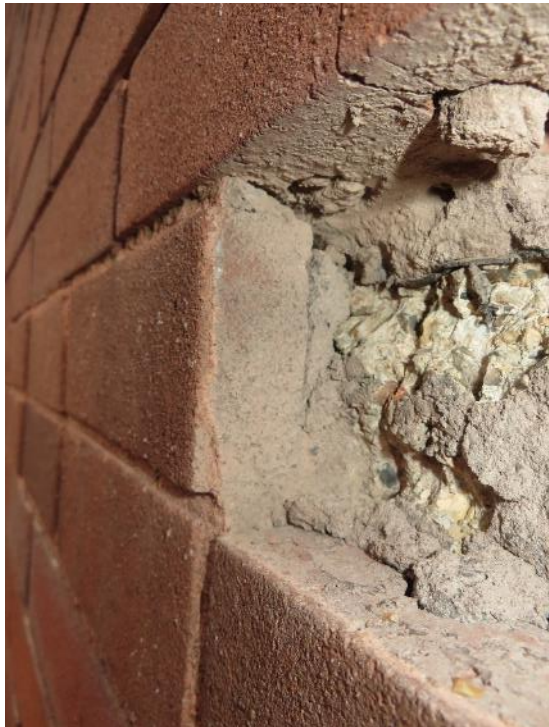
Figure 13. Location 11. Side Elevation. Second Floor. Slab Edge.

Brick slips over the slab edge removed. Only two slips compared to three on the lintels.
Exposed slab edge had a rough concrete finish.
Unable to locate reinforcement.
Vertical bedding joint well mortared.
Tip of cavity tray exposed, but the tray is lower than the joint between the slips.
Cobwebs behind the vertical mortar joint indicate the slips are delaminated.

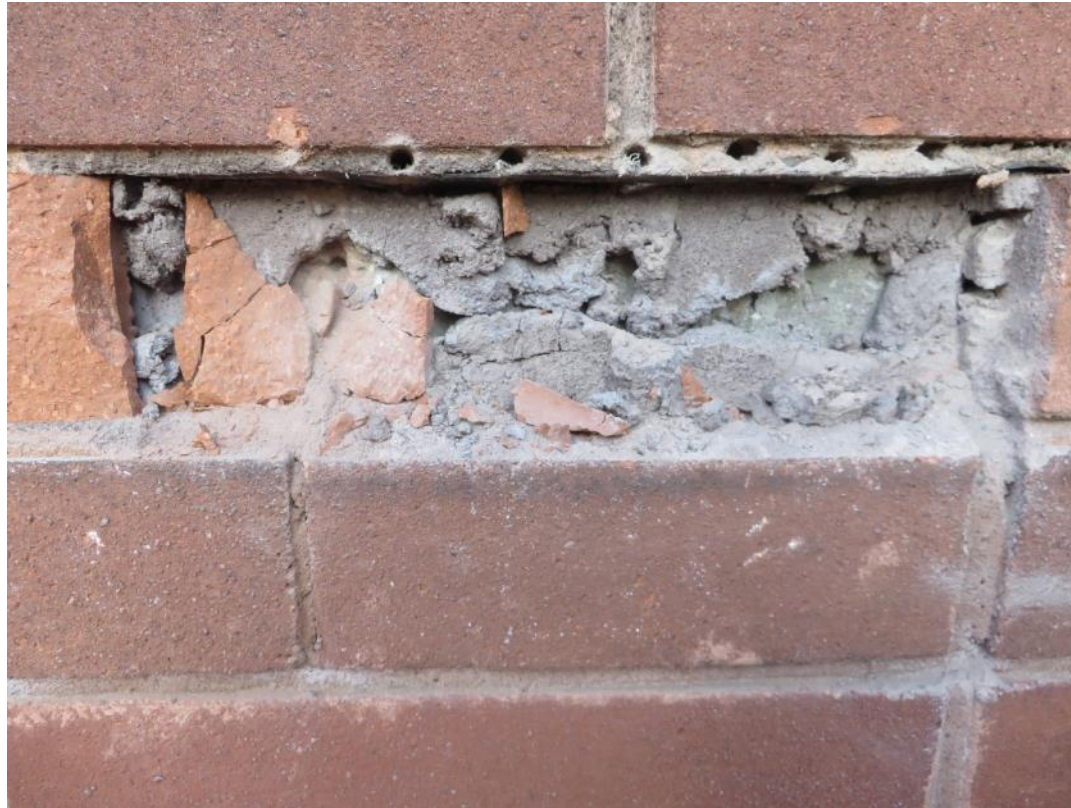
Figure 14. Location 12. Side Elevation. First Floor. Slab Edge.

Third, second and first floor slips inspected for hollow sounding areas.
One small hollow area identified on the first floor.
Vertical bedding joint behind slips only partially mortared.
Brick slips and vertical mortar bedding, minimum 42mm thickness.
Unable to locate reinforcement. Concrete carbonation depth was 10mm.
Holes were drilled above the cavity tray to allow inspection with an endoscope, blown fibre insulation prevented viewing.

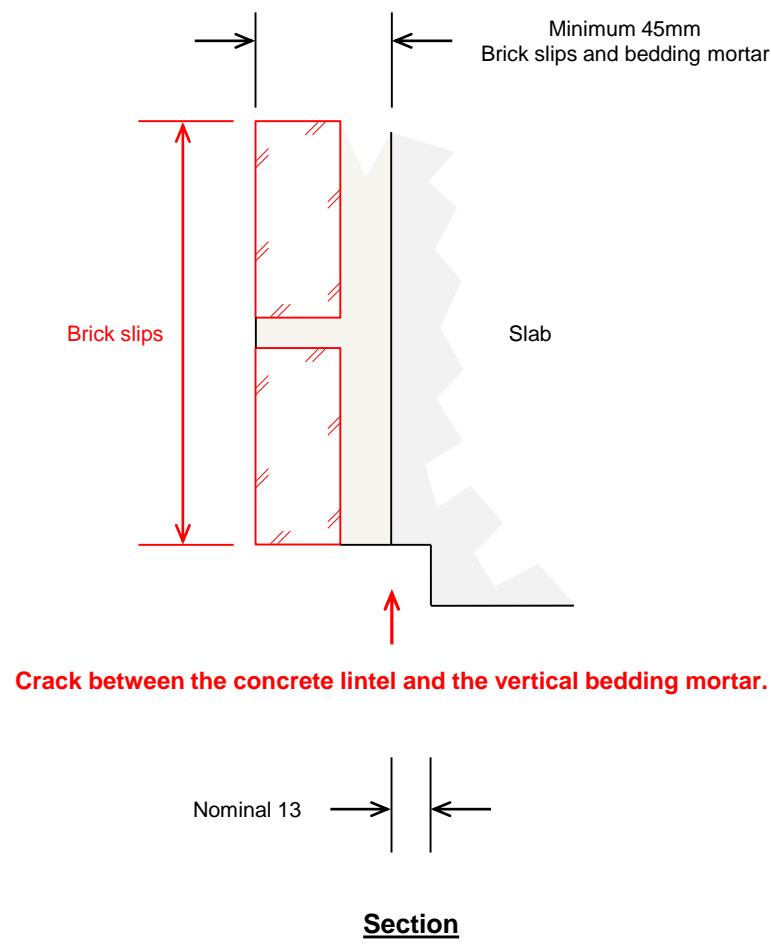
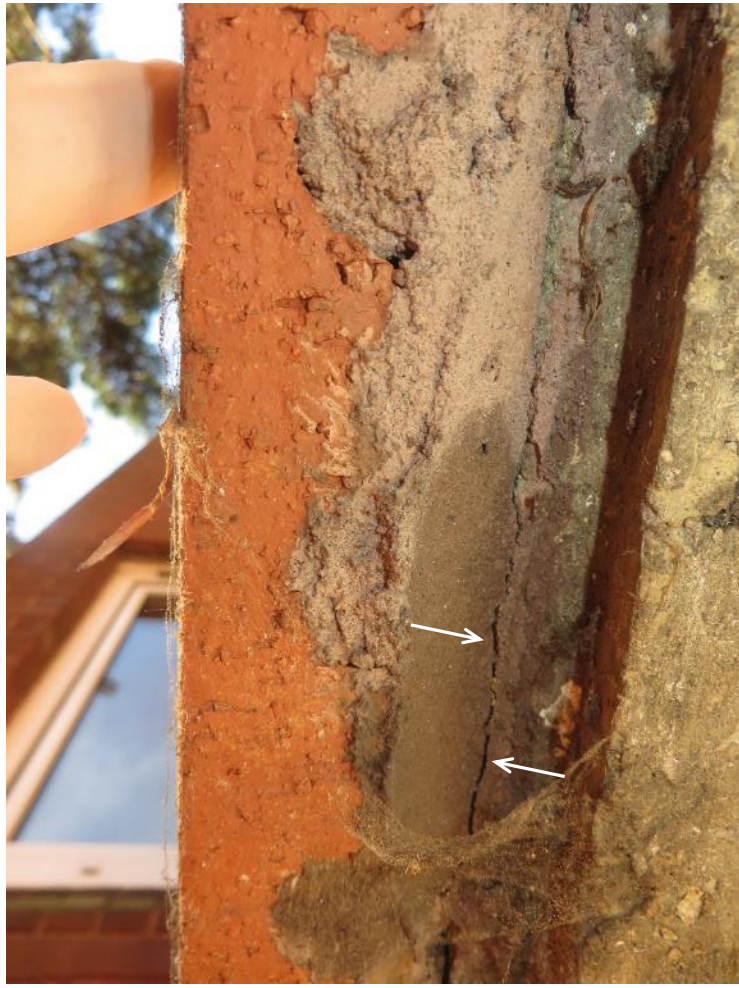
Figure 15. Location 12A. Side Elevation. First Floor. Window Lintel. Brick Slips Intact.

Crack between the concrete lintel and the vertical bedding mortar.

Brick slips over the small windows.
Crack visible between concrete lintel and the mortar in the vertical packing.
Brick slips sound hollow.

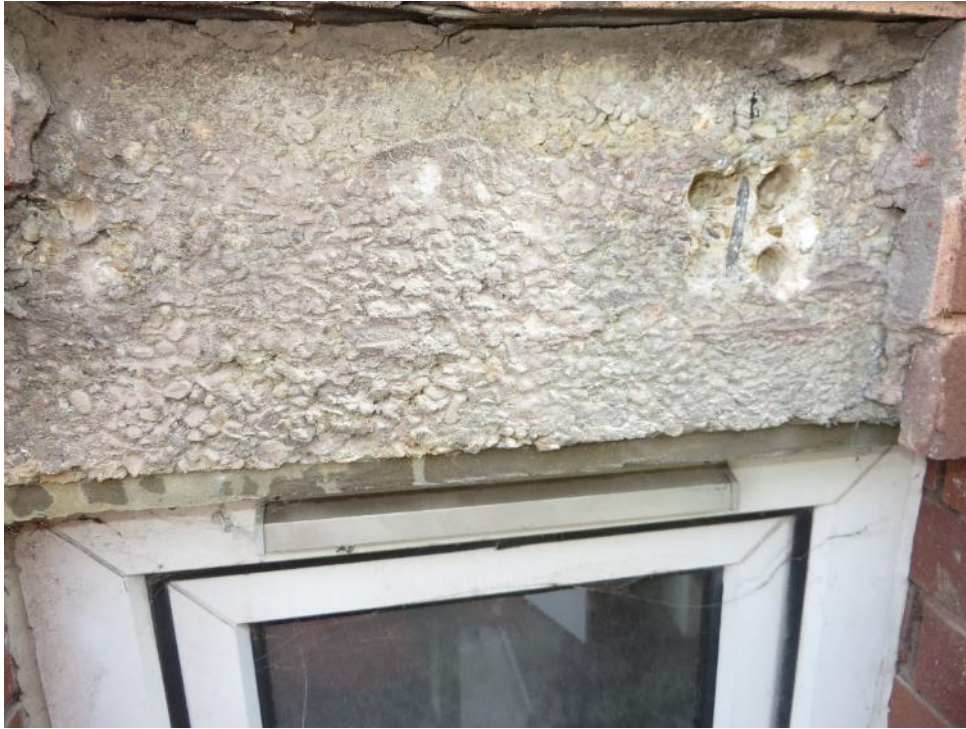
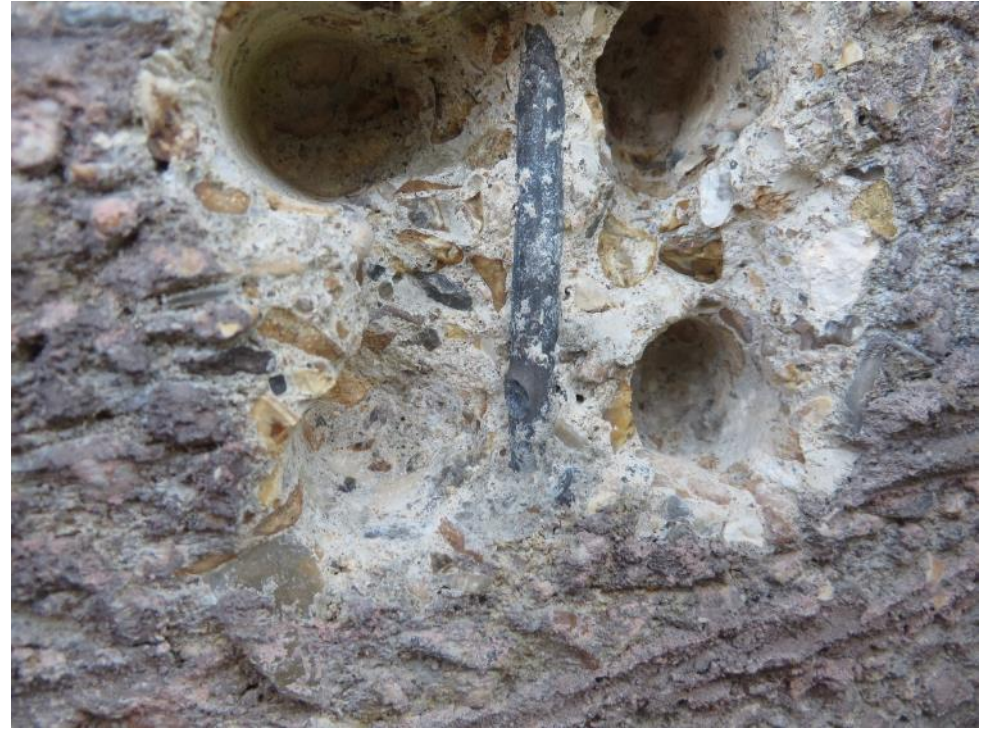
Figure 16. Location 13. Side Elevation. First Floor. Window Lintel. Brick Slips Partially Removed.

Bottom slips previously removed (by others) upper two courses of slips easily removed.
Vertical bedding joint well mortared. Slips and vertical mortar joint 47mm thick.
Concrete behind had a rough cast finish.
The reinforcement at 15mm concrete cover was clean.
The depth of concrete carbonation exceeded cover.
Tip of cavity tray exposed.
