REPORT 61351/S/1

SHELDON HOUSE, TEDDINGTON

INVESTIGATION OF MASONRY WALLS

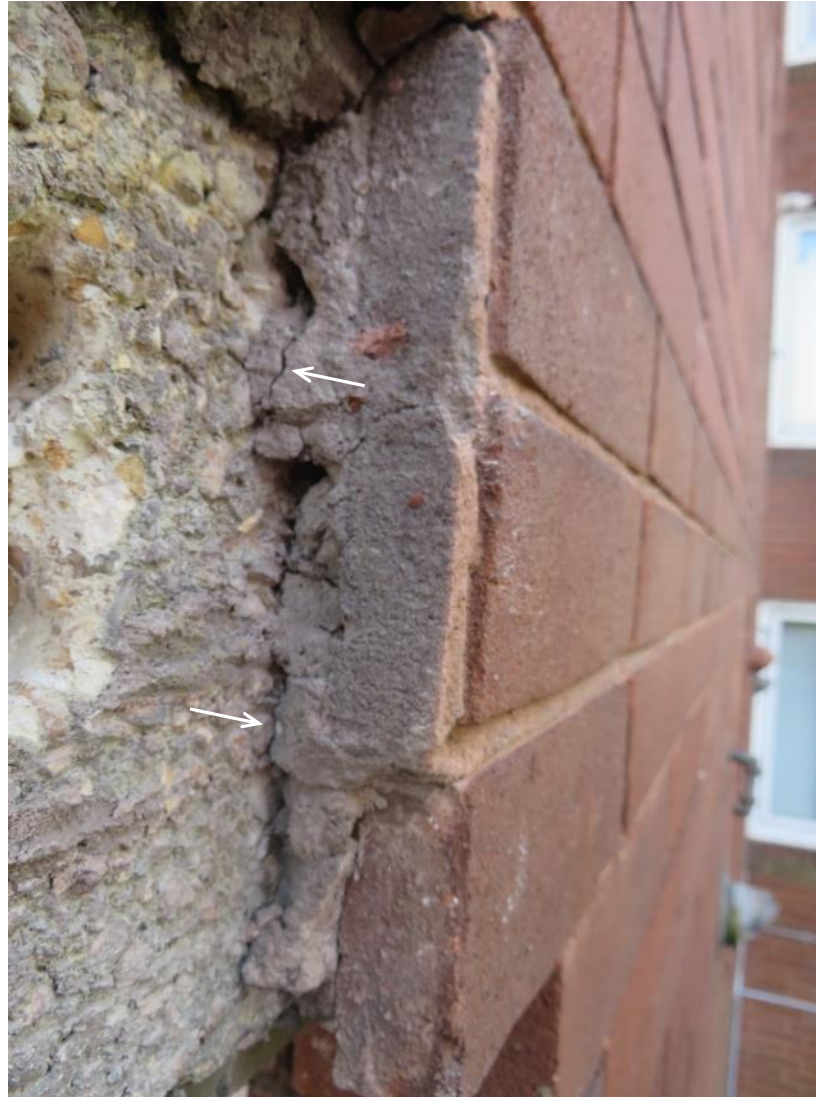
Figure 17. Location 13. Side Elevation. First Floor. Window Lintel. Brick Slips Partially Removed.

Apparent crack / de-bonding between the concrete lintel and the vertical bedding mortar.

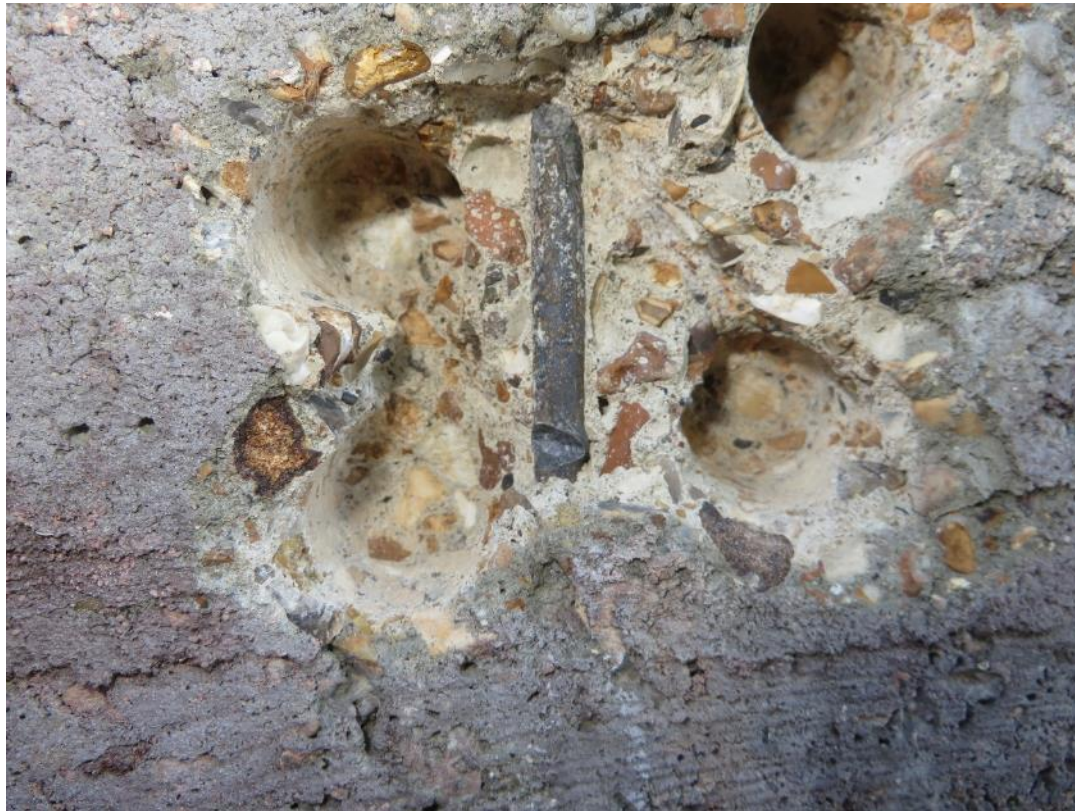
Figure 18. Location 14. Front Elevation. Fifth Floor. Window Lintel. Brick Slips Removed.

The brick slips had been removed (by others)
Concrete lintel behind had very slight surface honeycombing and a rough exposed aggregate finish.
Concrete cover was 13mm and the exposed bar had very slight patchy surface corrosion.
Carbonation depth exceeded cover.
Brick slips on the fourth floor replaced. Sound hollow.

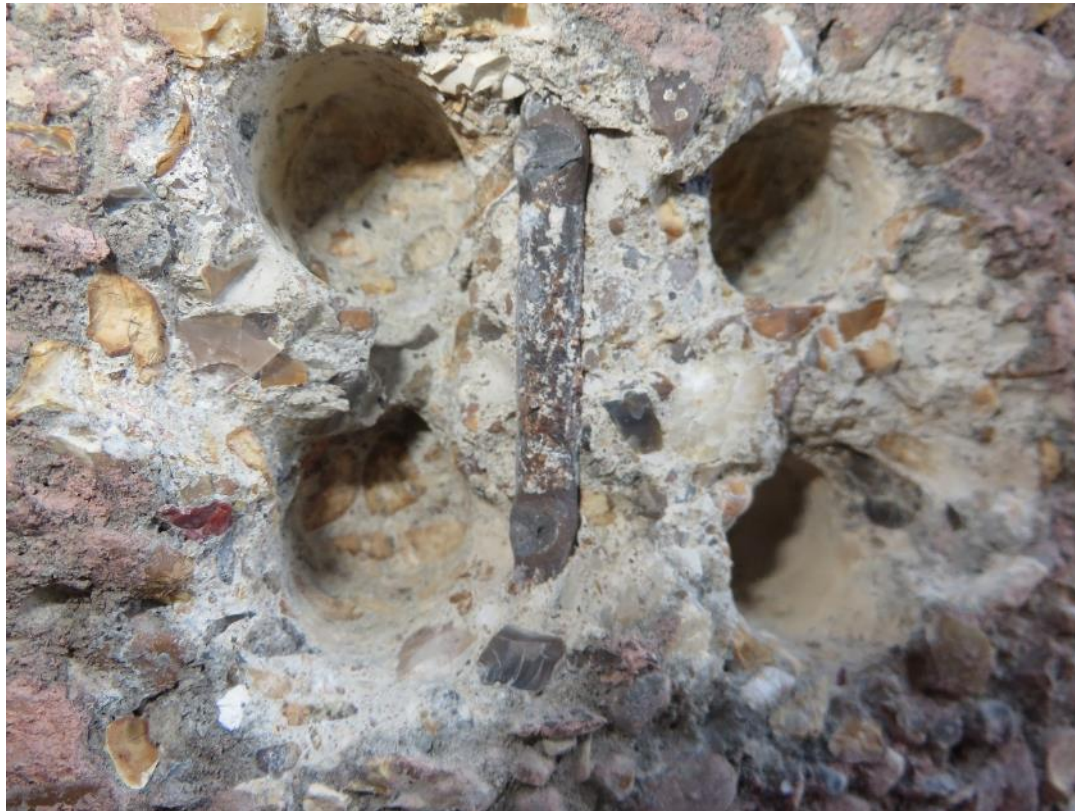
Figure 19. Location 15. Front Elevation. Second Floor. Window Lintel. Brick Slips Replaced.

The brick slips had been removed (by others)
Concrete lintel behind had very slight surface honeycombing and a rough exposed aggregate finish.
Concrete cover was 8mm and the exposed bar had very slight patchy surface corrosion.
Carbonation depth exceeded cover.

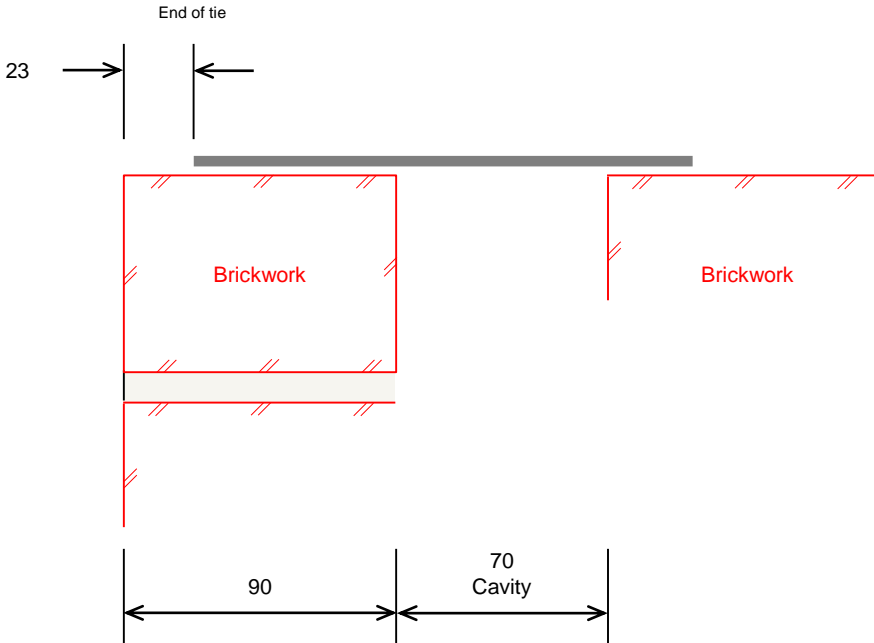
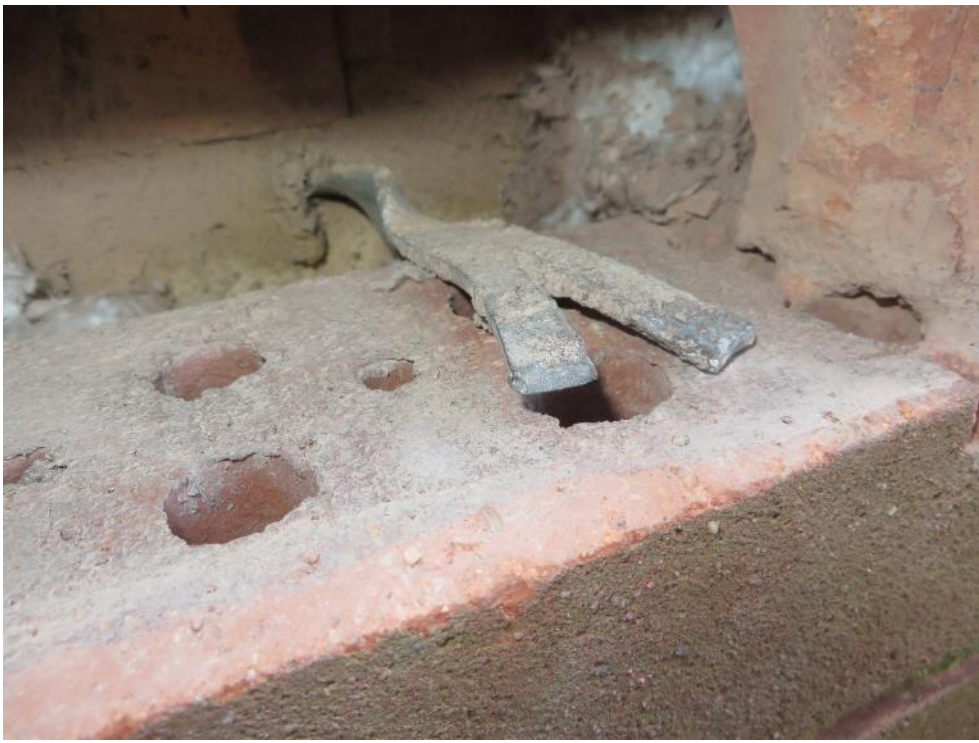
Figure 20. Wall Tie Inspection. Front Elevation. Third Floor.

At one location a brick was removed to inspect a wall tie. The tie was a twisted fishtail type (Figure 20). The tie was clean and unbridged, but poorly embedded in the inner leaf and could be moved about. A small map of the ties (Figure 21) found them to be evenly and well distributed. At a second location above the lintels, an expanded metal lath was found in a horizontal brickwork joint (Figure 22).

Twisted fish-tail tie.
Clean and not bridged with mortar.
Blown fibre insulation within cavity.
Tie poorly embedded in inner brick leaf. Tie can be moved by hand, but not pulled out.

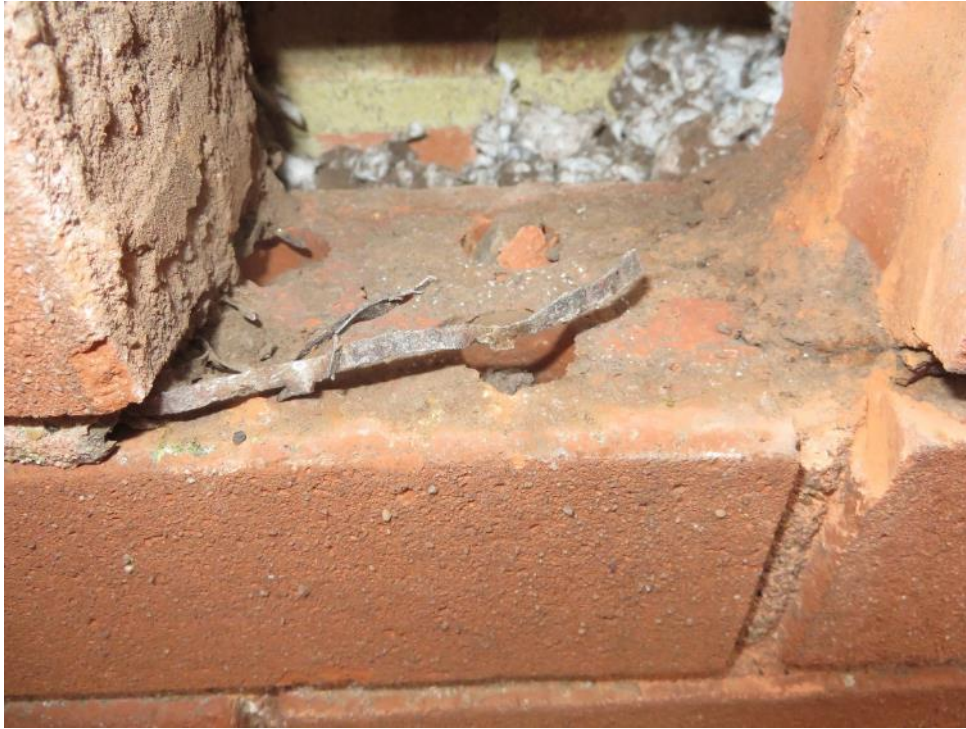
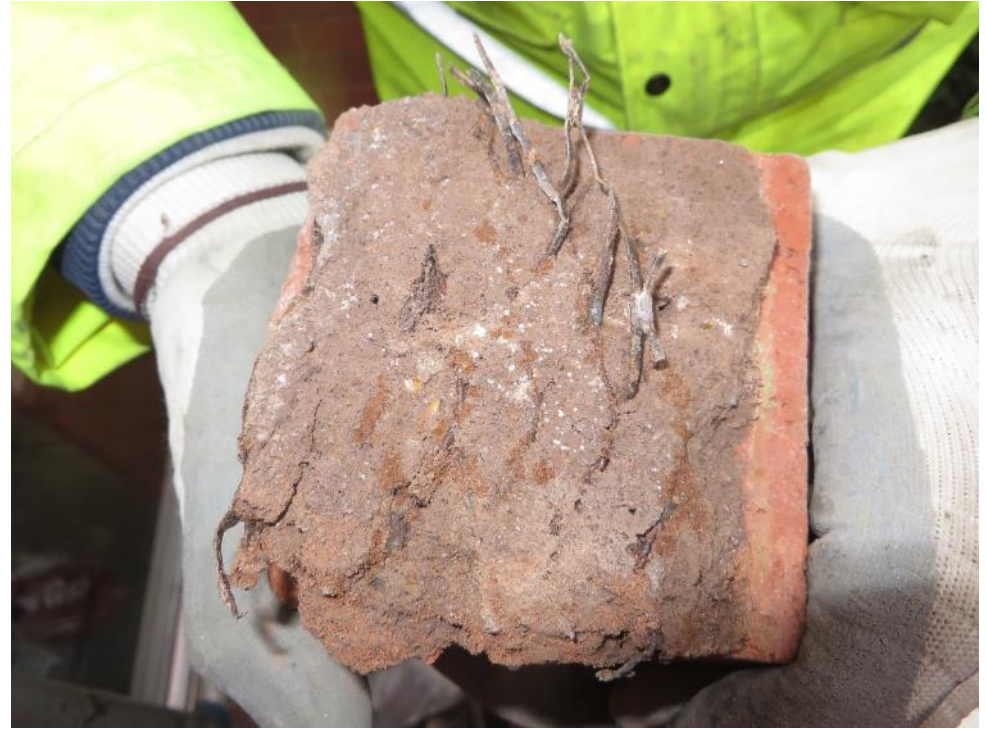
Figure 22. Wall Tie Map. Rear Elevation. Third Floor. Beneath Windows.

Three courses above the brick slips.
Expanded metal mesh within the horizontal brickwork joint.

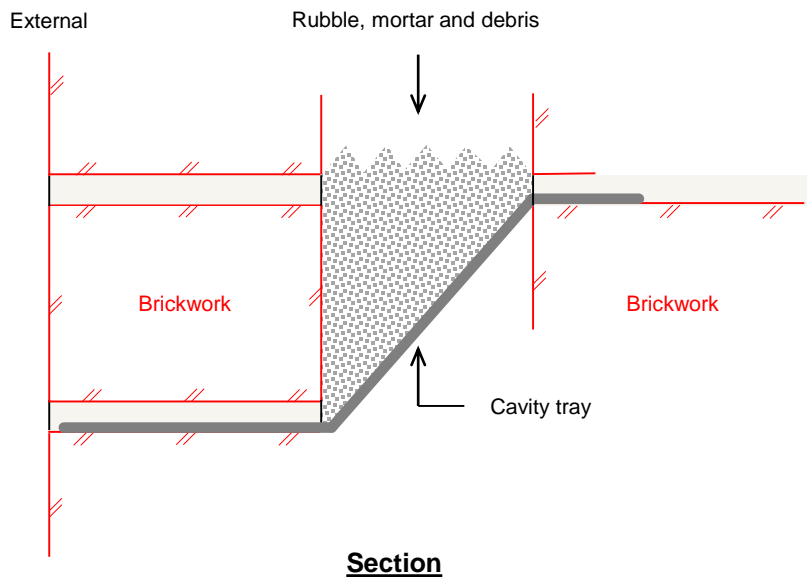
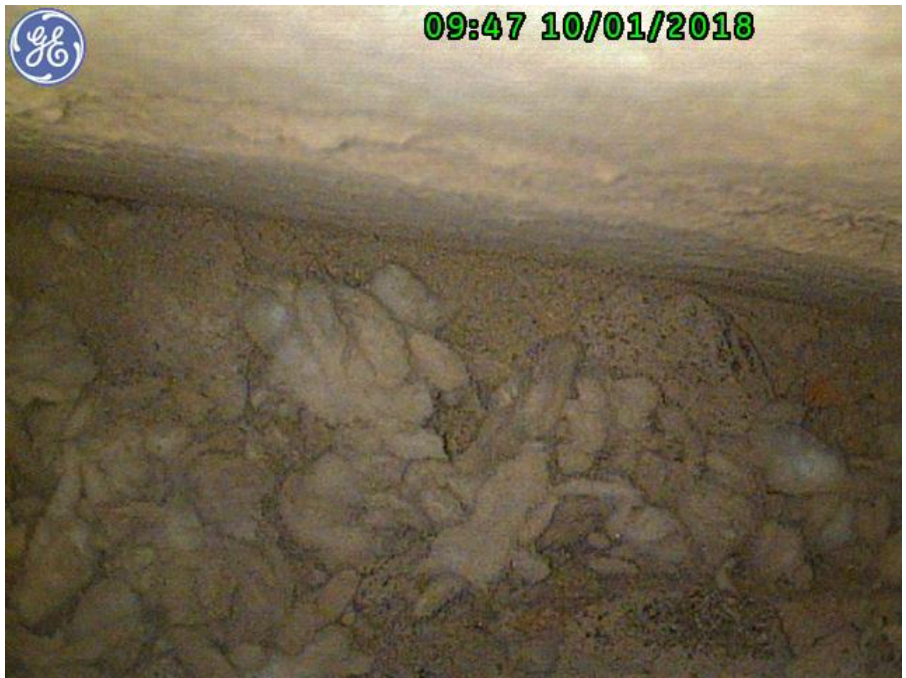
Figure 23. Cavity Tray Inspection. Front Elevation. Fifth Floor.

The cavity tray although present is in some areas inadequate. The cavity contains mortar debris which is also blocking the efficient drainage.

Detail of the debris sitting on the cavity tray.

- Cavity tray bituminous sheet.
- Cavity tray height, one brick course.
- Cavity tray covered in mortar and construction debris.
- Blown fibre insulation within cavity.

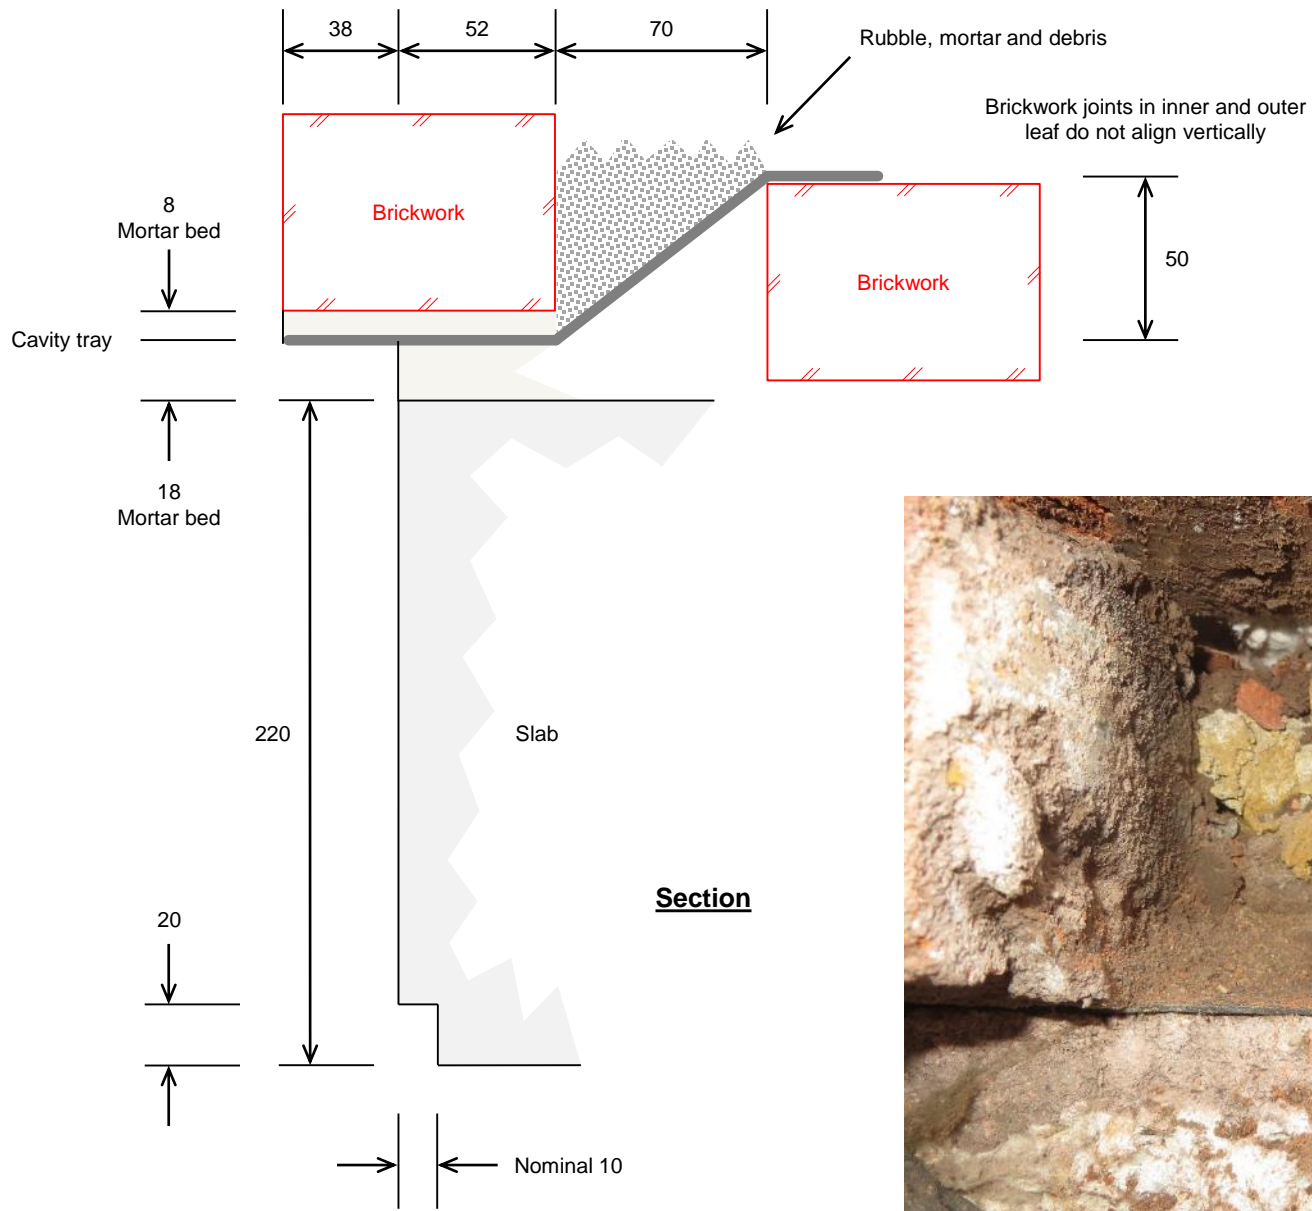
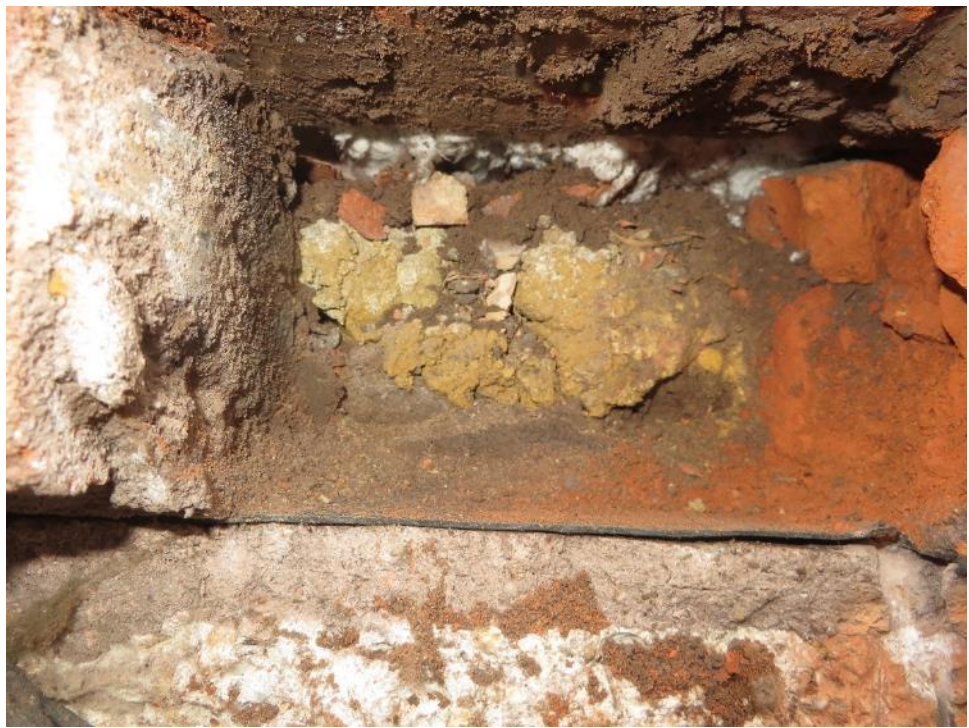
Figure 24. Cavity Tray Inspection. Rear Elevation. Fourth Floor.

Debris and mortar above the cavity tray

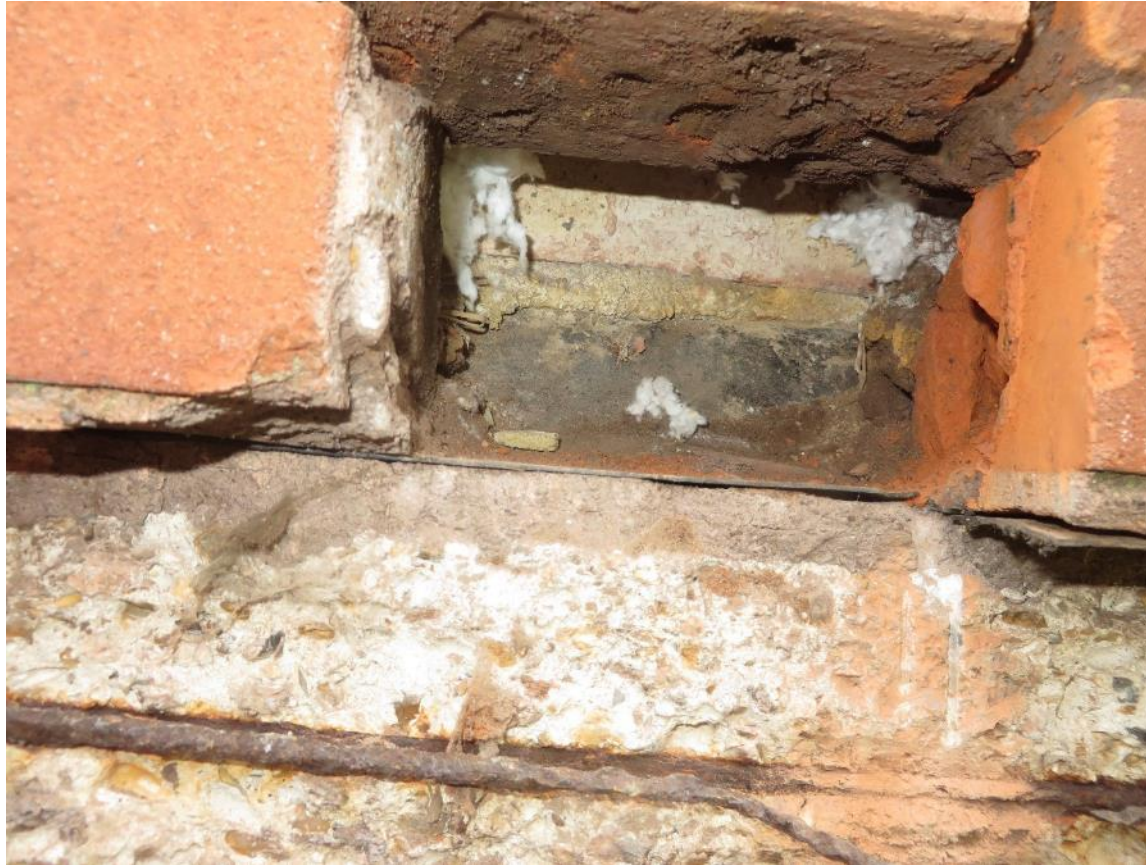
Cavity tray bituminous sheet.
Cavity tray height only 50mm. Joints in inner and outer leaf's don't align vertically.
Cavity tray covered in mortar and construction debris.
Blown fibre insulation within cavity.

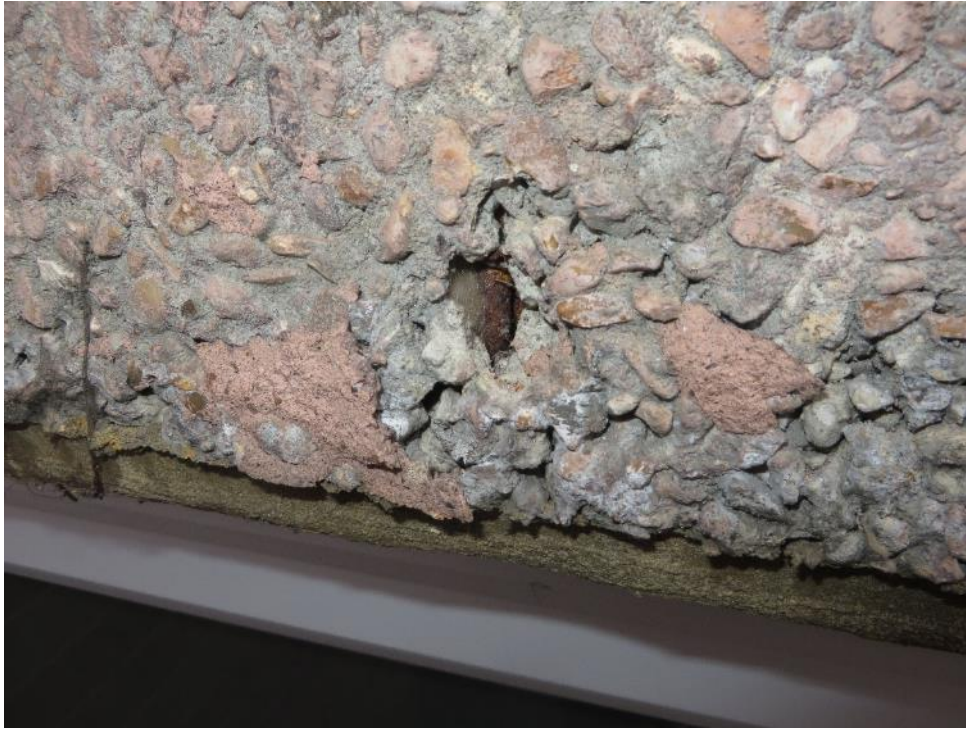
First floor rear elevation. Typical surface honeycombing, corroding reinforcement visible.

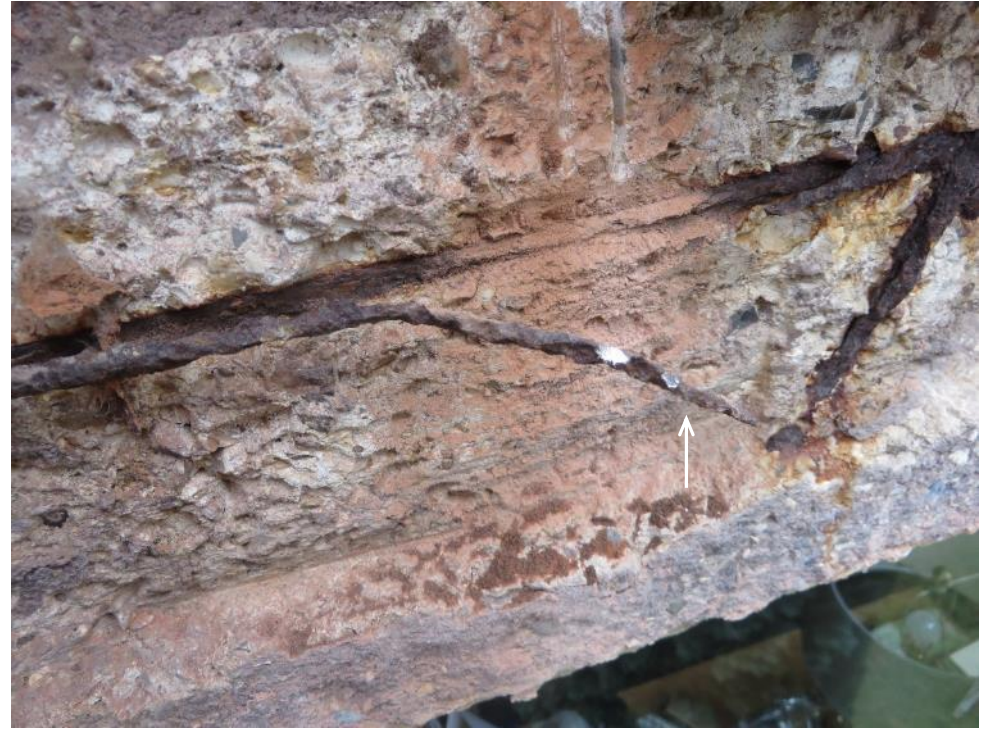
There were numerous shallow areas of surface honeycombing noted on the exposed face of the lintels, where corroding reinforcement was visible at typically 10mm cover. On 2o. two lintels severe concrete spalling was noted, exposing corroding reinforcement, with a 100% loss of horizontal steel section noted at one of these.

Third floor rear elevation.
One hundred percent loss of section to the horizontal top reinforcement.

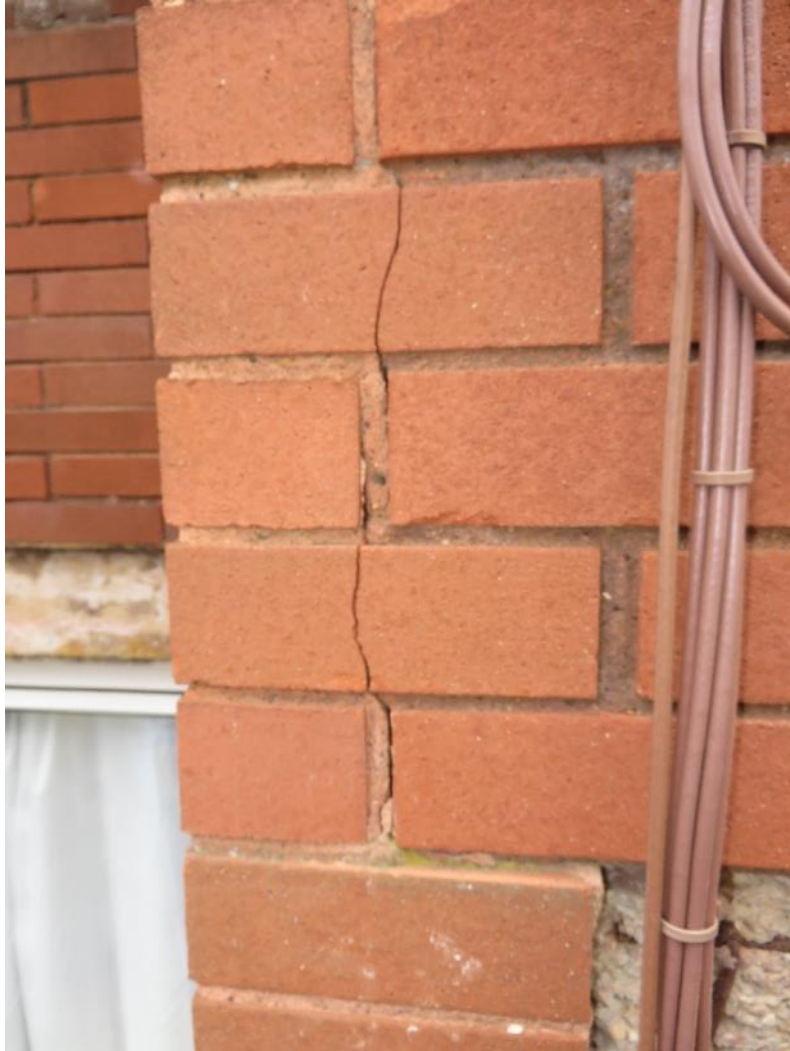
Vertical cracking in the brickwork above a lintel.

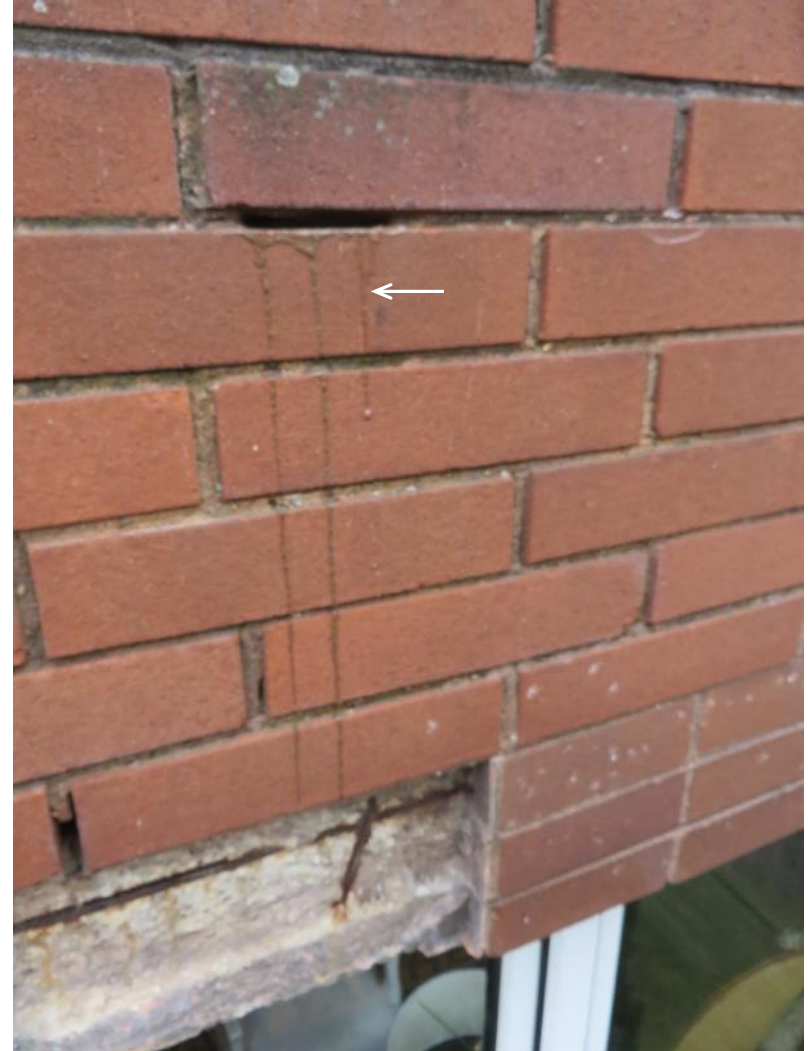
During an investigation into the wall ties on the third floor rear elevation. Water seeped out of the horizontal mortar joint, when it was disturbed.
