**BS 5837:2012 Tree Survey & Arboricultural Impact of  
Upgrading the Pedestrian Garden Path**

**Address: Landmark Arts Centre,  
Teddington**

**Date 30<sup>th</sup> June 2023**

## Landmark Arts Centre Upgraded Pathway

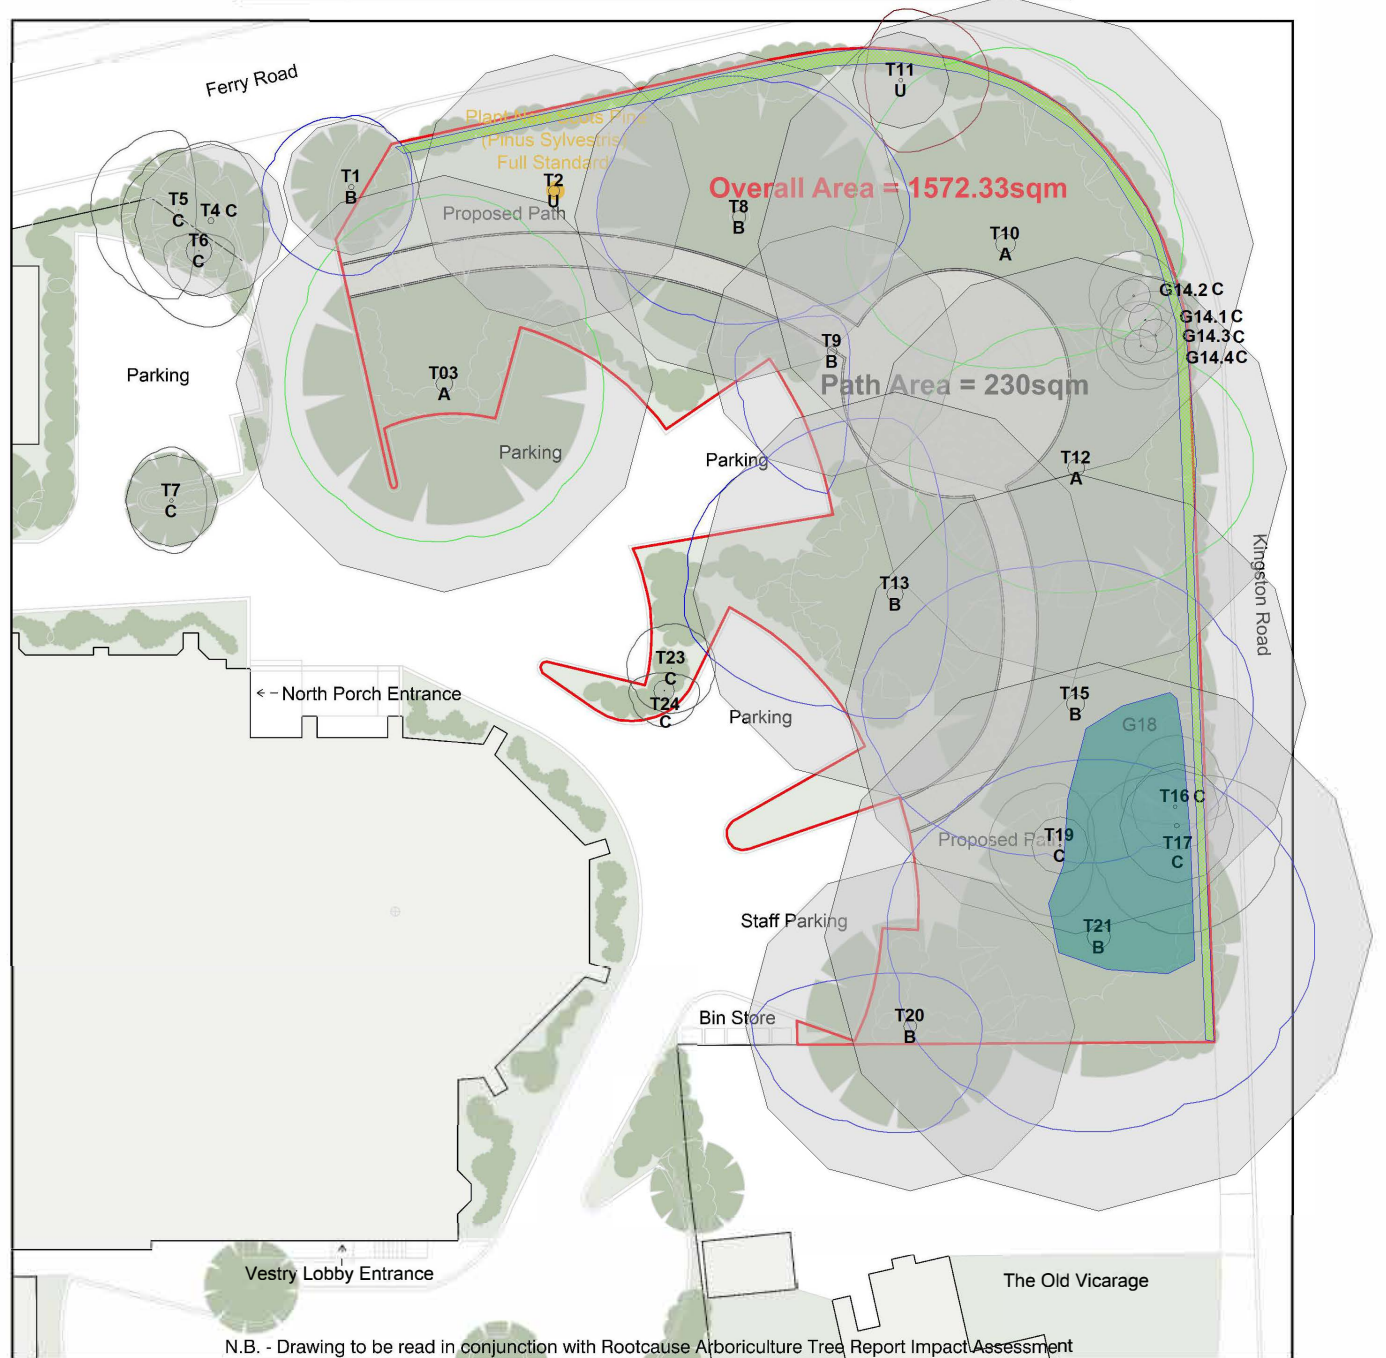
## 12. Appendix 3 Proposed Plan with Tree Constraints

This plan is based on a raster image using Plan LAC SK004A 31.03.2023
