## Descriptive Schedule of Condition

of the premises known as  
**Garages at 19-23 Friars Stile Road,  
Richmond, London, T10 6NH**

for and on behalf of  
**Malins Group**

**Ref:** CBS/00753

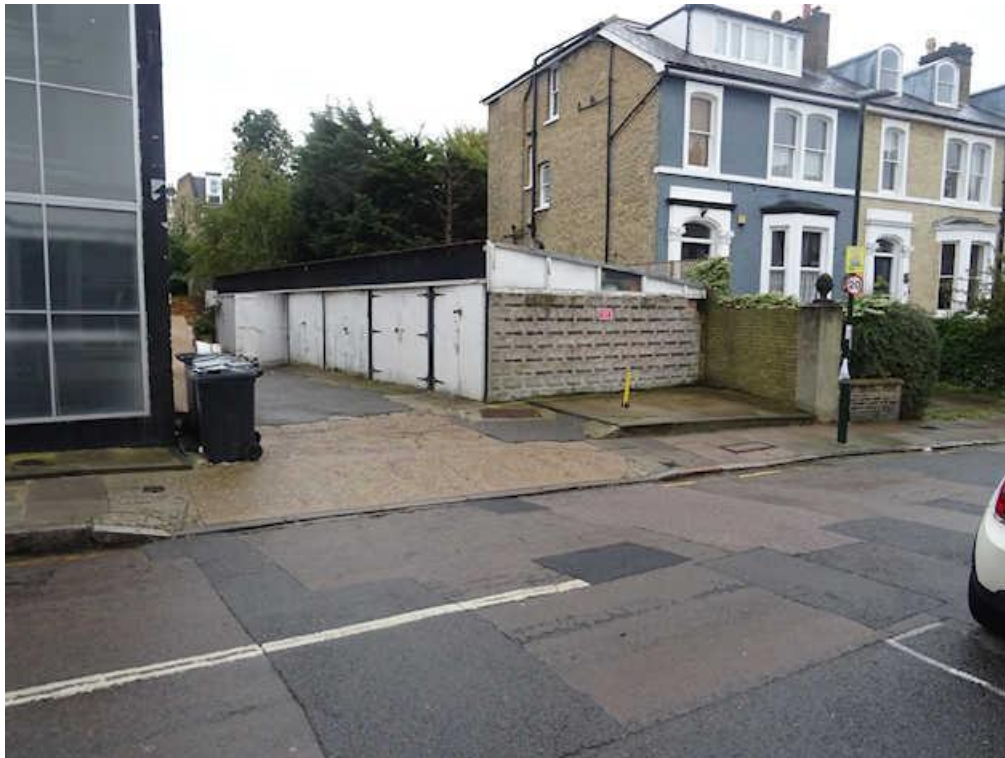
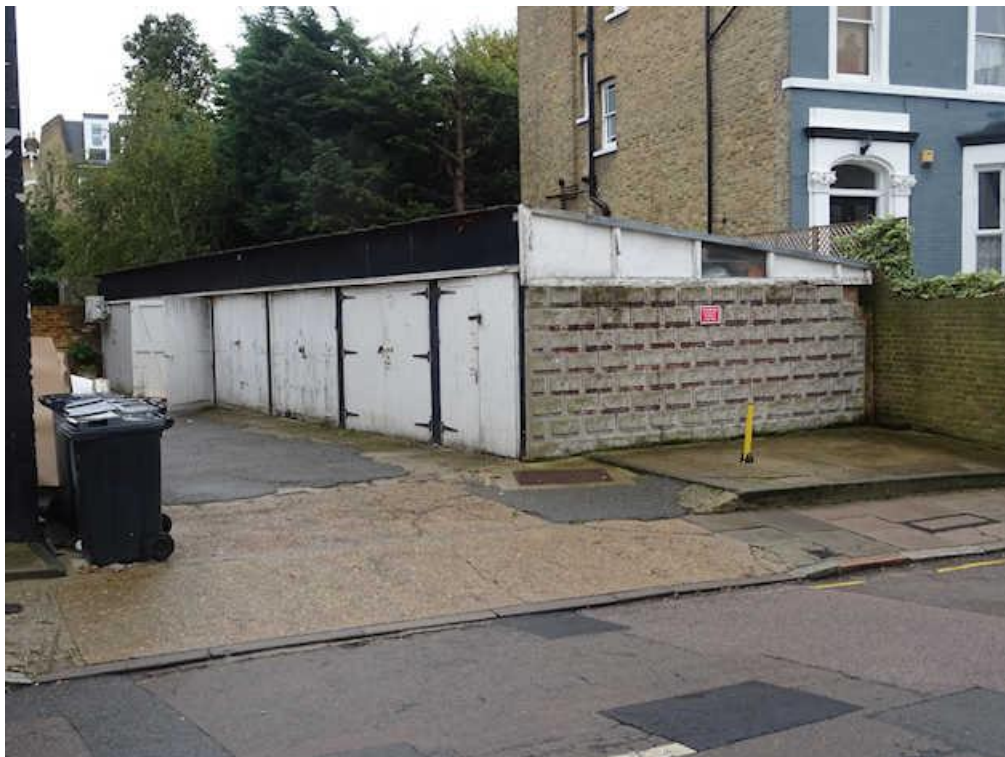
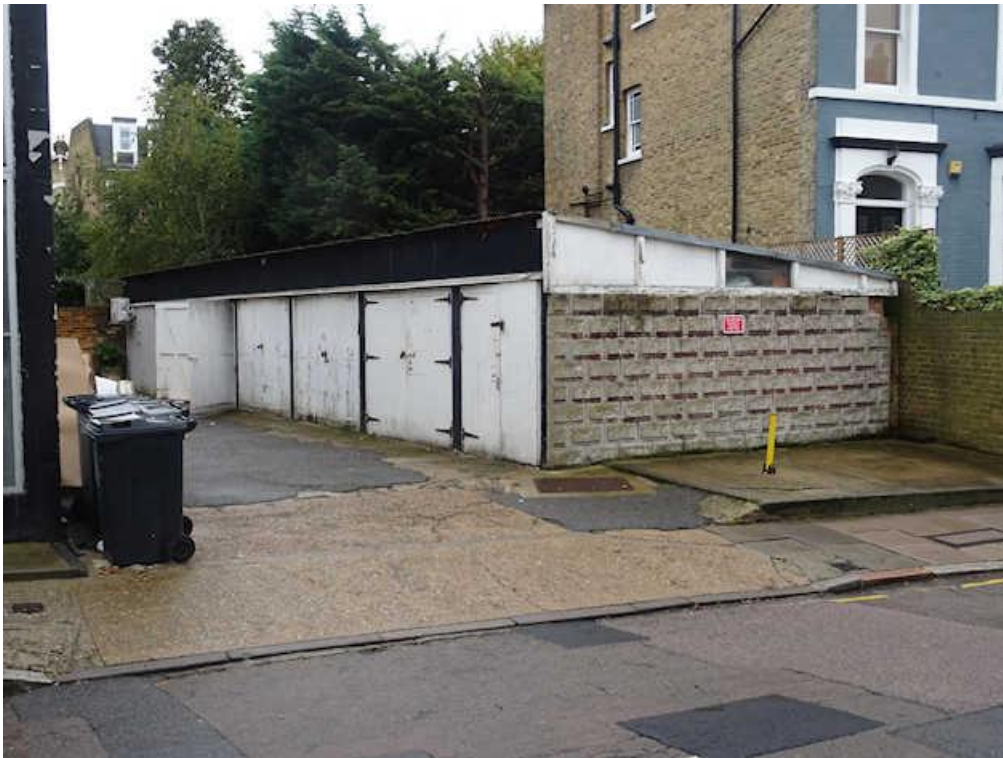
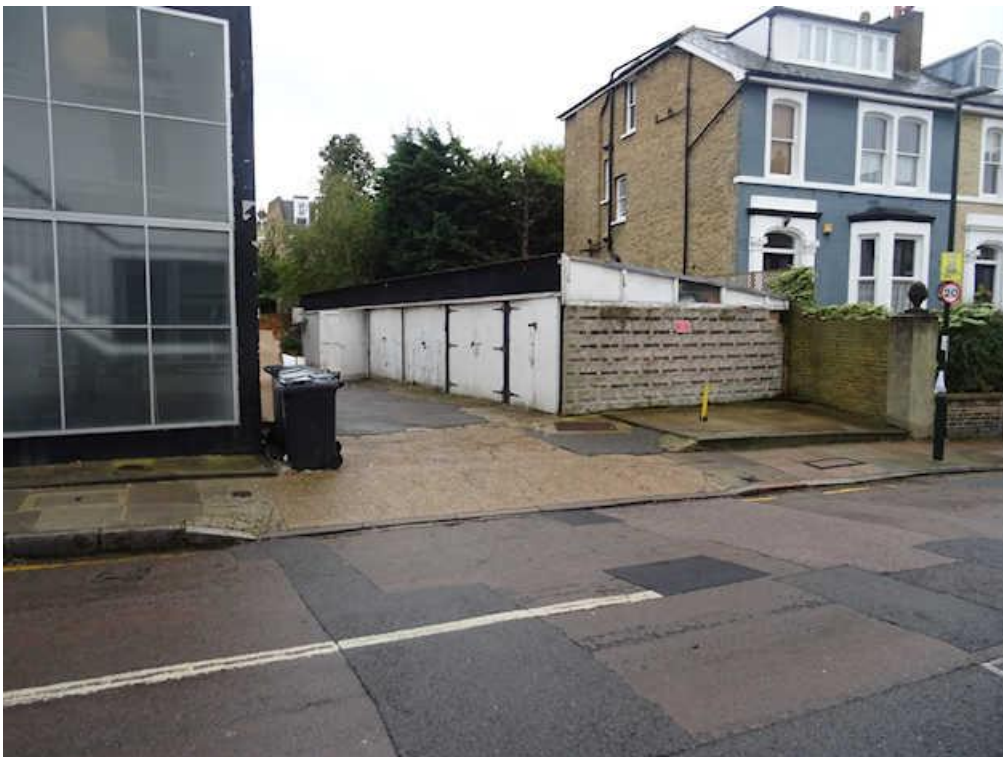
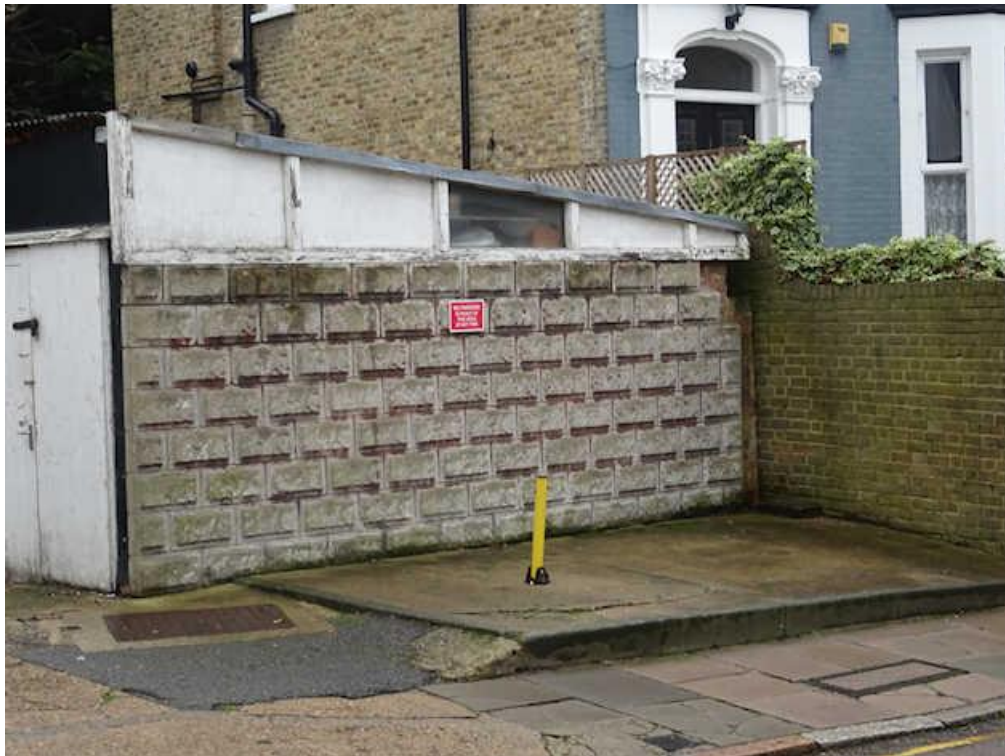
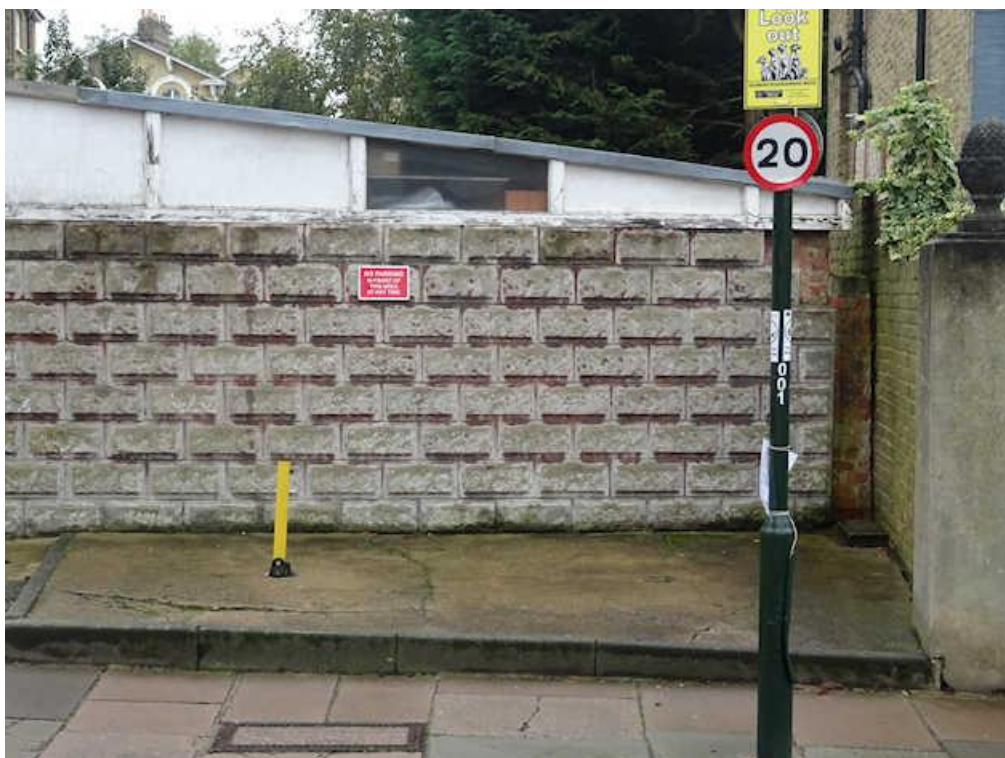
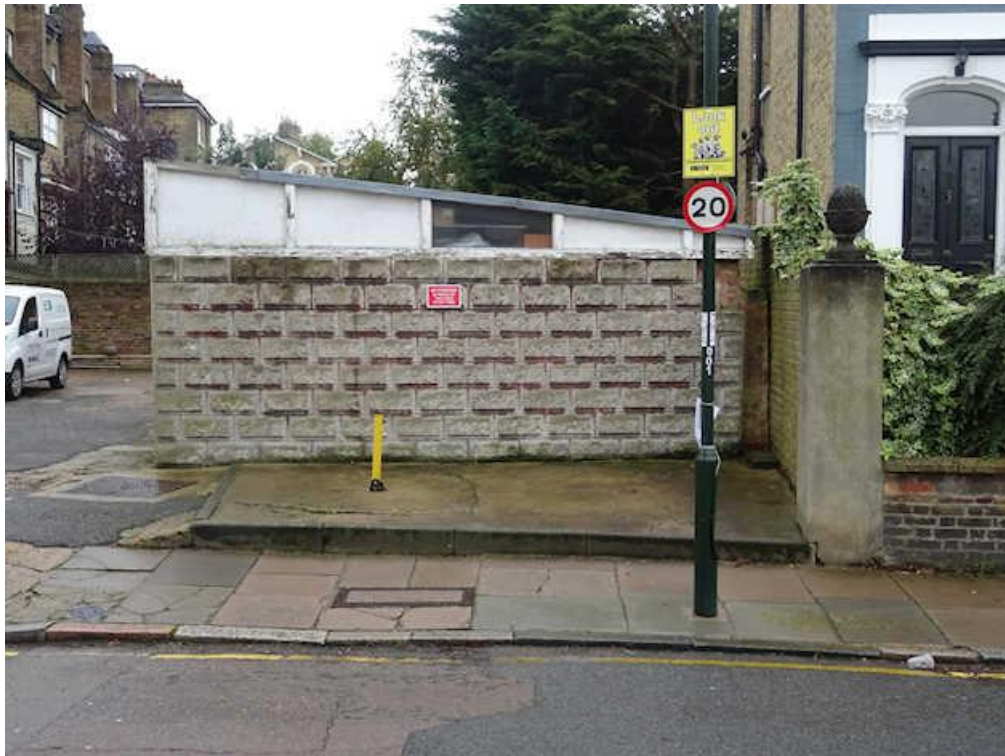
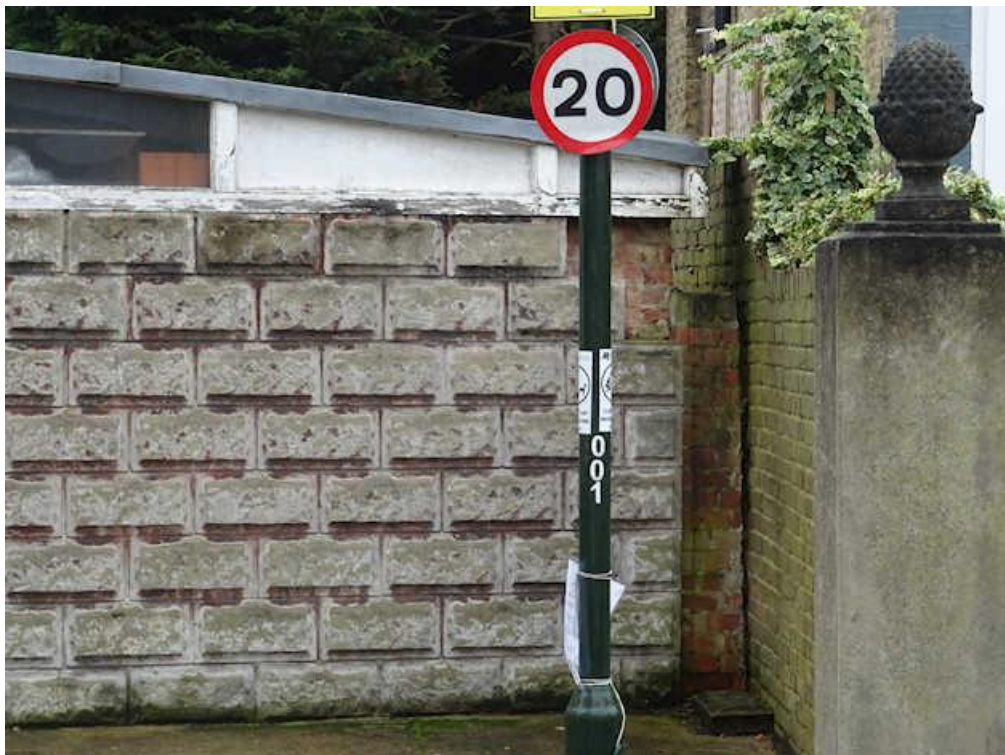
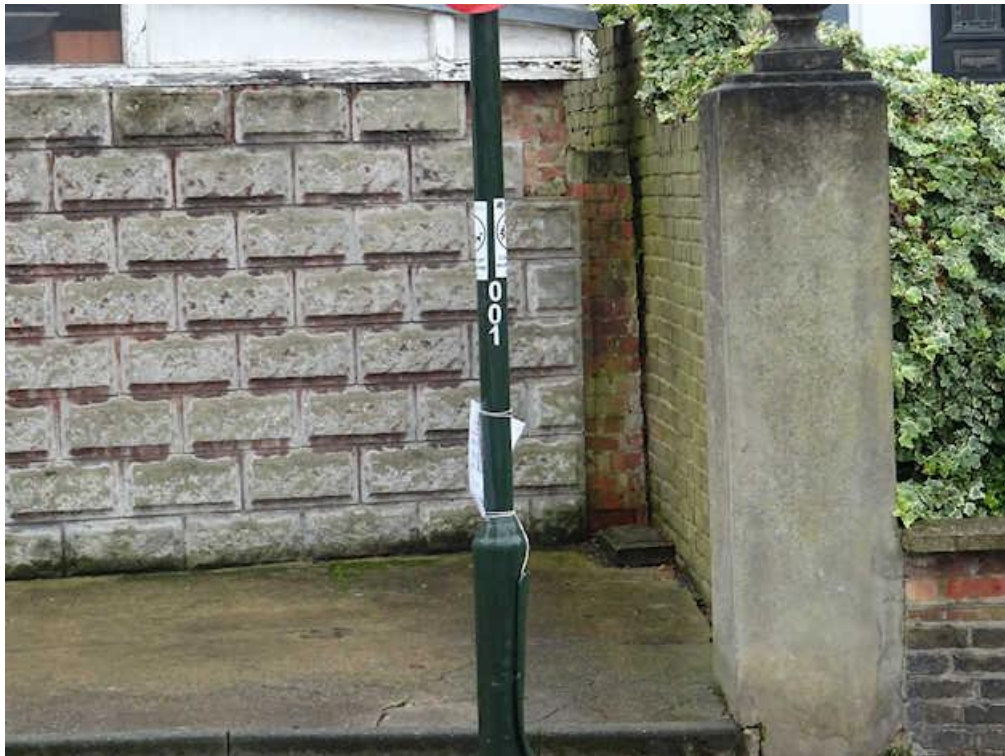
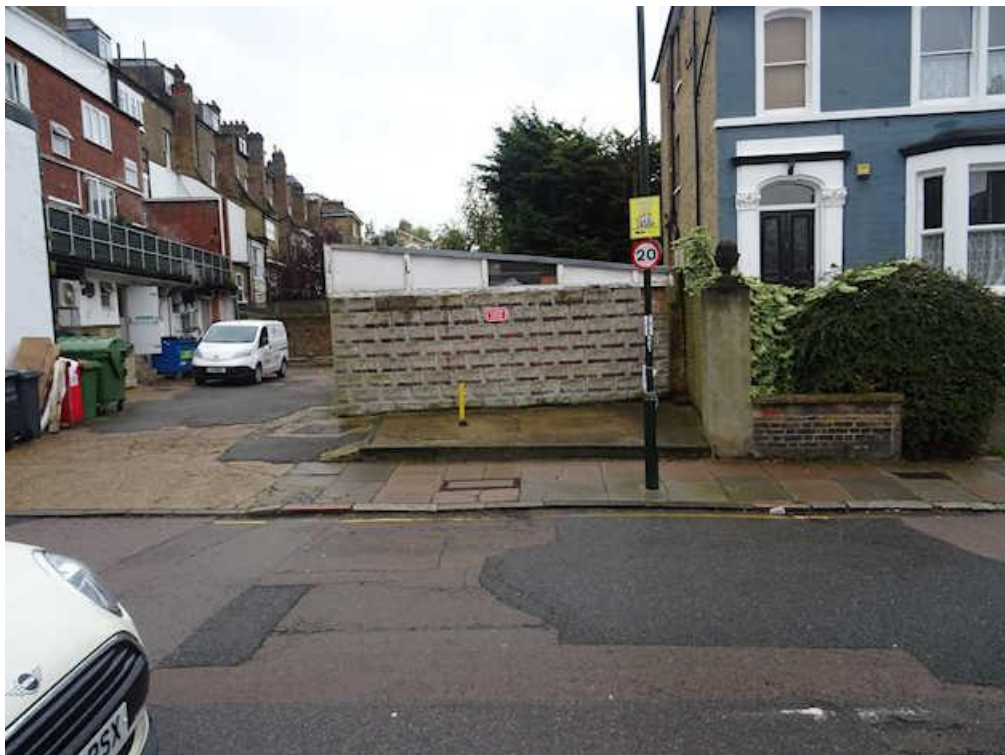
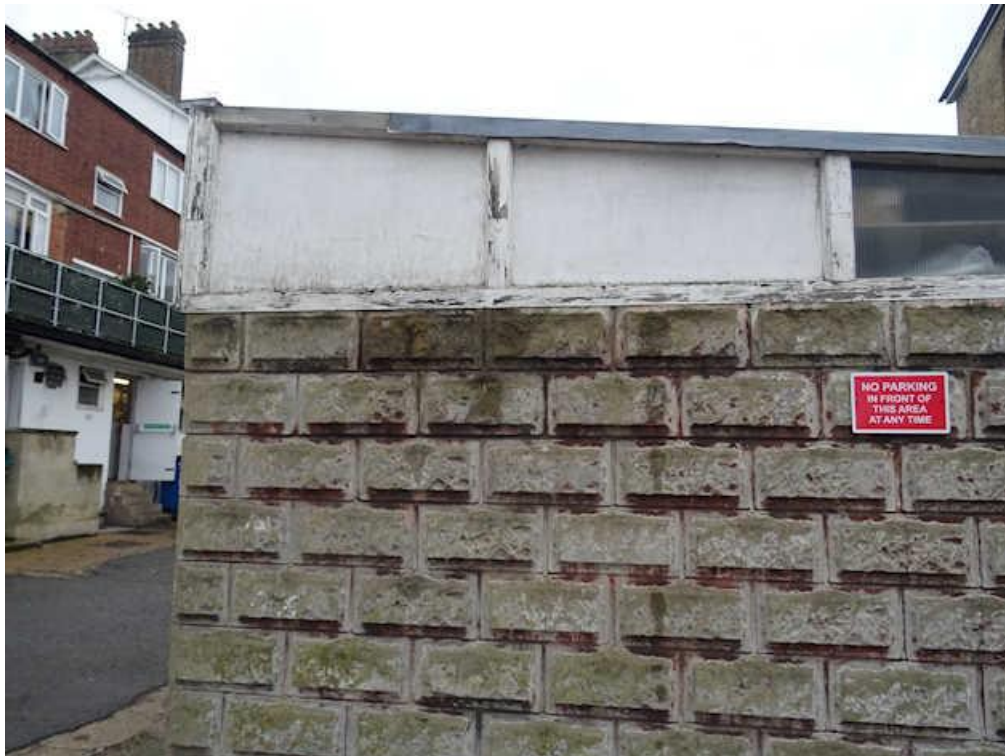
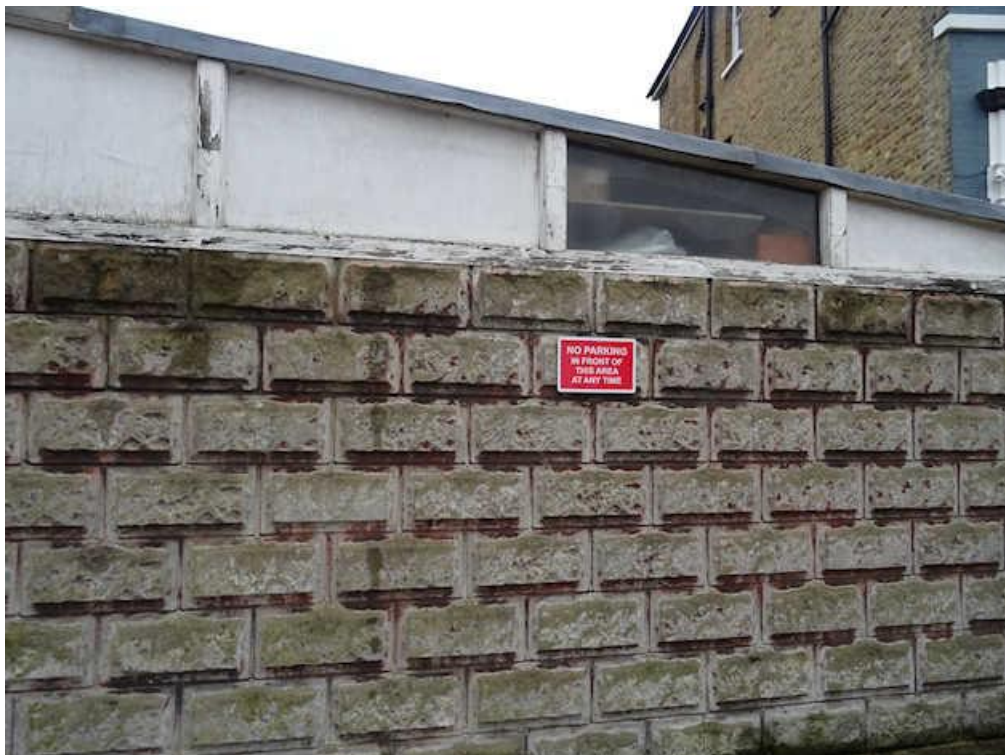
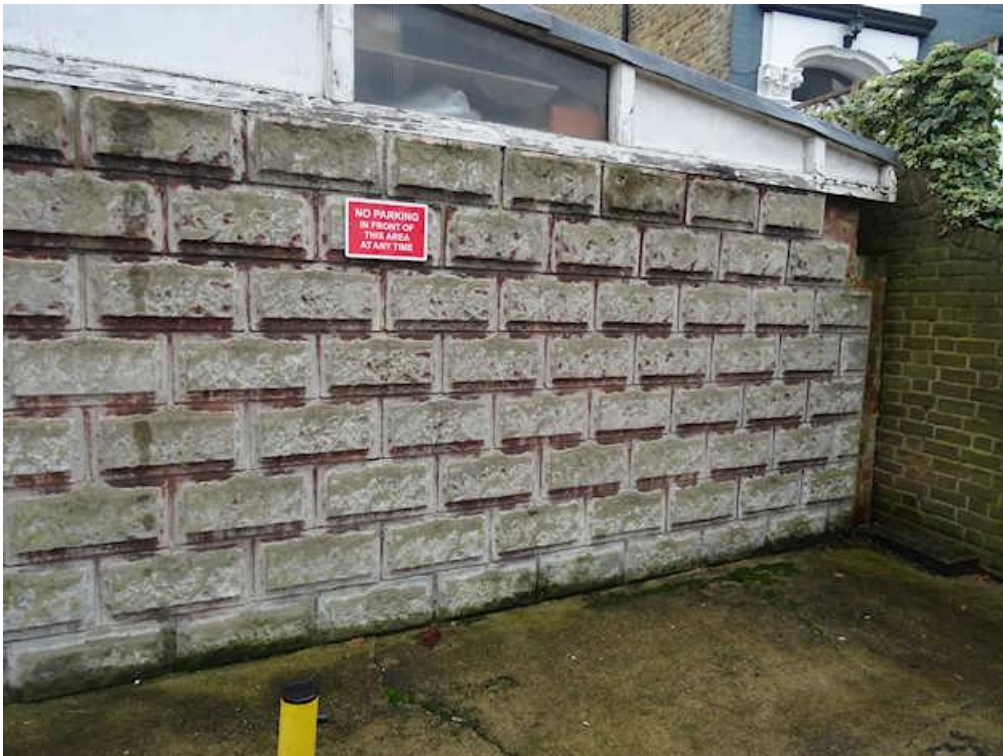
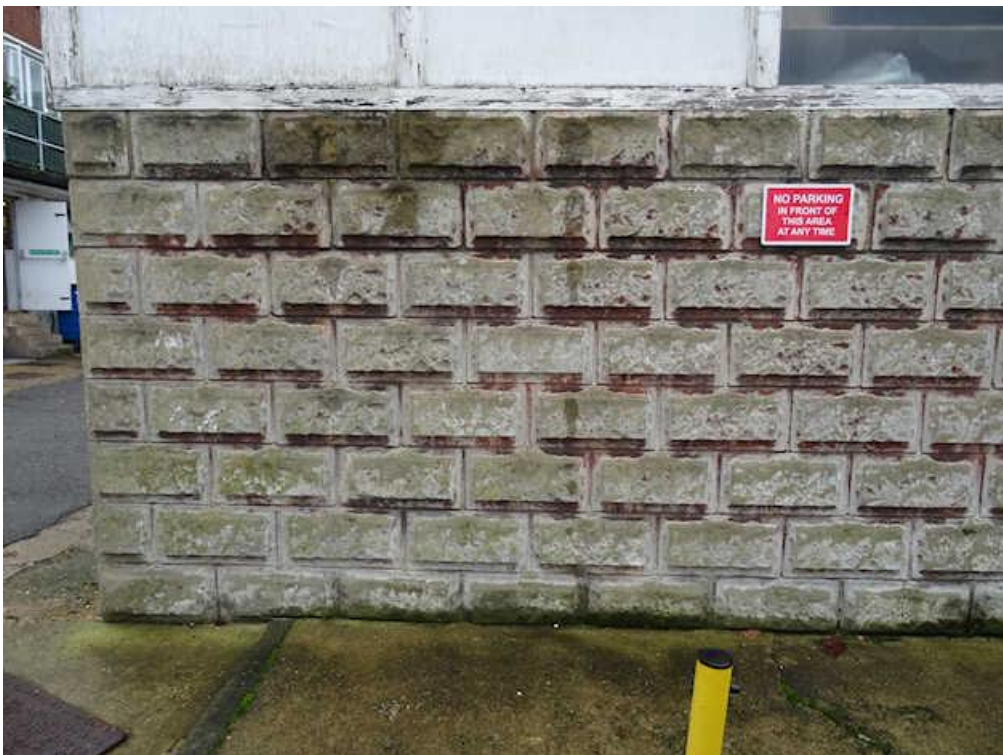
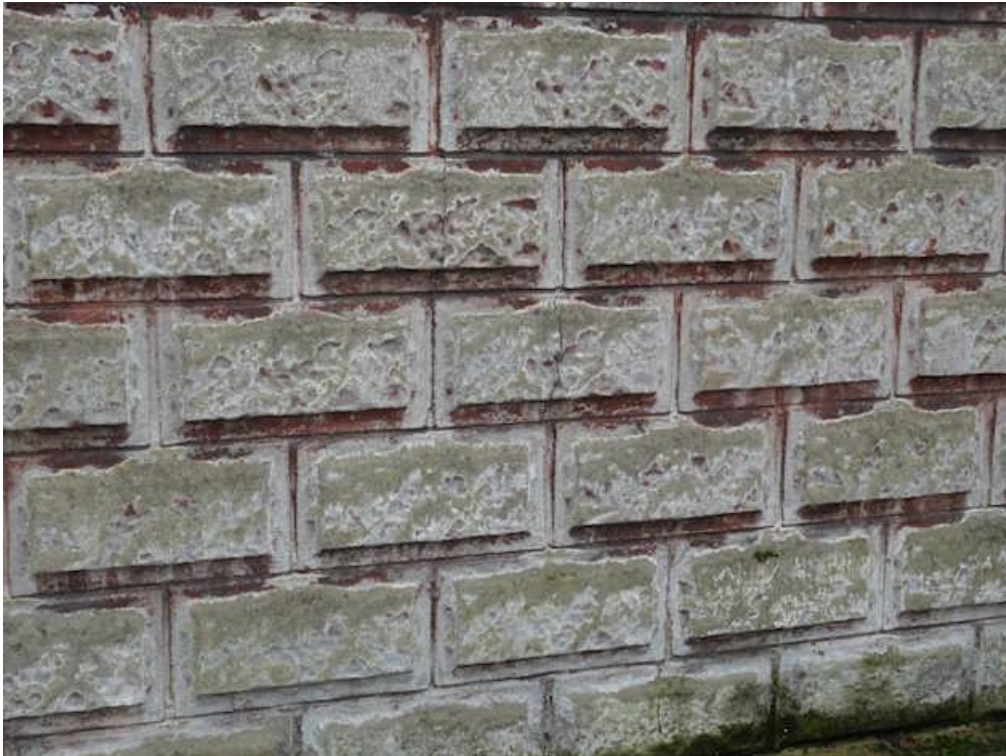
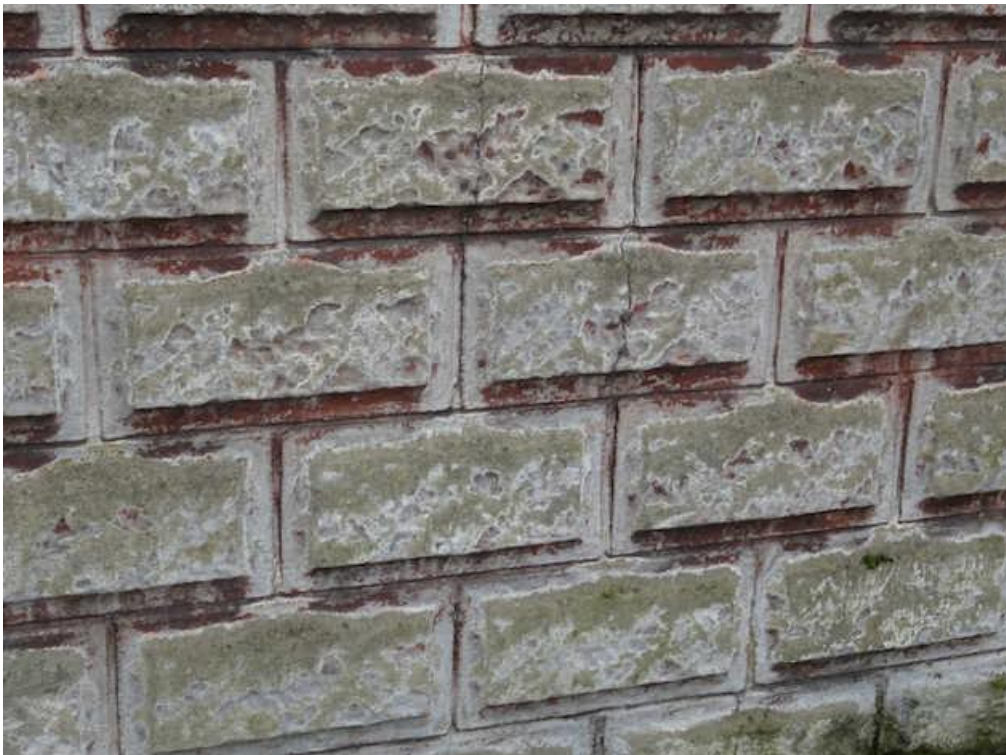
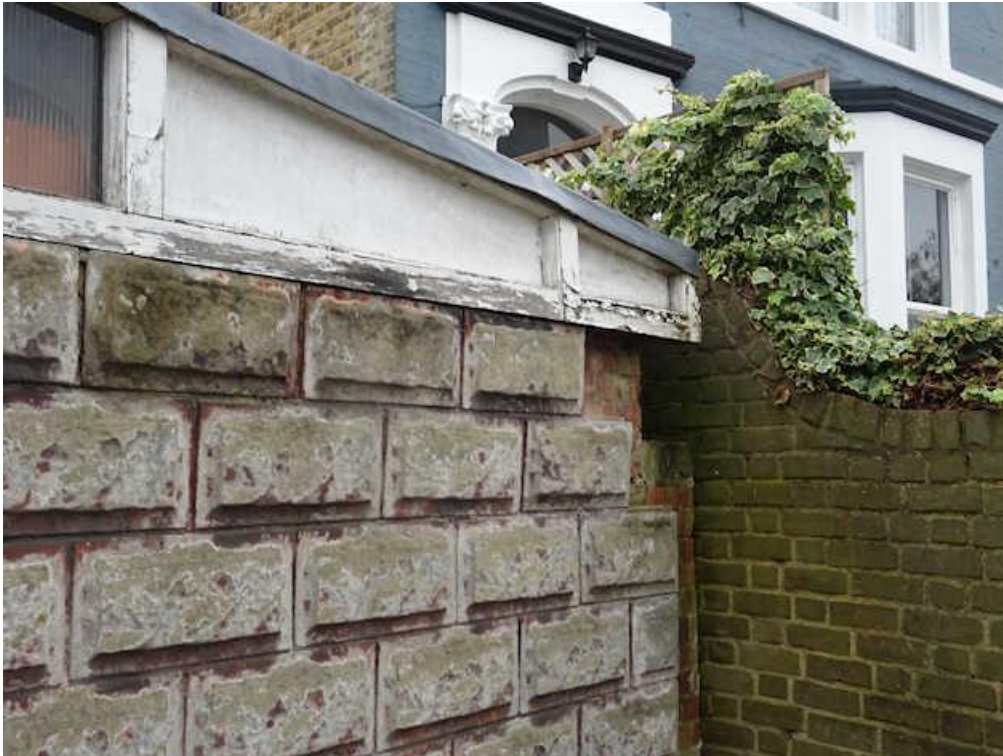
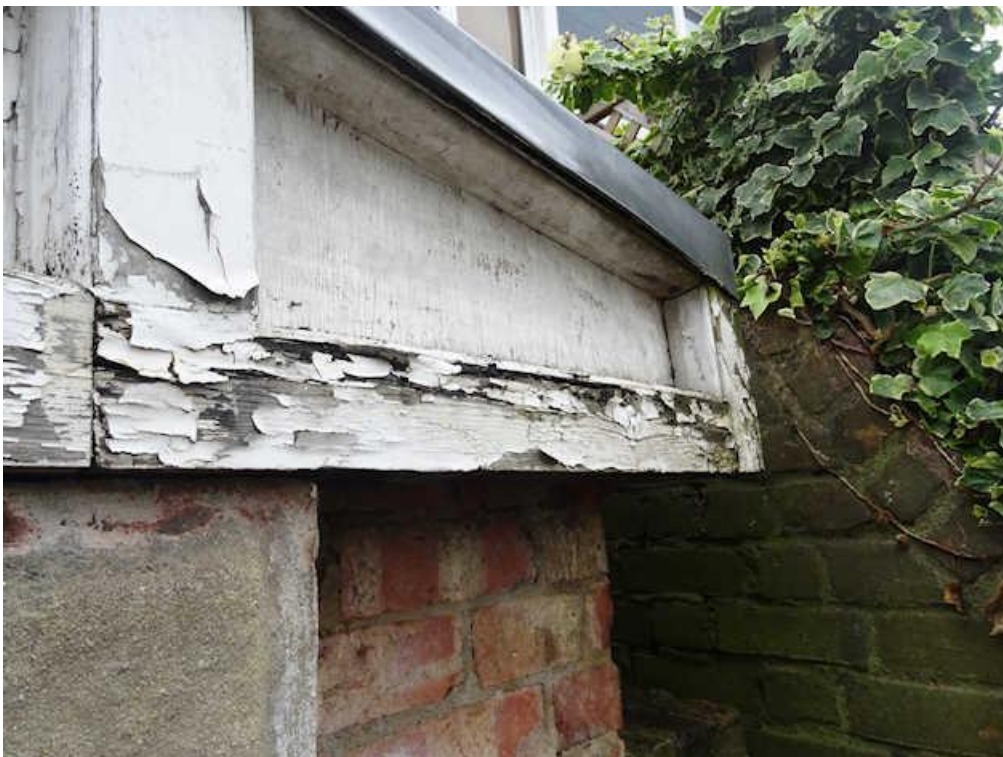
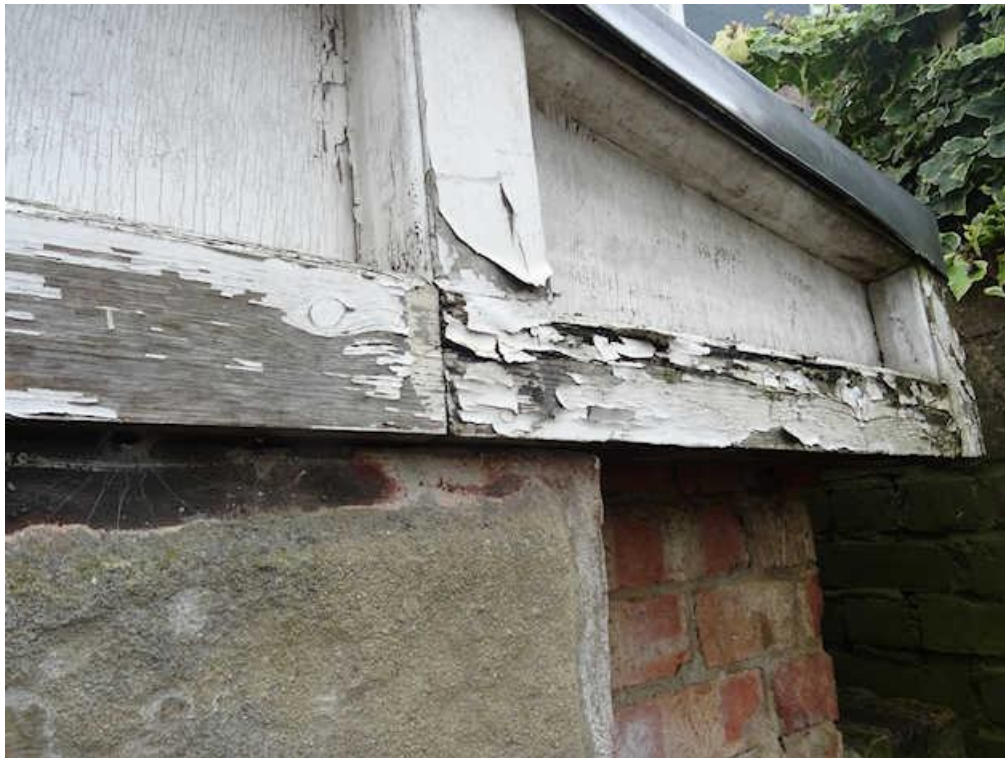
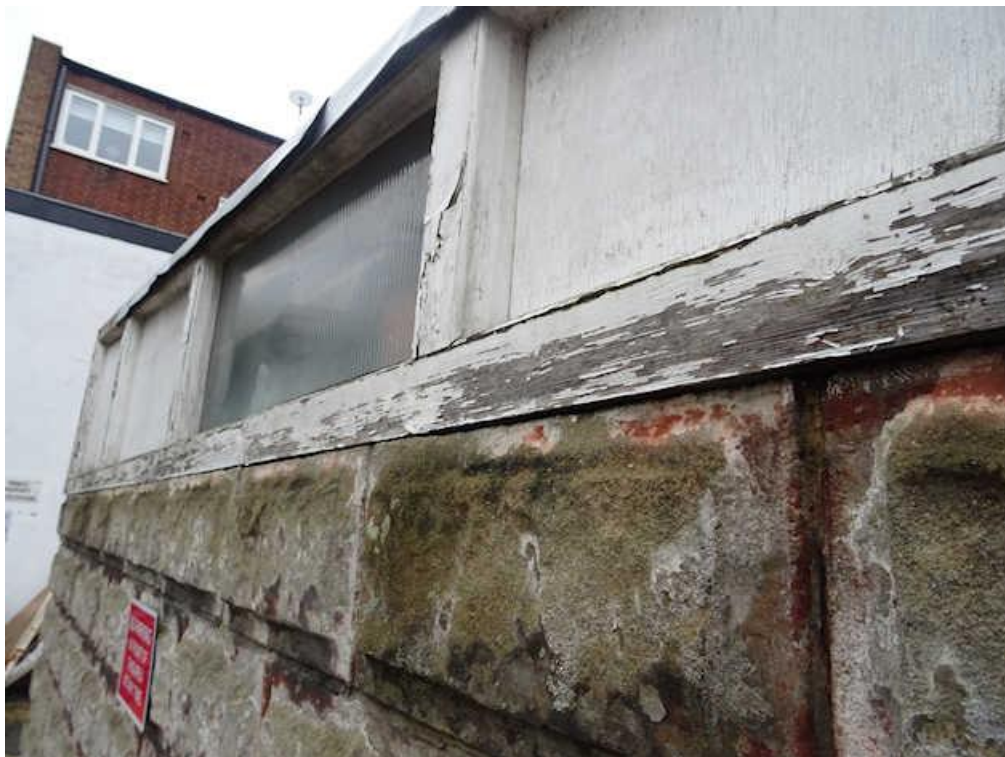
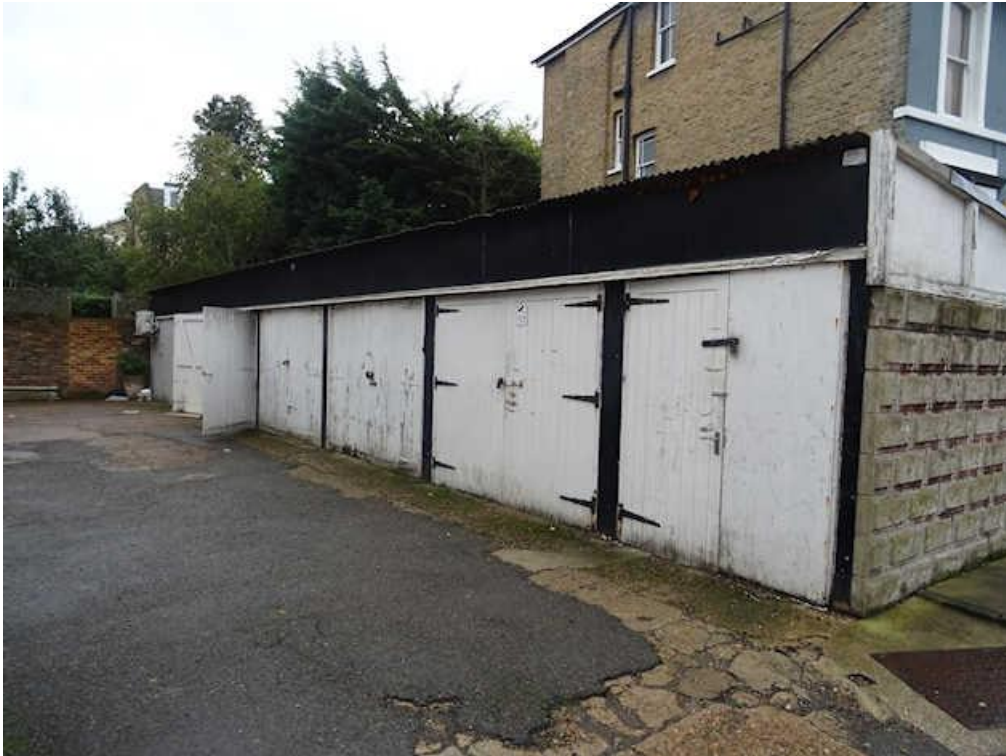
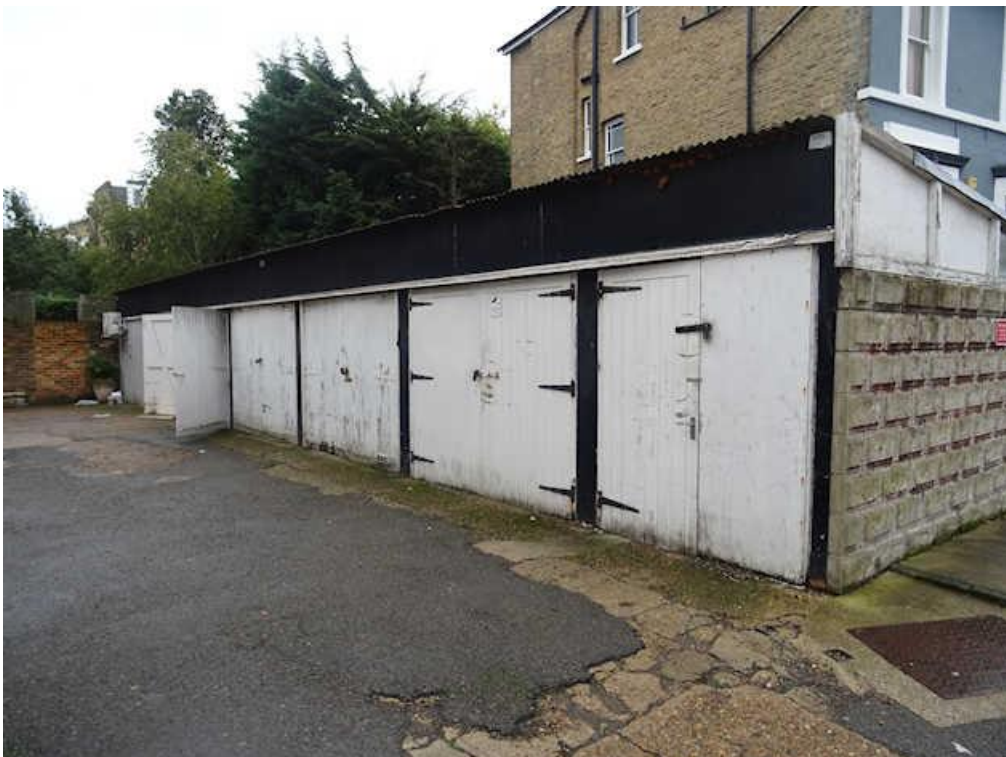
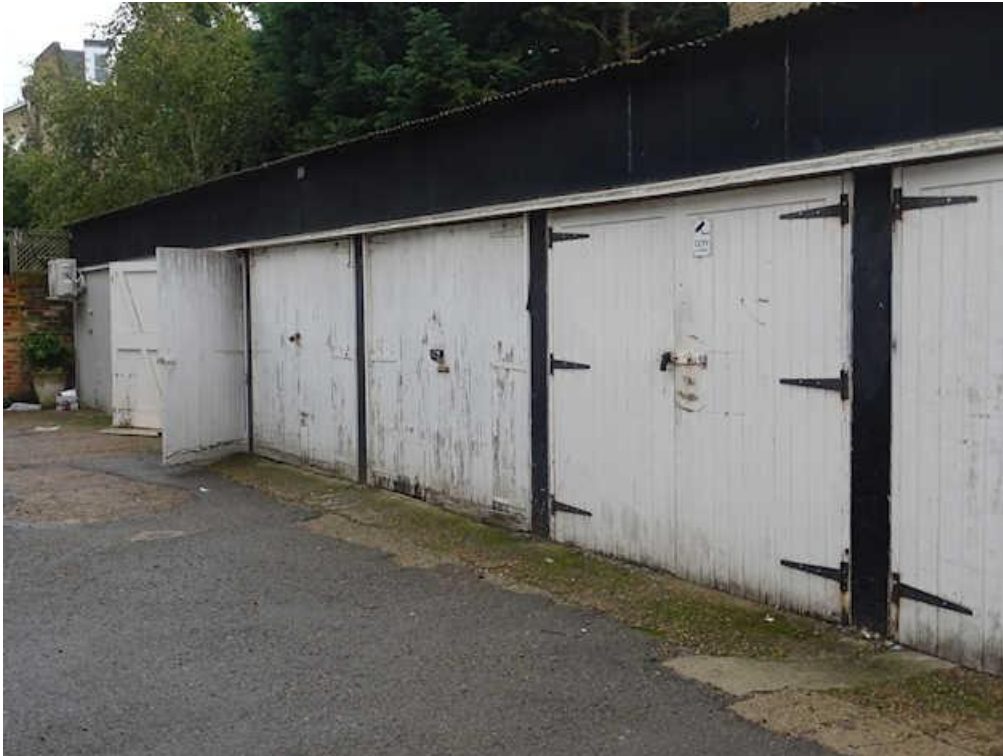
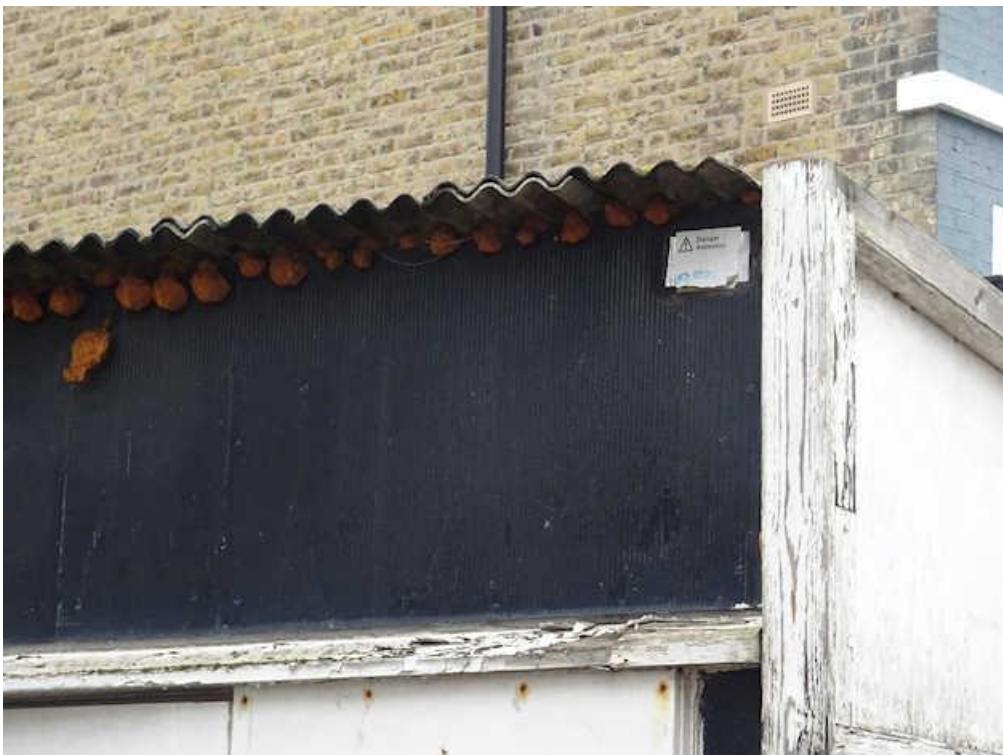
Item	Description	Condition	Photo Ref
1.0	<b>External Areas</b>		
1.1	Elevations - The garages are a single storey storage facility, with a mono pitched roof. The garages are constructed of brickwork and blockwork which is exposed to the right-hand elevation of the building. The front of the building is formed by the timber entrance doors to the garage units and a timber trim with a fascia which notes asbestos stickers along the front, above leading up to the mono pitched roof, which slopes backwards to the rear of the property. There are timber boards forming the right-hand gable, angled down towards the rear of the property. 1 No. gable panel has been replaced with a Perspex unit showing through into the internal parts of the garage, with obscured Perspex finish.	The right-hand elevation blockwork is heavily stained throughout and there are open mortar joints, particularly at high level towards the rear of the property. There is cracking to blockwork to the centre of the right-hand elevation wall. There are missing blockwork sections to the rear upper corner of the right-hand elevation where the brickwork is exposed, which is also heavily stained. The timber frame forming the gable detail at high level to the right-hand elevation is heavily rotten, particularly towards the rear of the property and is stained throughout, with sections of damage particularly to the surfaces. The timber doors to the front property all have areas of rot, particularly at low levels to the frames and to the doors themselves, noting this is consistent along the front elevation of the unit. The fascia is stained and marked throughout and noted to contain asbestos. There is expanding foam along the underside of the roof, coming down the top of the fascia towards the right-hand side of the front elevation. There is heavy rot to the timber trim above the timber entrance doors along the entire elevation, noting this is consistent throughout. The doors are in poor order throughout, with corrosion to the ironmongery, inclusive of hinges, locking mechanisms, etc. The edge of the asbestos roof sheets are uneven to the front elevation of the garages.	1-47

3.0	Conclusion	It is note that the 7 garages are at the end of their usable life. They have asbestos roofs and are not considered watertight. The cost of repairs are economically unviable and they should be demolished.
