## Descriptive Schedule of Condition

of the premises known as  
**Garages at 19-23 Friars Stile Road,  
Richmond, London, T10 6NH**

for and on behalf of  
**Malins Group**

**Ref:** CBS/00753

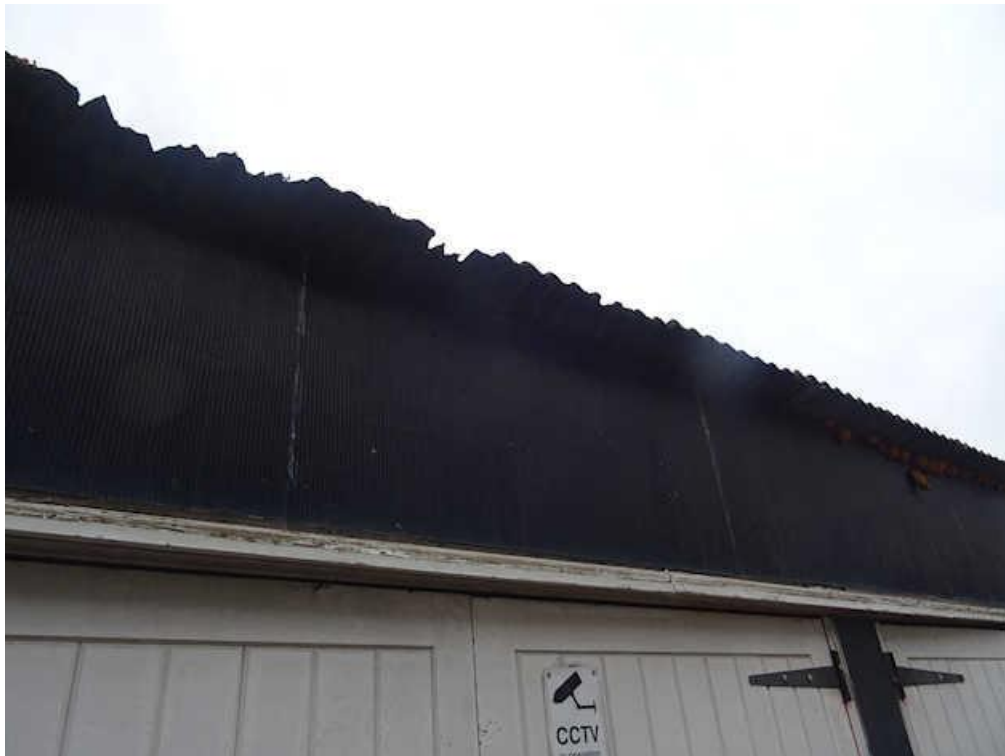
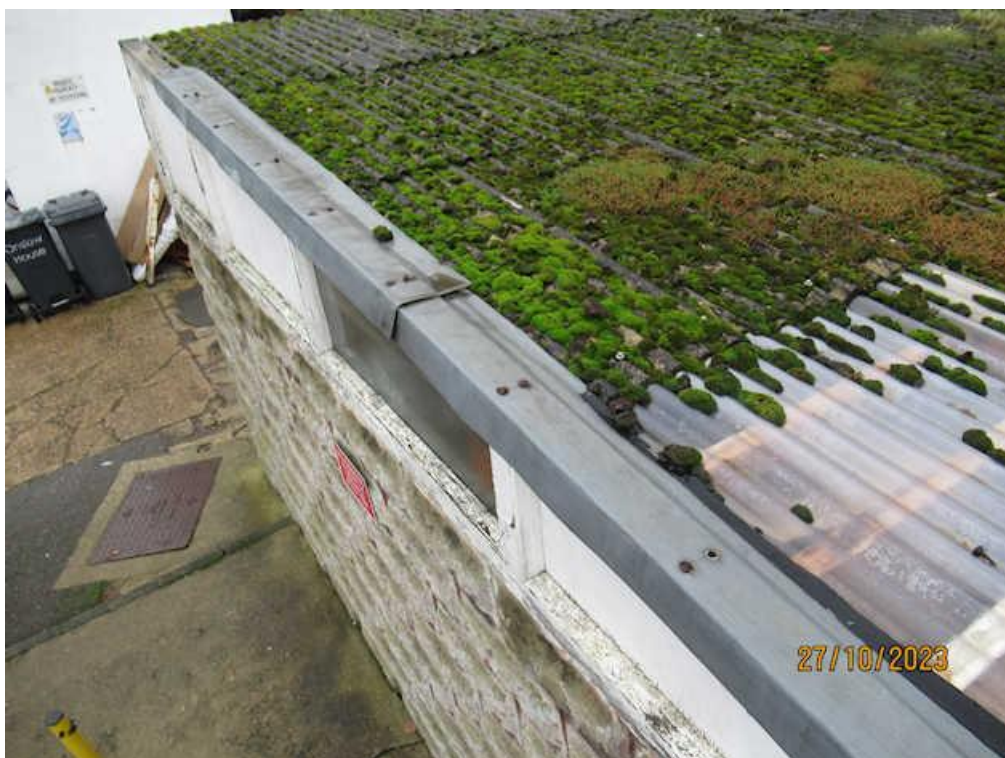
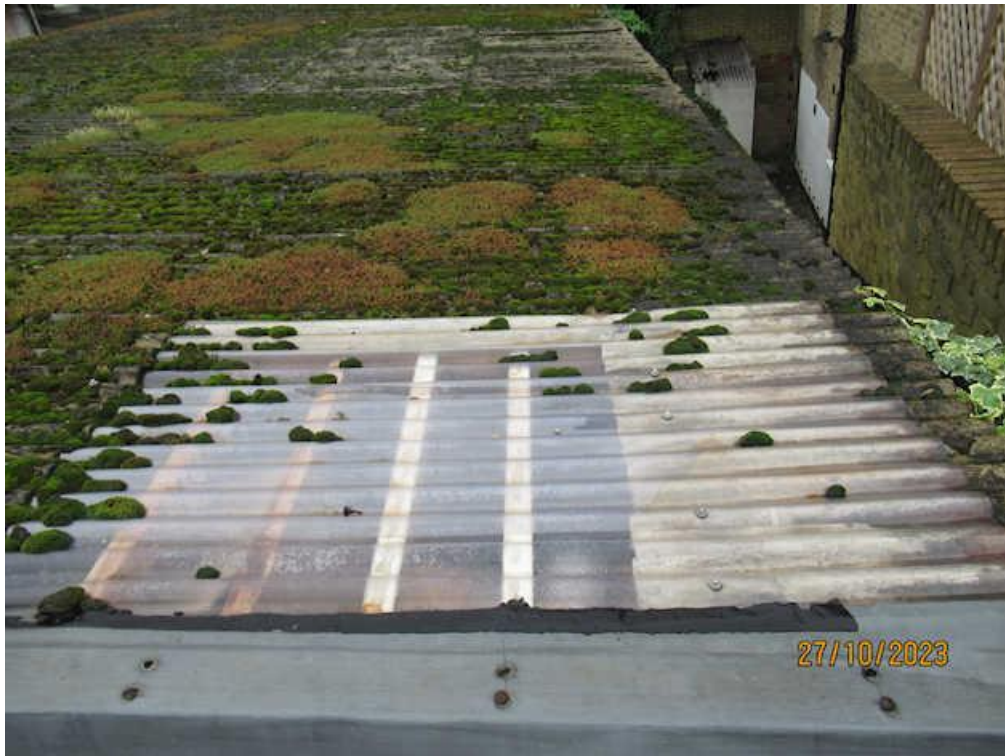
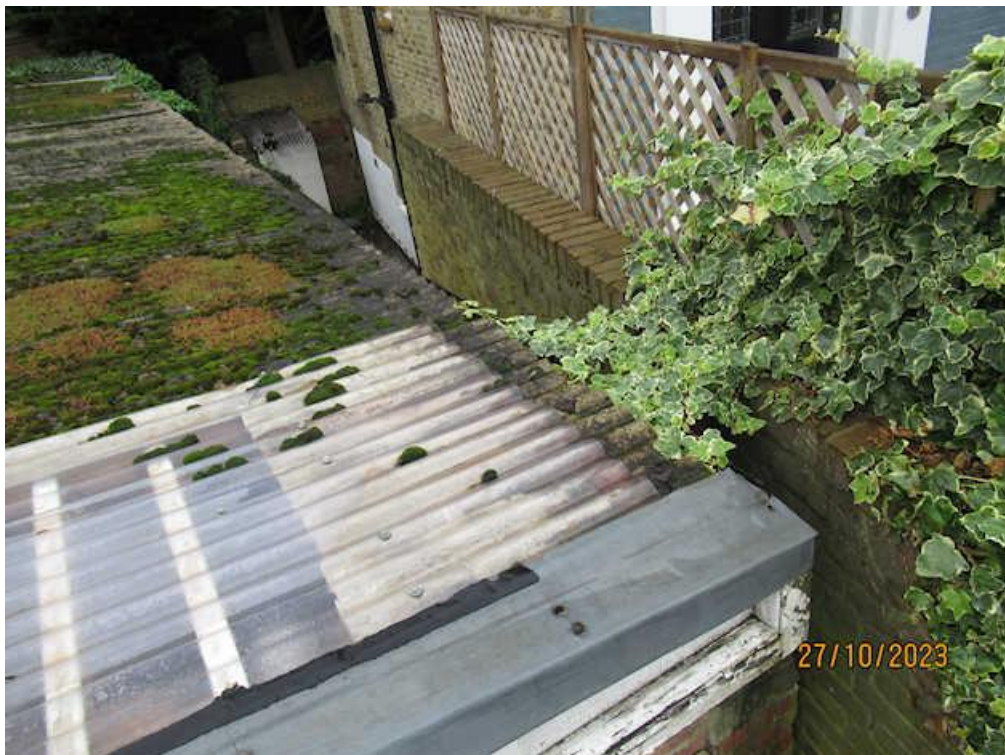
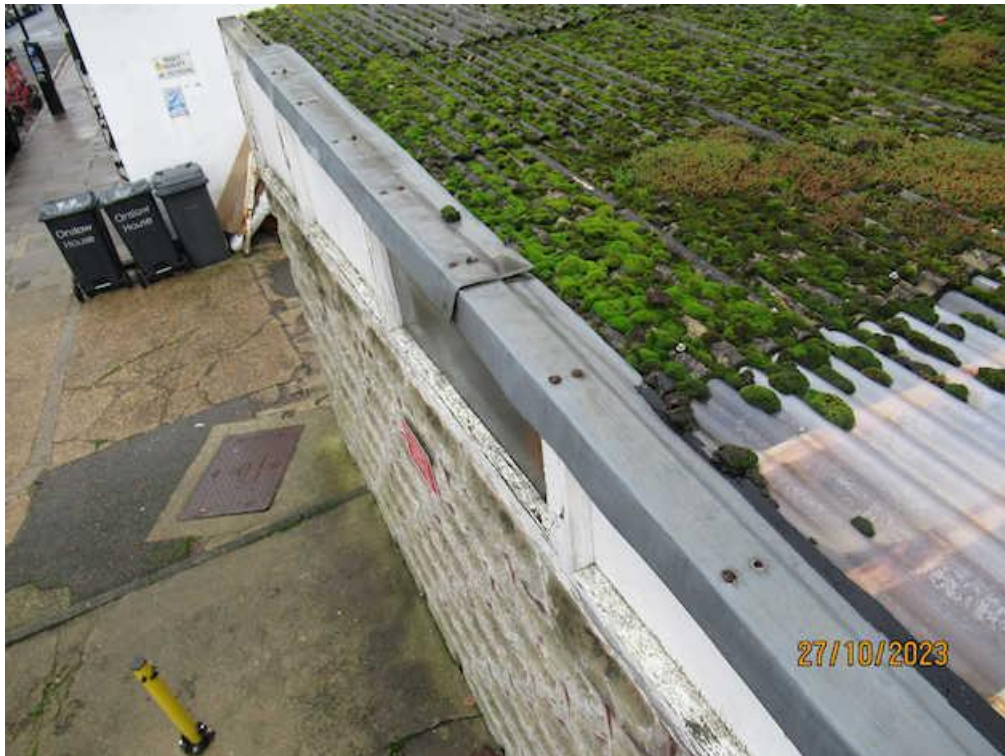
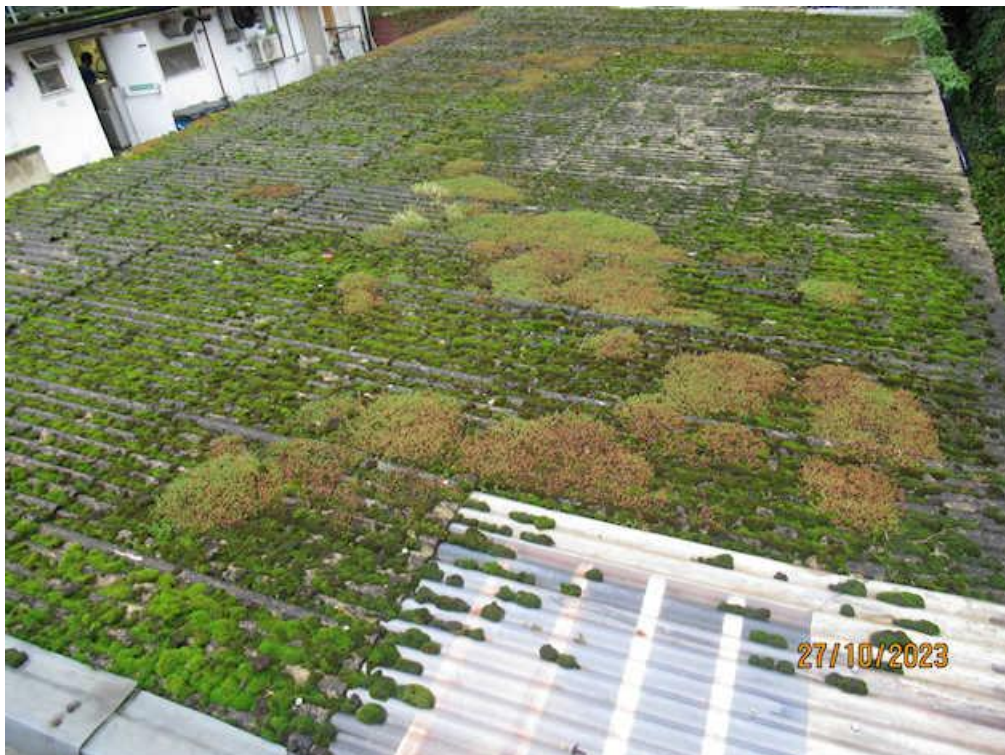
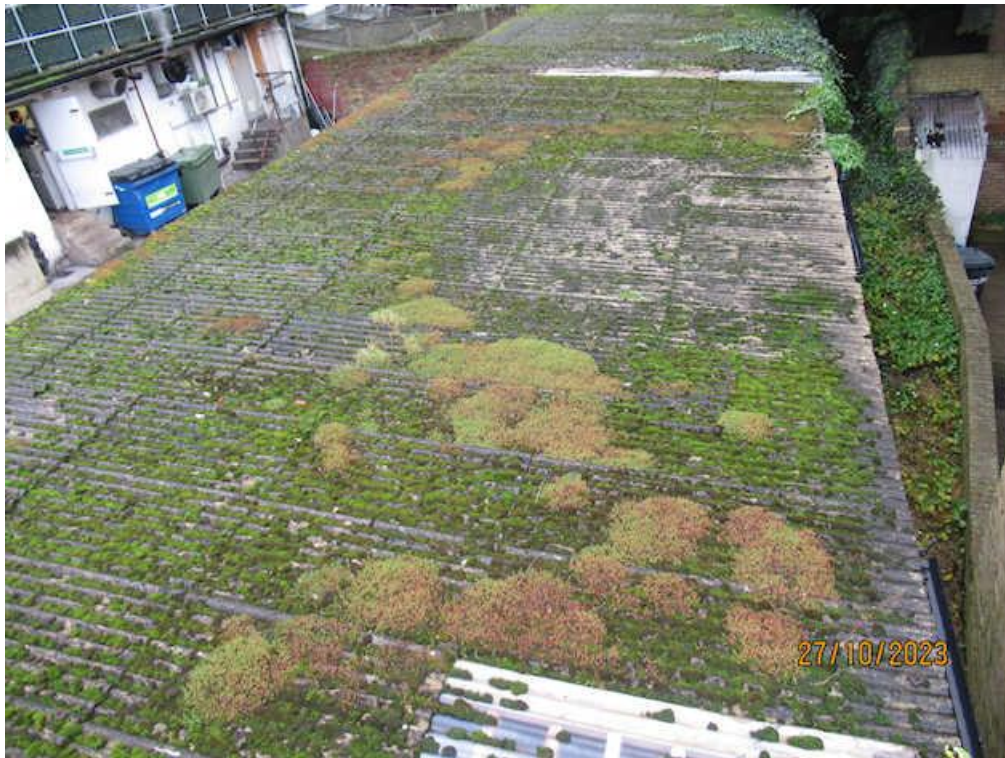
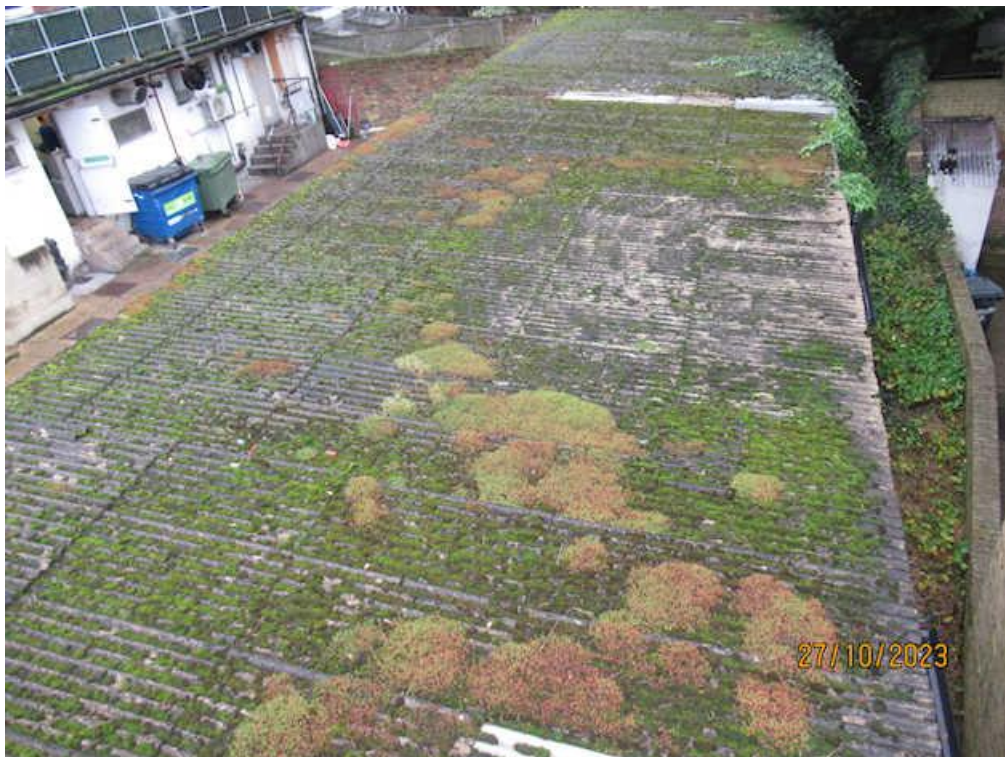
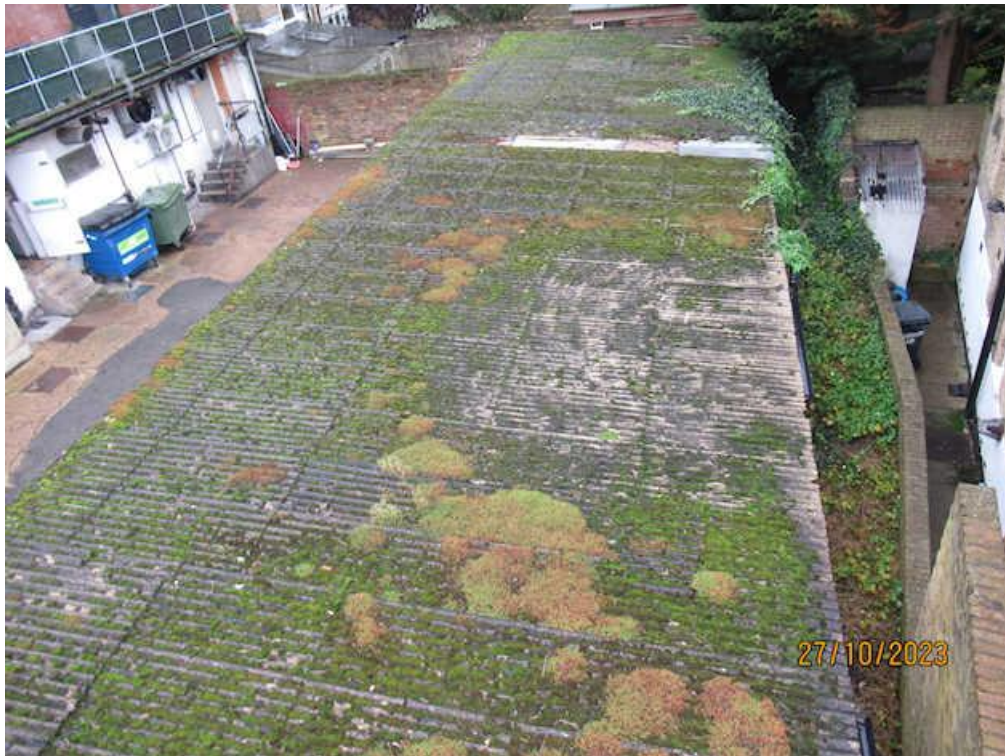
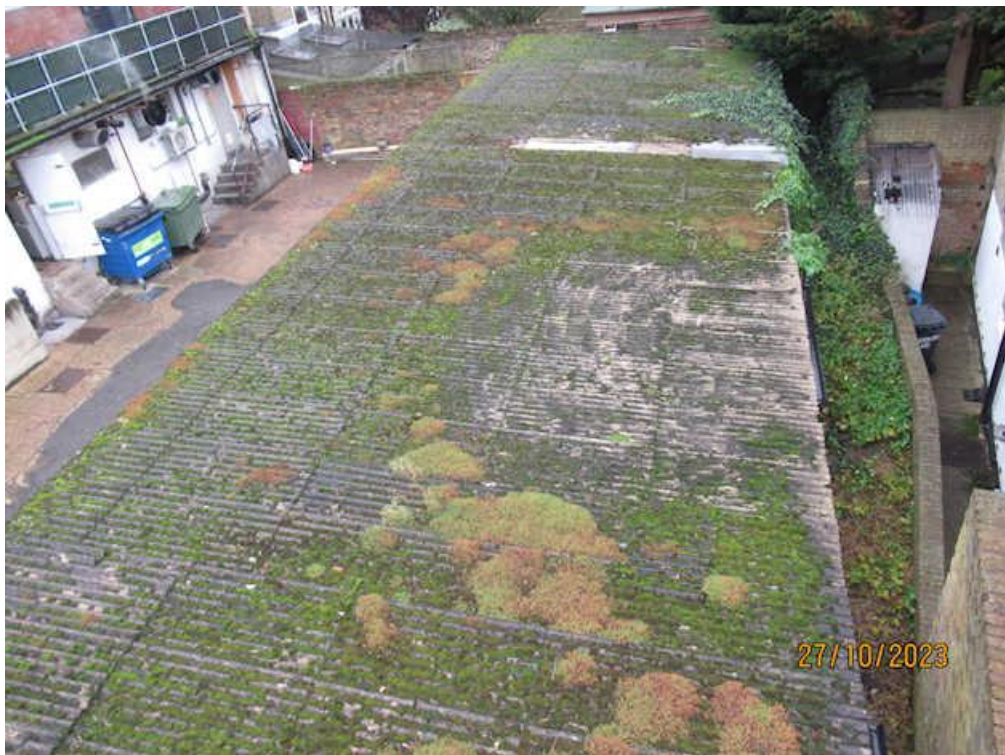
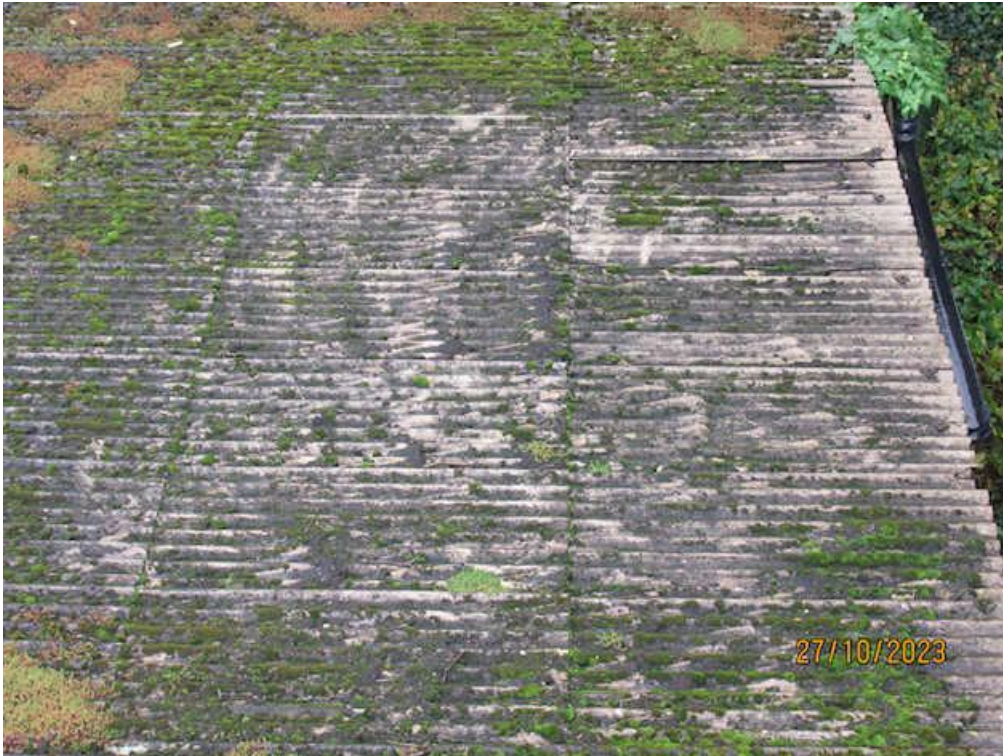
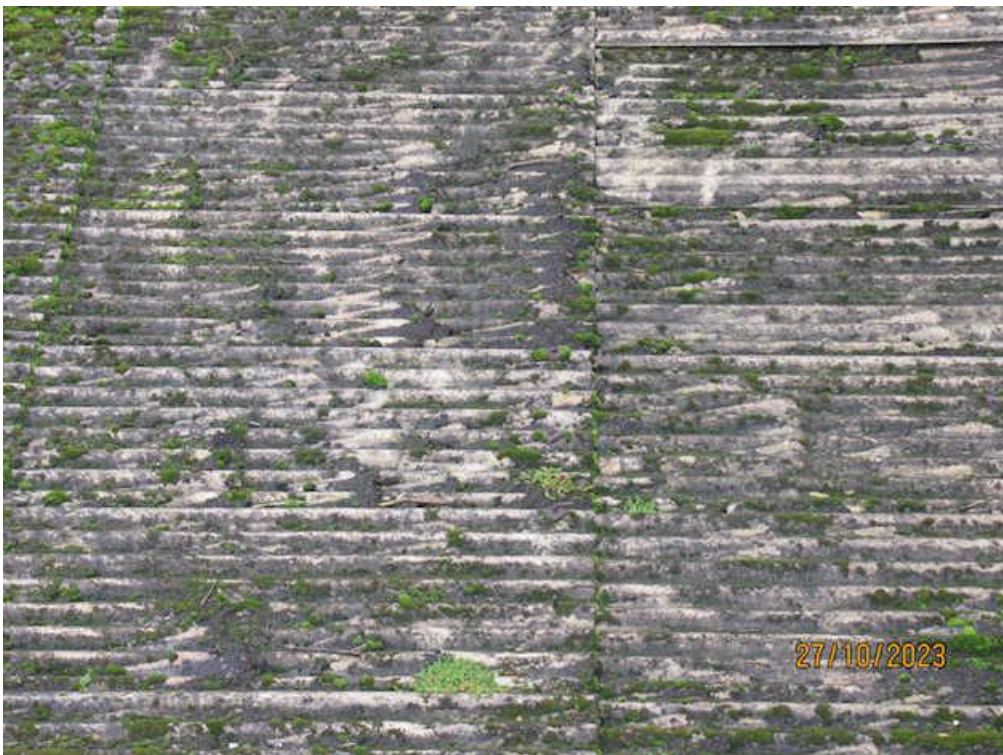
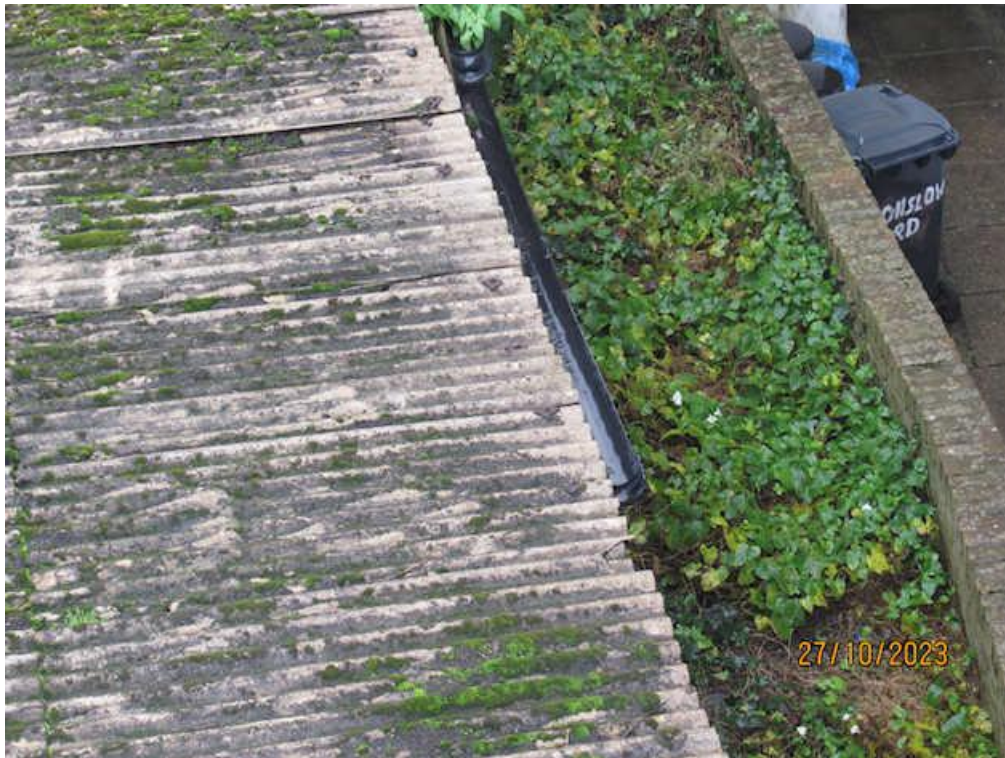
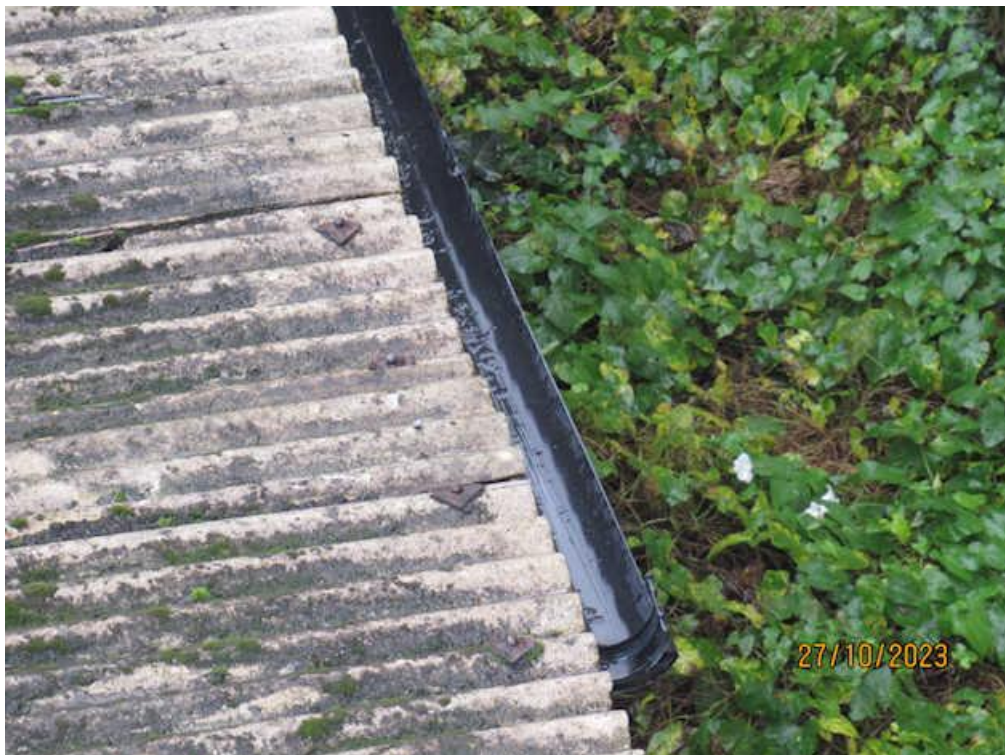
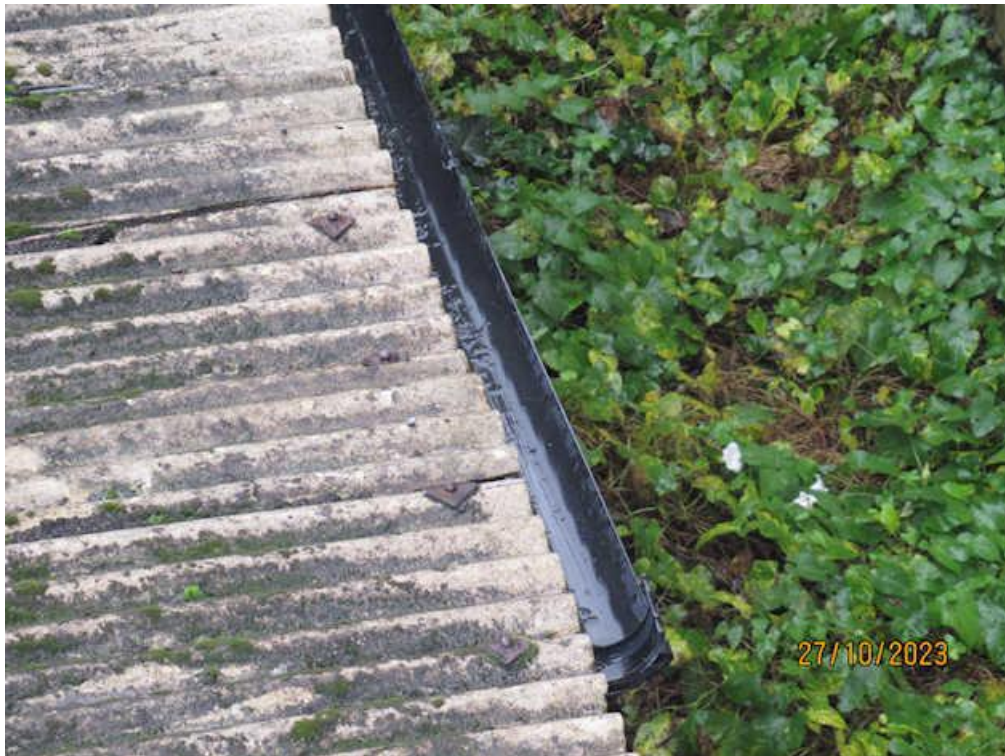
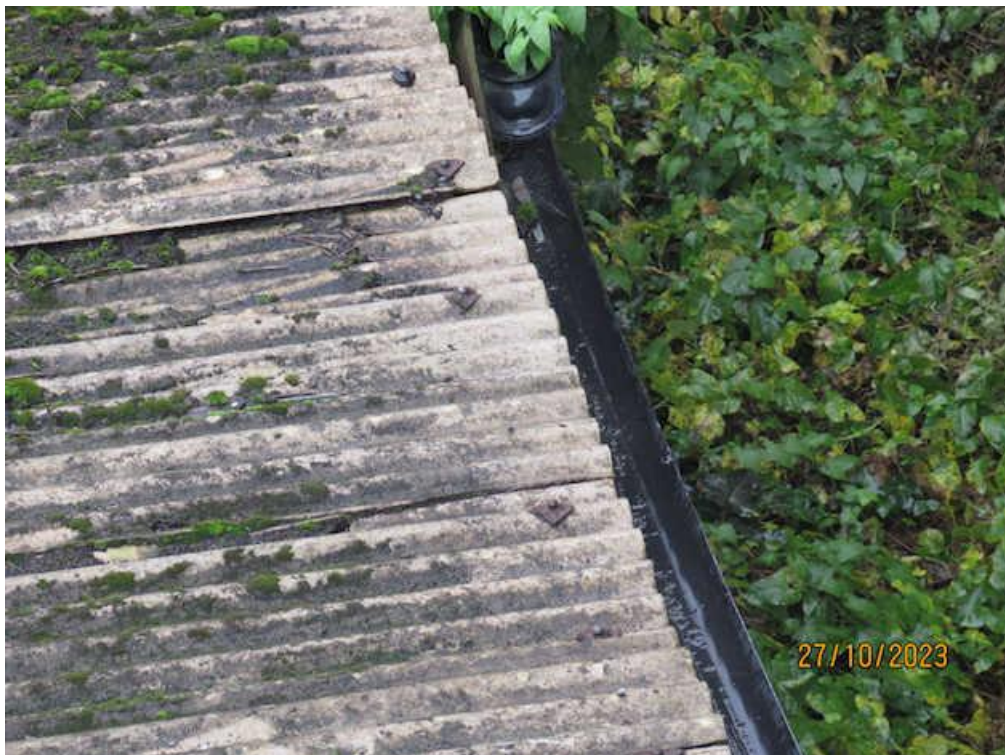
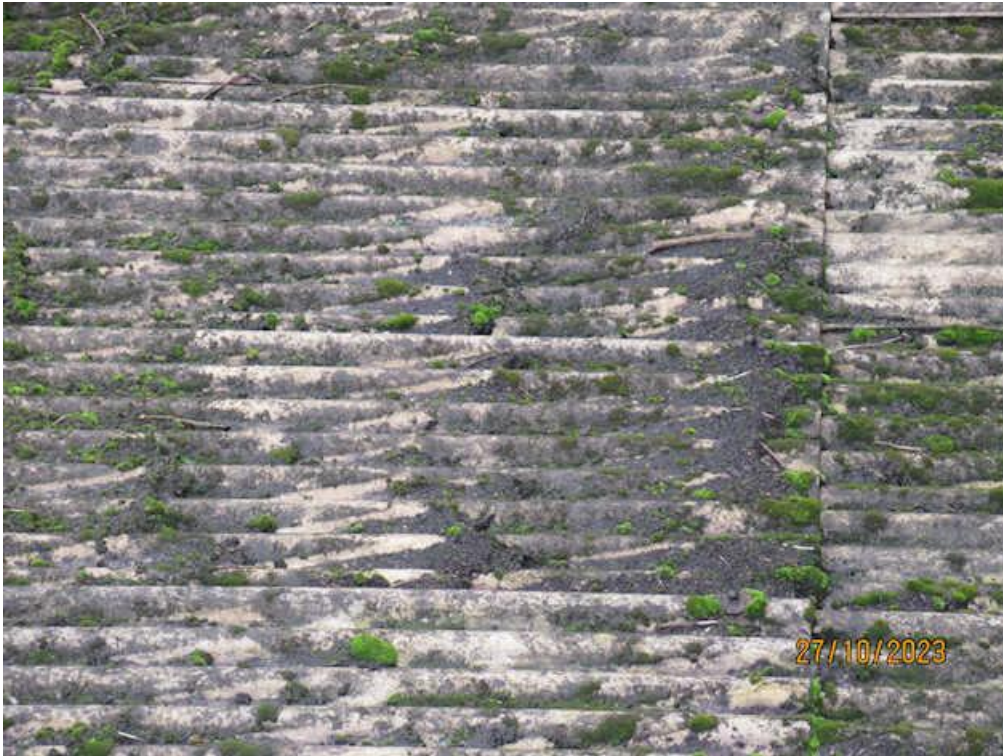
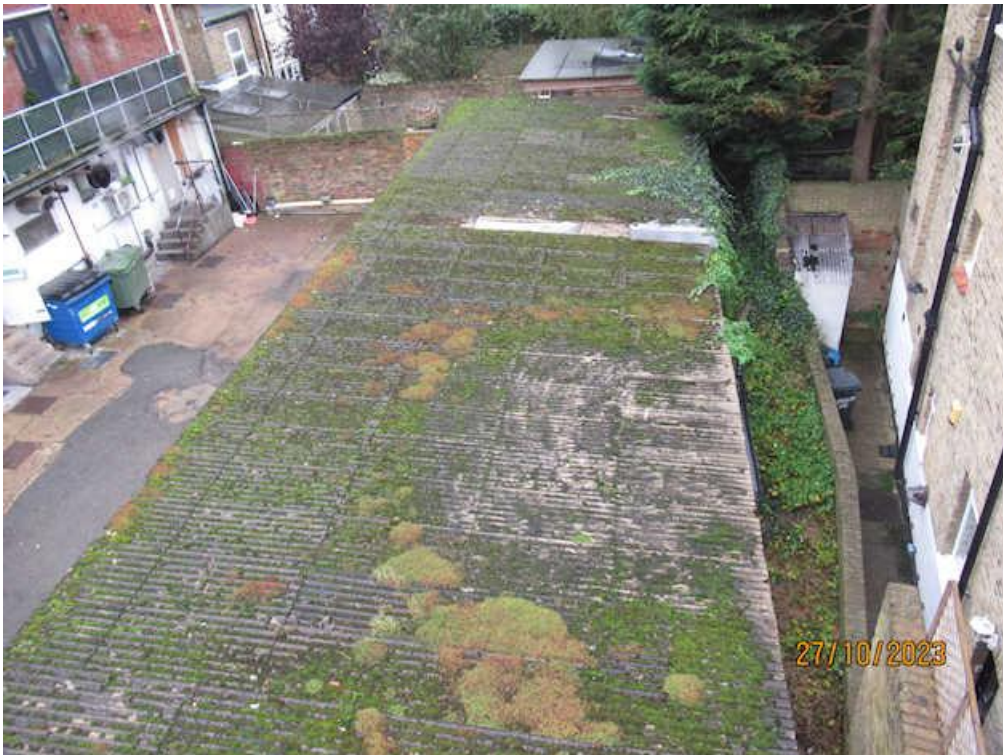
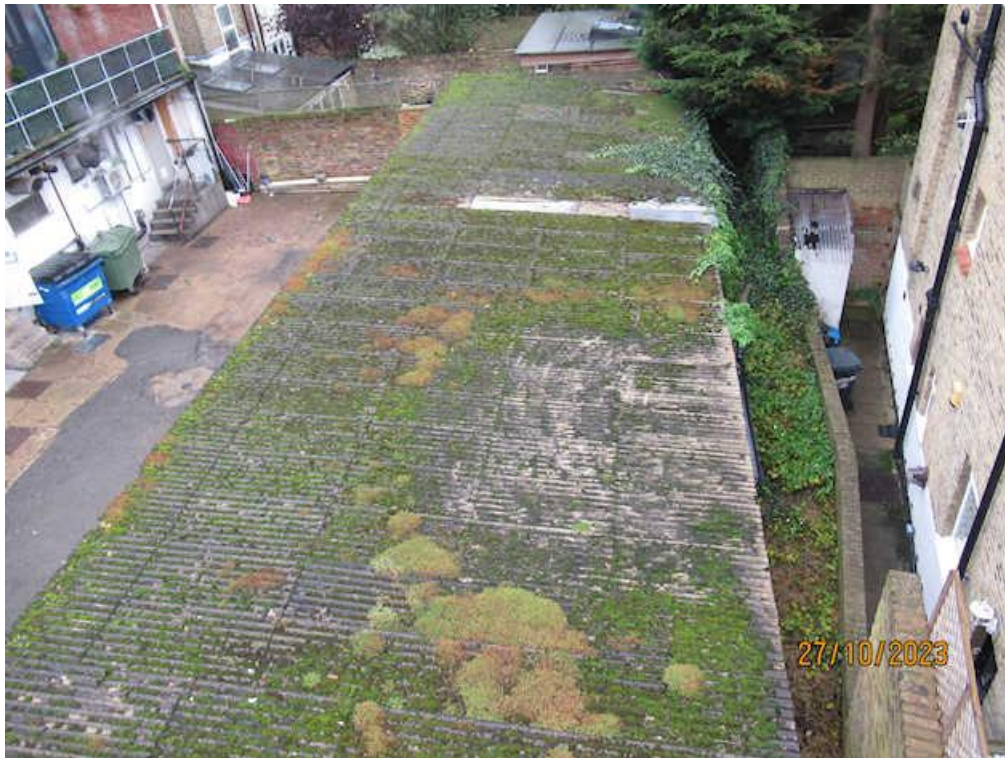
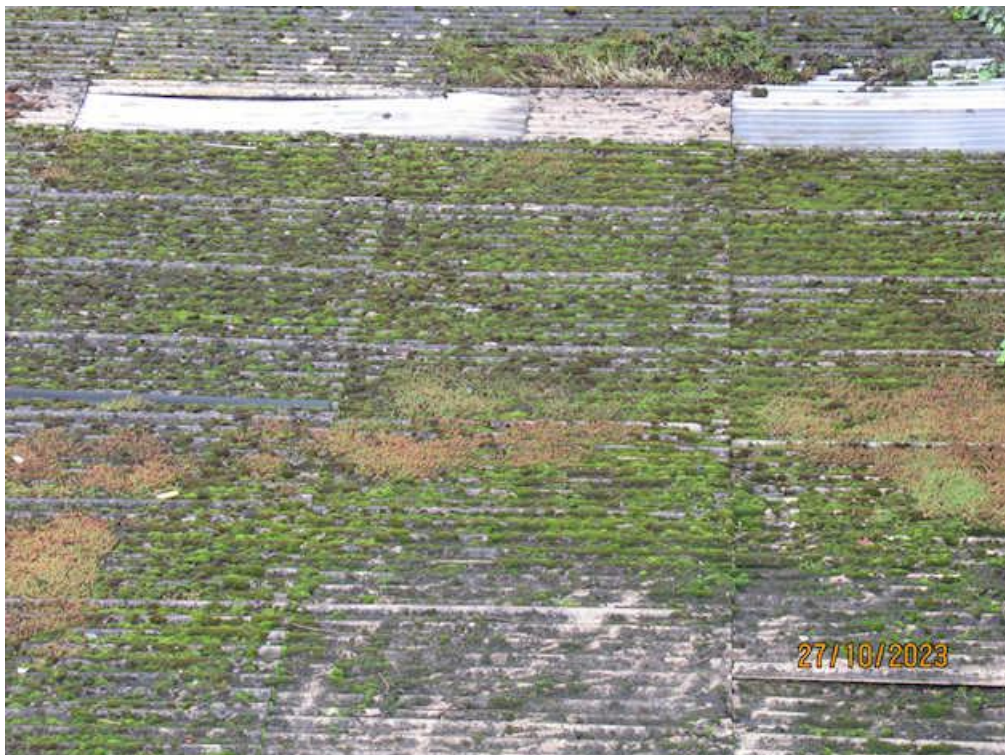
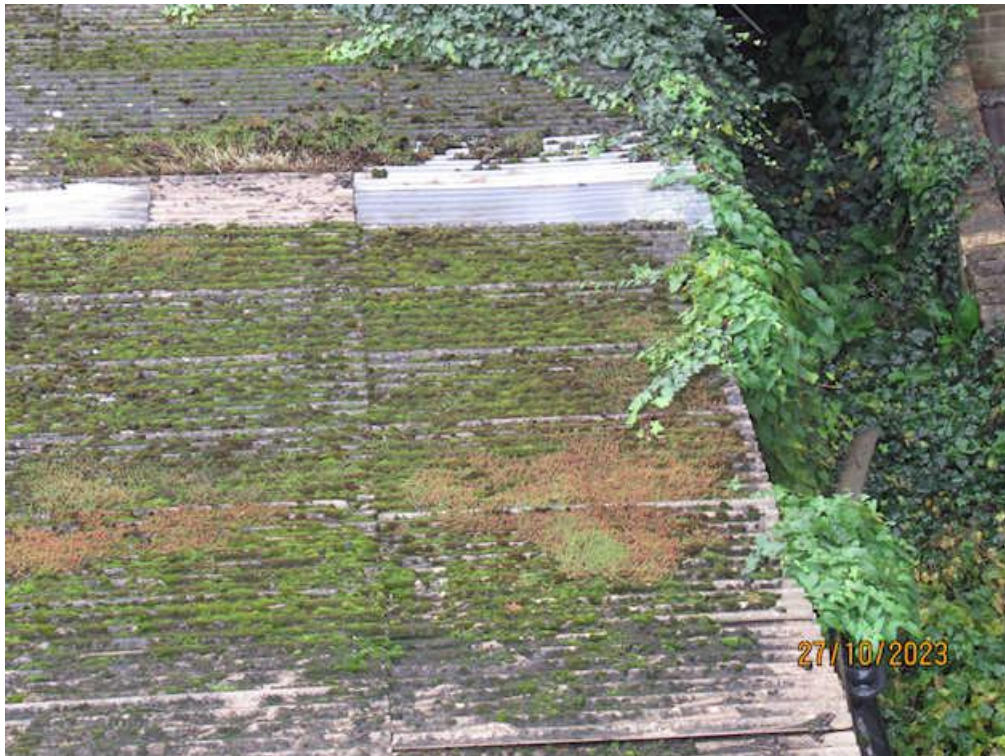
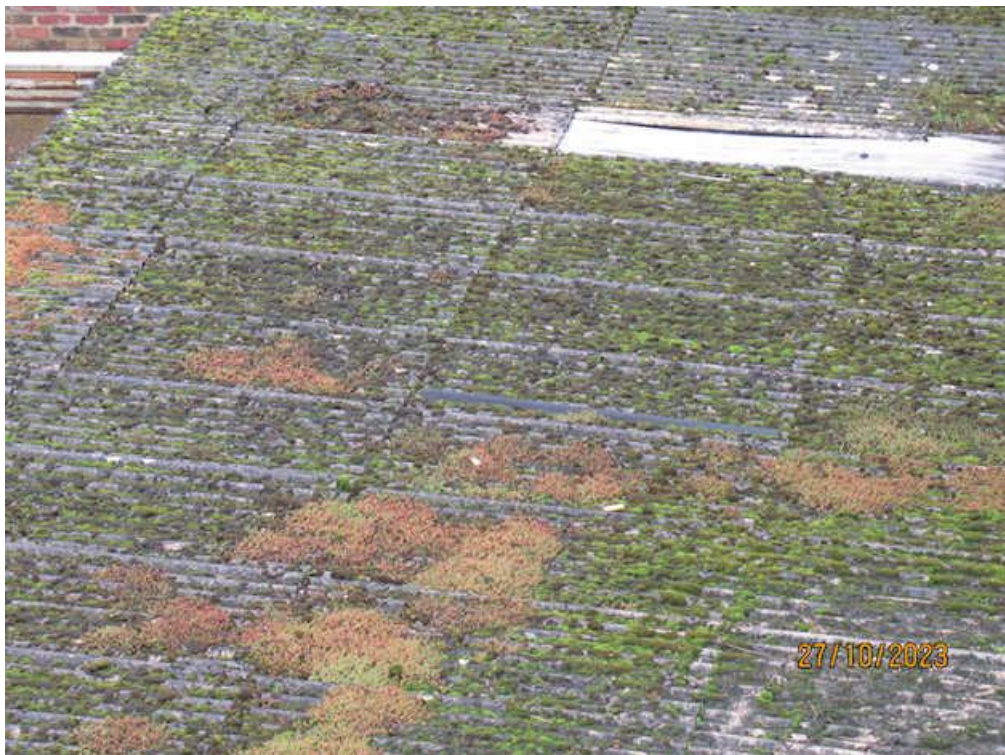
2.0	Roofs – The roof parts to the garages are finished in asbestos roof sheets. There is a section toward the right-hand side of the garages that has been replaced with a plastic Perspex material. There are sections of replacement toward the centre of the roof in a plastic Perspex material	The roof is covered in staining and moss growth throughout. The asbestos sheets are clearly aged and there is corrosion throughout to the fixings. The Perspex sheet is stained in general. There is vegetation overgrowth toward the rear eaves of the roof. The rear plastic gutter detail is damaged with a large section missing to the centre. The replaced sections to the centre of the roofs appear bowed and stained throughout and have been generally fixed poorly. There are areas of damage and breaking to the edges of the asbestos sheets to the front the rear of the roof.	48-70

3.0	Conclusion	It is note that the 7 garages are at the end of their usable life. They have asbestos roofs and are not considered watertight. The cost of repairs are economically unviable and they should be demolished.
