project
HAMPTON WATERWORKS

drawing title
EXISTING DOOR TYPES &
SCHEDULE
KARSLAKE

drawing no. 1685-A-P044

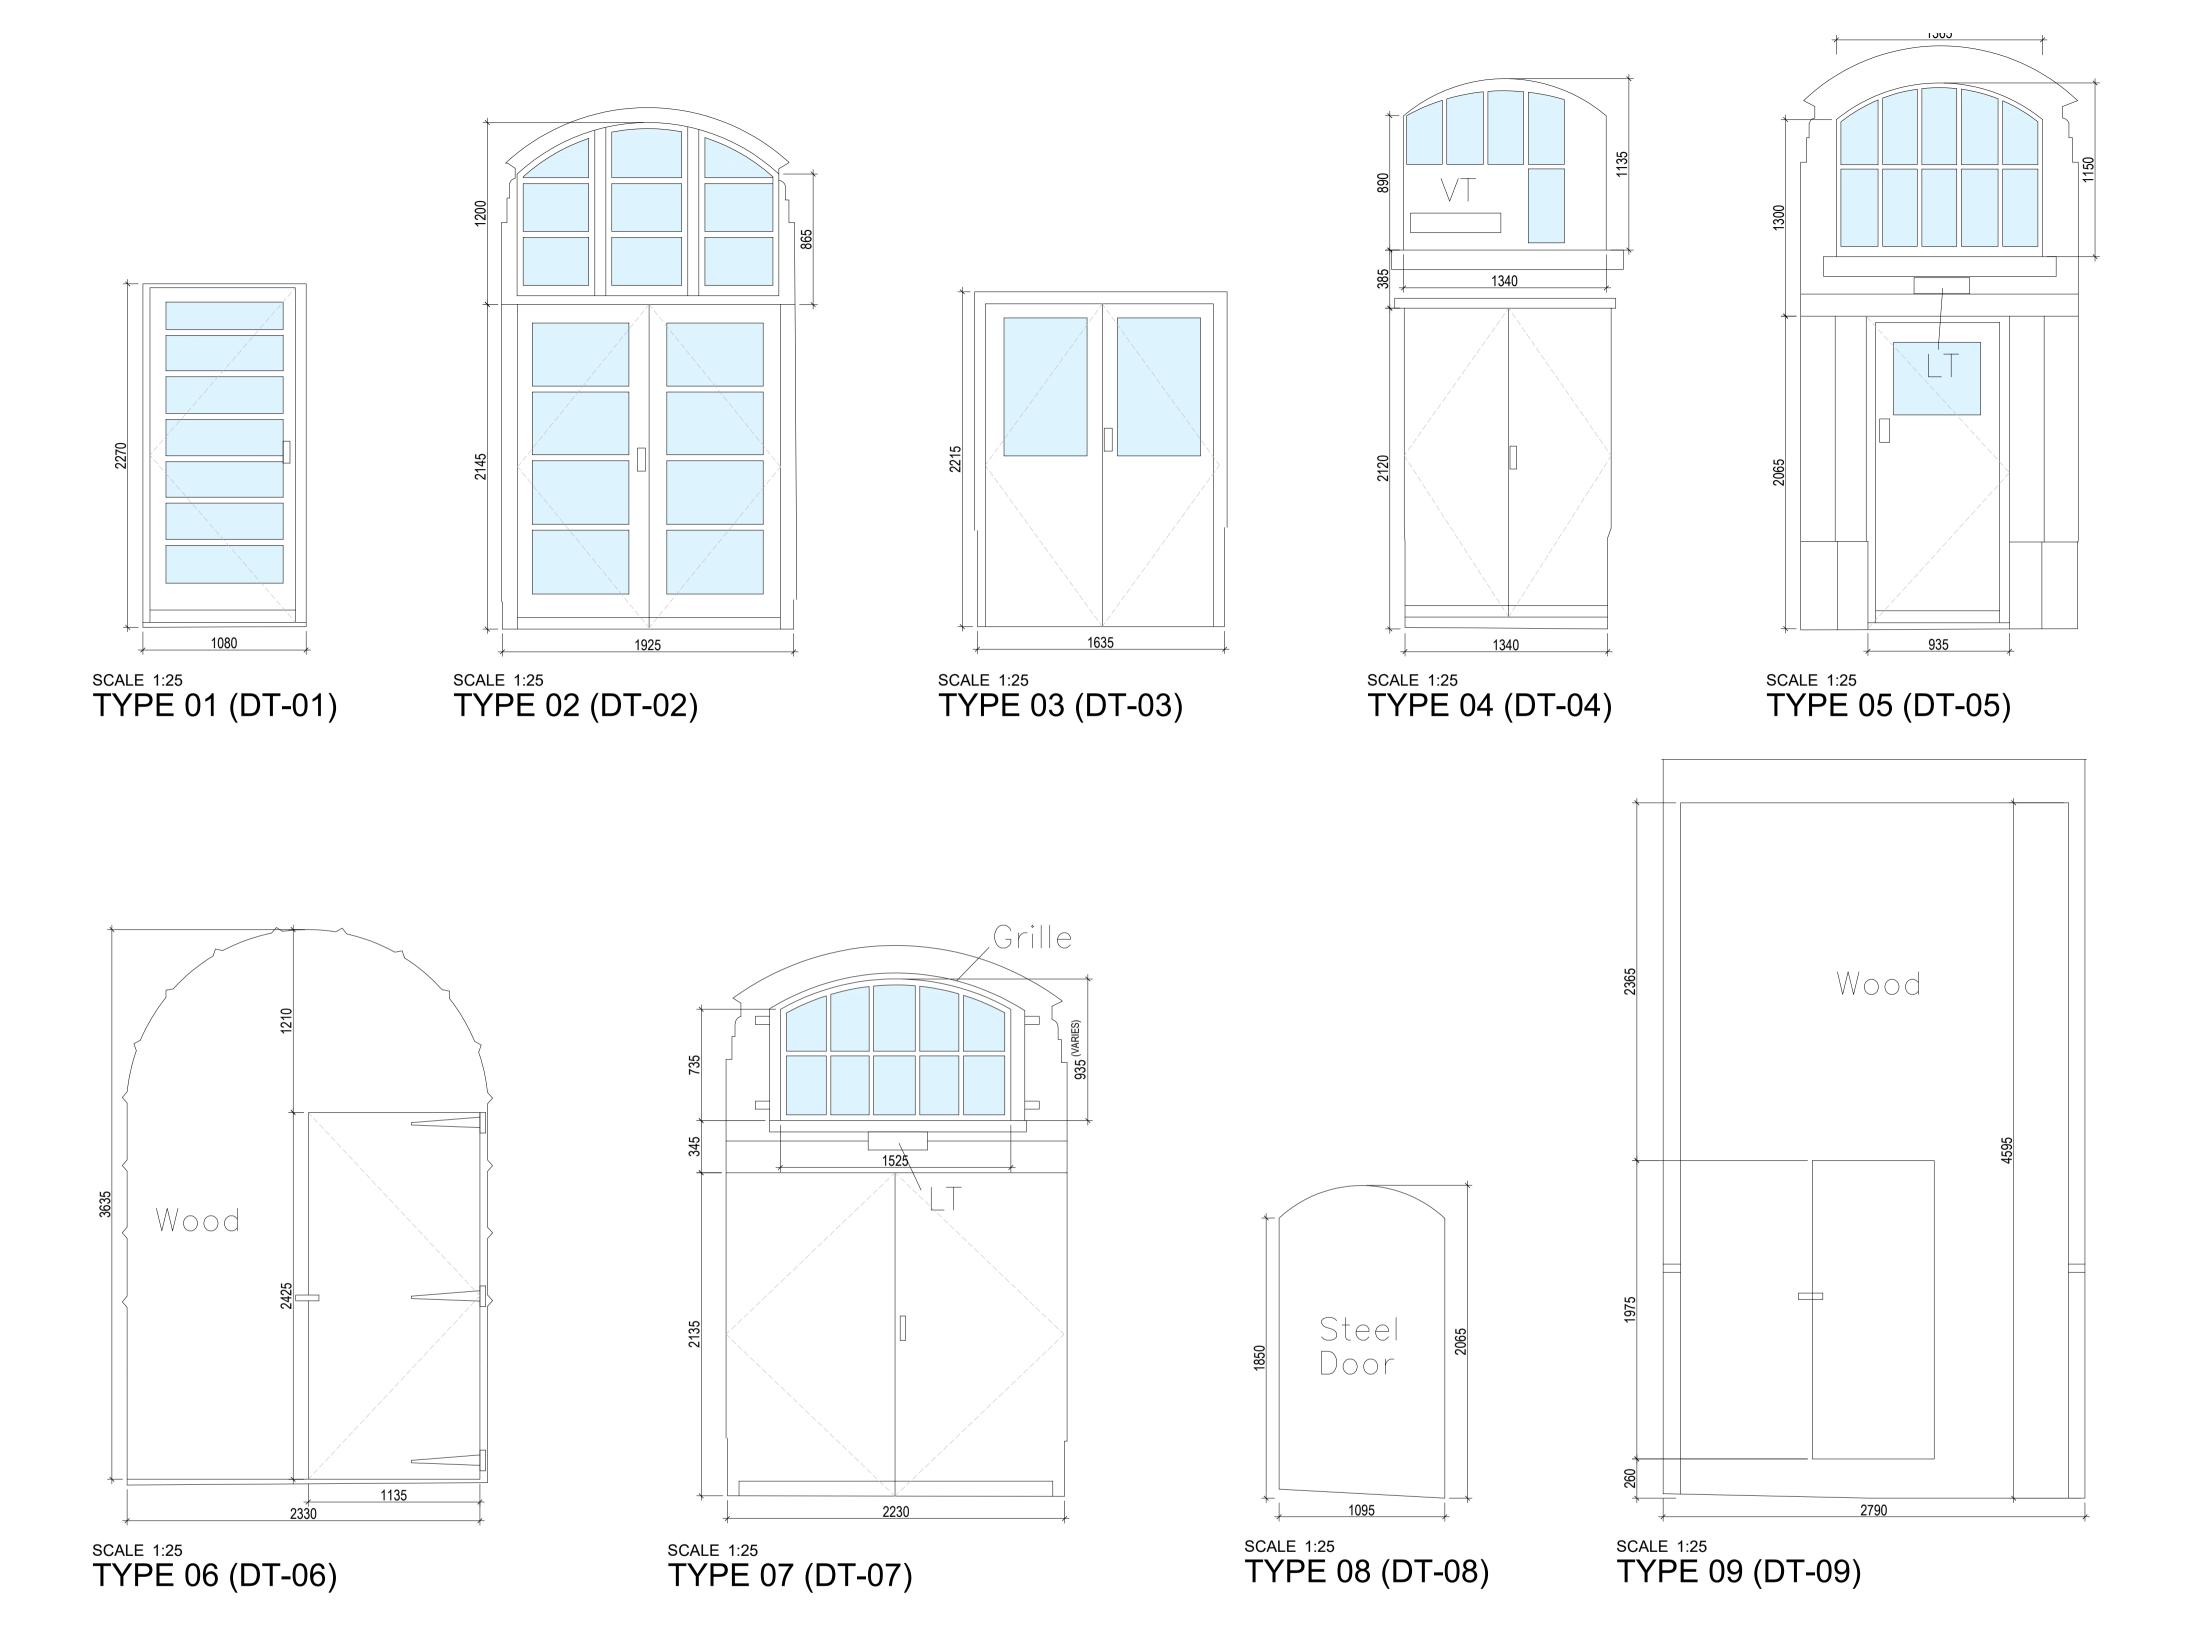
D-04	TYPE 04/ DT-04	KARSLAKE ELEVATION 1	1340	2120	1340 X 2120 PLUS 1200MM IRREGULAR ARCHED TRANSOM WINDOW OVER	DOUBLE	N/A	WOOD	N/A	Y	4	TIMBER, PAINT DEFECTS	REPLACED WITH PROPOSED NEW DOOR & WINDOW OVER DOOR TYPE 19, D-52 & WINDOW TYPE 27, W-102	N/A	-	D-04. REFER TO 1685-A-607	EARLY-TWENTIETH CENTURY
D-05	TYPE 05/ DT-05	KARSLAKE ELEVATION 1	935	2065	935 X 2065 PLUS TRANSOM WINDOW OVER 1365N WIDE BY 1150MM HIGH	M SINGLE	N/A	WOOD	SINGLE	N	4	TIMBER, PAINT DEFECTS, GLAZING	REPLACED WITH PROPOSED NEW DOOR & WINDOW OVER DOOR TYPE 19, D-53 & WINDOW TYPE 27, W-103	N/A	-	D-05. REFER TO 1685-A-607	EARLY-TWENTIETH CENTURY
D-06	TYPE 06/ DT-06	KARSLAKE ELEVATION 2	2330	3635	2330 X 3635 ARCHED EXISTING OPENING - EXISTING DOOR = 1135 X 2425	SINGLE - LARGE OPENING	N/A	WOOD	N/A	N	4	TIMBER, PAINT DEFECTS	REPLACED WITH PROPOSED NEW WINDOW. TYPE 31, W-117	N/A	-	D-06. REFER TO 1685-A-607	EARLY-TWENTIETH CENTURY

D-07	TYPE 07/ DT-07	KARSLAKE ELEVATION 3	2230	2135	2230 X 2135 WITH ARCHED TRANSOM WINDOW OVER 1525MM WIDE BY 935MM HIGH	DOUBLE	N/A	WOOD	N/A	N	3	PAINT DEFECTS	REPLACED WITH PROPOSED NEW DOOR. TYPI 22, D-57	E N/A	-	D-07. REFER TO 1685-A-607	EARLY-TWENTIETH CENTURY
D-08	TYPE 07/ DT-07	KARSLAKE ELEVATION 4	2230	2135	2230 X 2135 WITH ARCHED TRANSOM OVER WINDOW 1525MM WIDE BY 935MM HIGH	DOUBLE	N/A	WOOD	N/A	N	2	PAINT DEFECTS	DEMOLISHED & OPENING IN-FILLED WITH MATCHING BRICKWORK	N/A	-	D-08. REFER TO 1685-A-607	EARLY-TWENTIETH CENTURY
D-09	TYPE 09/ DT-09	KARSLAKE ELEVATION 5	2790	4595	2790 X 4595	SINGLE - LARGE OPENING	N/A	WOOD	N/A	N	4	PAINT DEFECTS	REPLACED WITH PROPOSED NEW DOOR. TYPI 22, D-59	E N/A	-	D-09. REFER TO 1685-A-607	EARLY-TWENTIETH CENTURY
D-10	TYPE 08/ DT-08	KARSLAKE ELEVATION 5	1095	1850 / 2065	1095 X 1850 / 2065 (TOP OF ARCH)	SINGLE	TBC	STEEL	N/A	N/A	TBC	TBC	RETAINED / REPAIRED	N/A	-	TBC	EARLY-TWENTIETH CENTURY
